STATE OF CALIFORNIA
CALIFORNIA NATURAL RESOURCES AGENCY
DEPARTMENT OF WATER RESOURCES
DIVISION OF SAFETY OF DAMS

INSPECTION OF DAM AND RESERVOIR IN CERTIFIED STATUS

Name of Dam San Joaquin Reservoir Dam No. 1029 County Orange
 Type of Dam Earth Type of Spillway Drop Inlet
 Water is 1.3 feet below spillway crest and 6.8 feet below dam crest.
 Water Surface Elevation EI. 469.2'
 Weather Conditions Sunny
 Contacts Made Danielle Drake and Bill Wesson with IRWD
 Reason for Inspection Periodic Maintenance Inspection

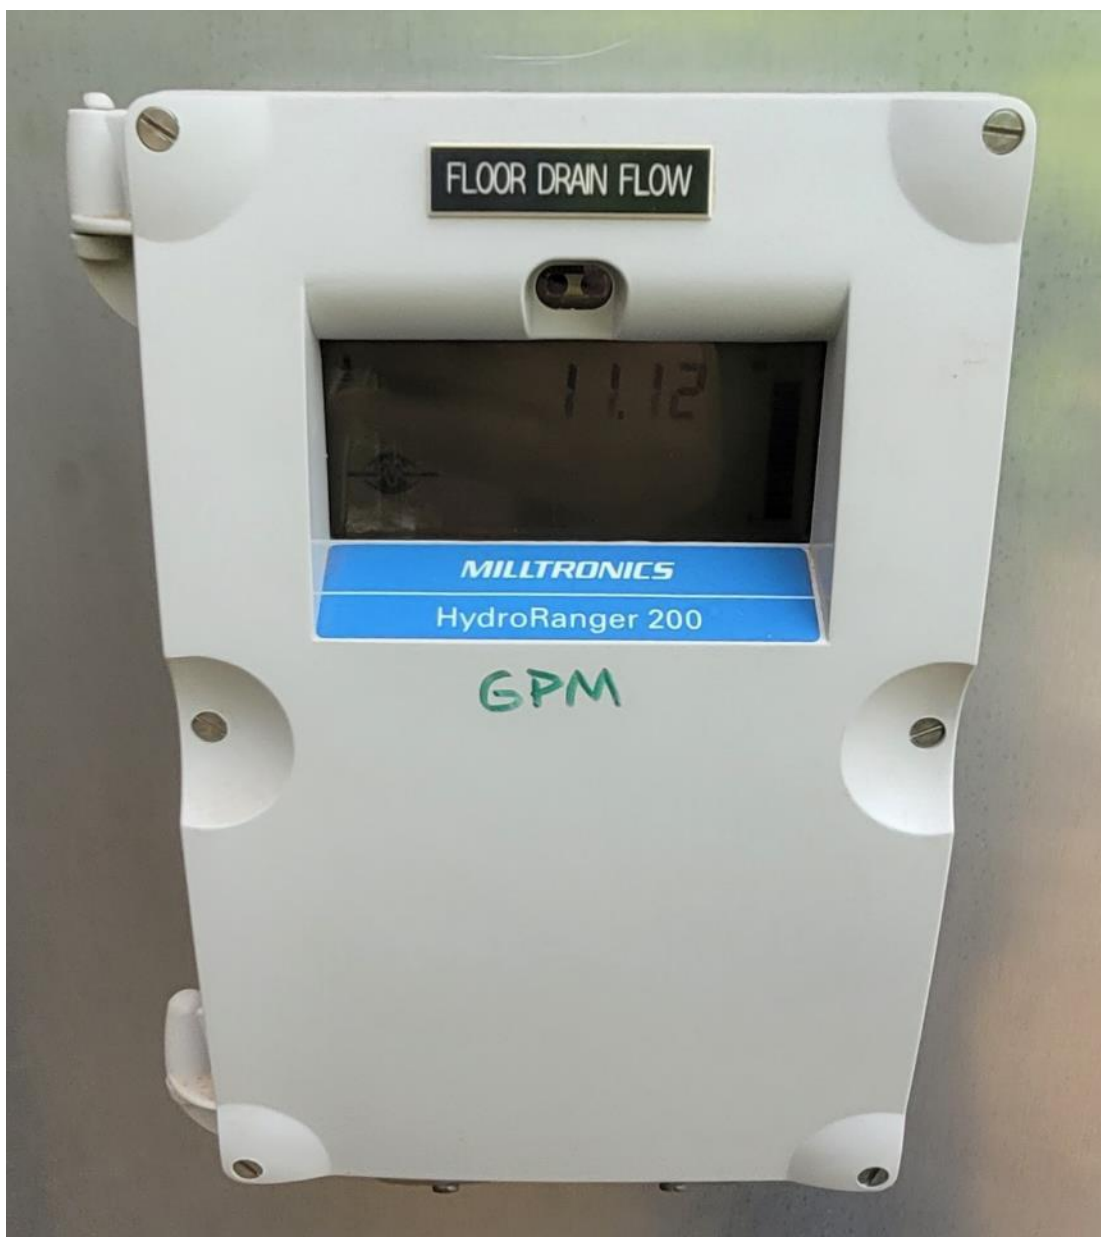
All flows appeared clear and within historical ranges for this reservoir, except for the Floor seepage point reading (see Instr. section below for details).

The floor seepage ranges from approximately 1 GPM to 5.5 GPM shown in instrumentation report. However, in the inspection conducted on June 13, 2022, it was reported that the floor seepage point showed 11.5 GPM. Also, during this maintenance inspection on April 18, 2023, it showed that the floor seepage point was reading 11.12 GPM (Photo 1). There is a discrepancy in the data reported from the DSOD field inspections and the annual instrumentation report submitted by the owner. The owner needs to investigate this discrepancy and ensure that the field data matches the data reported.

Photo 1: View of the floor drain seepage showing 11.12 GPM.

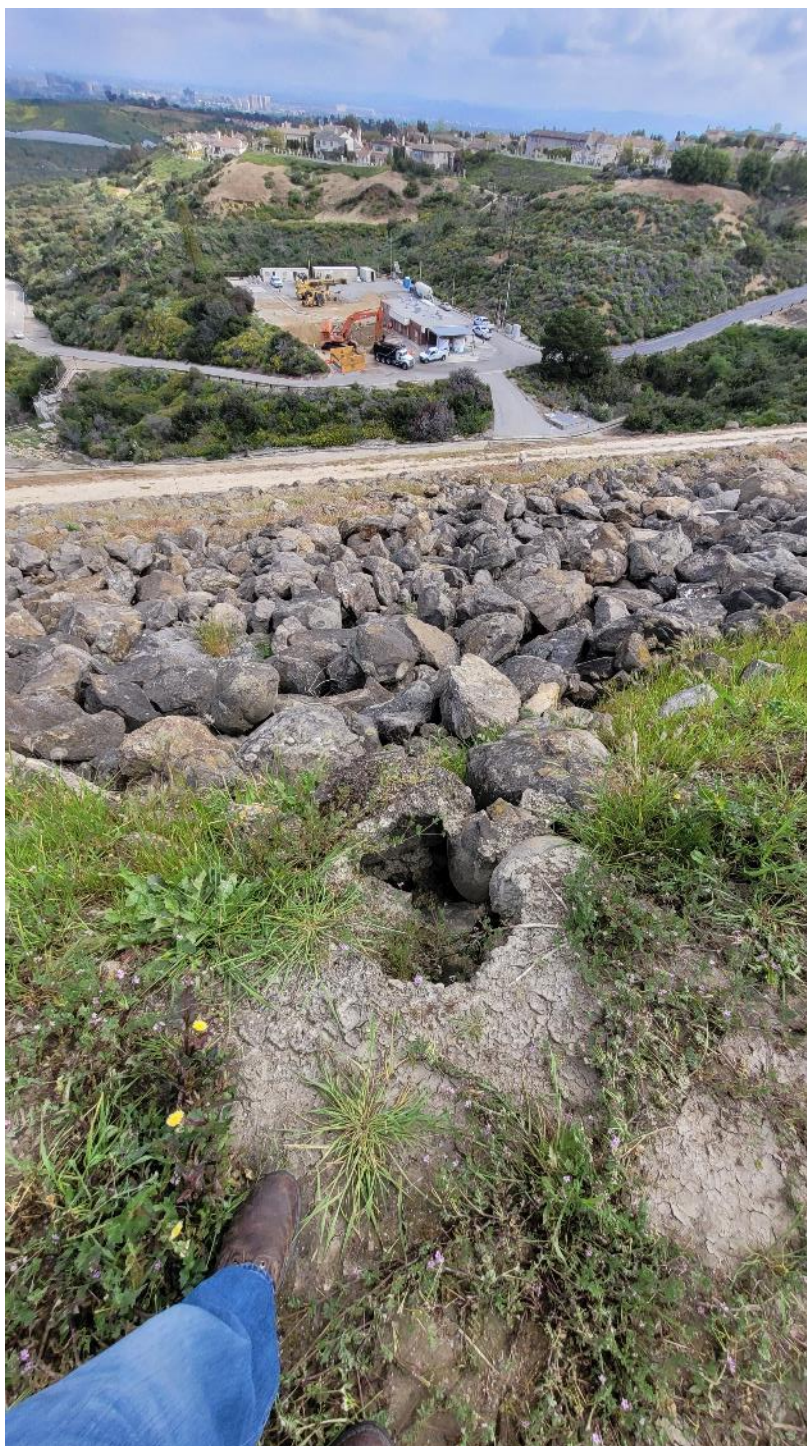
<u>Dam</u>	The crest appeared level and well-aligned. Overall, the asphalt-lined upstream slope, and the earthen downstream slope appeared uniform, stable, and in satisfactory condition. There is some minor erosion on one of the benches on the downstream slope. The owner needs to backfill and compact erosion rills as they appear as an ongoing maintenance item. The groins, downstream toe, and abutments appeared satisfactory with no signs of instability or distress. The vegetation is well managed with periodic vegetation control from the owner. The rodent control is satisfactory with no signs of rodent activity.
<u>Spillway</u>	The spillway approaches and entrances of both drop inlets were clear of debris. The concrete elements of the drop inlets appeared to be in satisfactory condition. The exit of the spillway was clear and unobstructed.
<u>Outlet</u>	The outlet consists of 5 upstream butterfly valves and 2 downstream butterfly valves. All valves were fully cycled in DSOD's presence on October 19, 2020, besides one of the upstream butterfly valves. The 48-inch upstream butterfly valve at elevation 443 feet was inoperable and remains unchanged during this inspection. The owner plans to repair the valve by the end of 2023. The owner last fully cycled the operable valves on May 25, 2022. The owner will need to fully cycle all valves during the next maintenance inspection.

Photo 2: View of the erosion rill on one of the downstream benches.

- The owner needs to continue the following as ongoing maintenance items:
 - Backfill and compact erosion rills as they appear.
 - Maintain the pneumatic piezometers to ensure accurate readings.
- For future instrumentation reports, the owner needs to complete the following:
 - Rain data needs to be incorporated into the piezometer data plots.
 - Ensure that the field data and the report data match in regard to the Floor seepage point.
- The owner will need to fully cycle all valves during the next maintenance inspection.

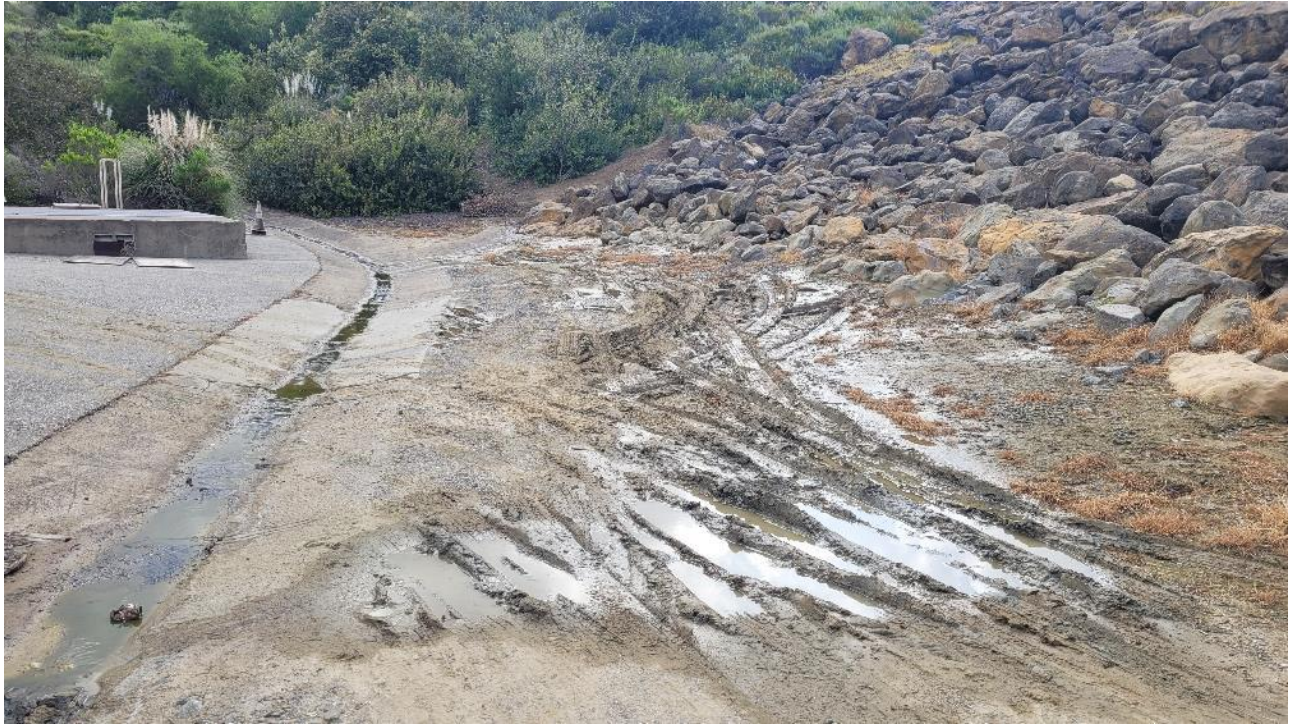
<u>Seepage</u>	There were wet spots along the benches of the dam that appeared to be seepage. Mr. Wesson stated that the wet spots were only due to recent rainfall. This dam has 8 seepage points that are reported in the annual instrumentation report.

Photo 3: View of the seepage and rain collected at the toe of the dam.

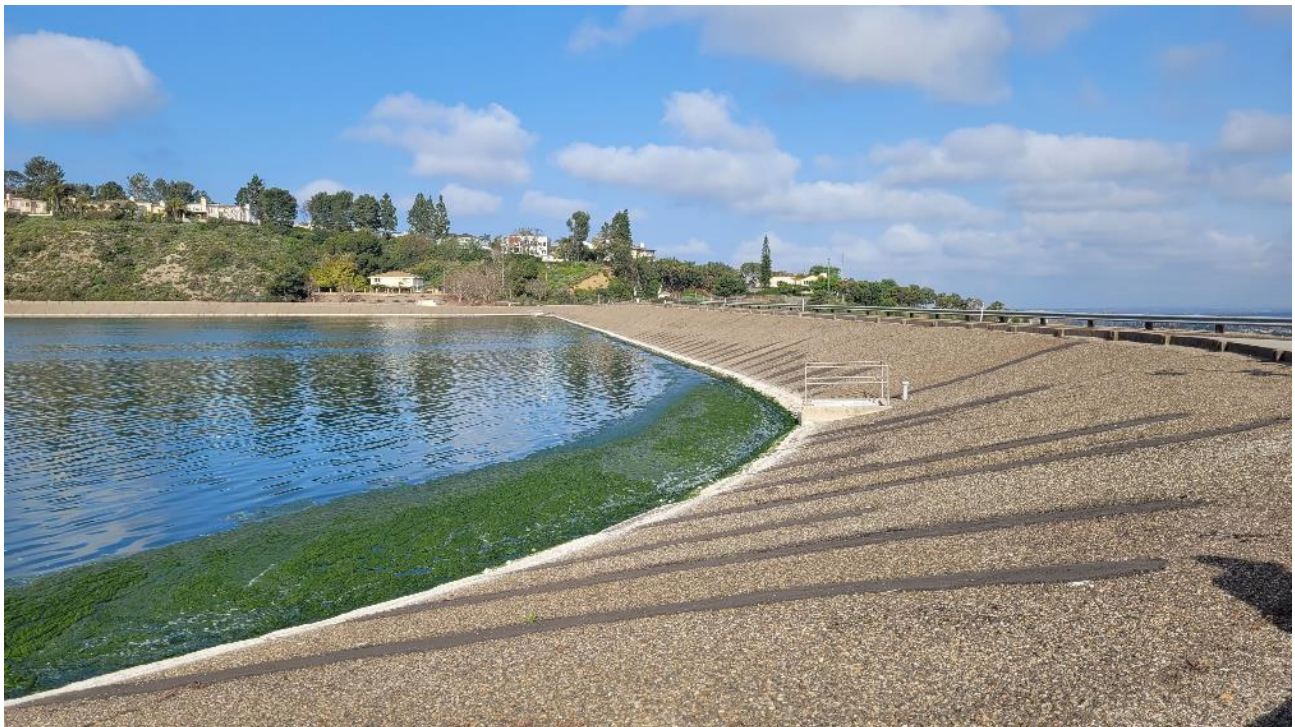
Photo 4: View of the upstream slope.
