October 11, 2011

Irvine Ranch Water District
Attention: Paul Weghorst
15600 Sand Canyon Avenue
Irvine, CA 92618

Subject: *Strand Ranch South Basin Field Reconnaissance and Remediation Recommendations*

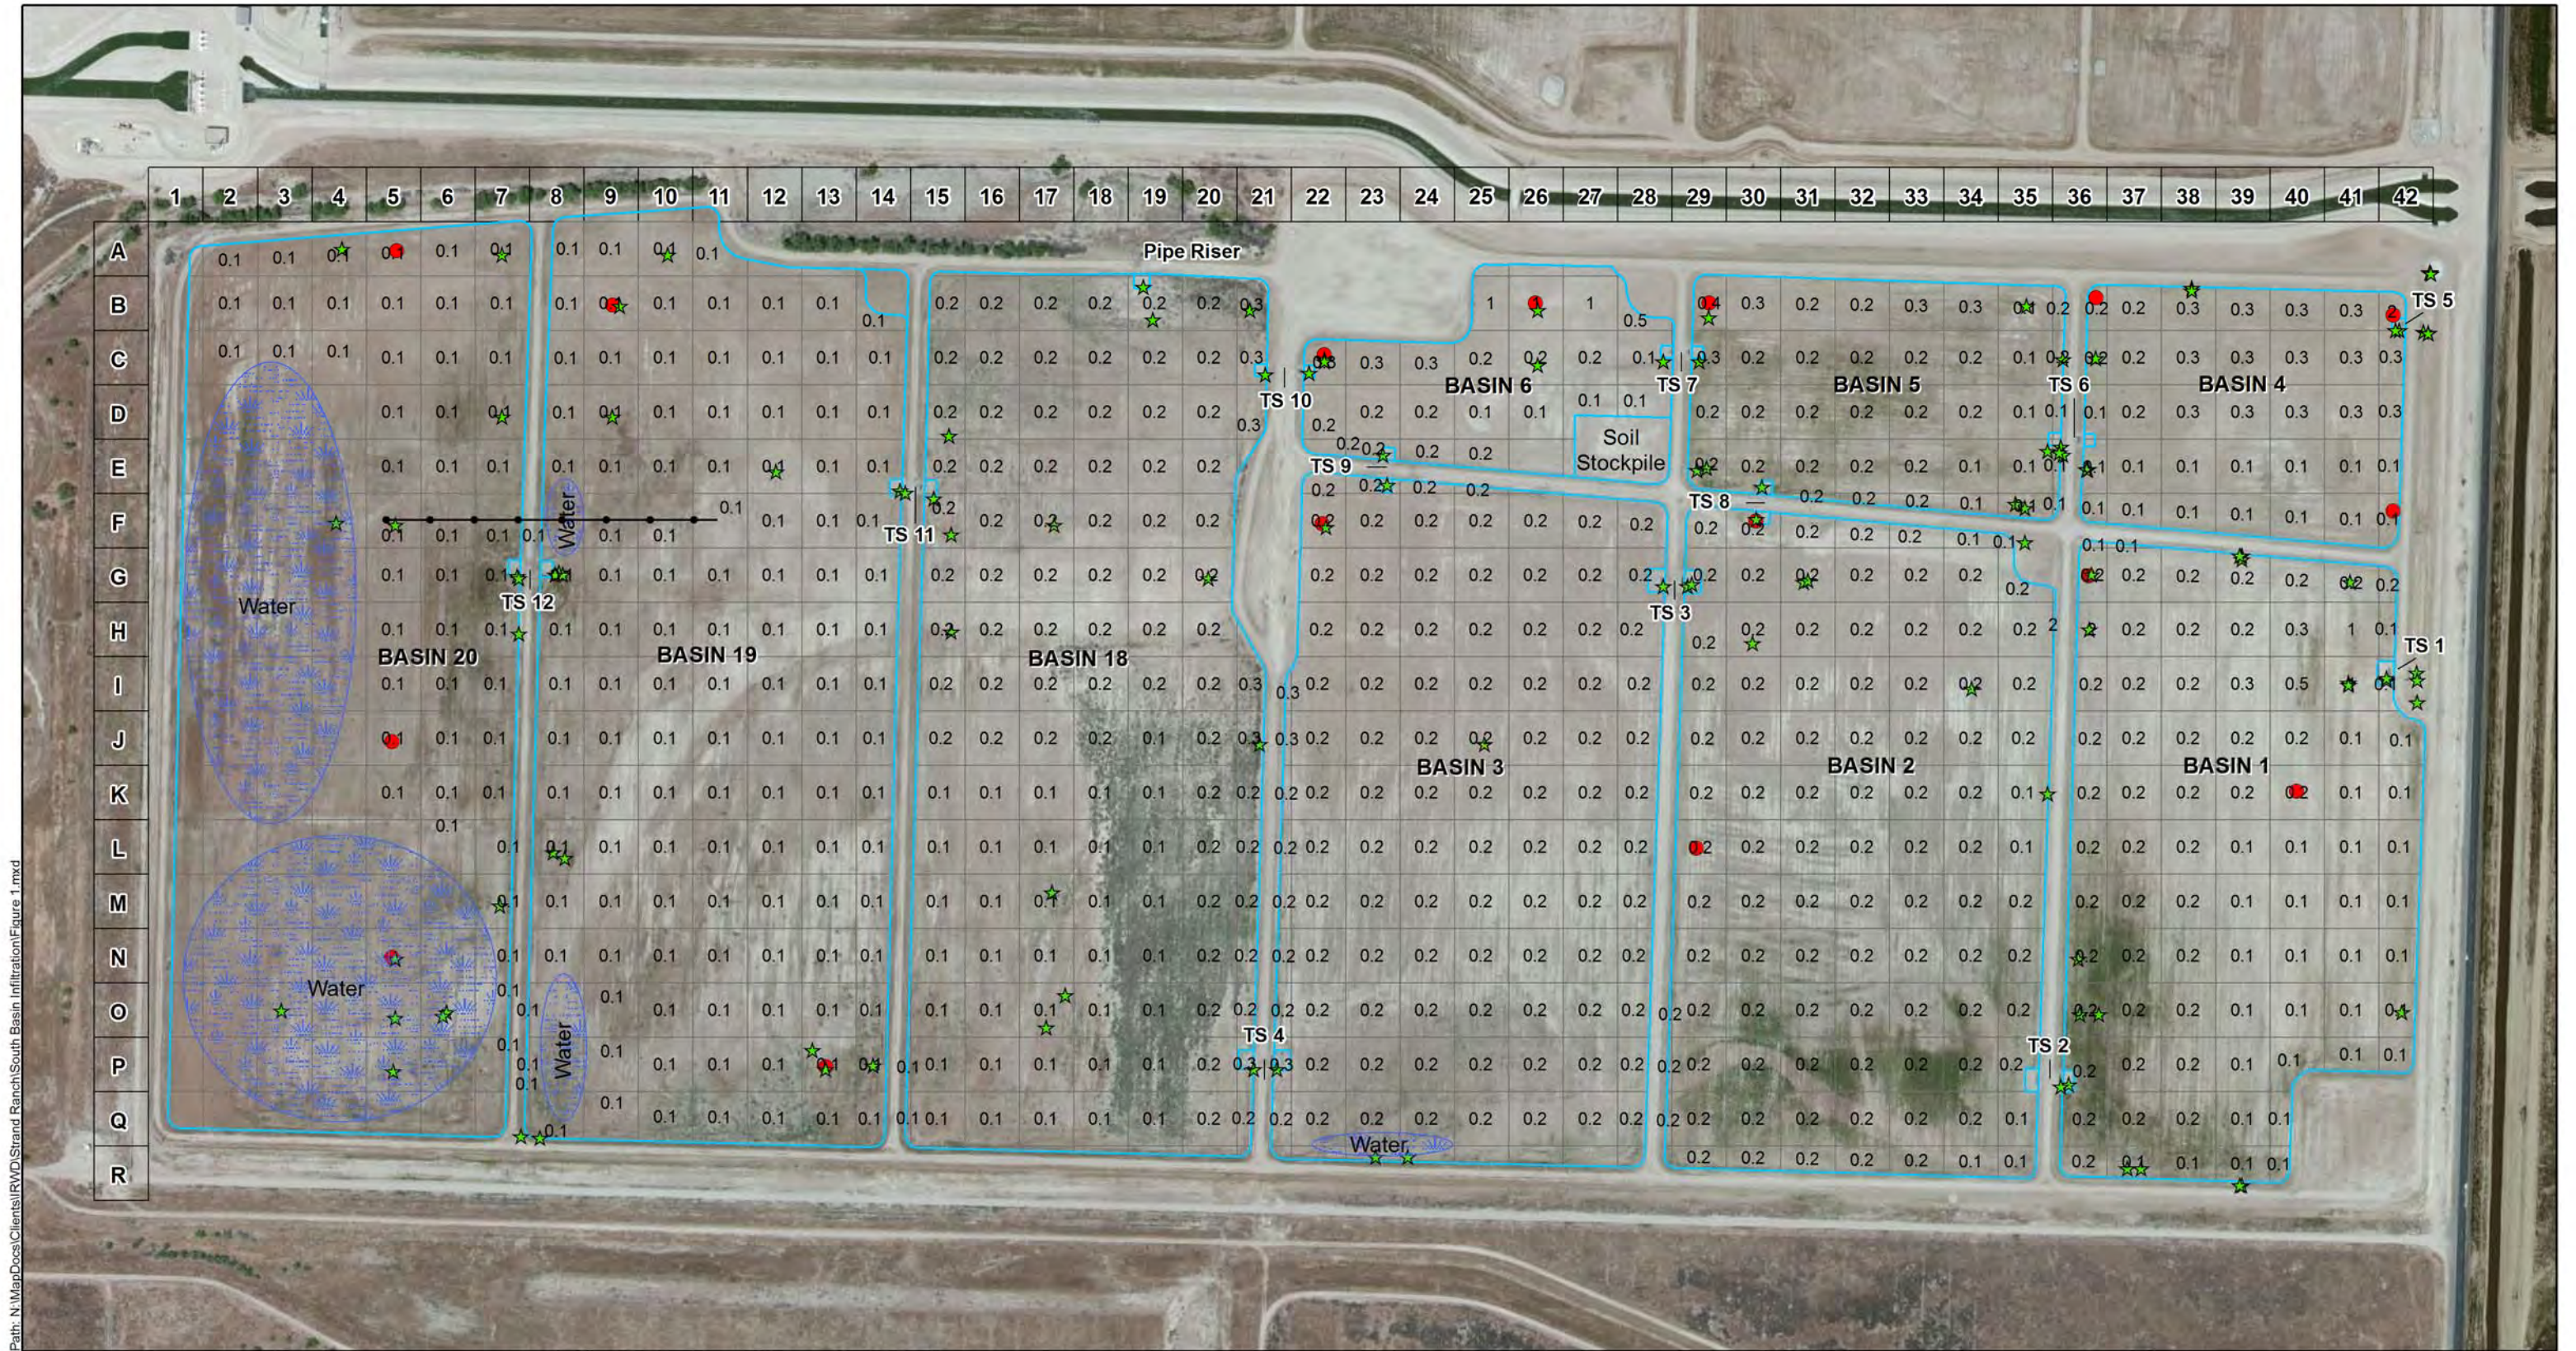
Figure 1

desiccation chips that are typically less than 2-inches across. As shown in Figure 1, the thickness of the sediment/algal deposits is typically less than 0.1 inch. Concrete irrigation pipe was observed in the bottom of Basin 19 in grids 9F, 10F, and 11F, and is presumed to be a remnant from the existing irrigation system. One bottom sediment sample was collected from Basin 19 at grid location B9. This sample is available for inspection.

Thickness (inches) of Clogging Layer at the Strand Ranch South Basins

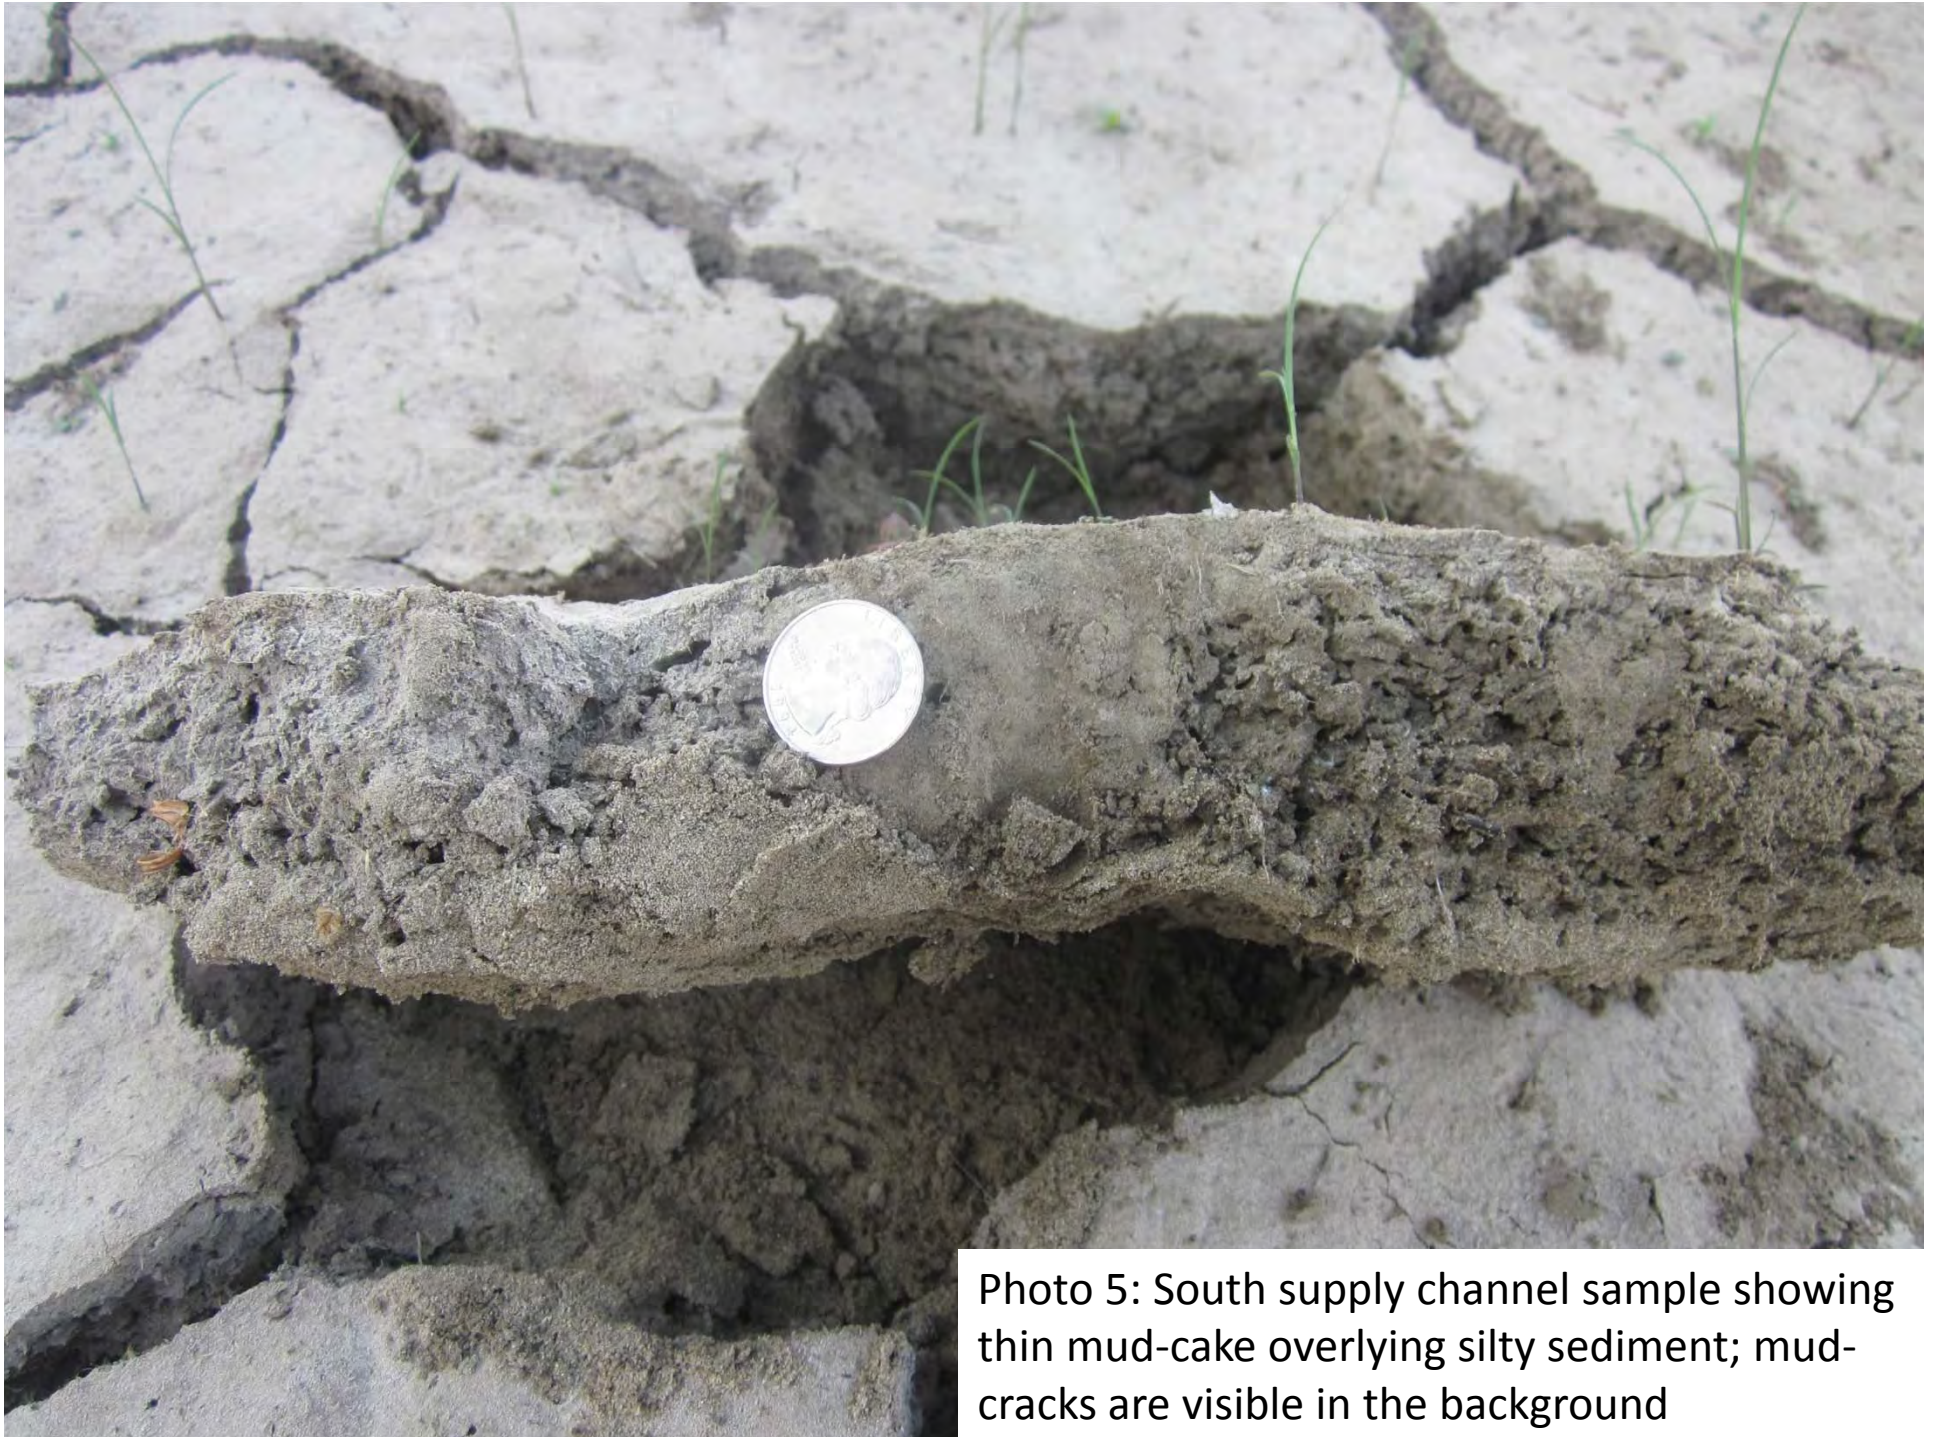
Photo 5: South supply channel sample showing thin mud-cake overlying silty sediment; mud-cracks are visible in the background

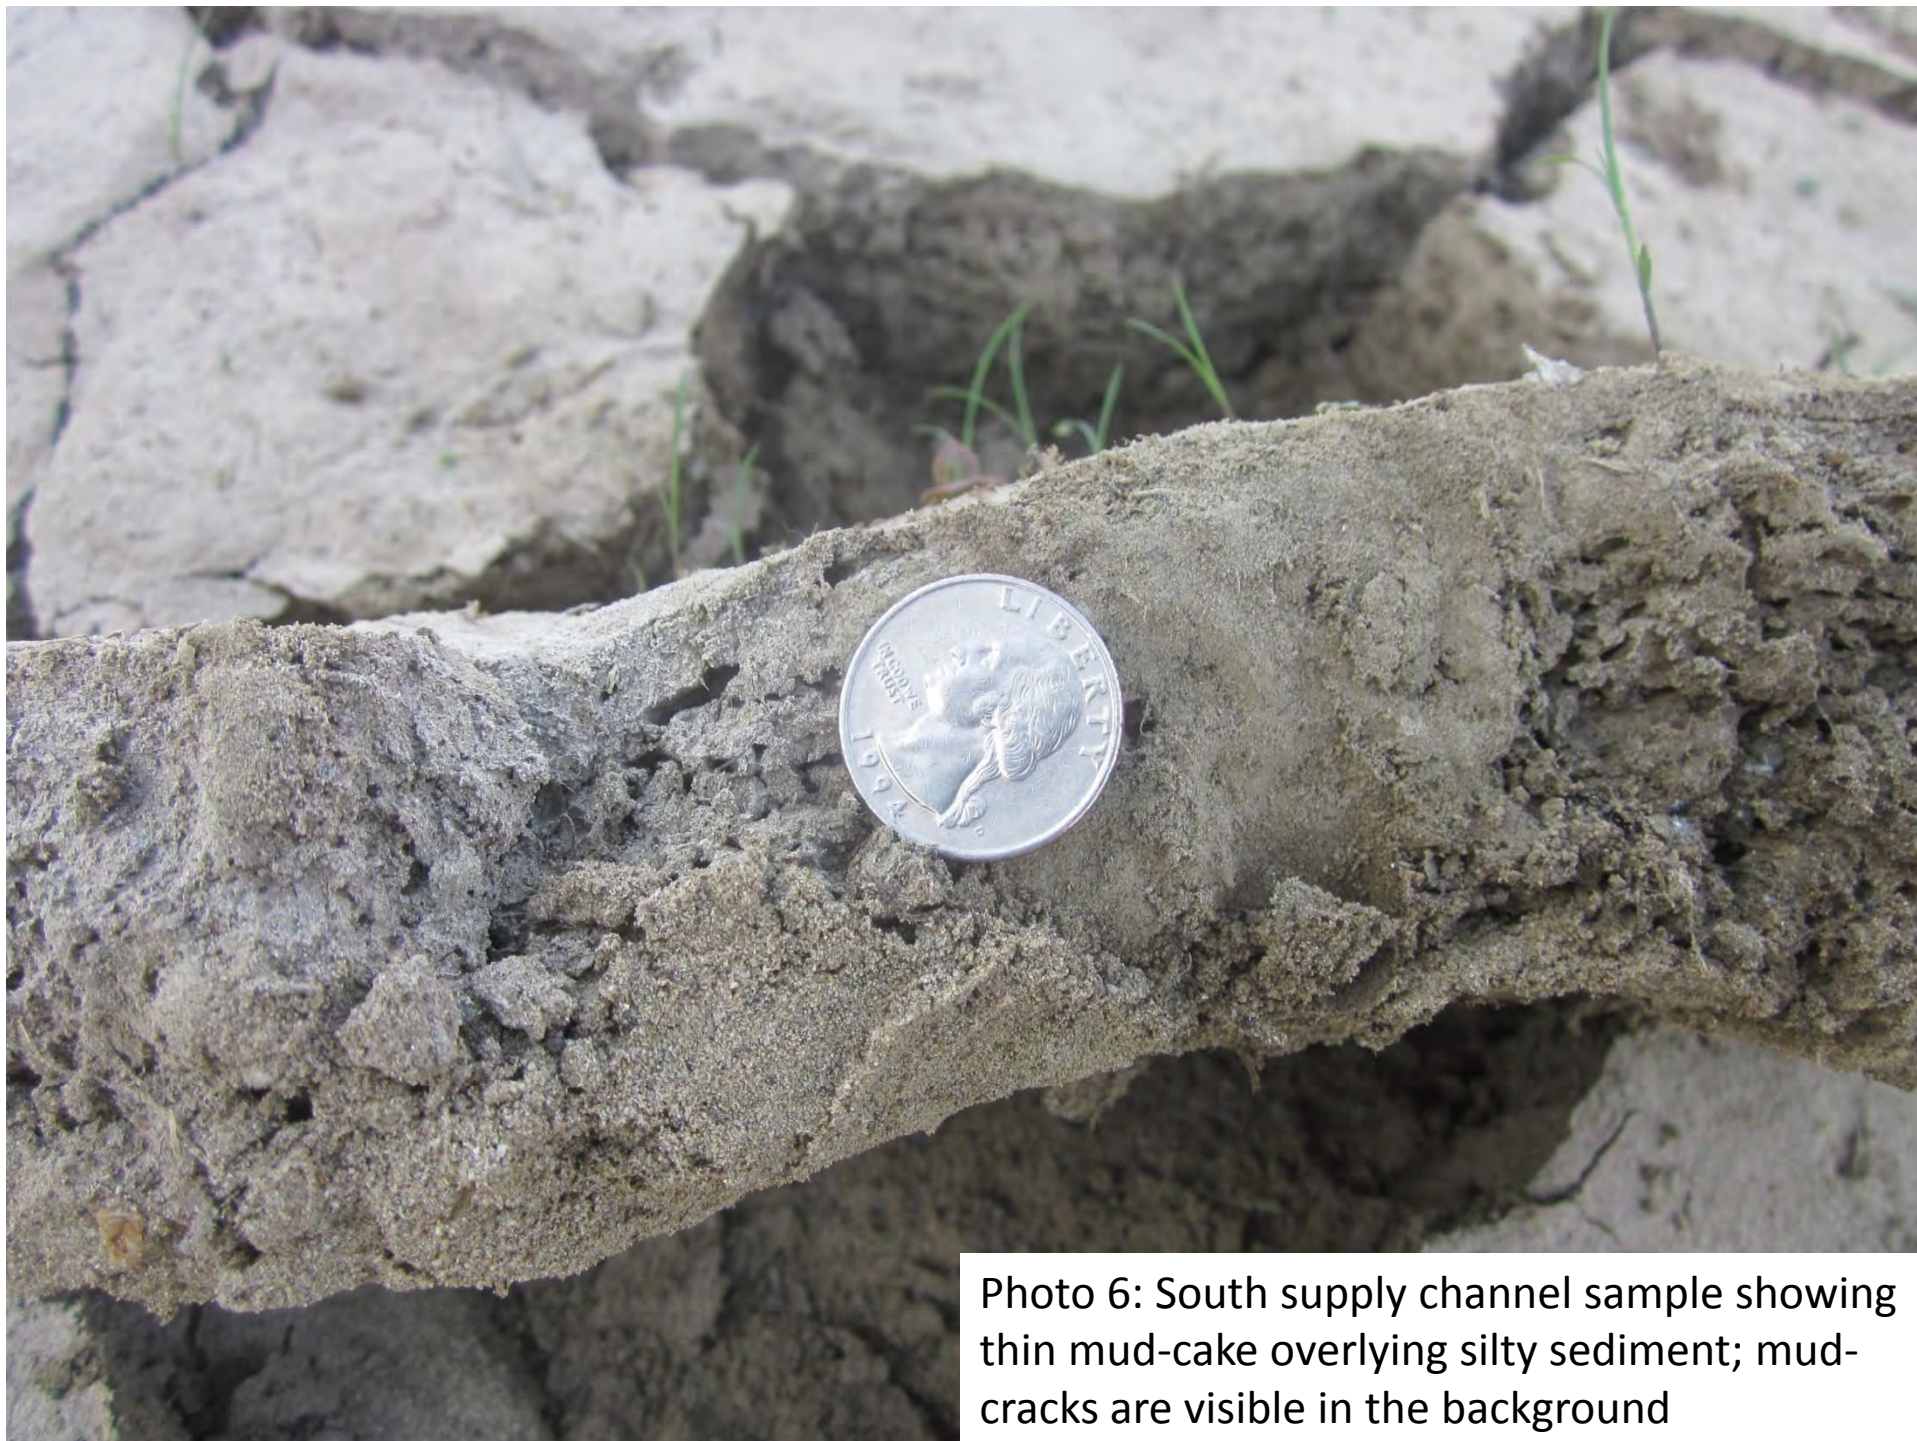
chips. The desiccation chips on the channel bottom are approximately 2 inches thick and are composed of fine-grained sediment. As shown in Photo 6, the channel bottom sediment consisted of silts and clays with some very fine-grained sand and contained a significant volume of open pores within the soil. There was no significant erosion observed within the channel bottom or sides. These observations apply to the entire channel except for the far south end where observations could not be made due to ponding over the concrete-lined section of the channel.

Photo 6: South supply channel sample showing thin mud-cake overlying silty sediment; mud-cracks are visible in the background

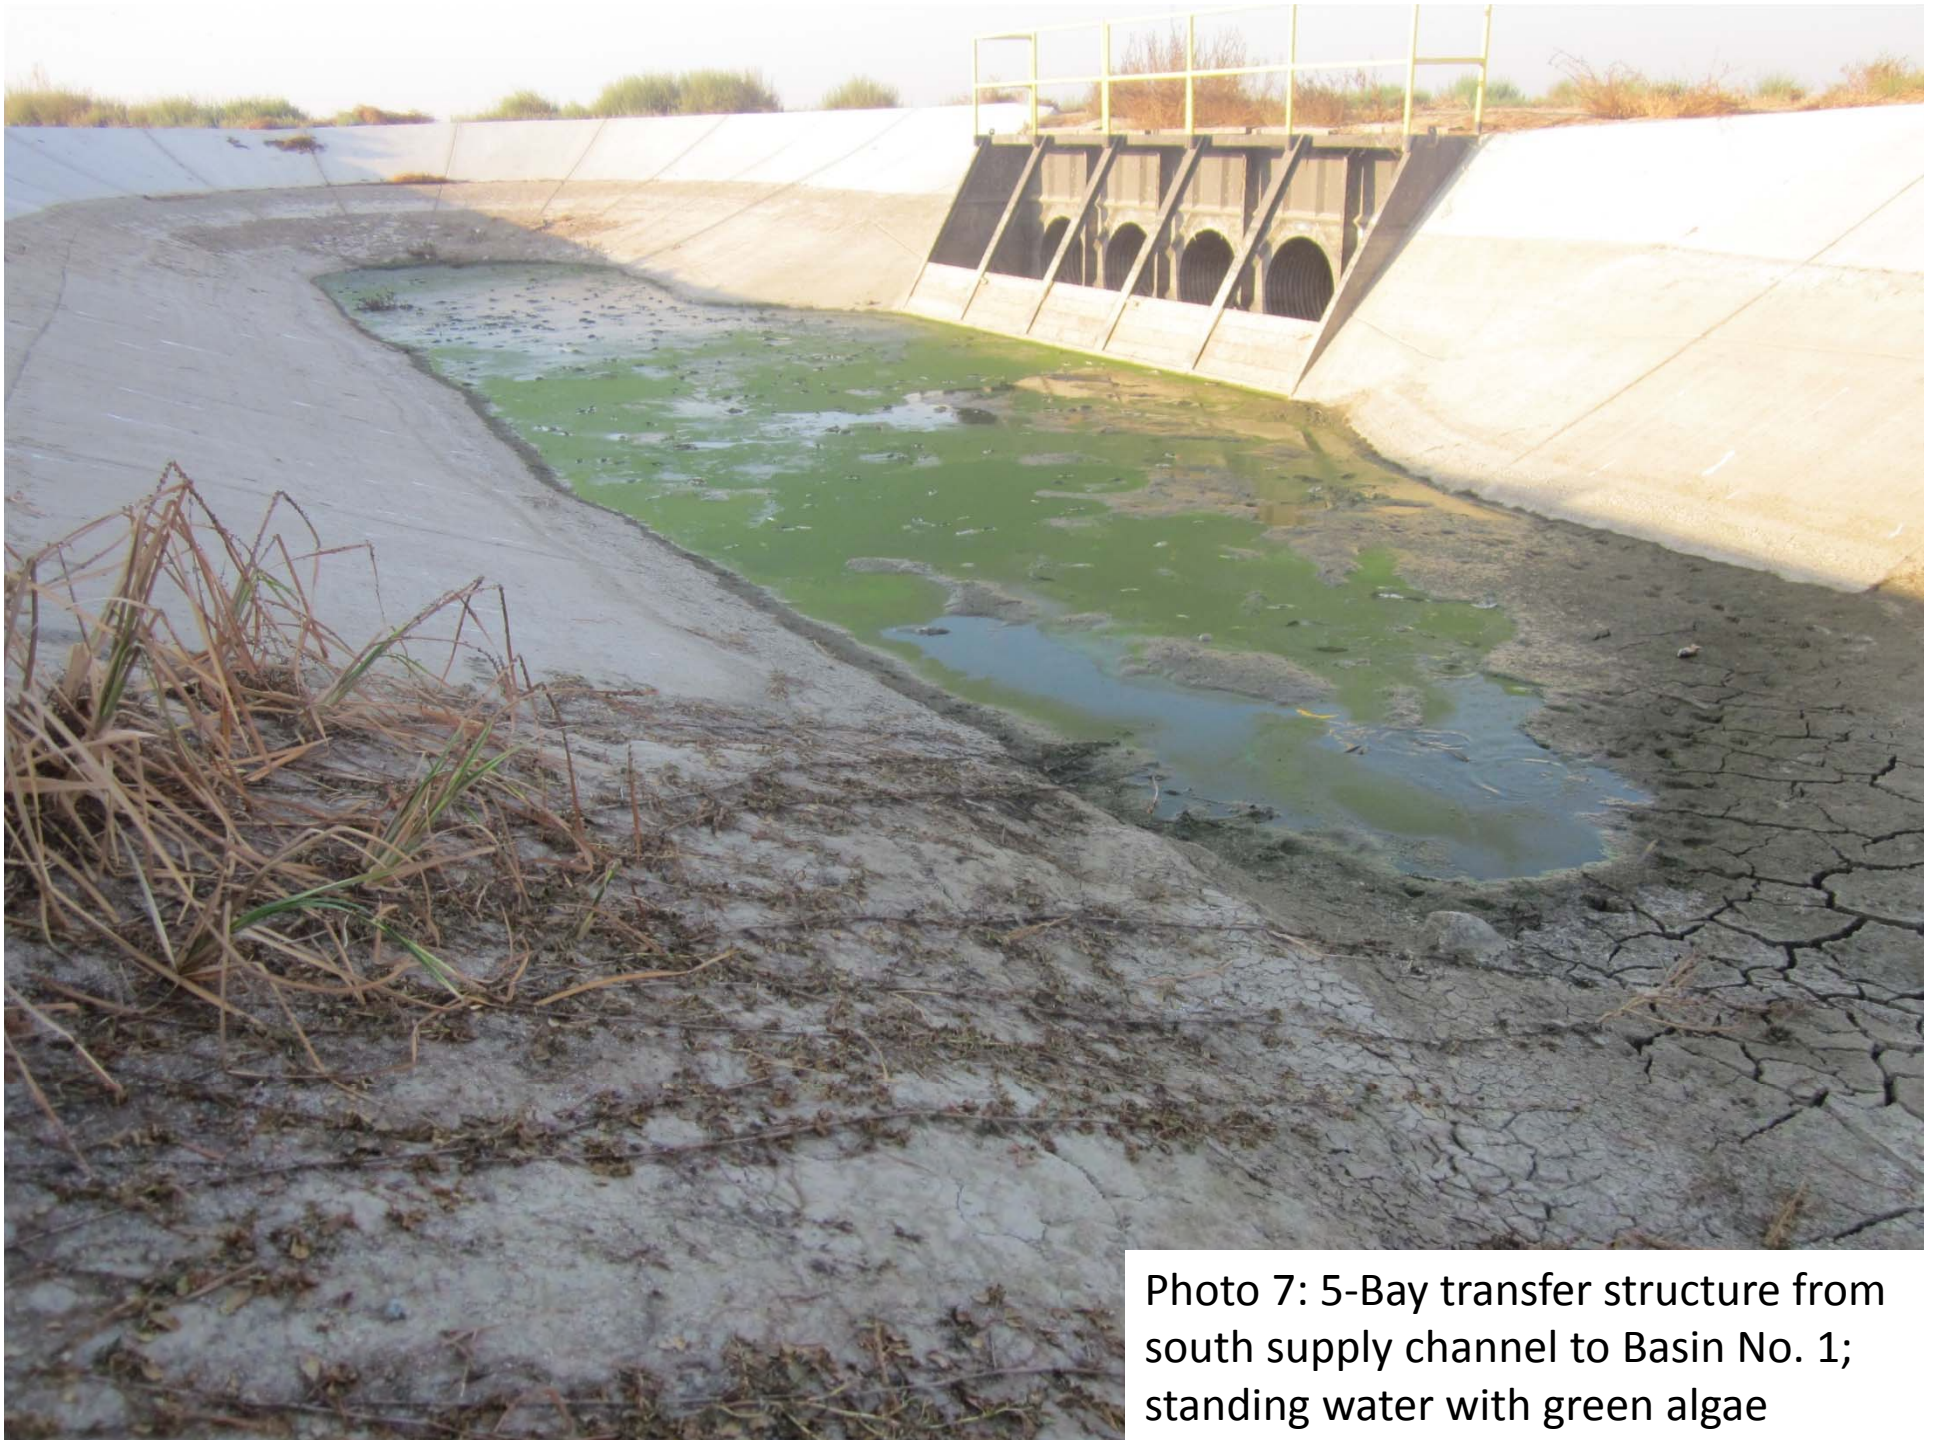
Photo 7: 5-Bay transfer structure from south supply channel to Basin No. 1; standing water with green algae

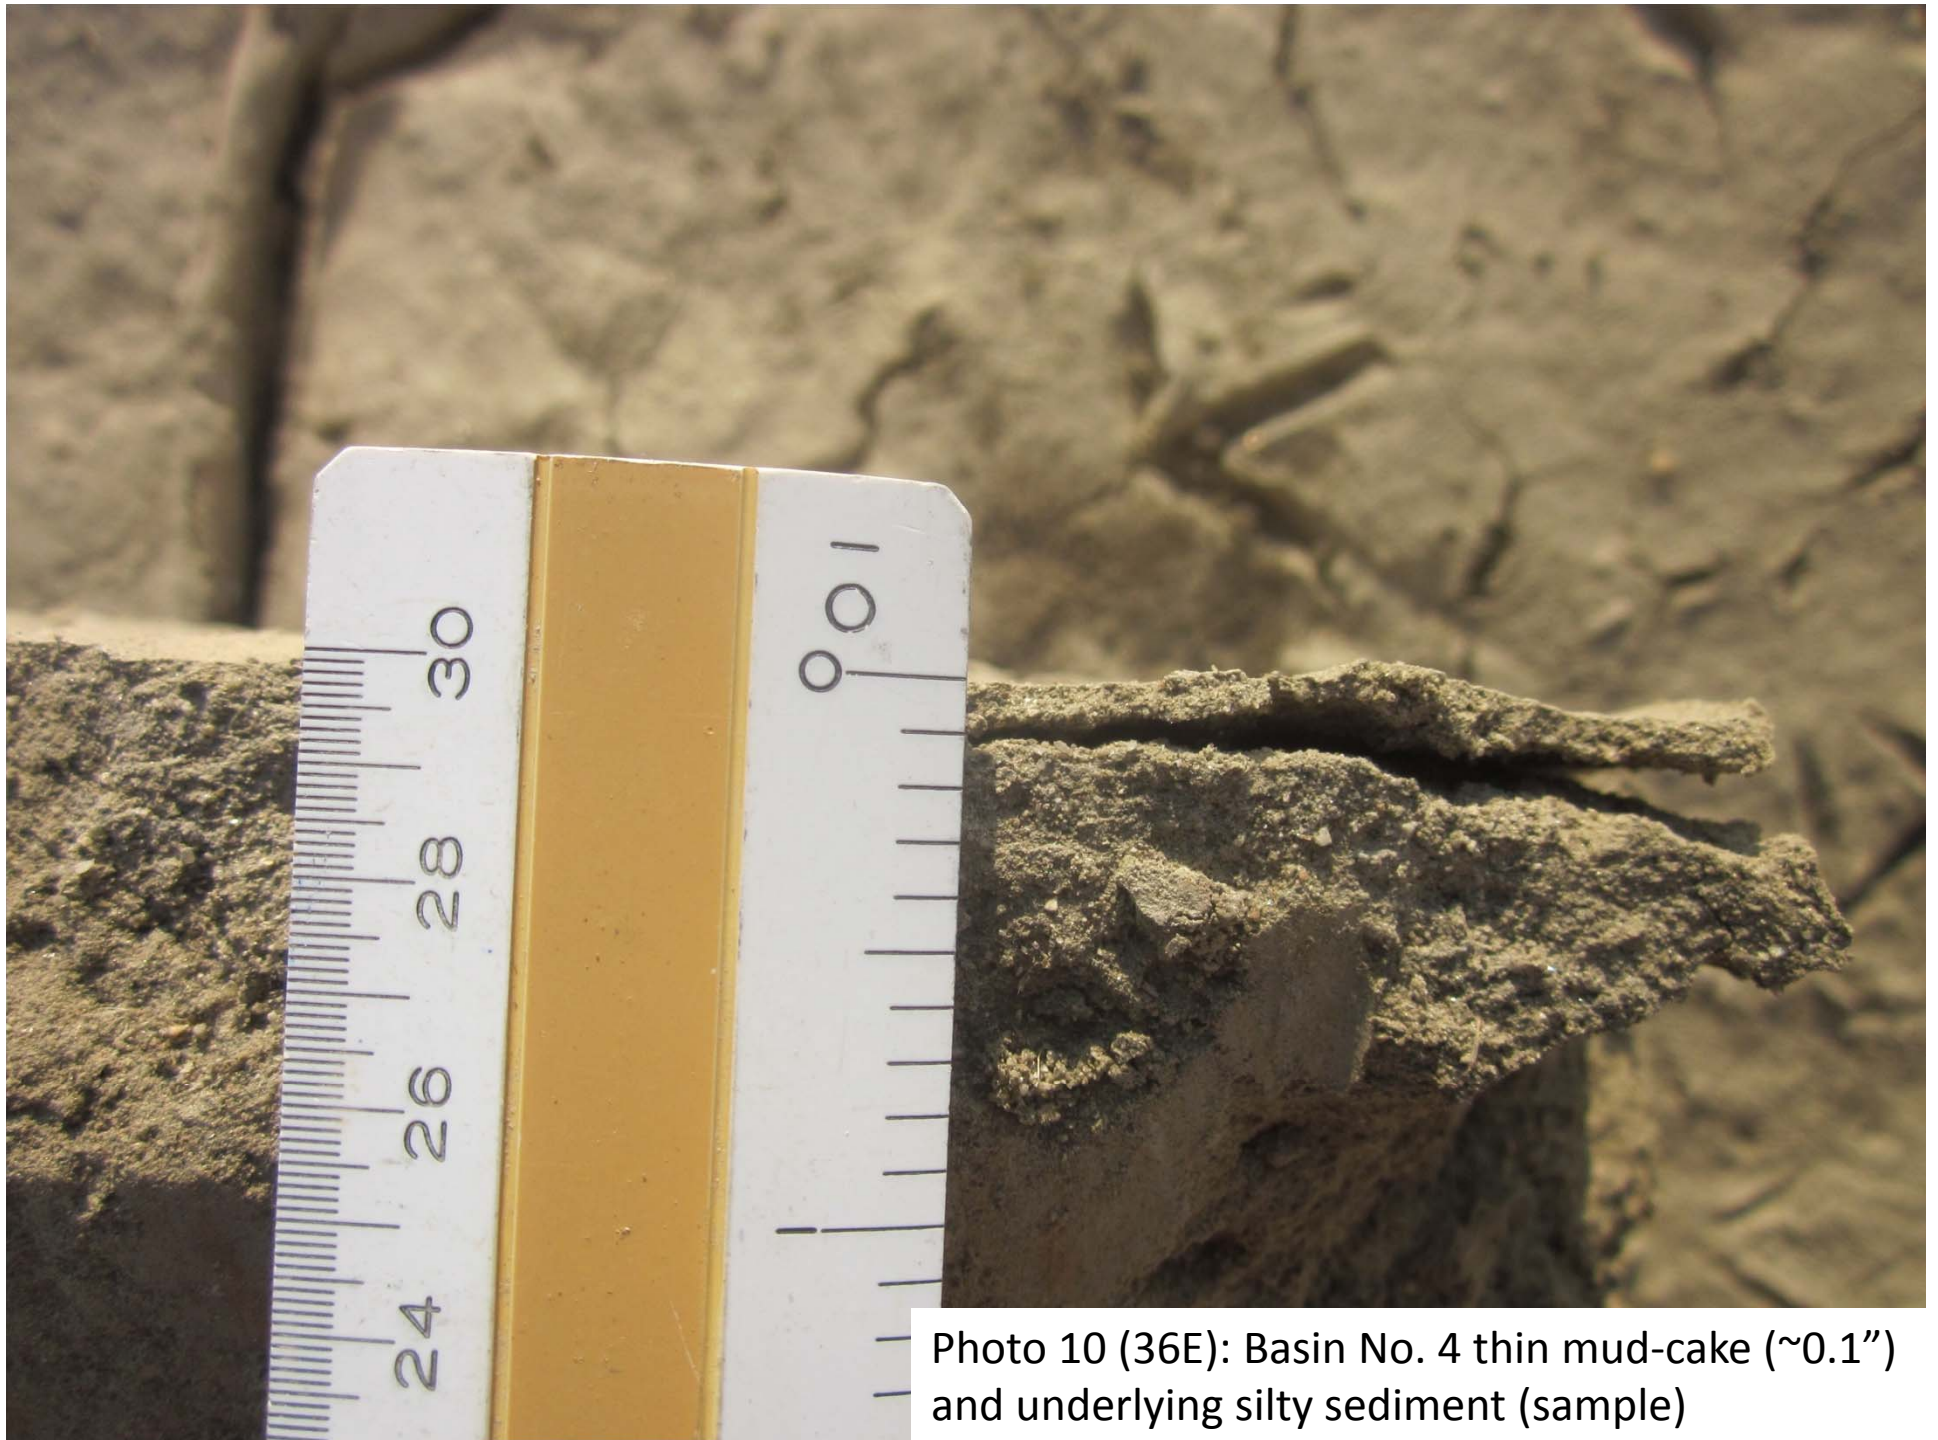
Photo 10 (36E): Basin No. 4 thin mud-cake (~0.1") and underlying silty sediment (sample)

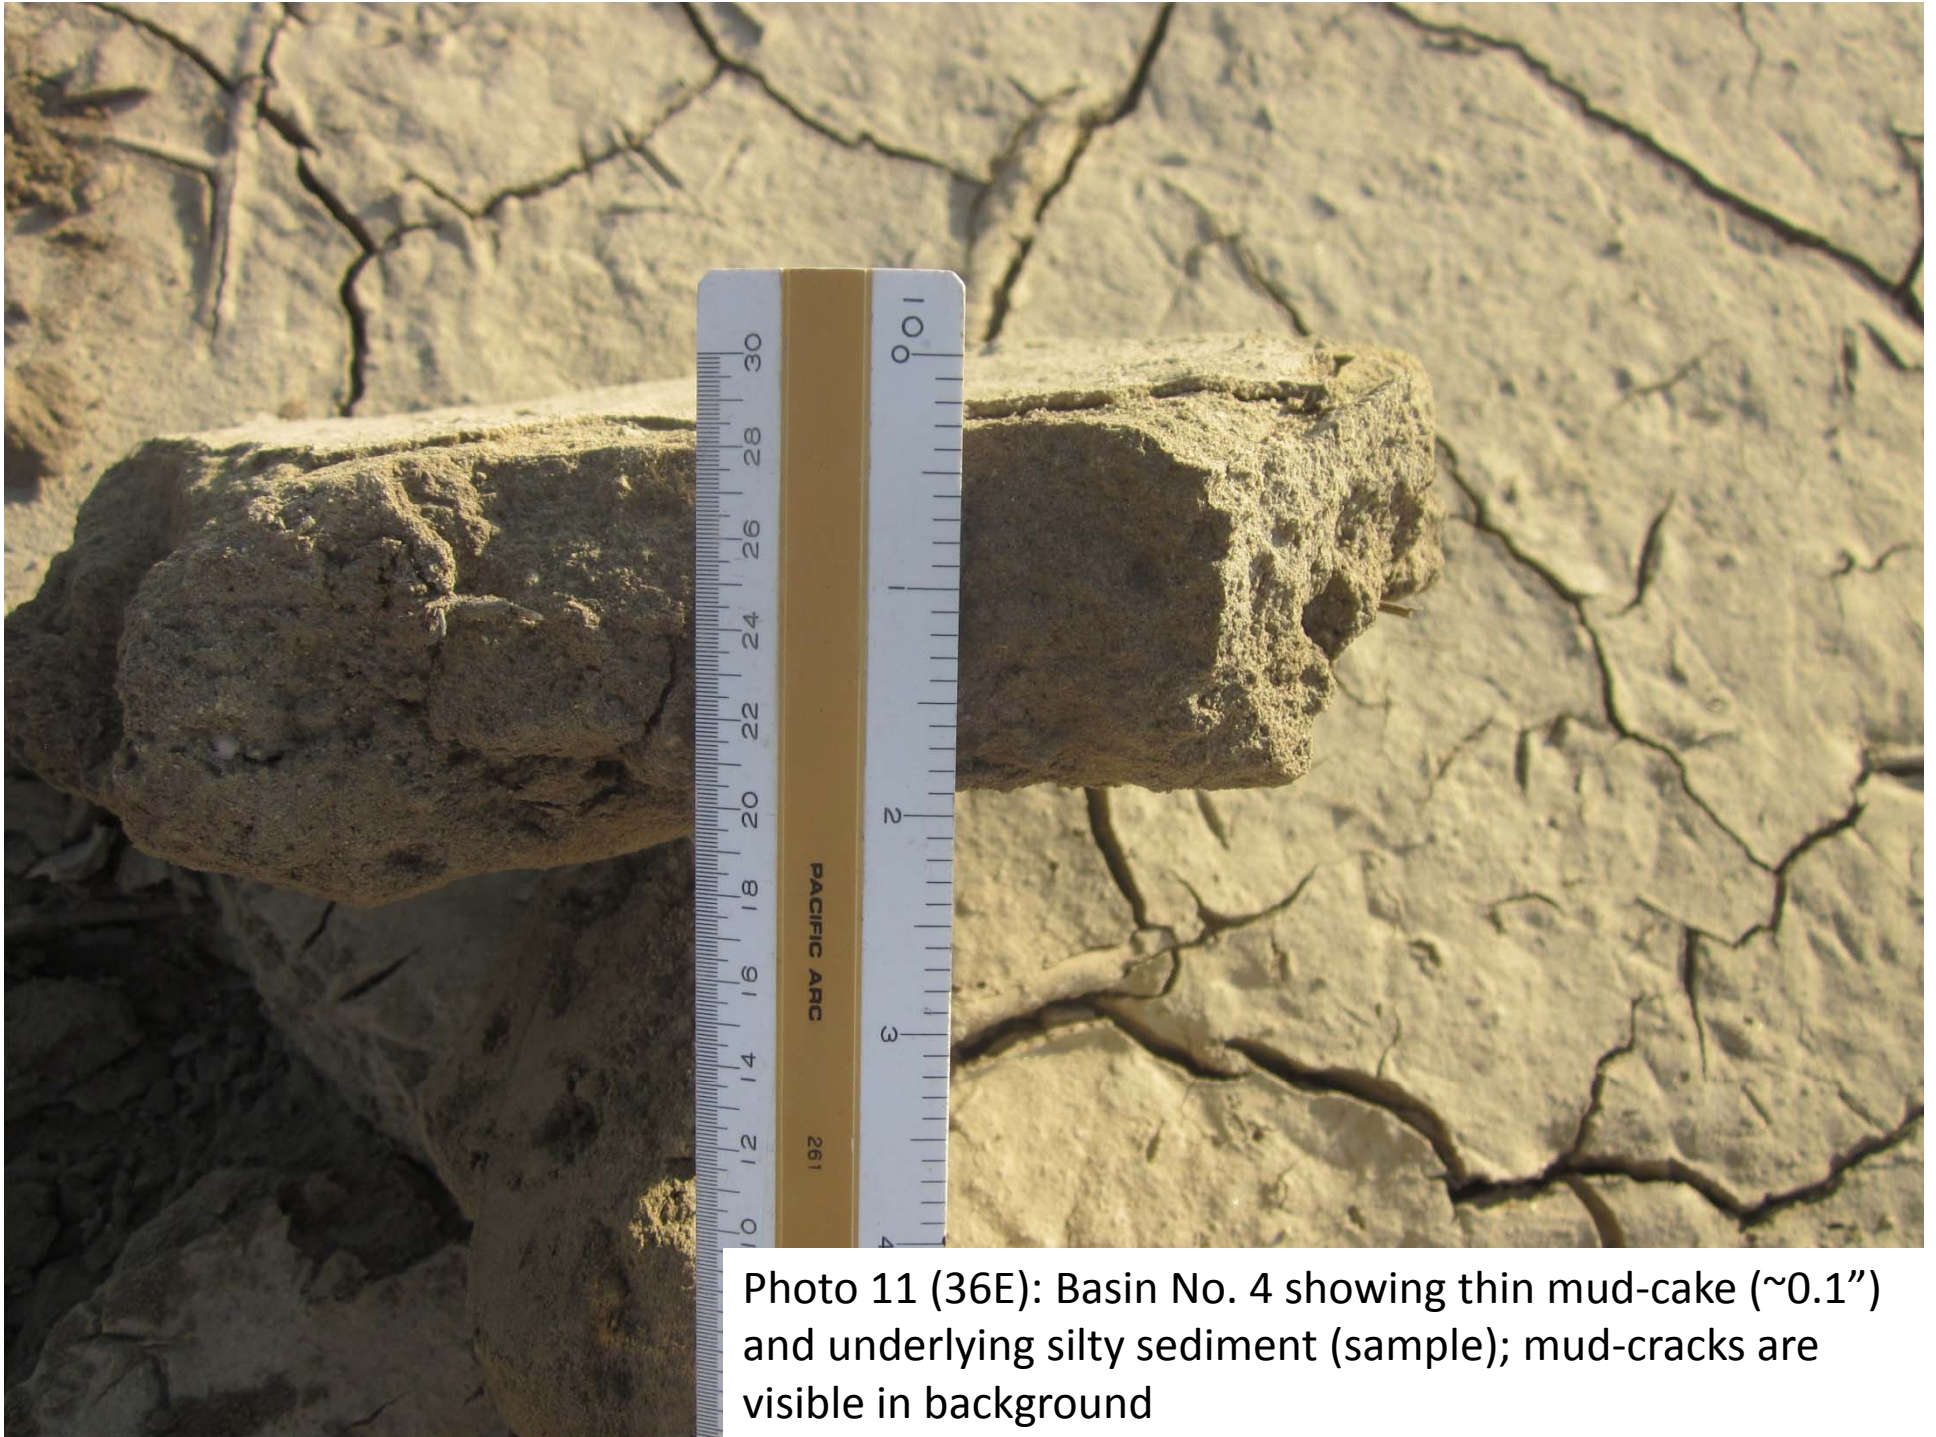
Photo 11 (36E): Basin No. 4 showing thin mud-cake (~0.1") and underlying silty sediment (sample); mud-cracks are visible in background

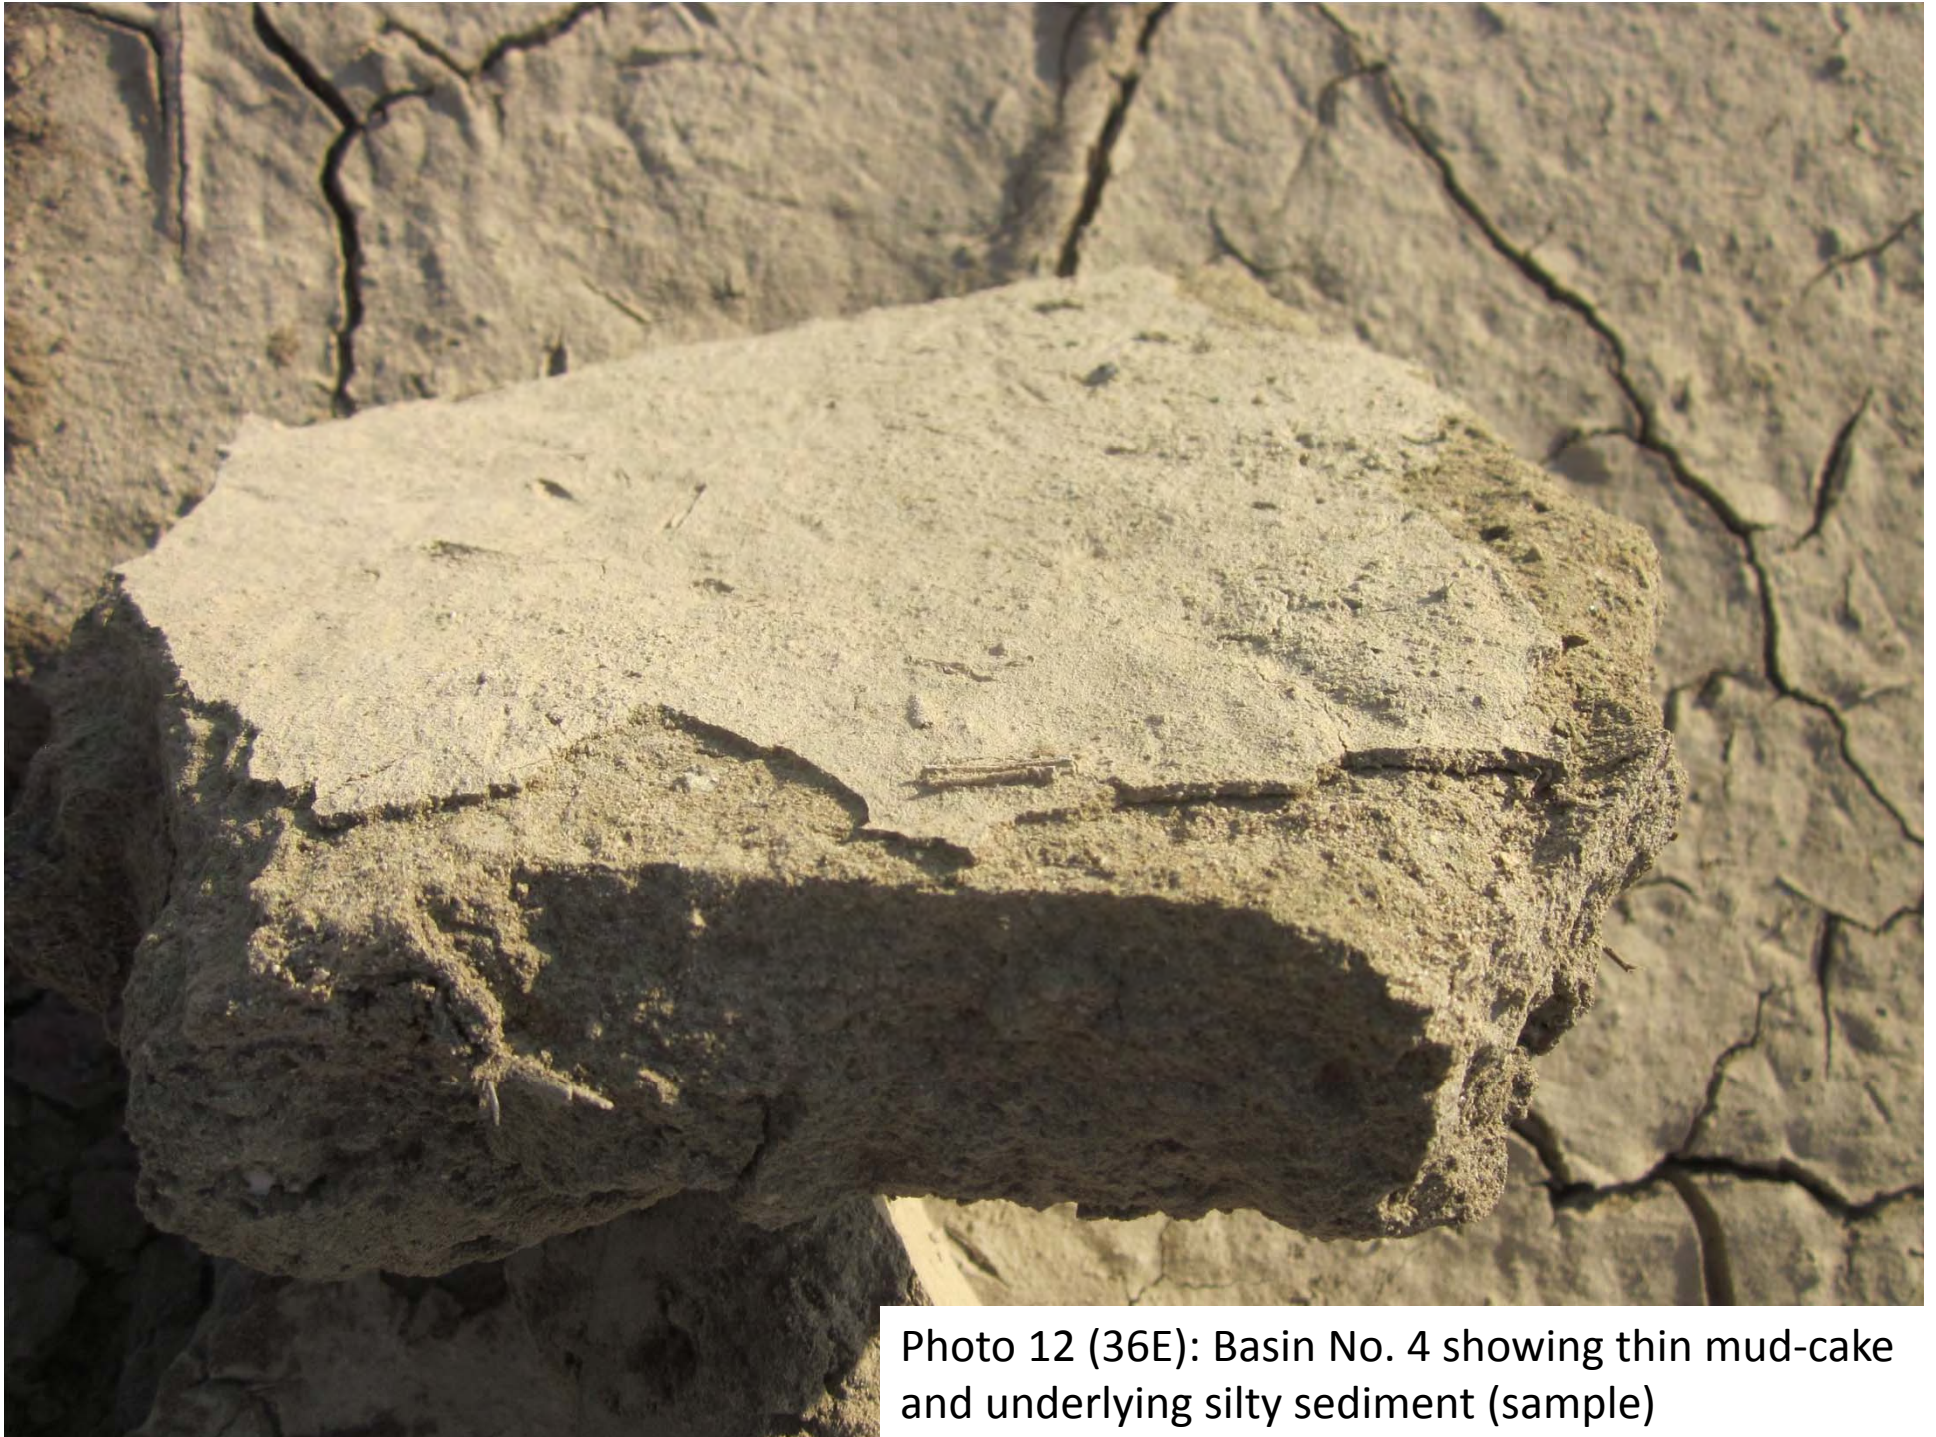
Photo 12 (36E): Basin No. 4 showing thin mud-cake and underlying silty sediment (sample)
