October 11, 2011

Irvine Ranch Water District
Attention: Paul Weghorst
15600 Sand Canyon Avenue
Irvine, CA 92618

Subject: *Strand Ranch South Basin Field Reconnaissance and Remediation Recommendations*

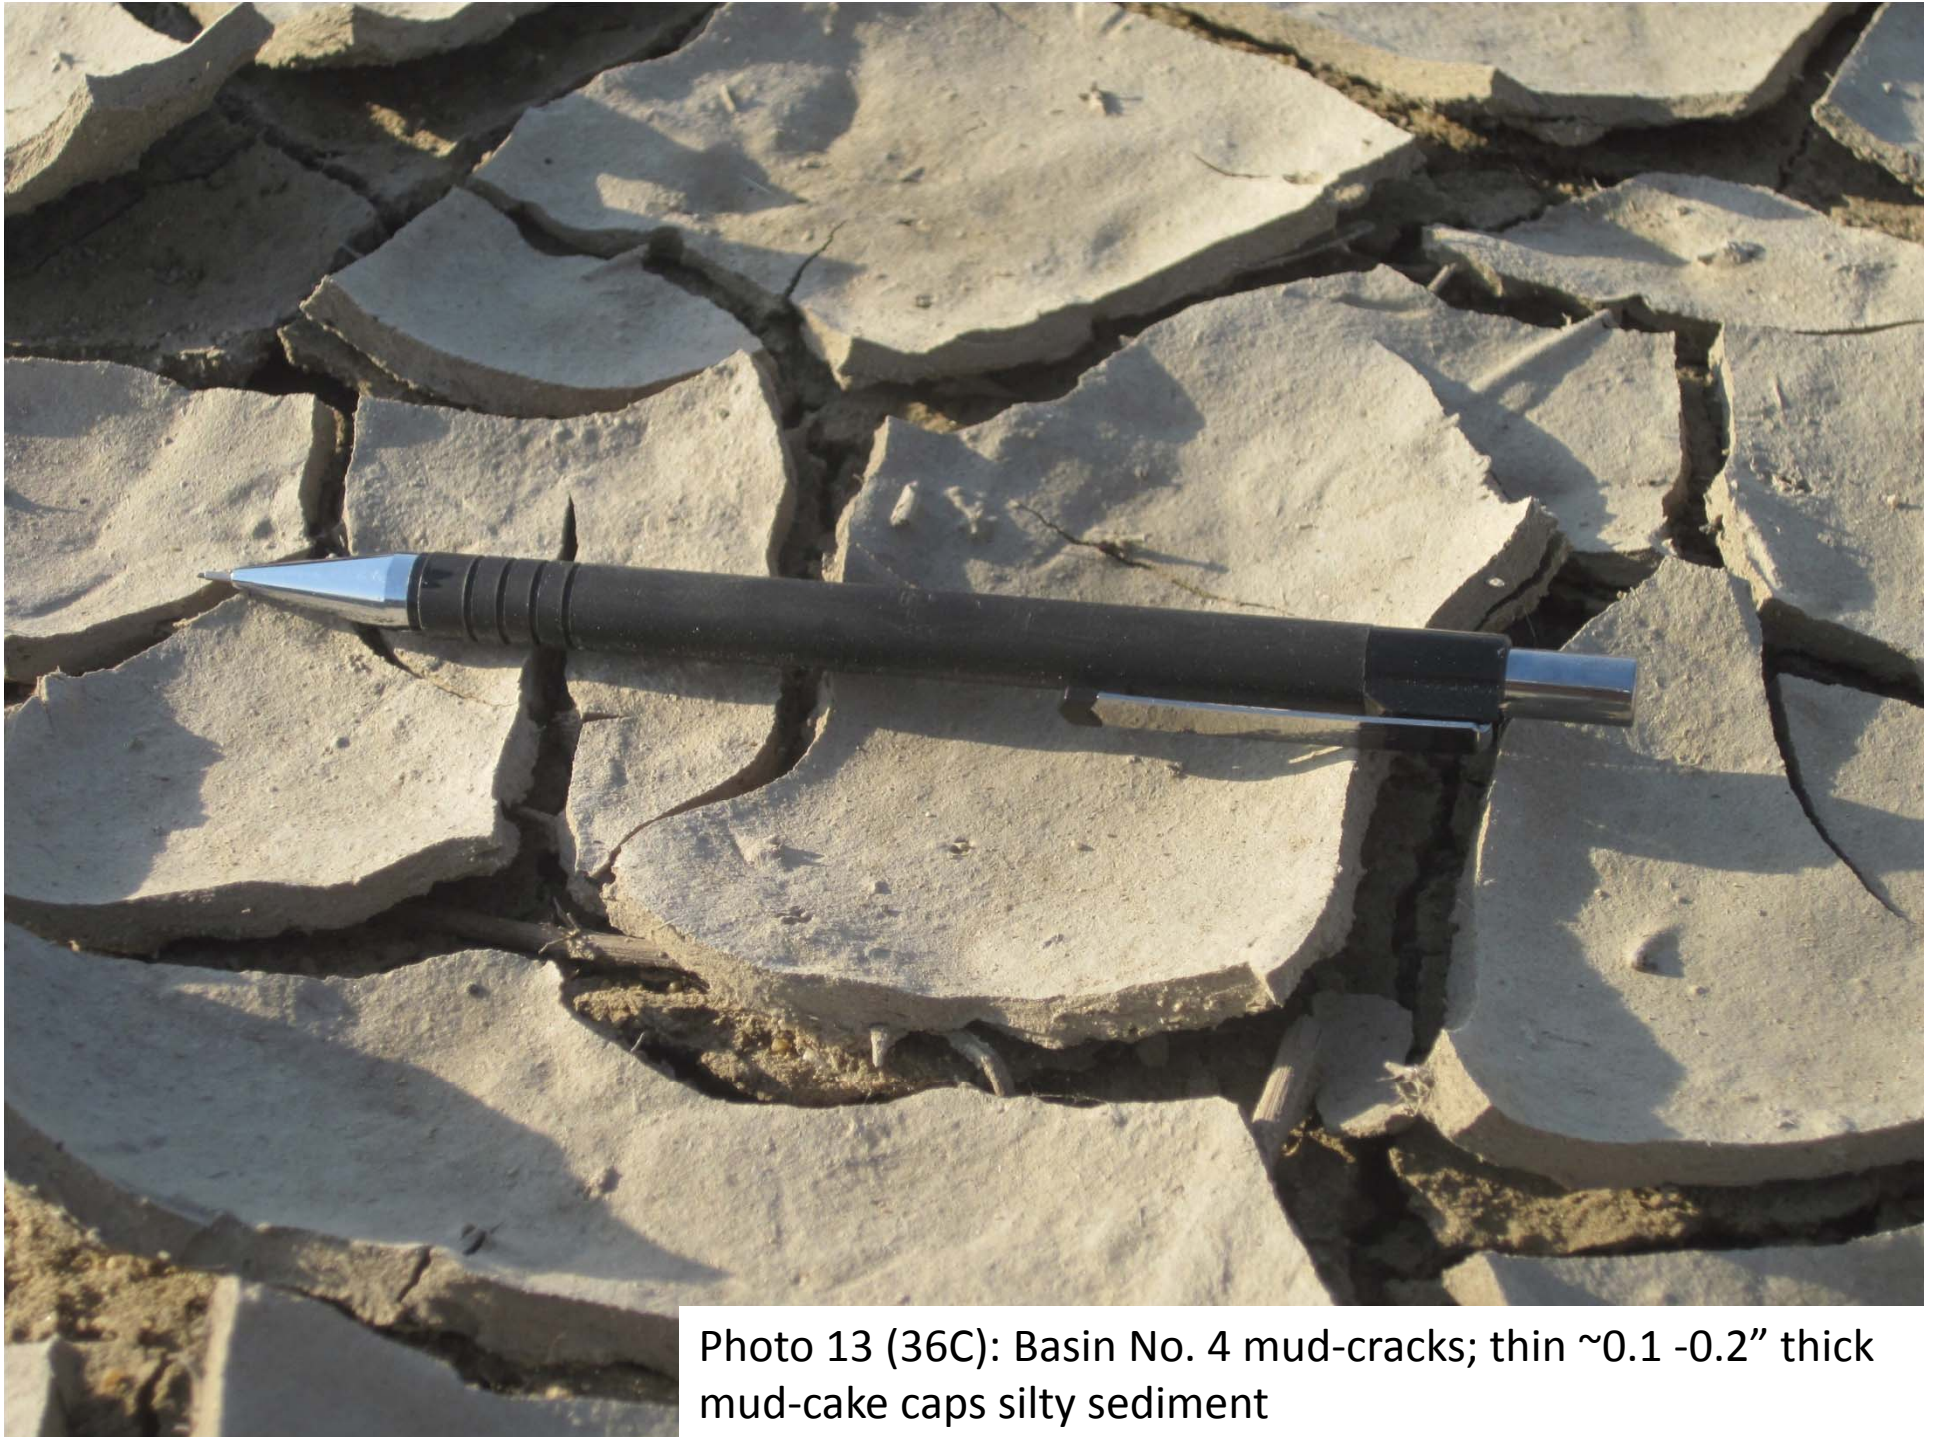
Photo 13 (36C): Basin No. 4 mud-cracks; thin ~0.1 -0.2" thick mud-cake caps silty sediment

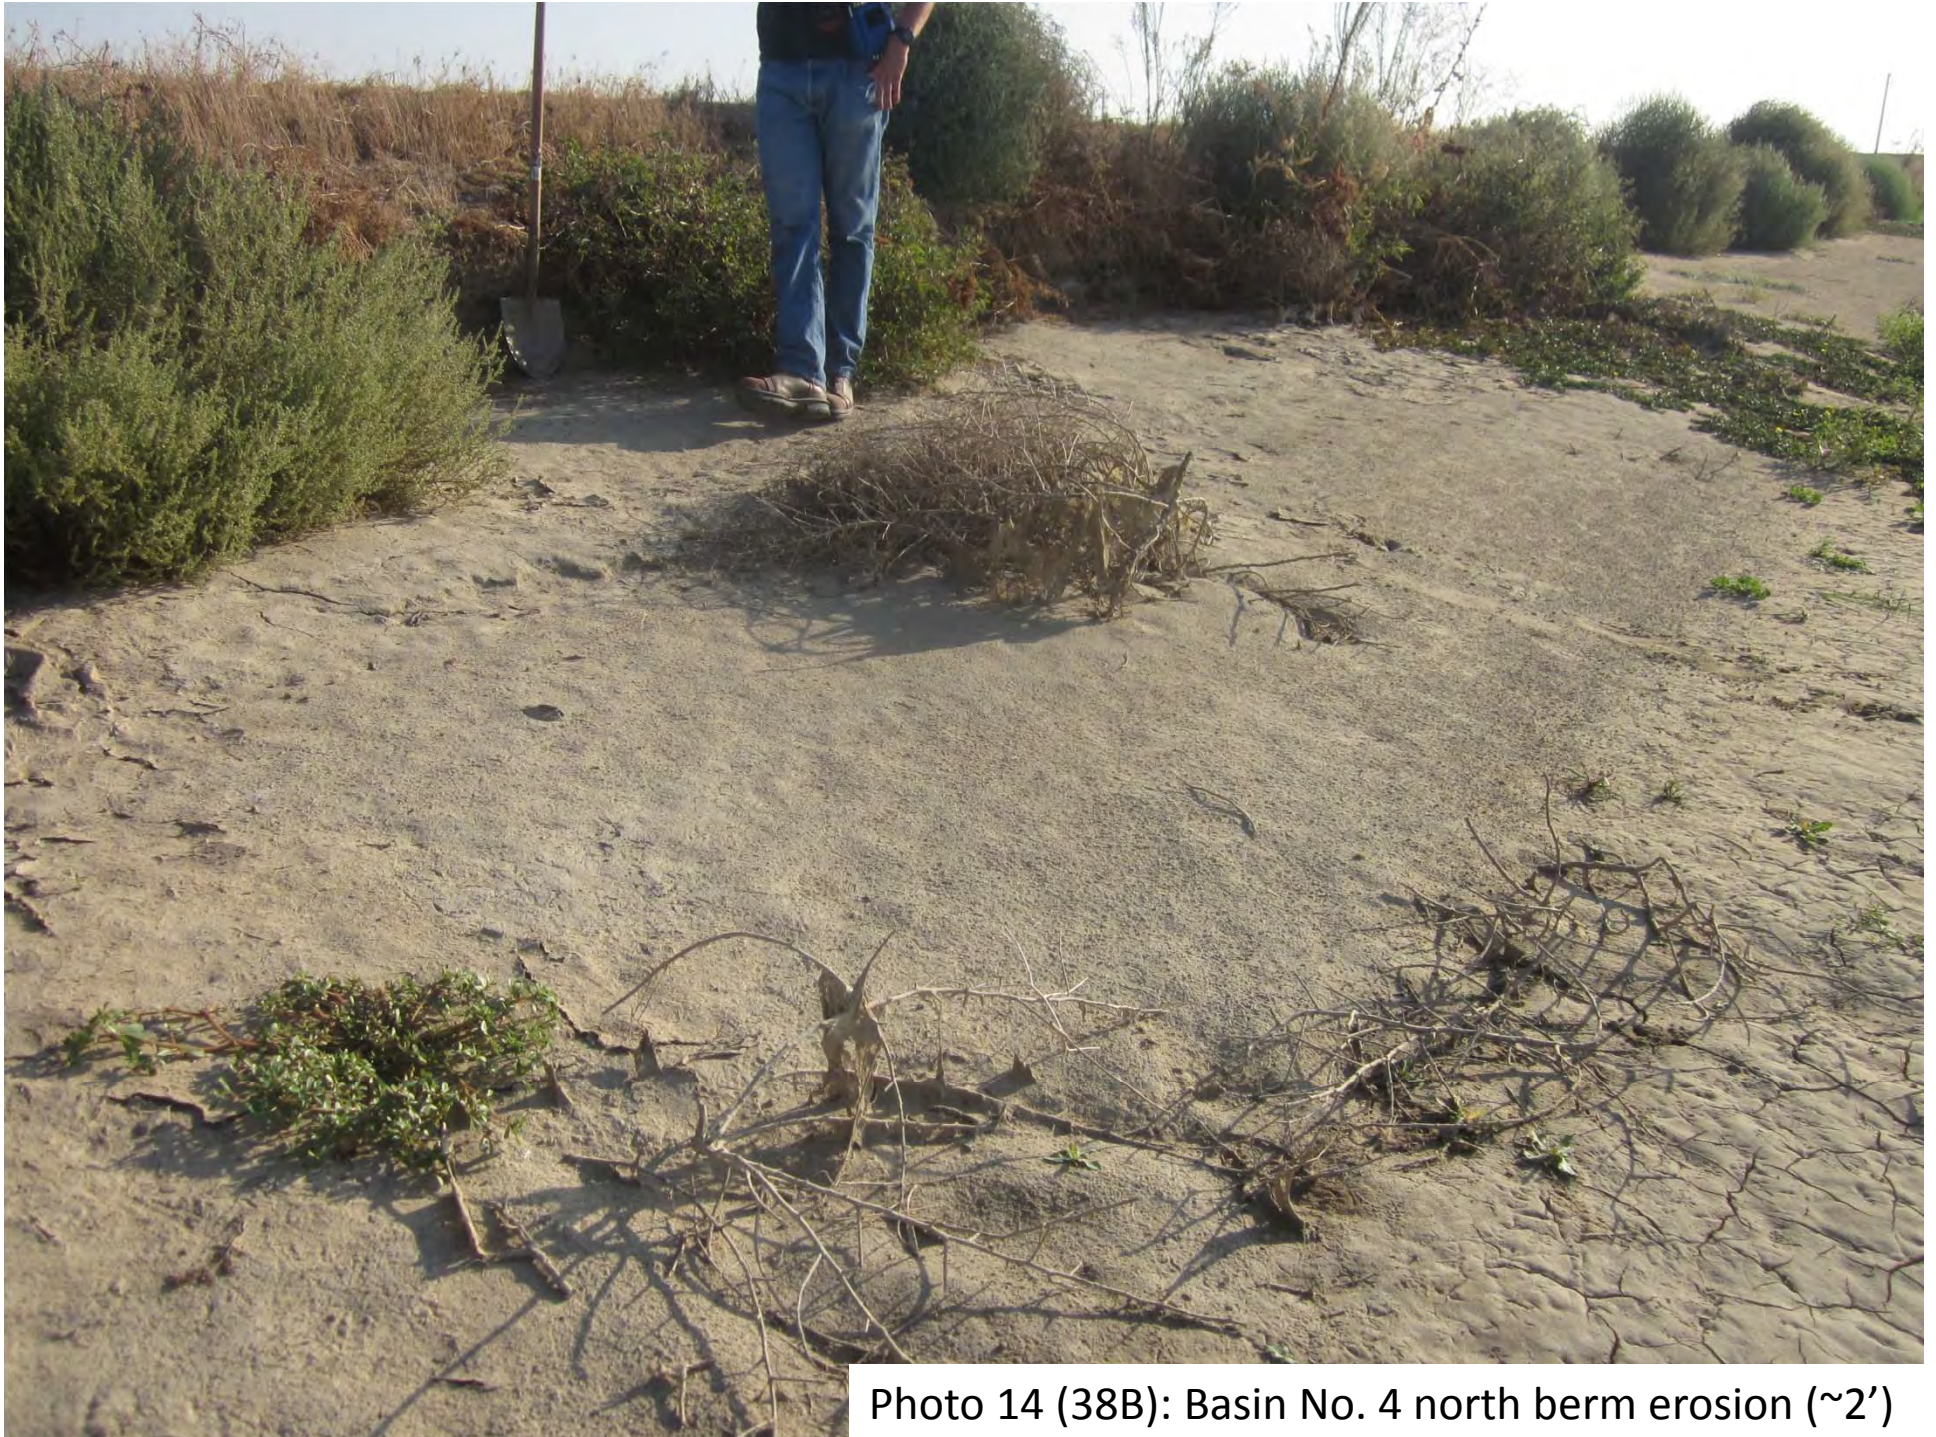
Berm erosion was observed in all basins where the standing water level intercepted the berm. The erosion has resulted in an approximately 1.5 to 2 foot vertical erosion face at the top of the berm. The coarser-grained materials eroded from the berm have been deposited over the lower part of the existing berm to form a relatively gently sloping apron from the bottom of the eroded face to the basin bottom. And, the finer-grained materials eroded from the berm have seemingly been deposited over the basin floor and contribute to the clogging layer.

Photo 14 (38B): Basin No. 4 north berm erosion (~2')

During basin remediation, care should be exercised to avoid disturbing the toe of the basin berms.

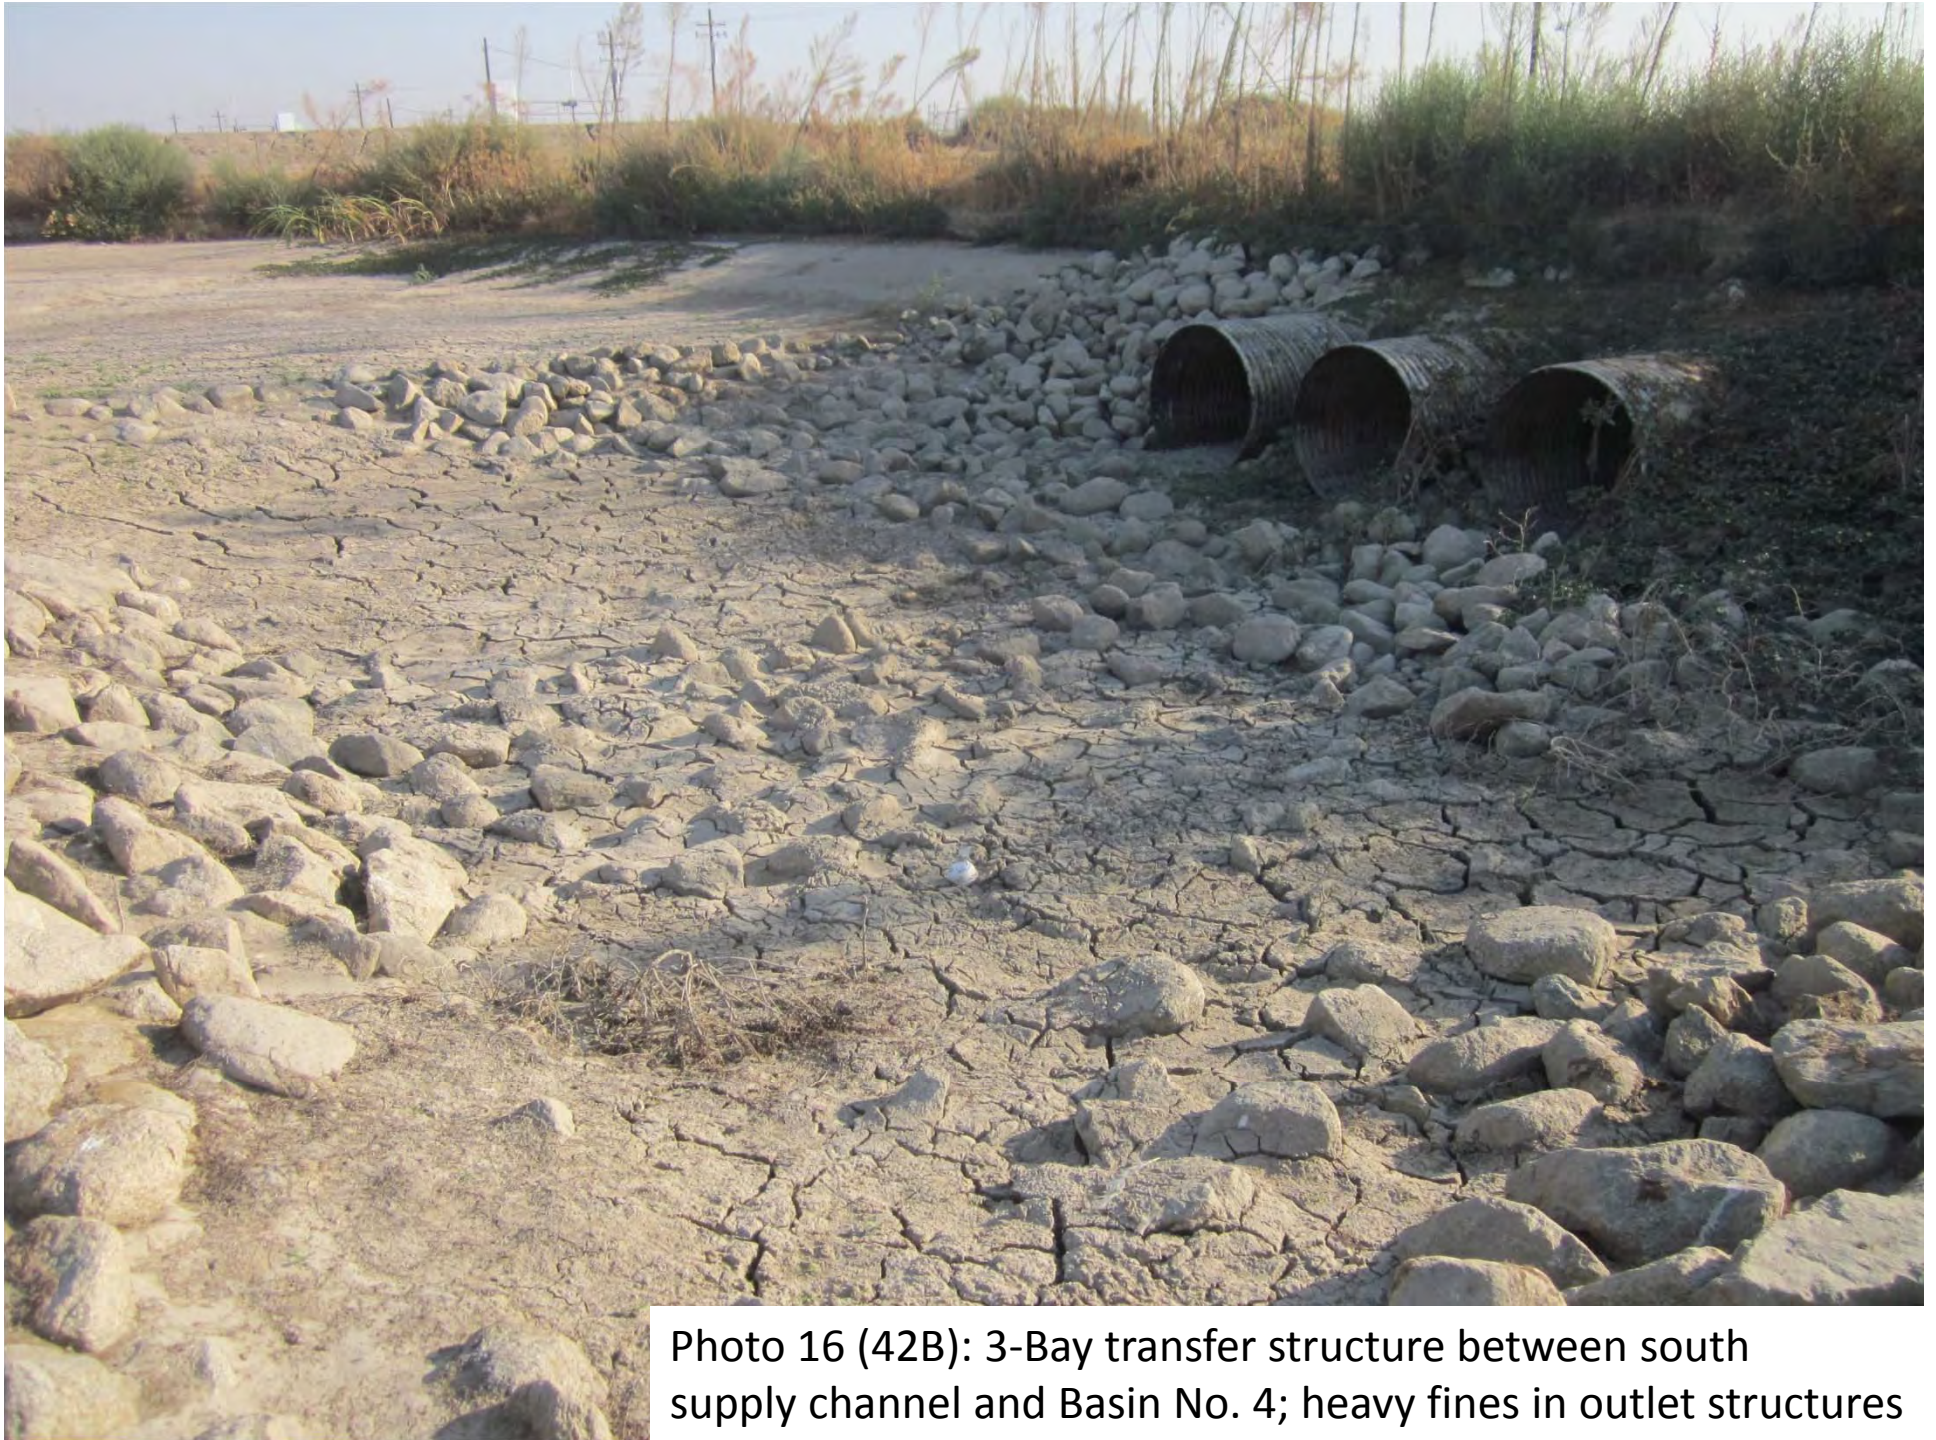
Photo 16 (42B): 3-Bay transfer structure between south supply channel and Basin No. 4; heavy fines in outlet structures

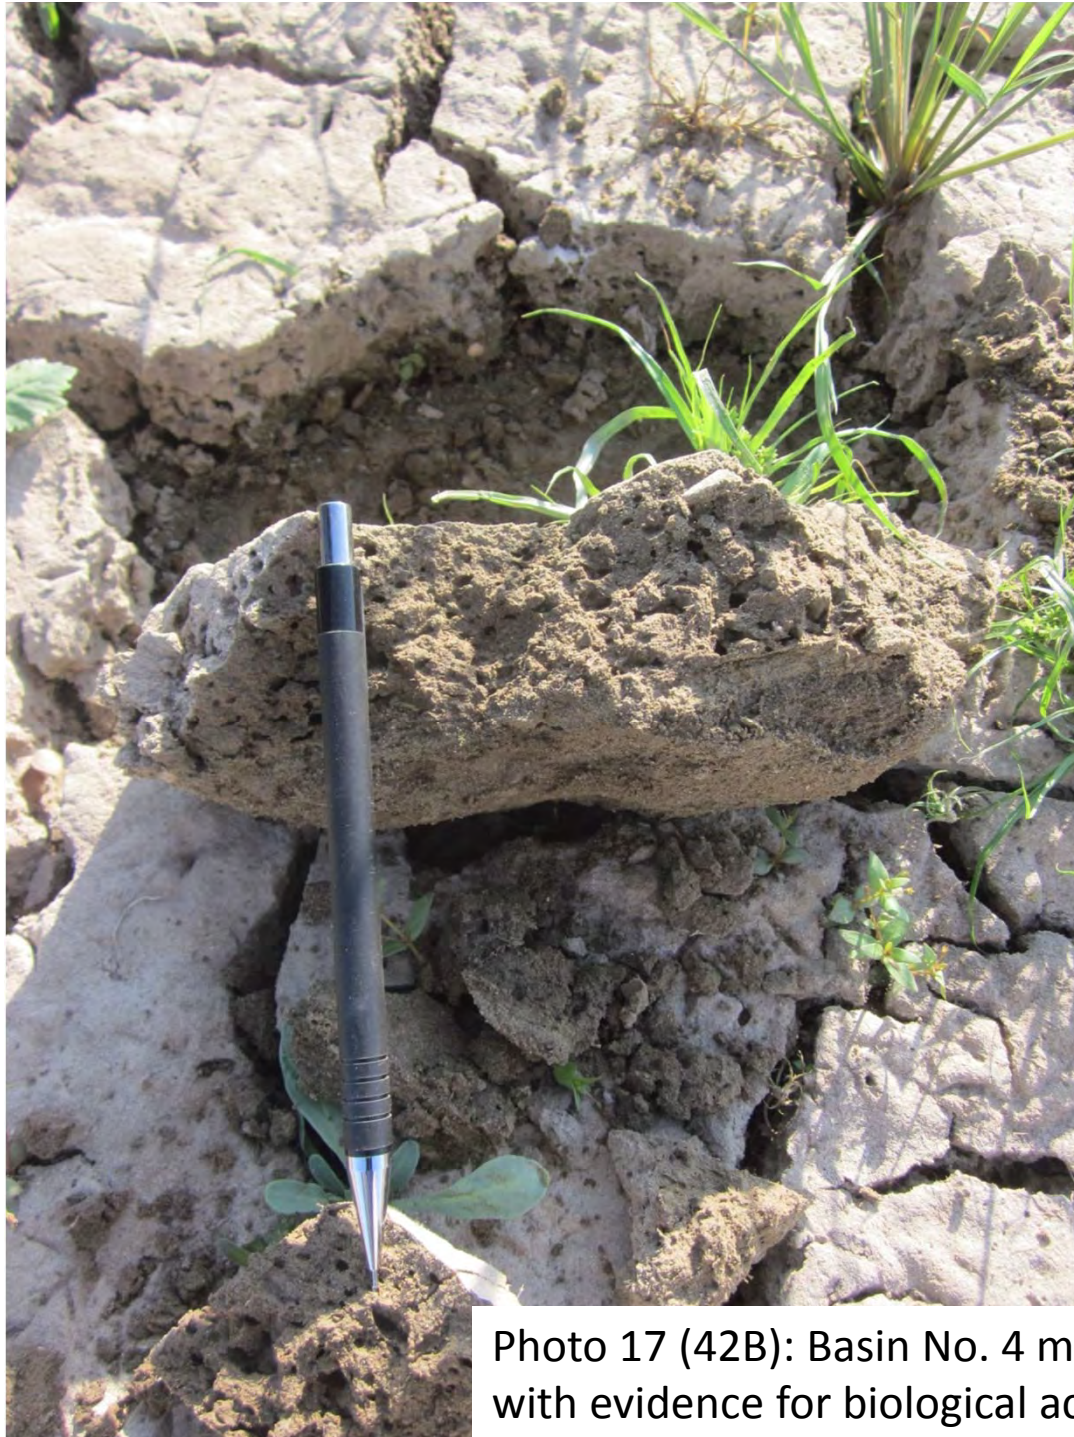
Photo 17 (42B): Basin No. 4 mud-cracks ~2" thick with evidence for biological activity

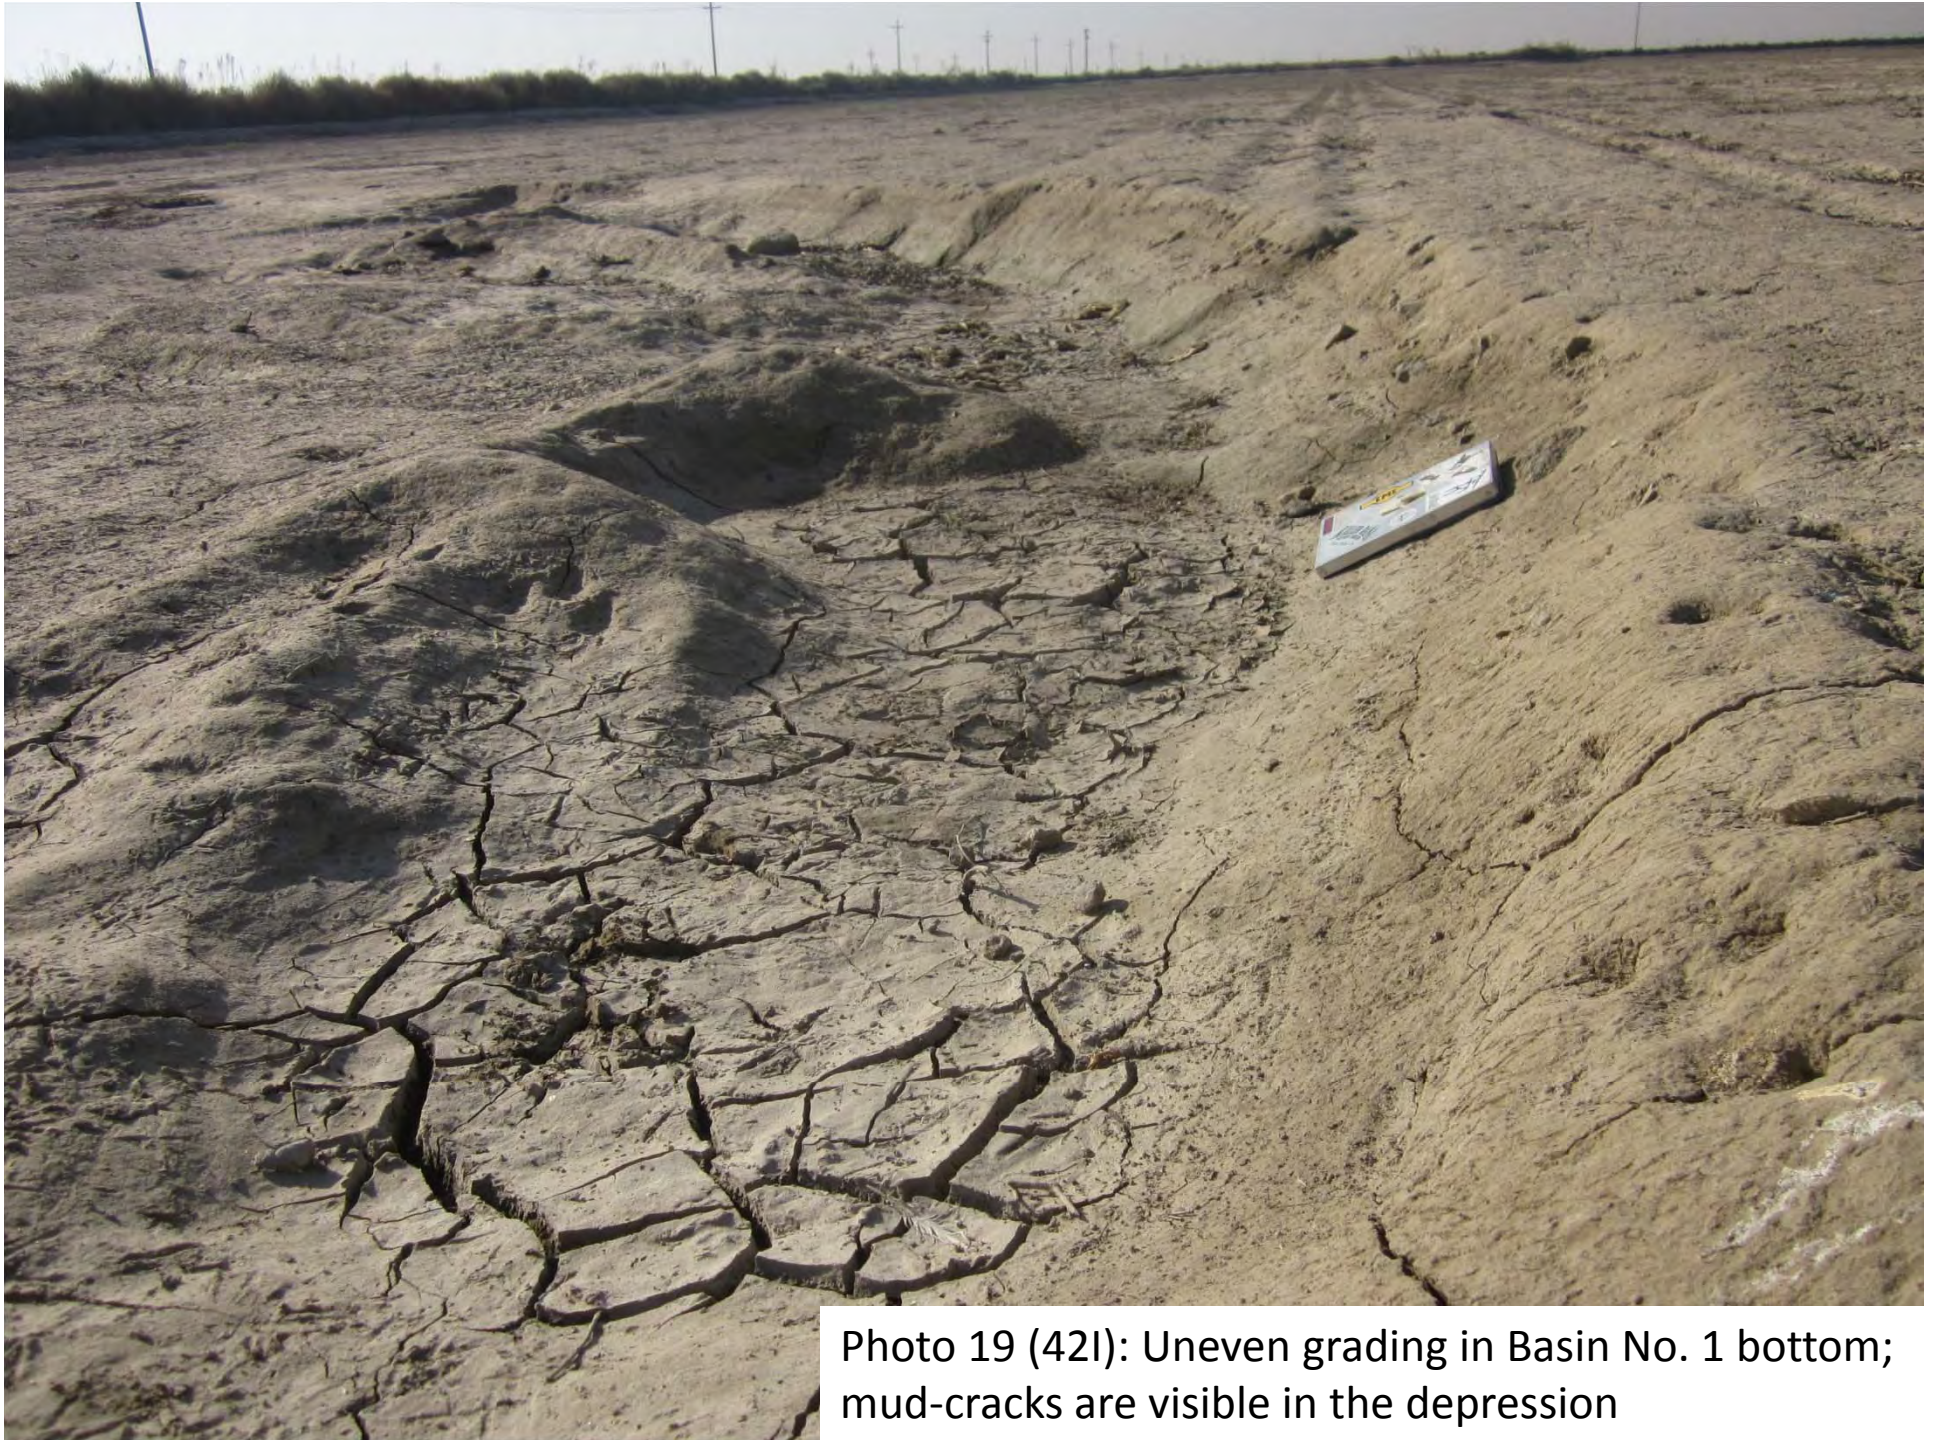
Photo 19 (42I): Uneven grading in Basin No. 1 bottom; mud-cracks are visible in the depression

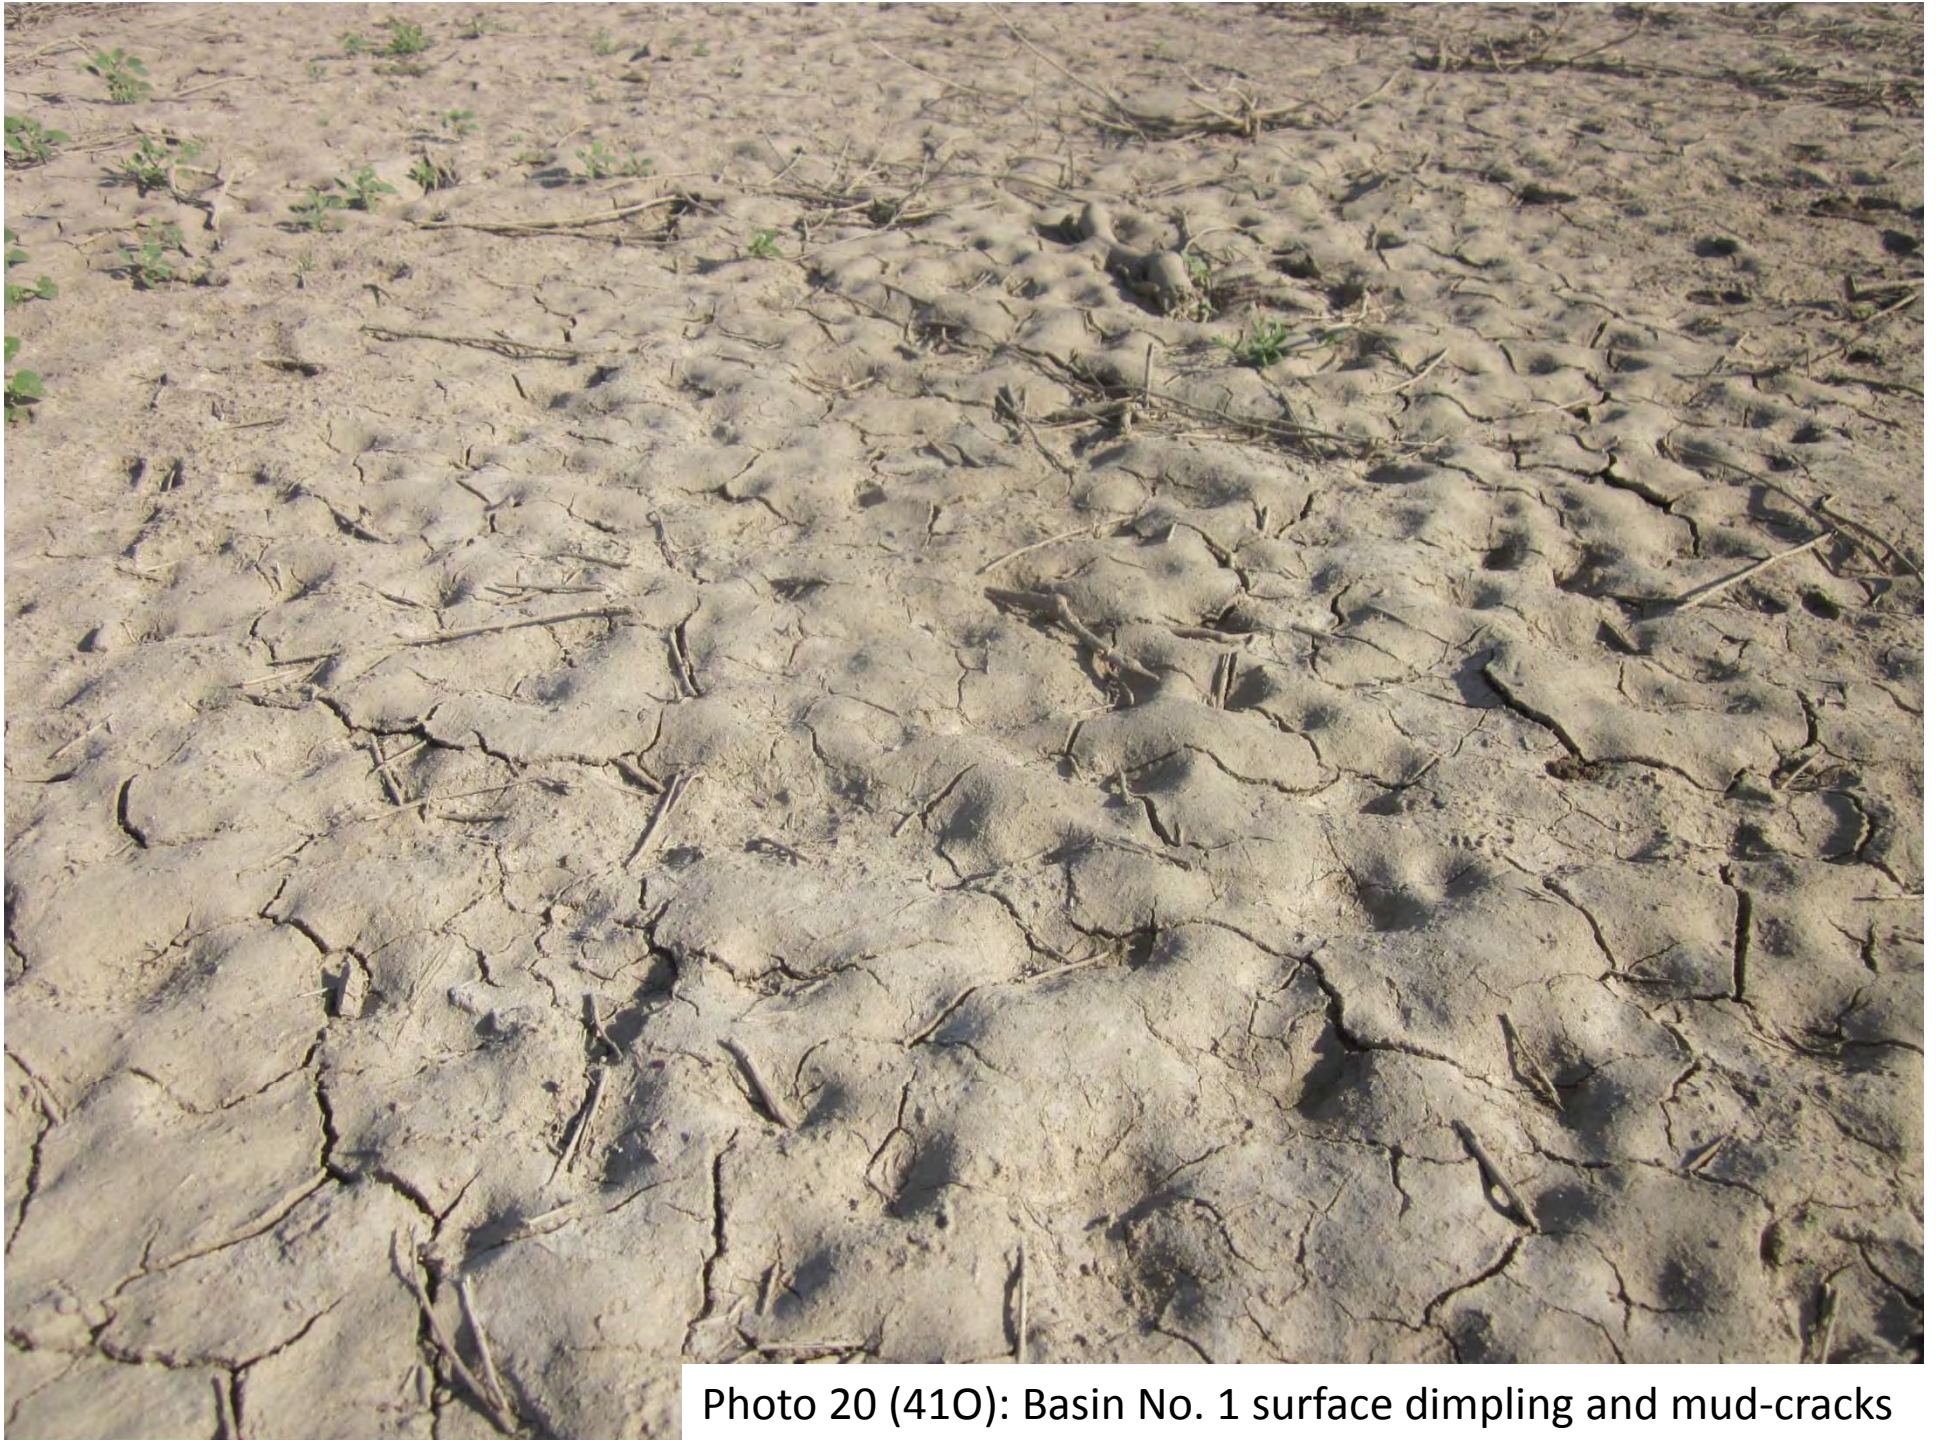
Photo 20 (410): Basin No. 1 surface dimpling and mud-cracks

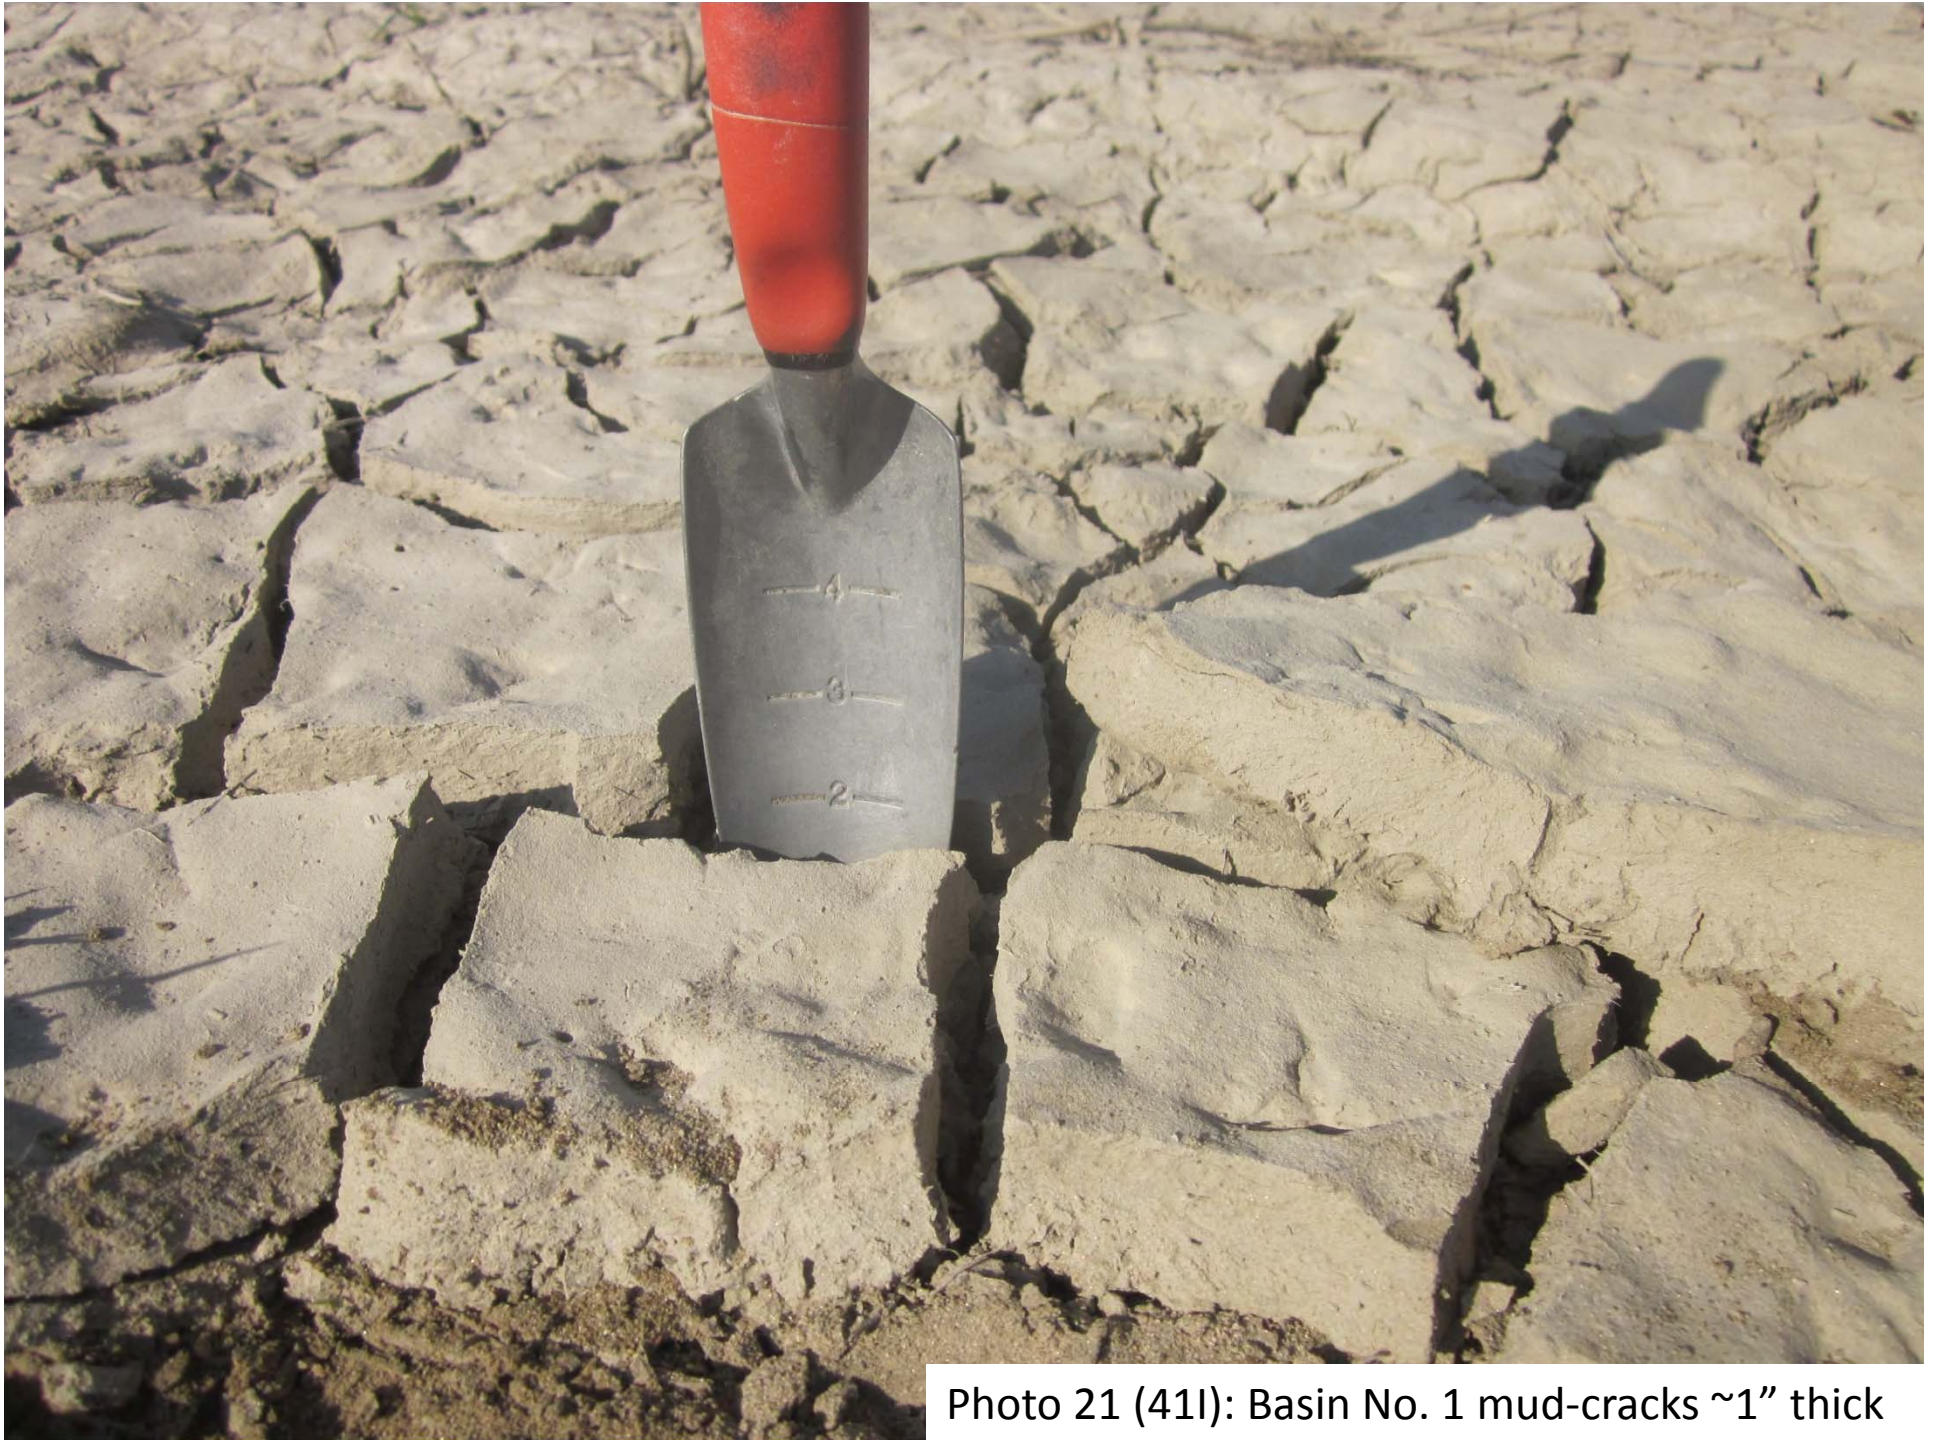
Photo 21 (41I): Basin No. 1 mud-cracks ~1" thick

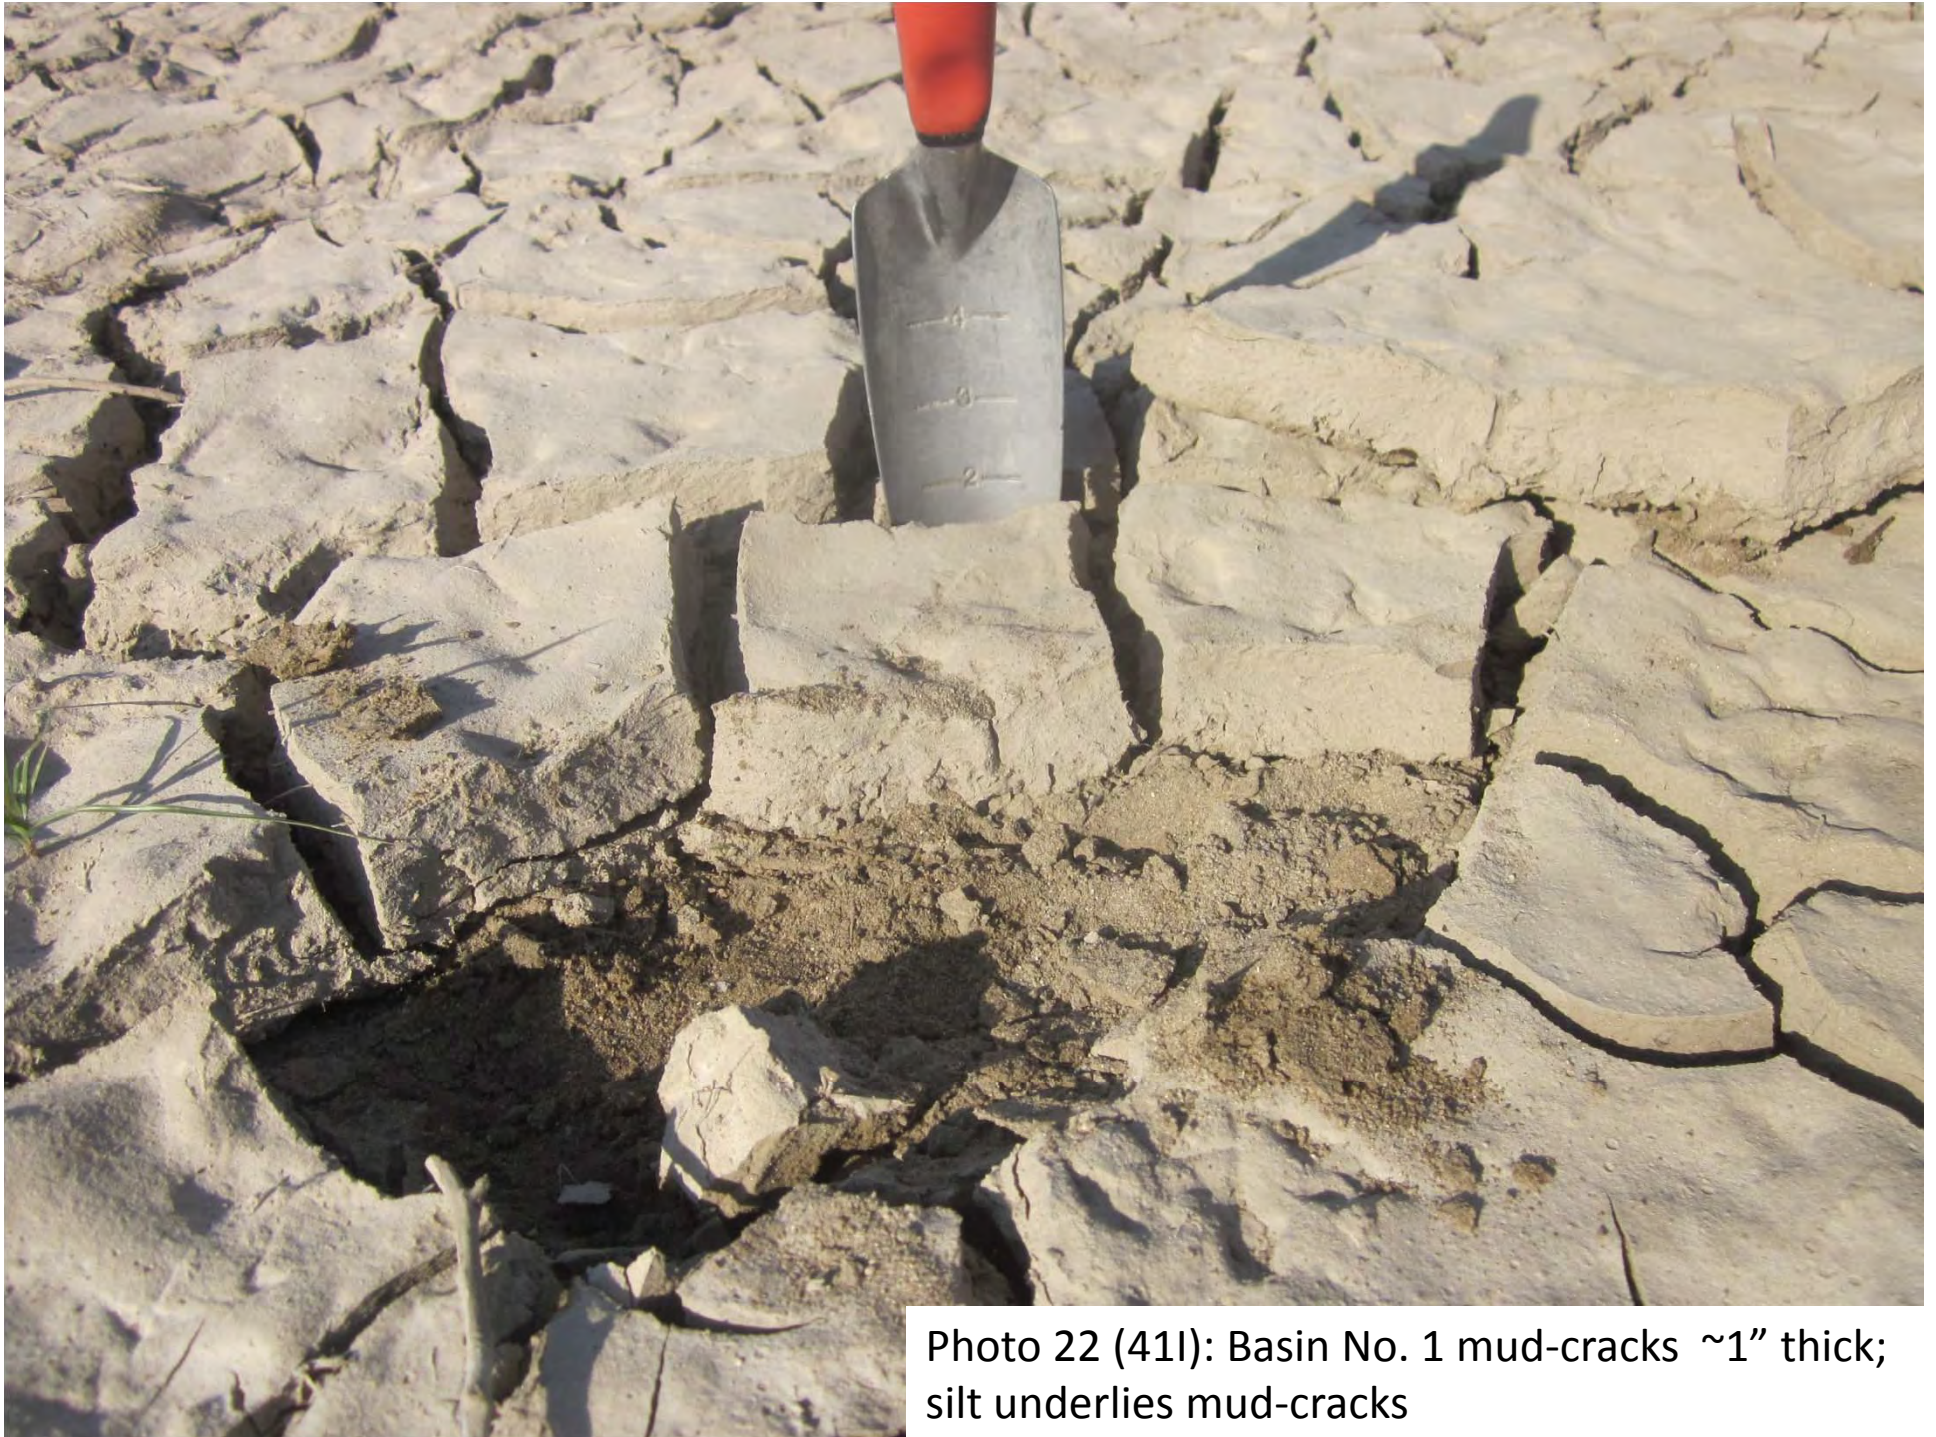
Photo 22 (41I): Basin No. 1 mud-cracks ~1" thick;
silt underlies mud-cracks
