October 11, 2011

Irvine Ranch Water District
Attention: Paul Weghorst
15600 Sand Canyon Avenue
Irvine, CA 92618

Subject: *Strand Ranch South Basin Field Reconnaissance and Remediation Recommendations*

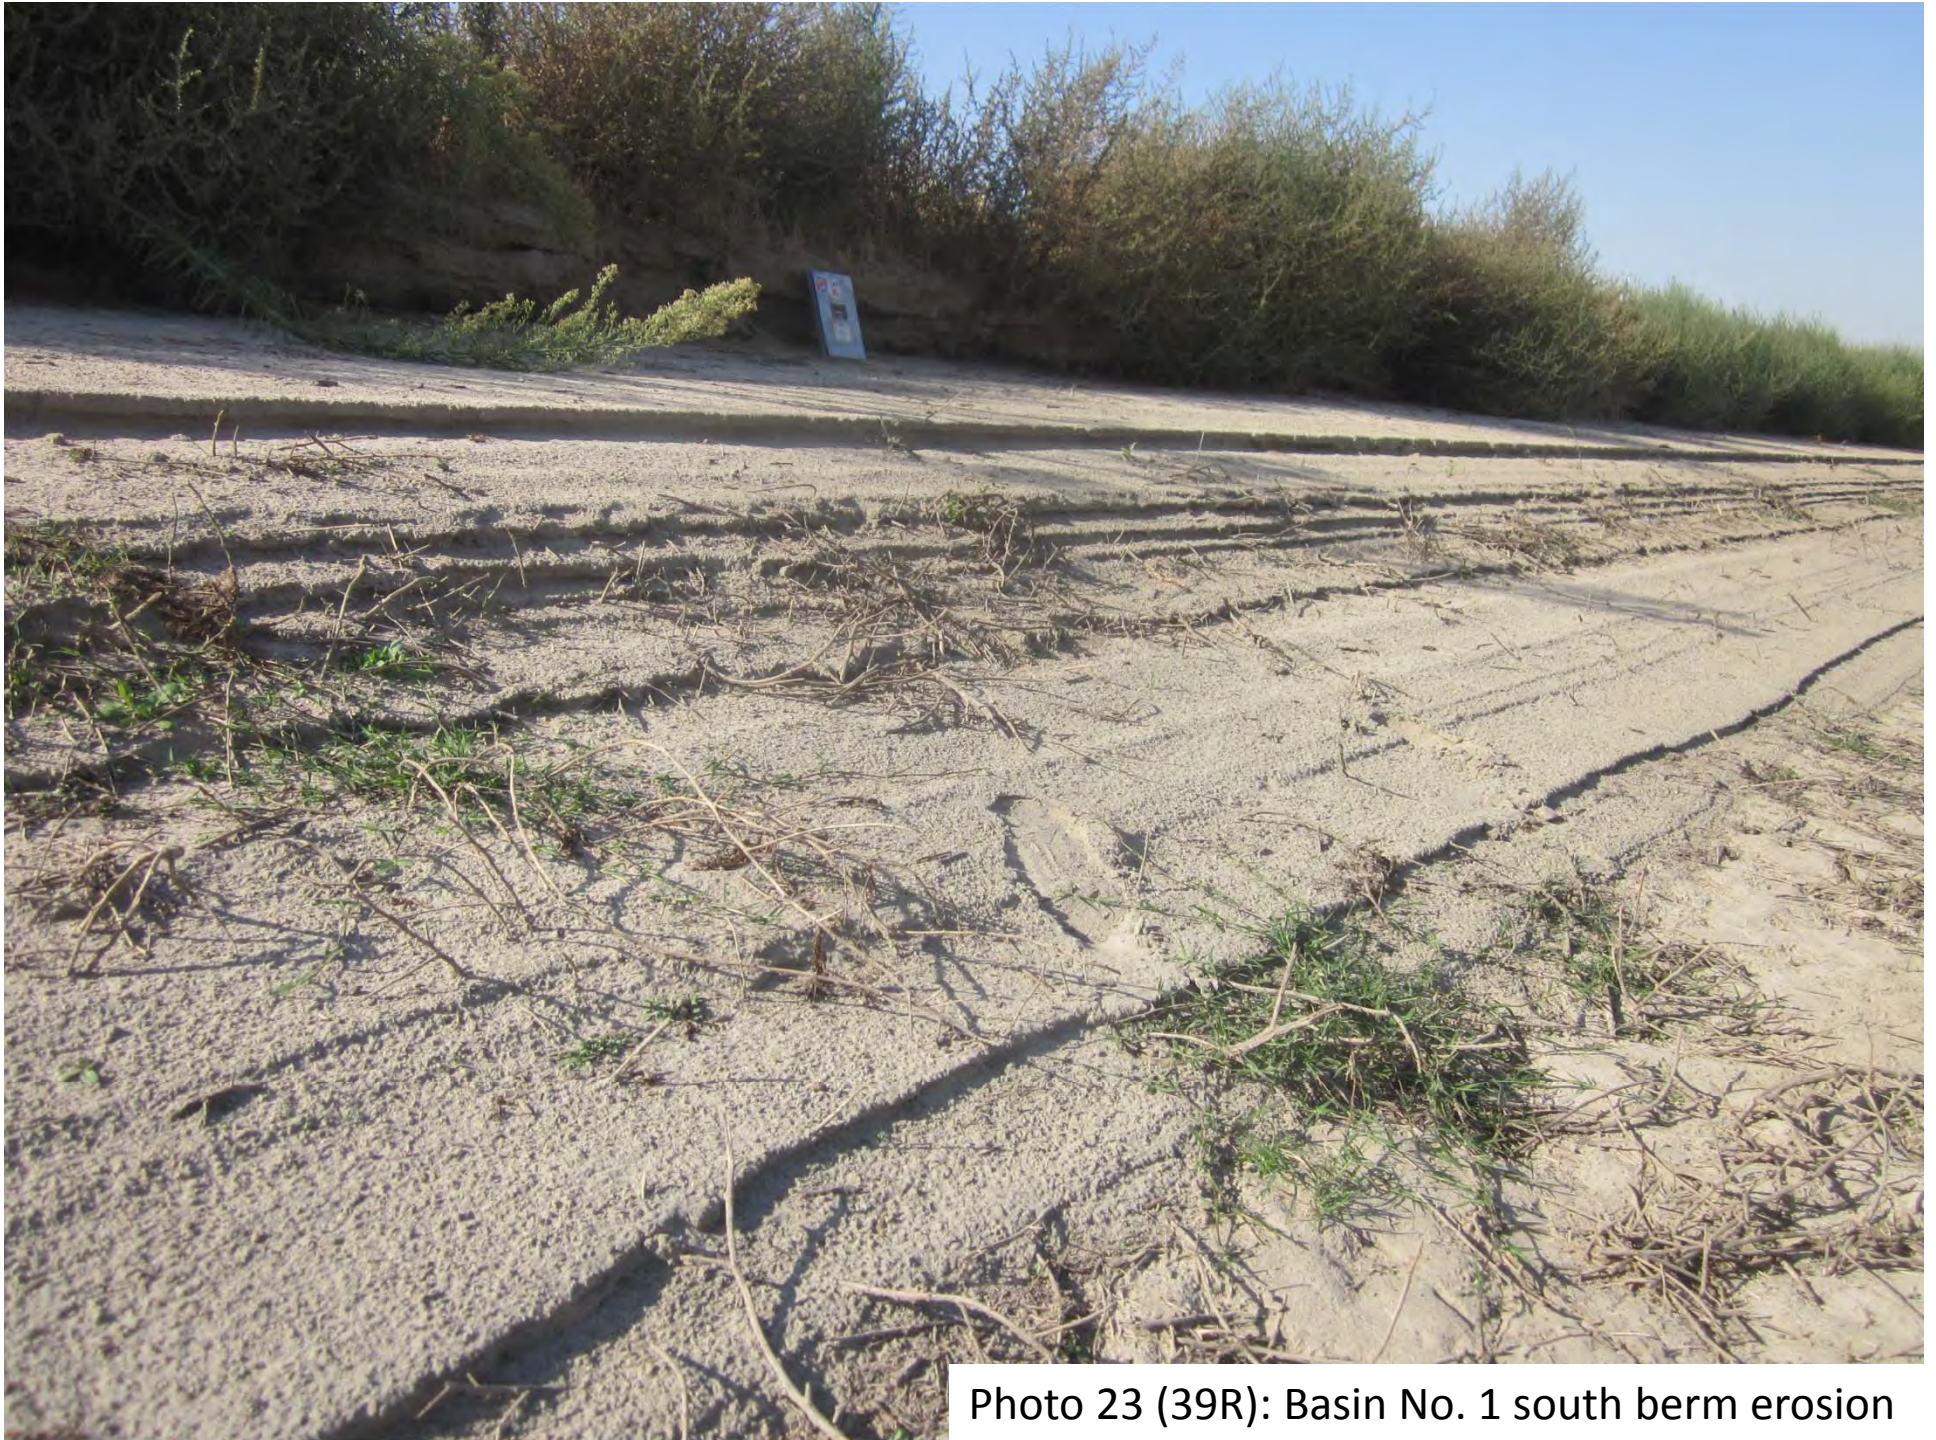
Photo 23 (39R): Basin No. 1 south berm erosion

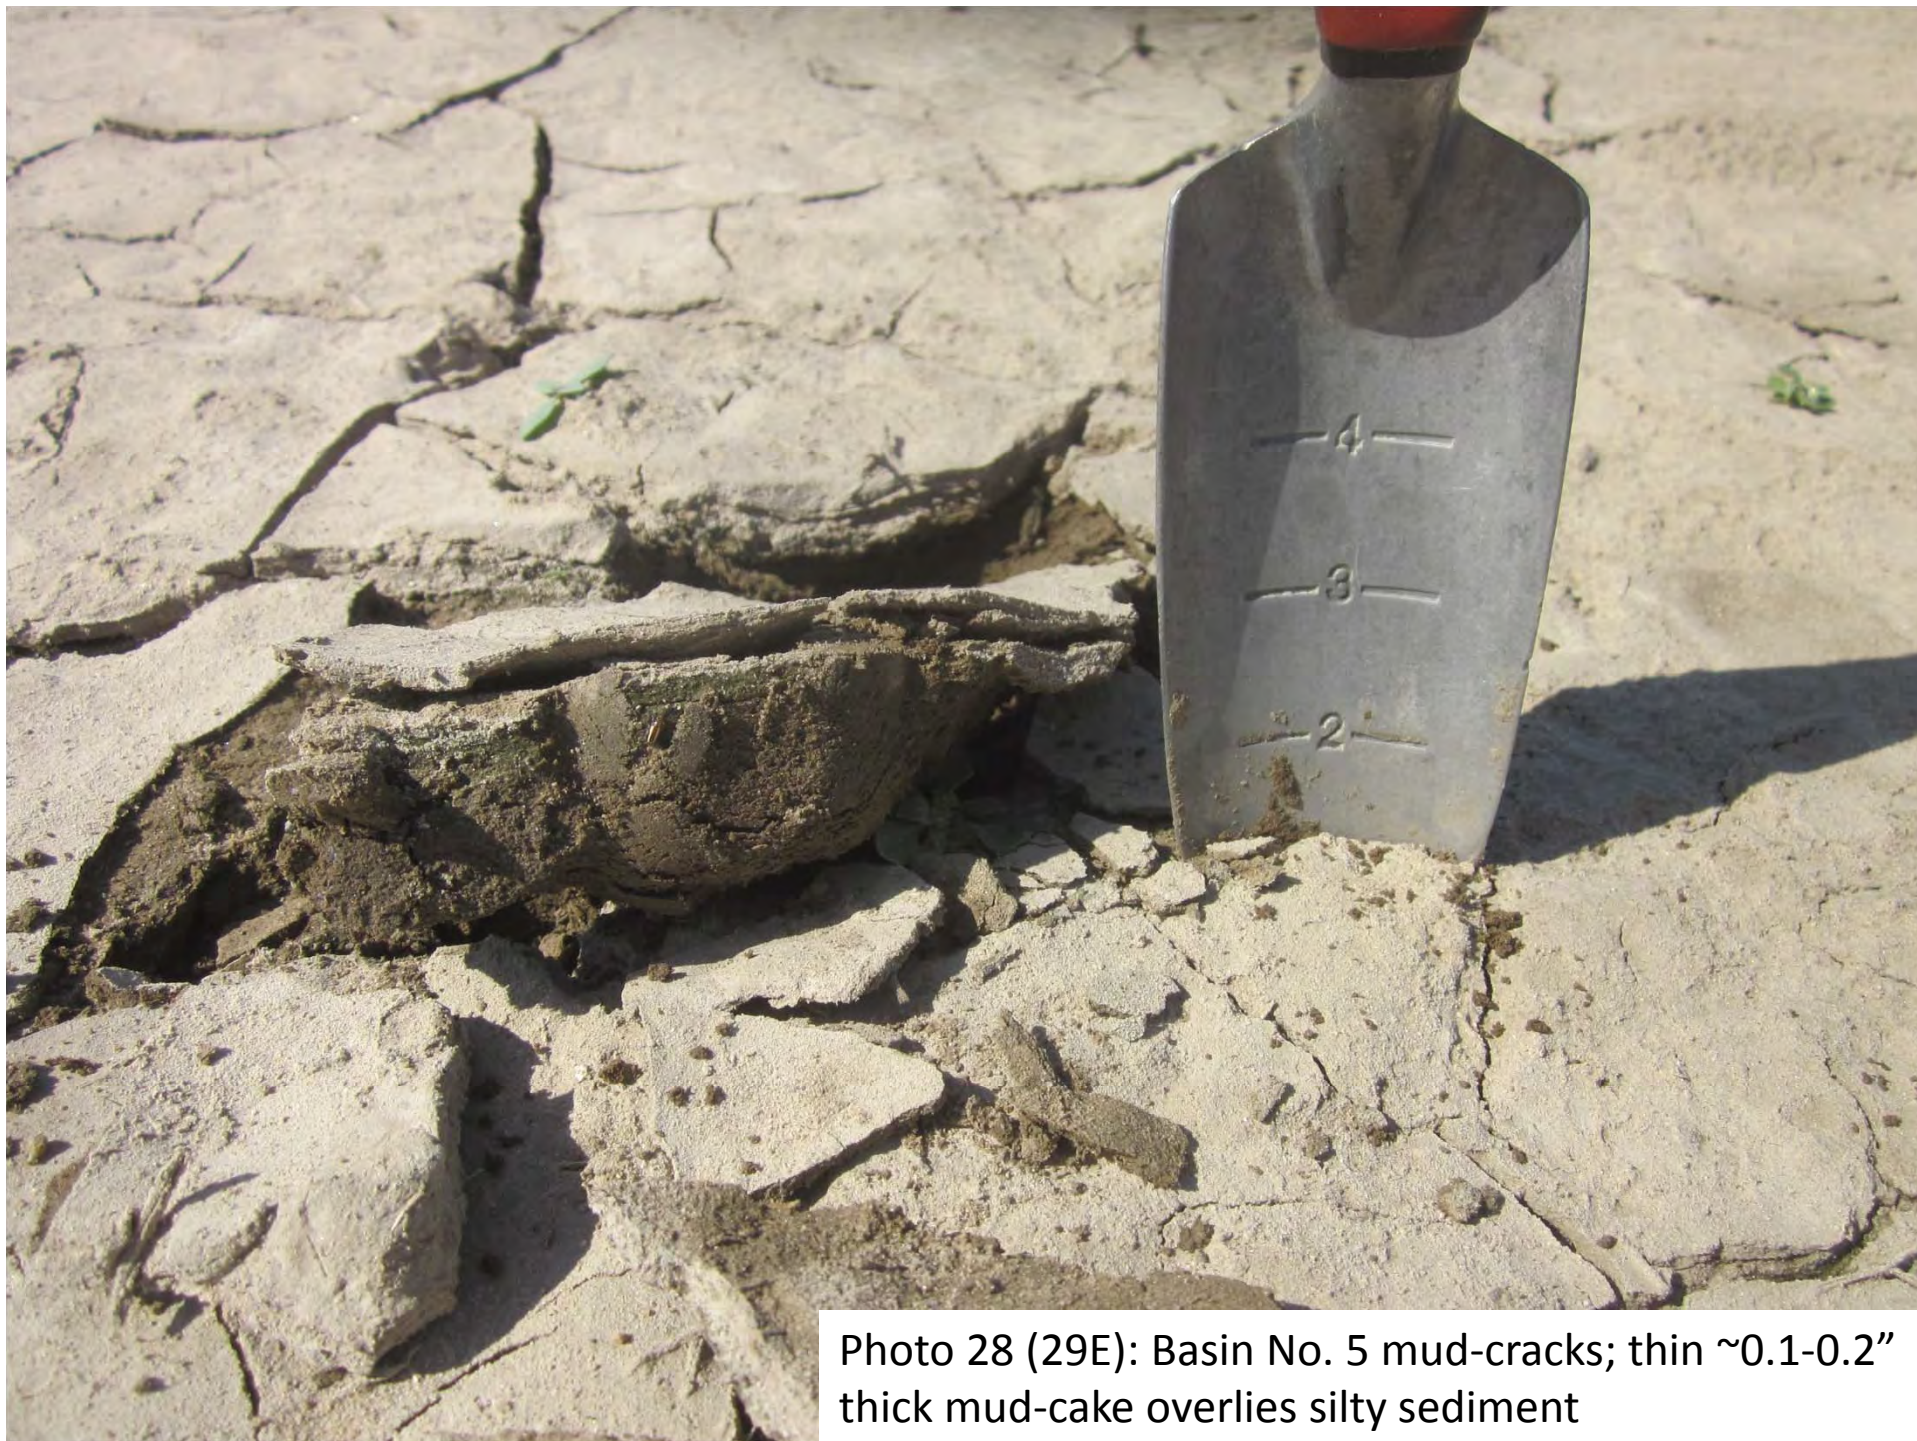
Photo 28 (29E): Basin No. 5 mud-cracks; thin ~0.1-0.2" thick mud-cake overlies silty sediment

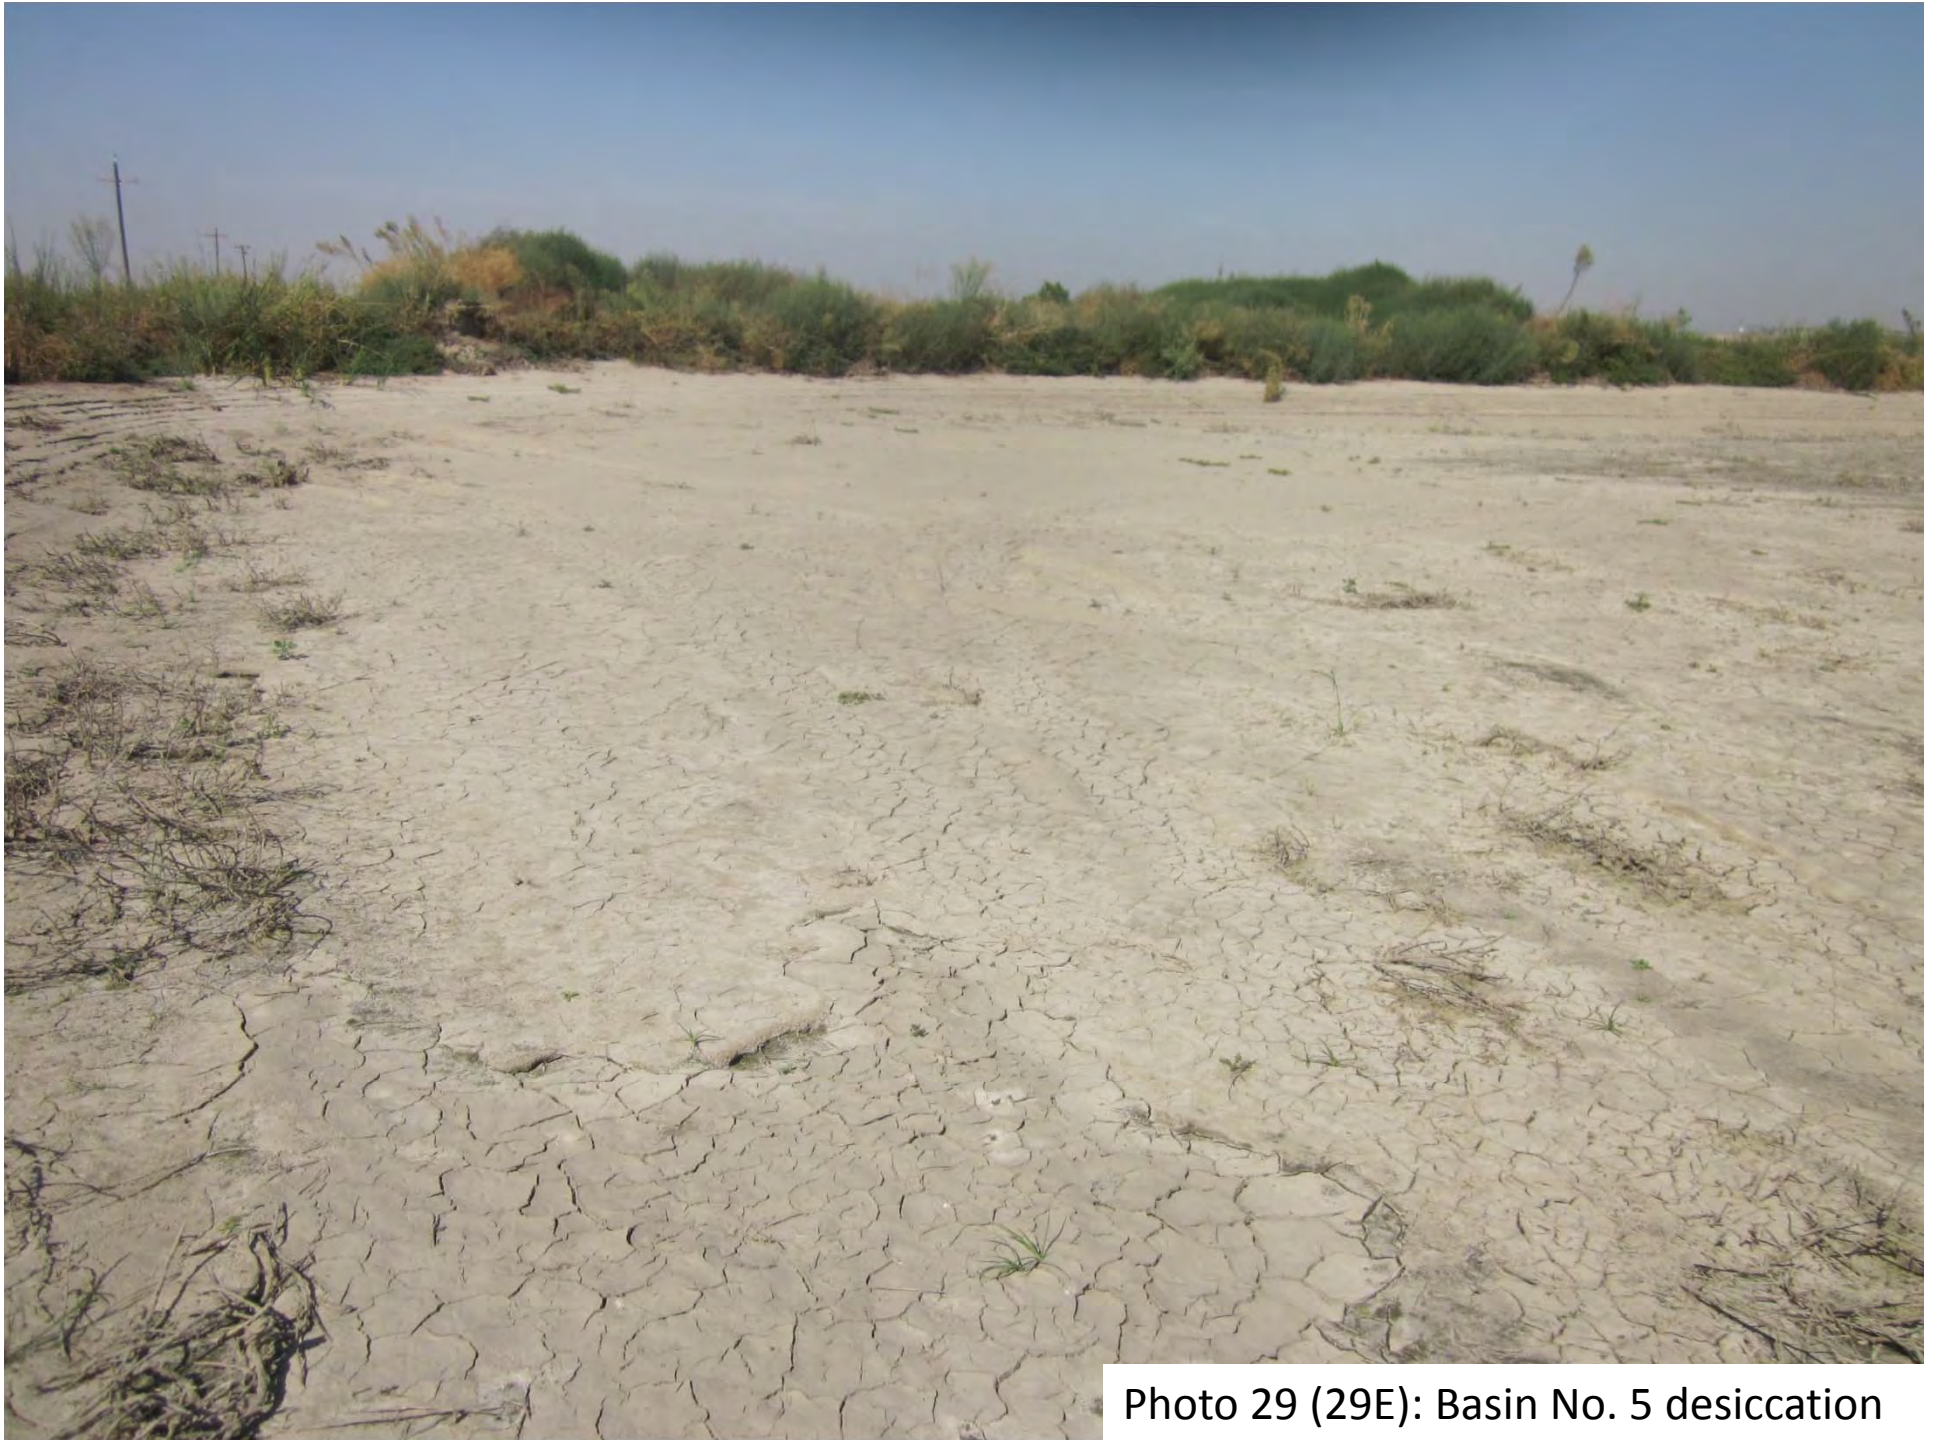
Photo 29 (29E): Basin No. 5 desiccation

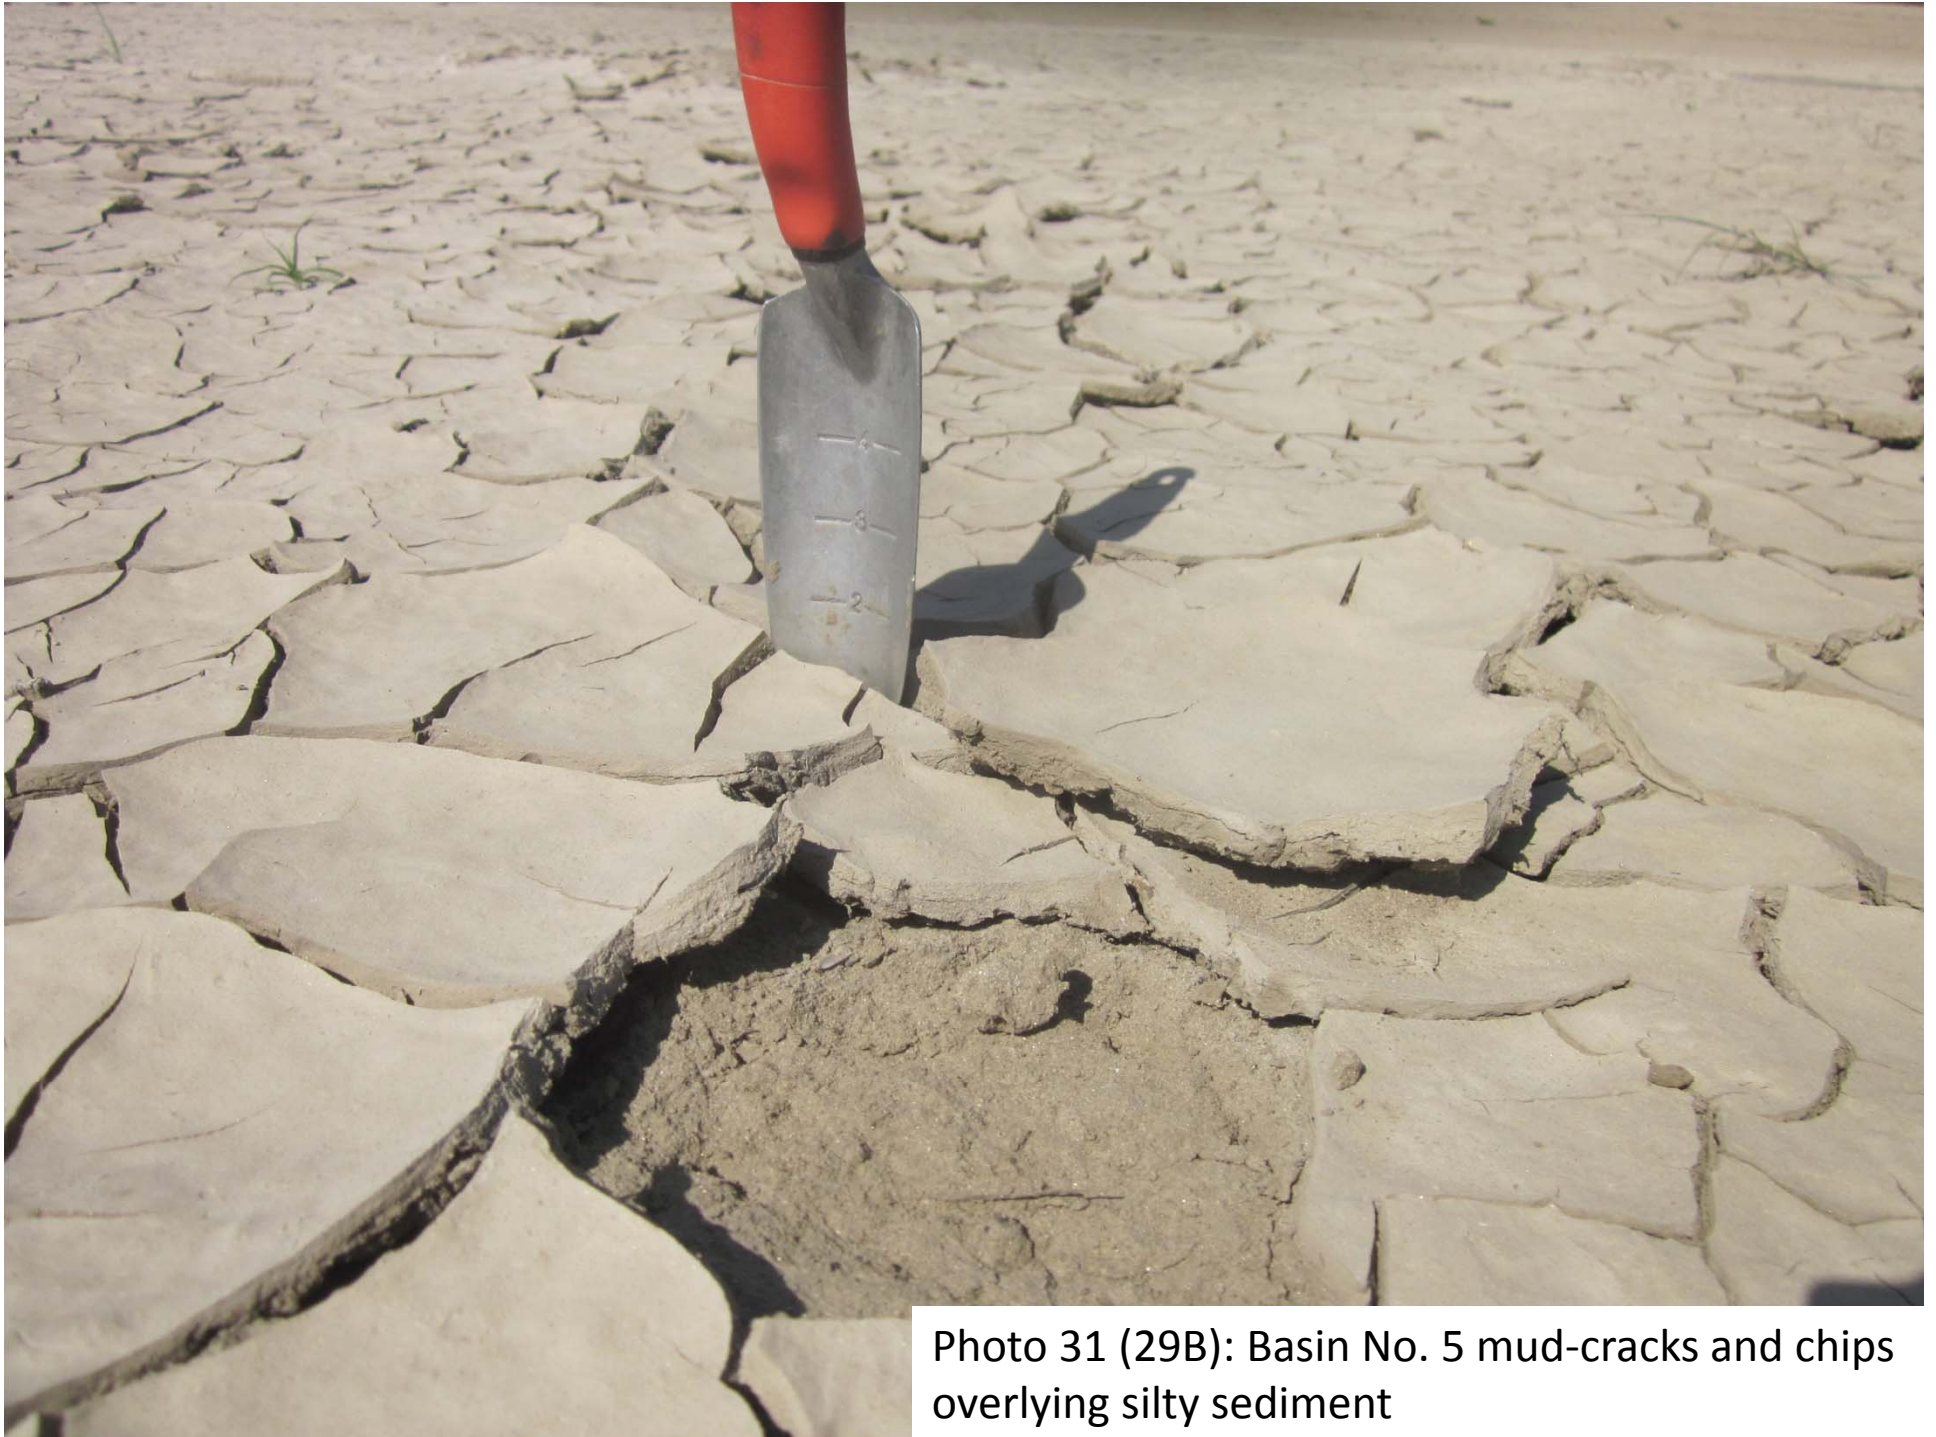
Photo 31 (29B): Basin No. 5 mud-cracks and chips overlying silty sediment

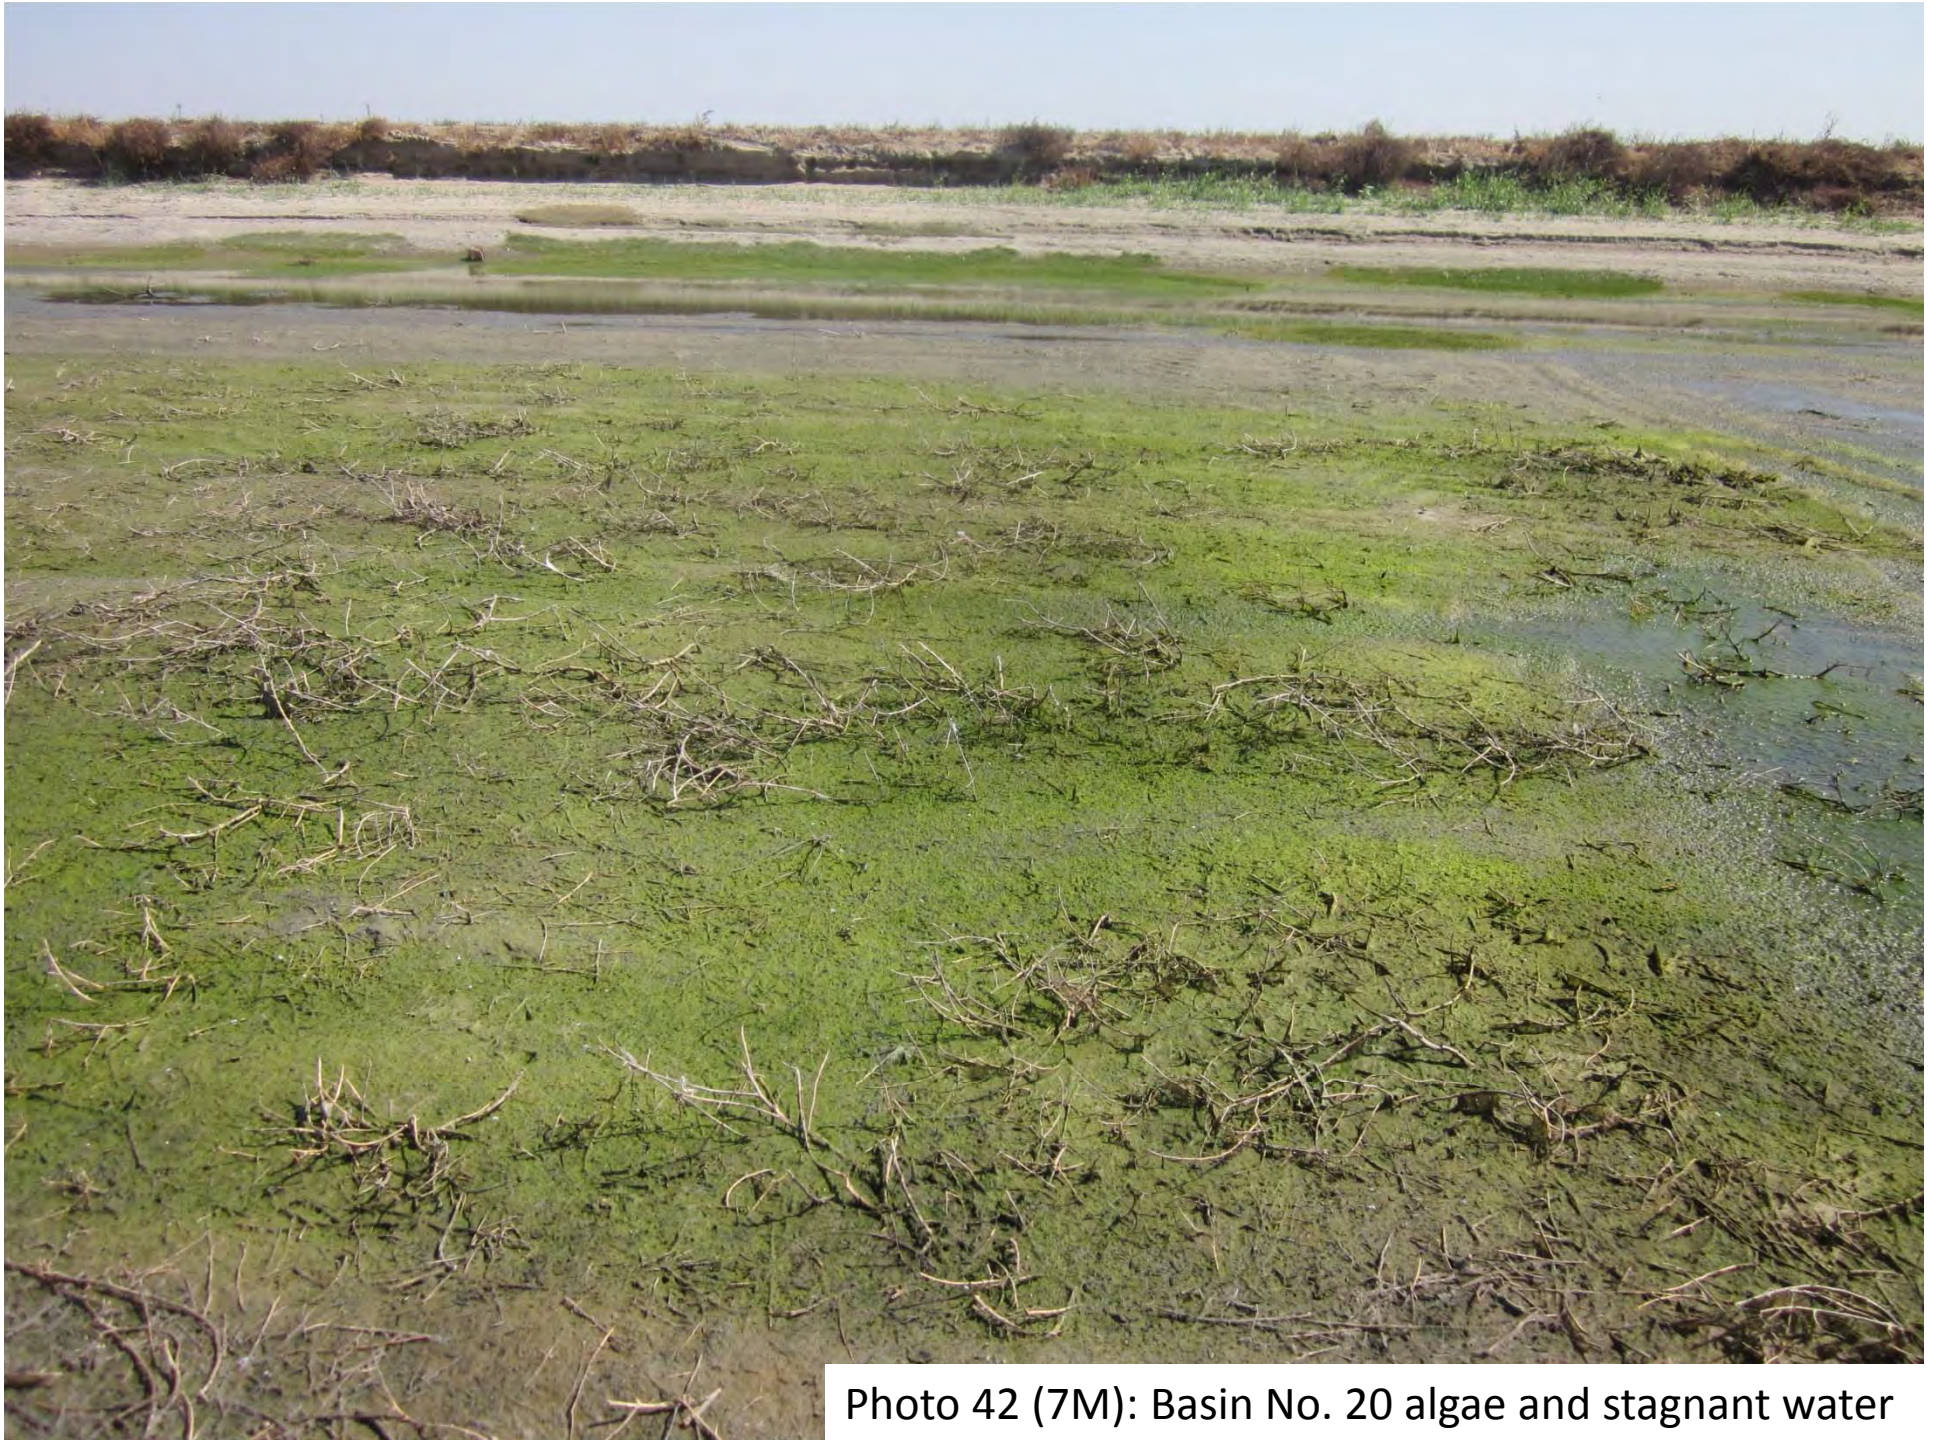
Photo 42 (7M): Basin No. 20 algae and stagnant water

During the field reconnaissance, much of Basin 20 was covered in standing water, and the entire basin bottom was wet. When Basin 20 is dry, we recommend that it be inspected for a clogging layer, and based upon our observations of the other basins, it will likely require the same method of remediation described above.

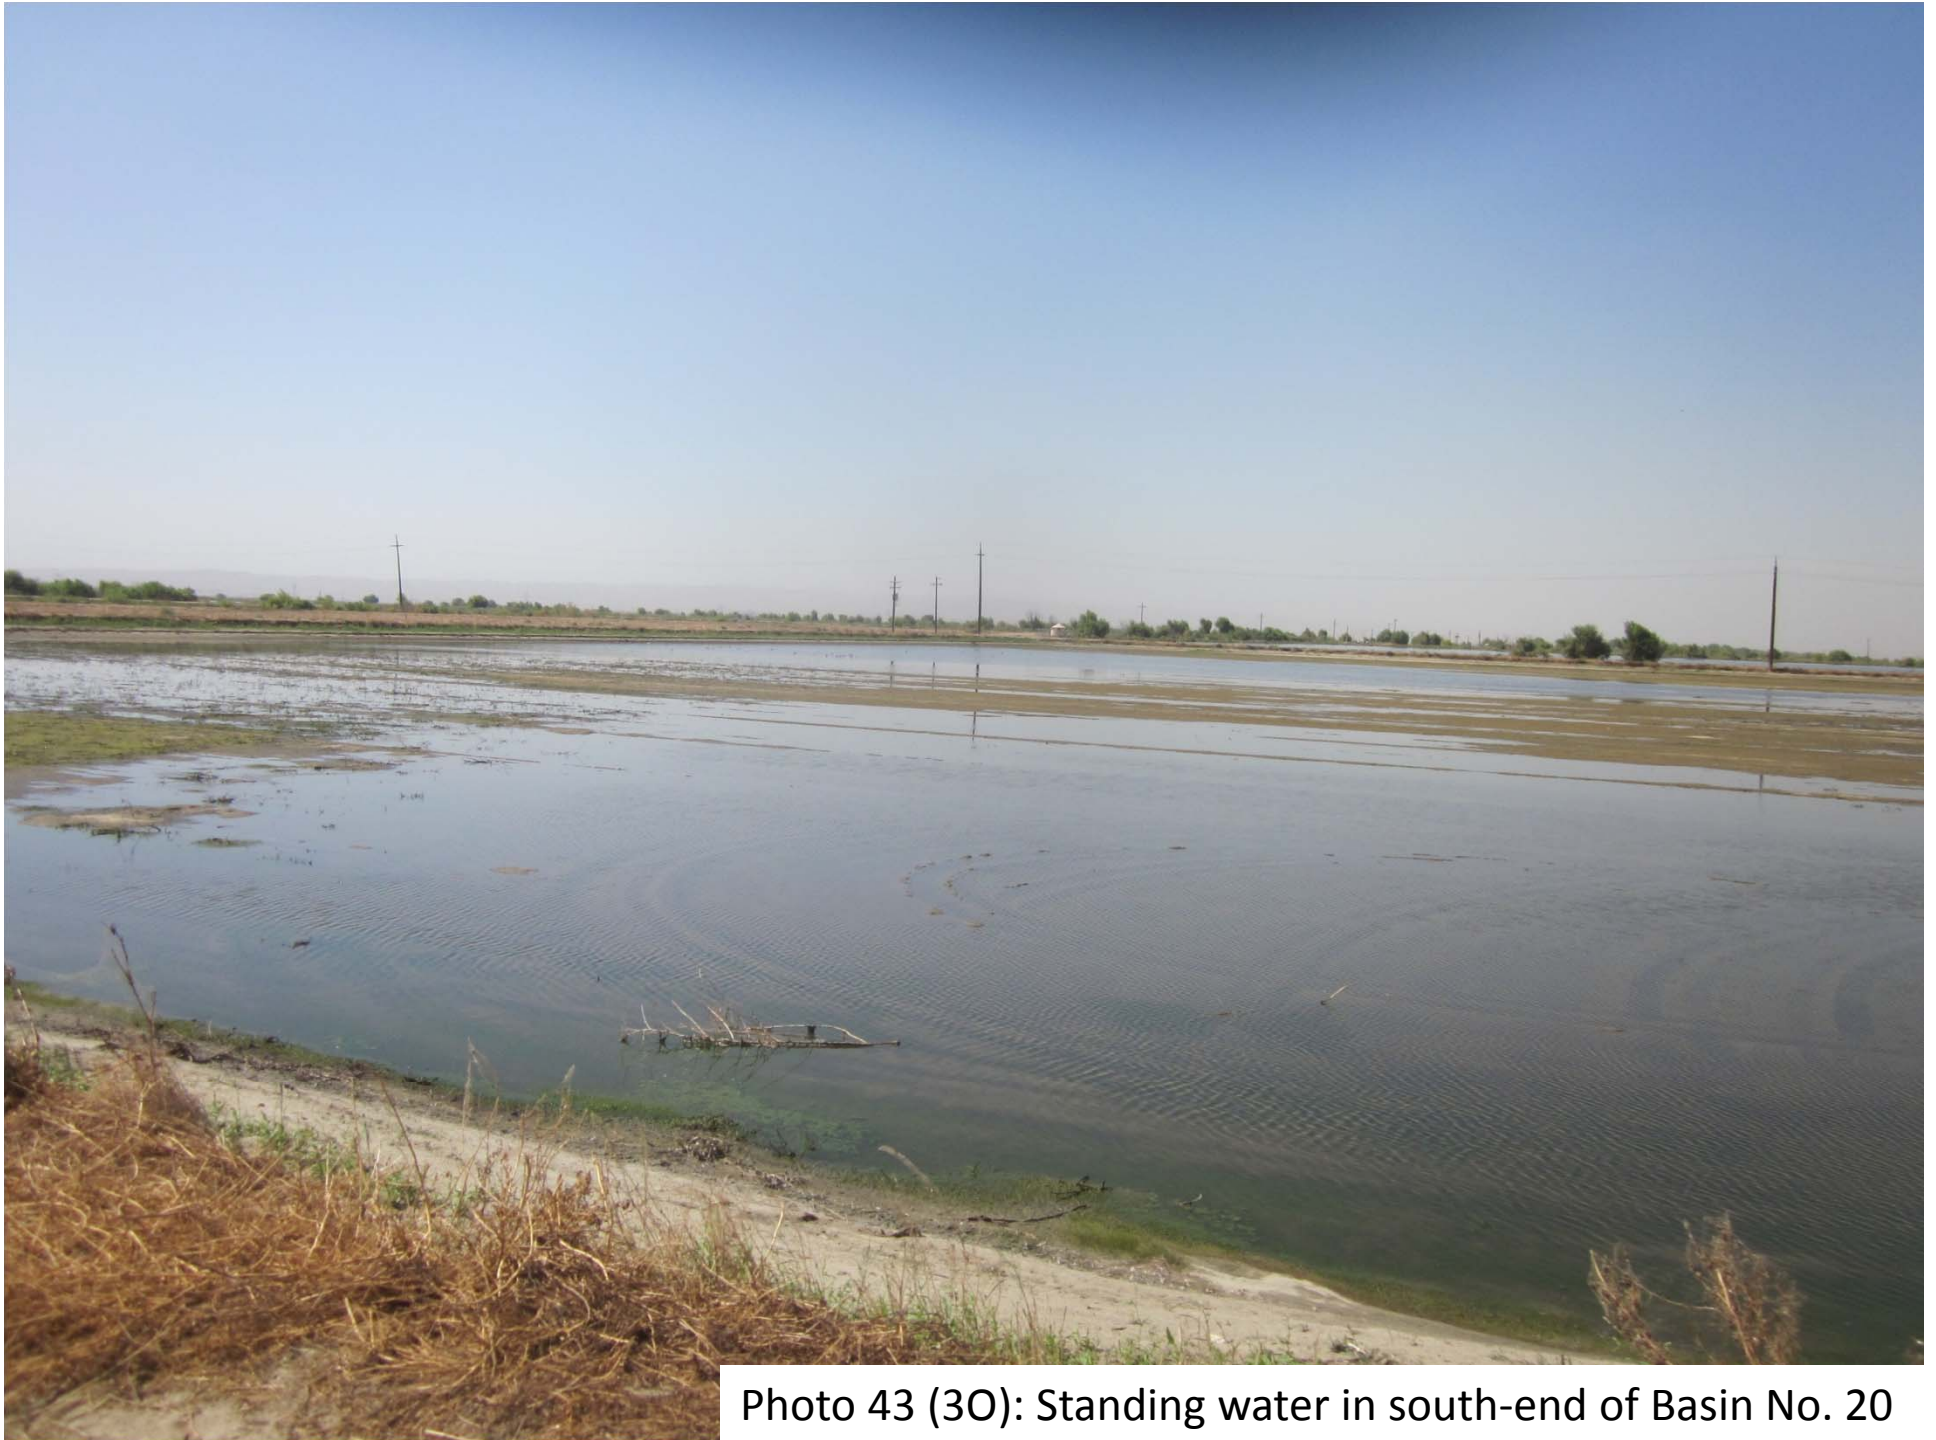
Photo 43 (30): Standing water in south-end of Basin No. 20

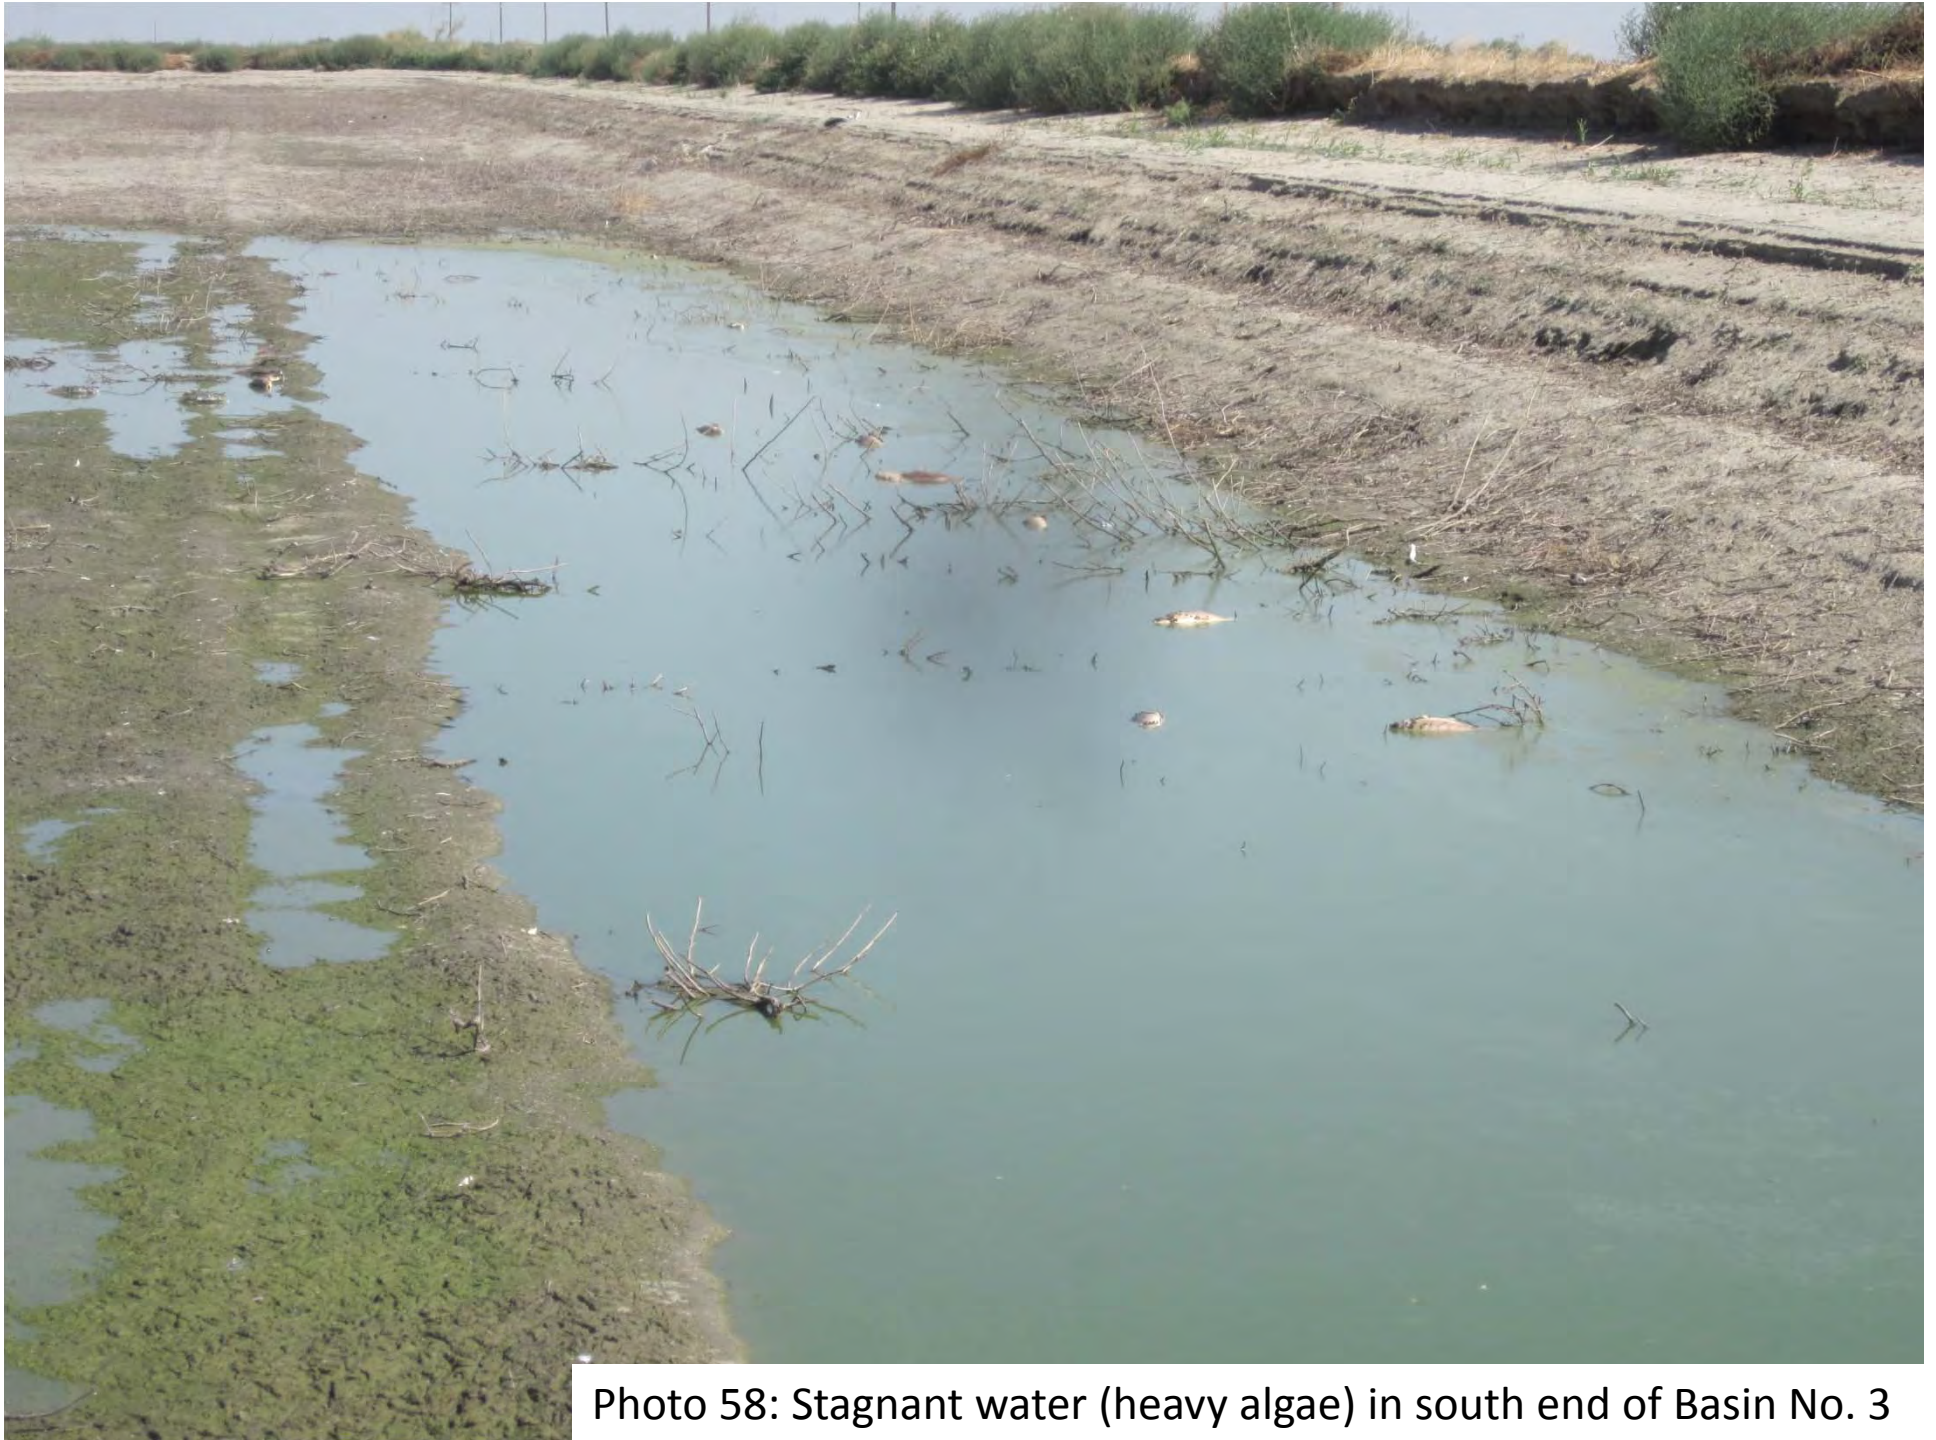
Photo 58: Stagnant water (heavy algae) in south end of Basin No. 3

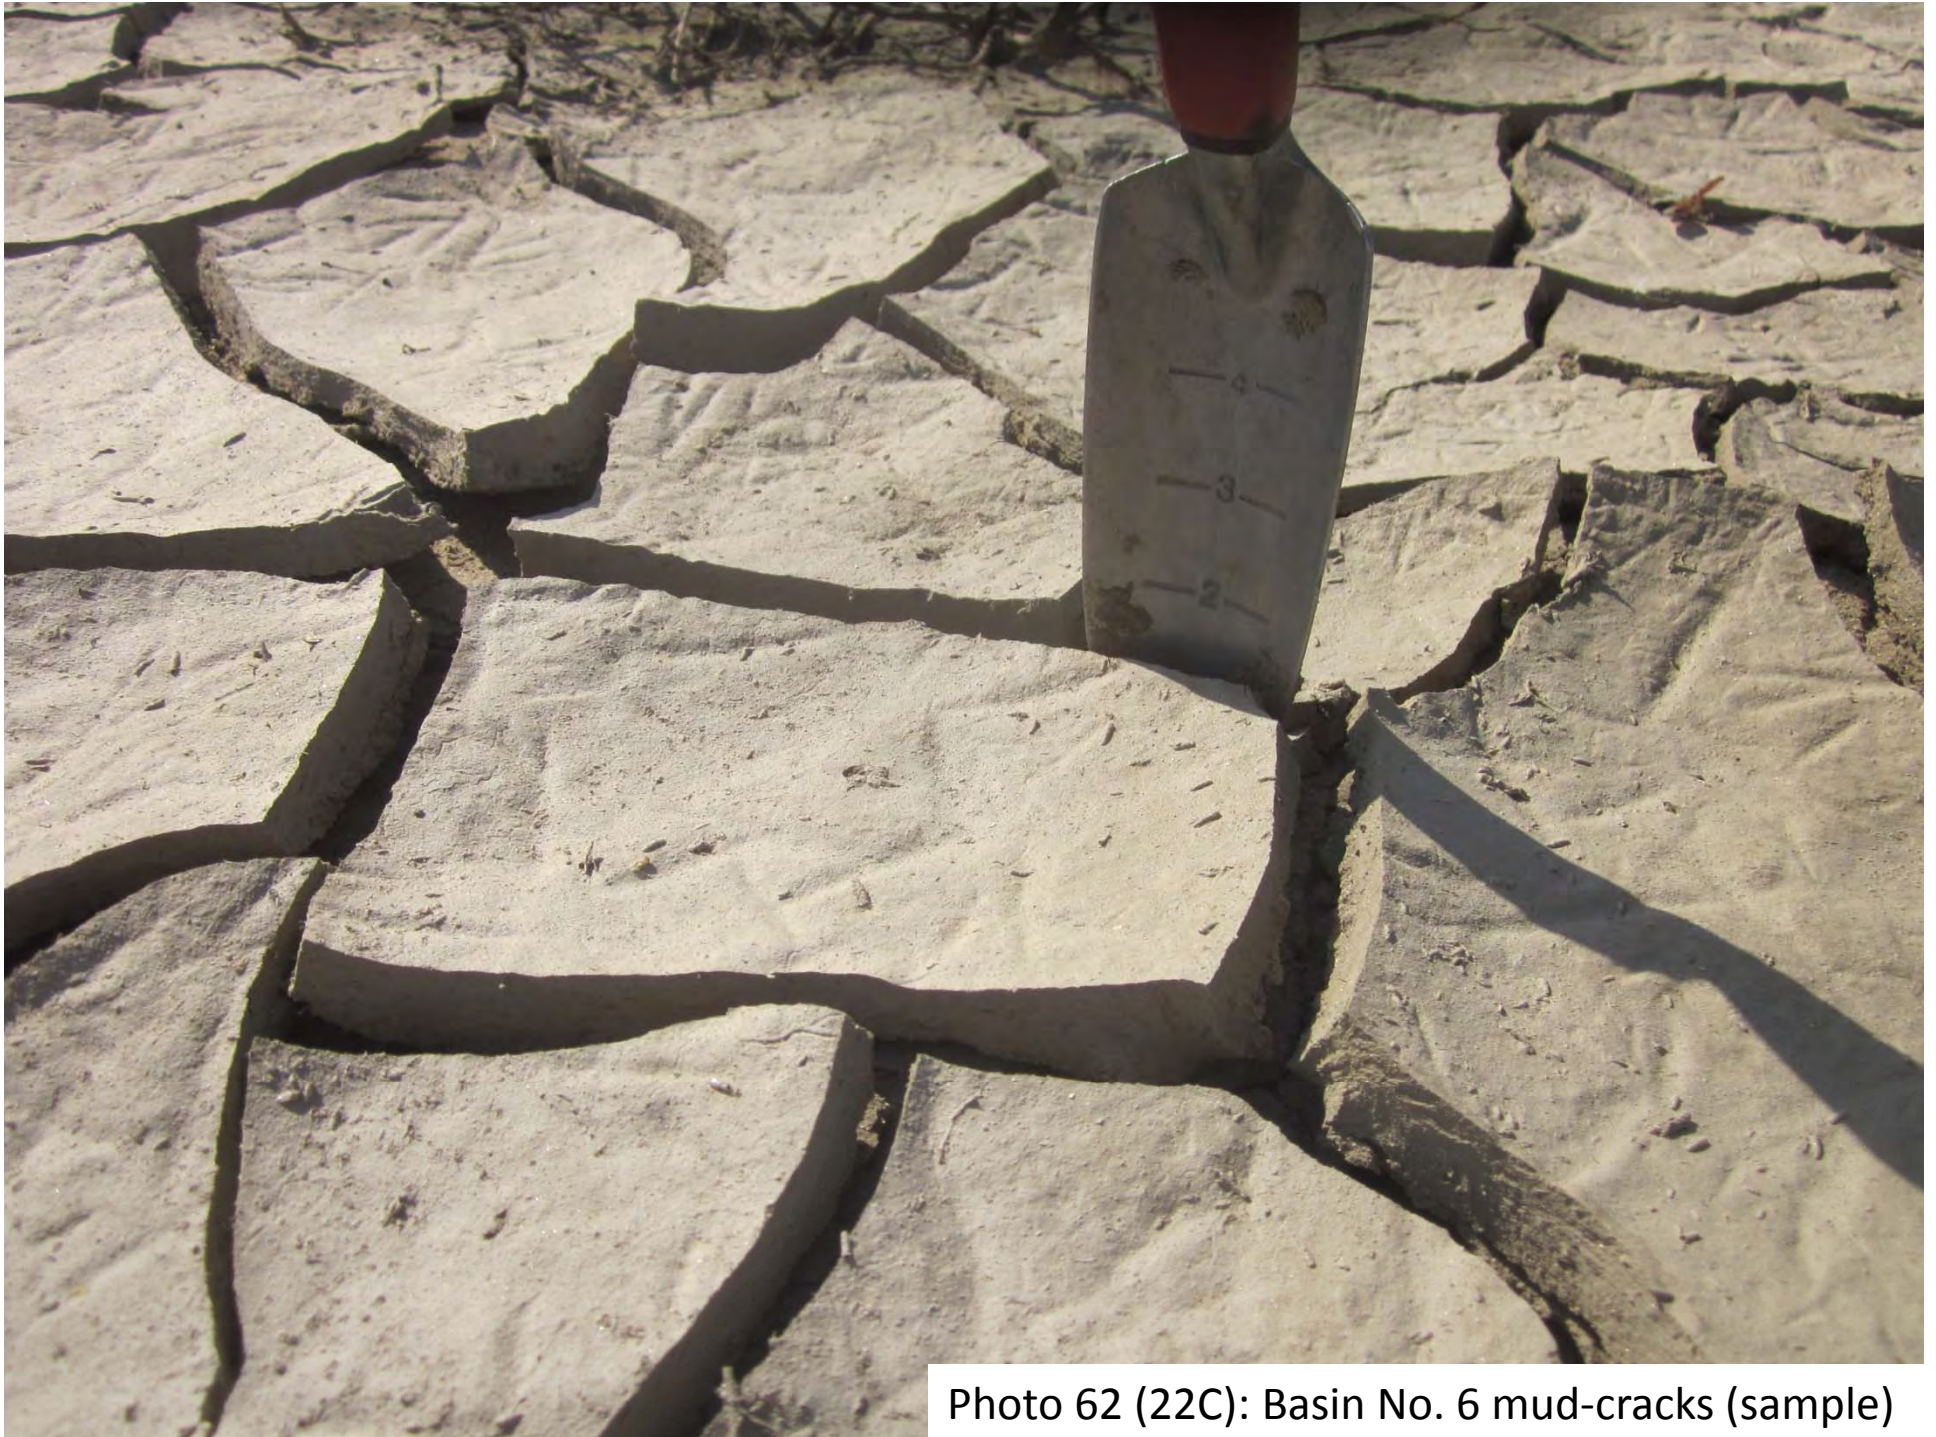
Photo 62 (22C): Basin No. 6 mud-cracks (sample)
