October 11, 2011

Irvine Ranch Water District
Attention: Paul Weghorst
15600 Sand Canyon Avenue
Irvine, CA 92618

Subject: *Strand Ranch South Basin Field Reconnaissance and Remediation Recommendations*

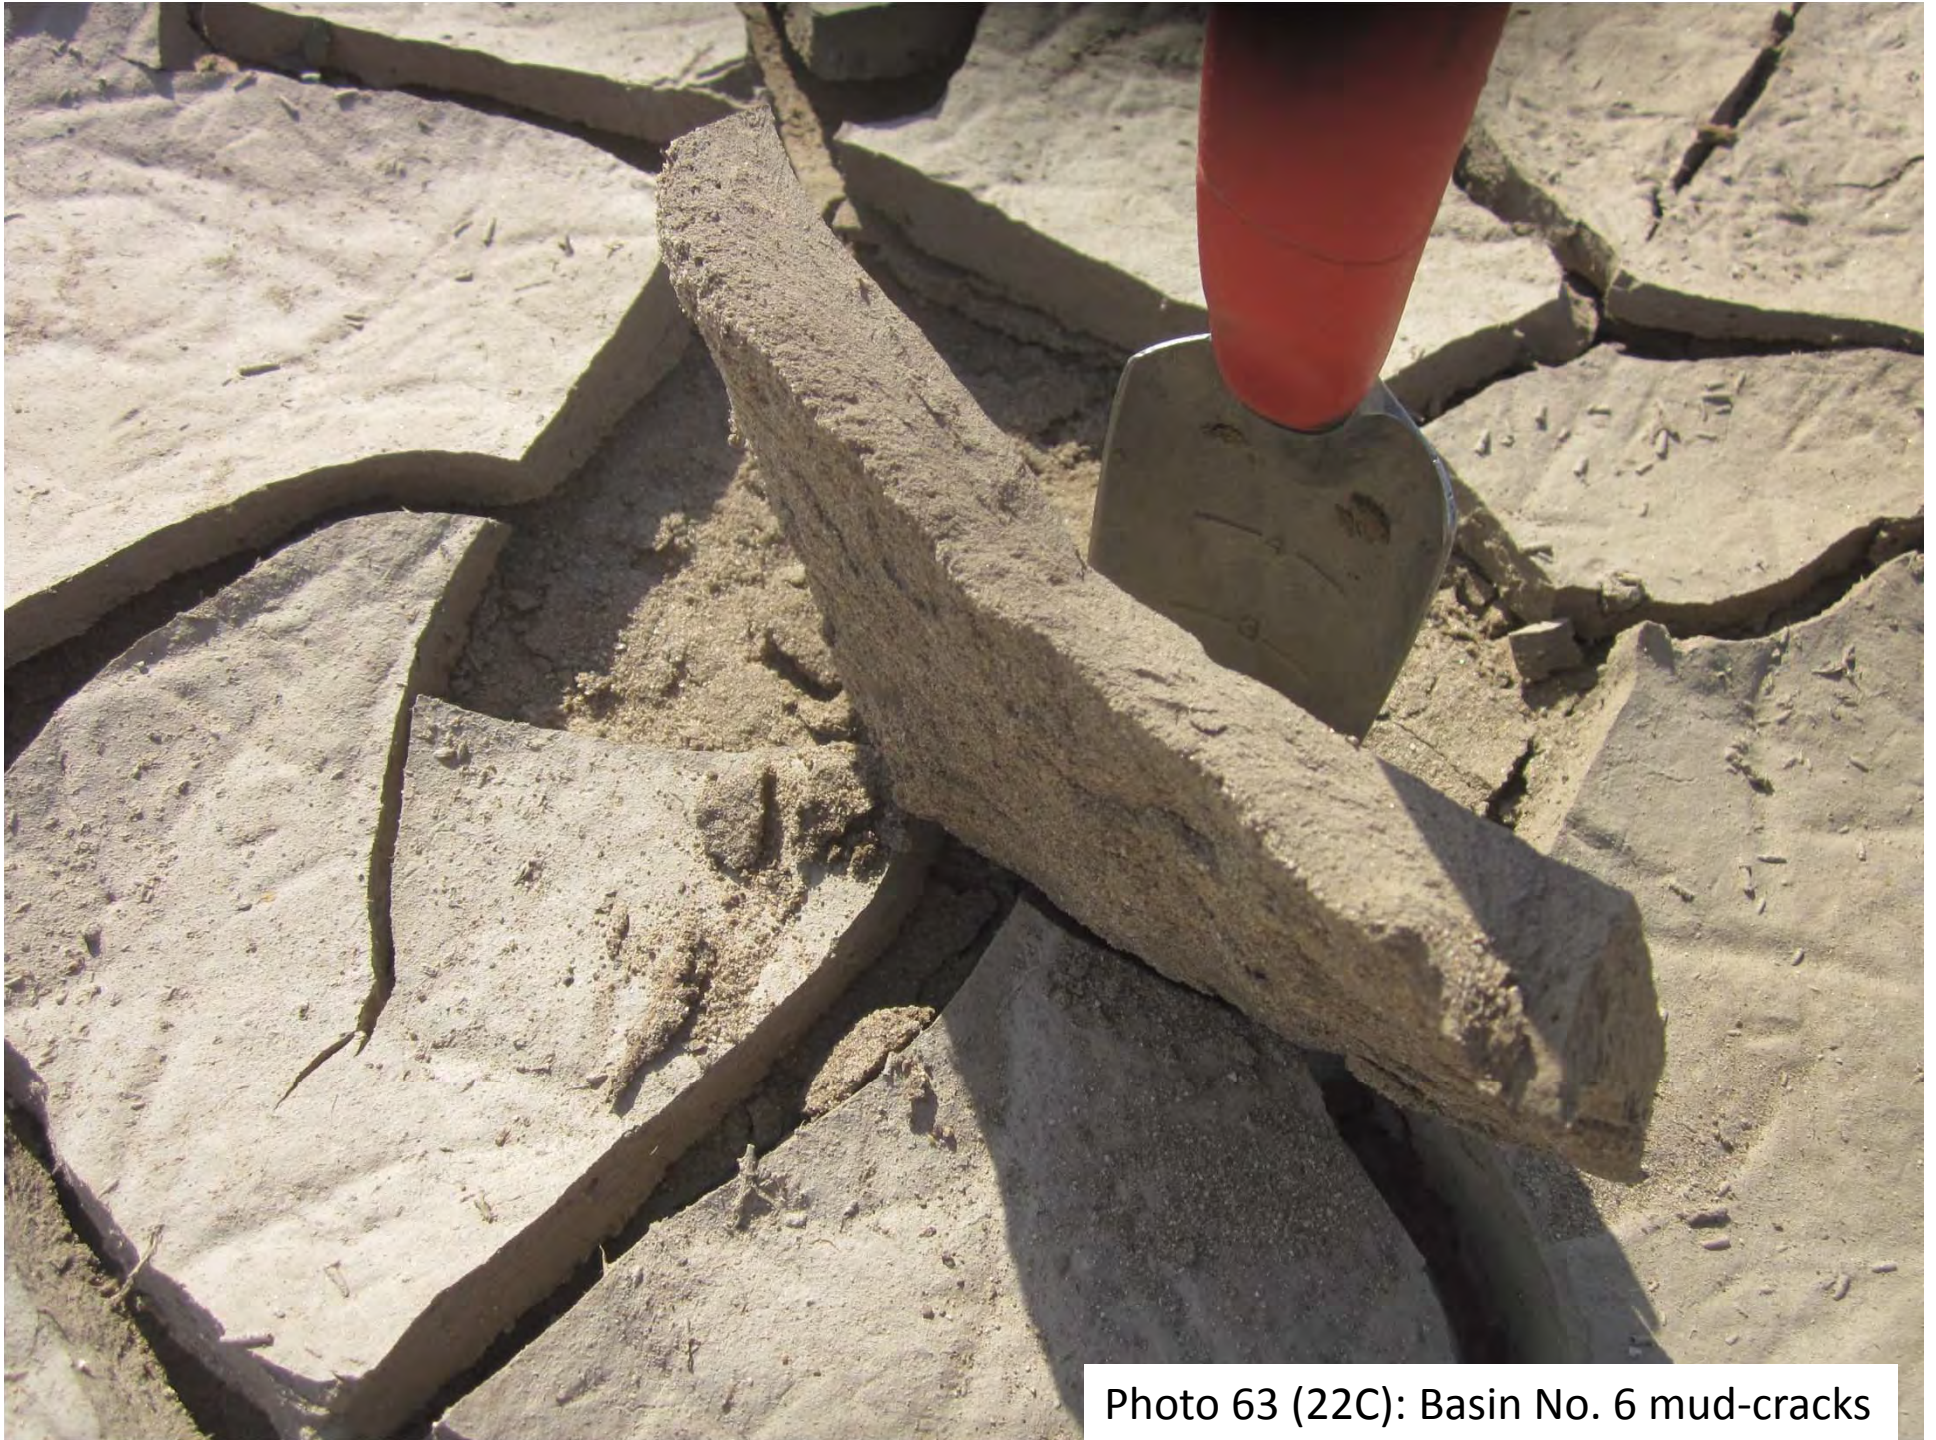
Photo 63 (22C): Basin No. 6 mud-cracks

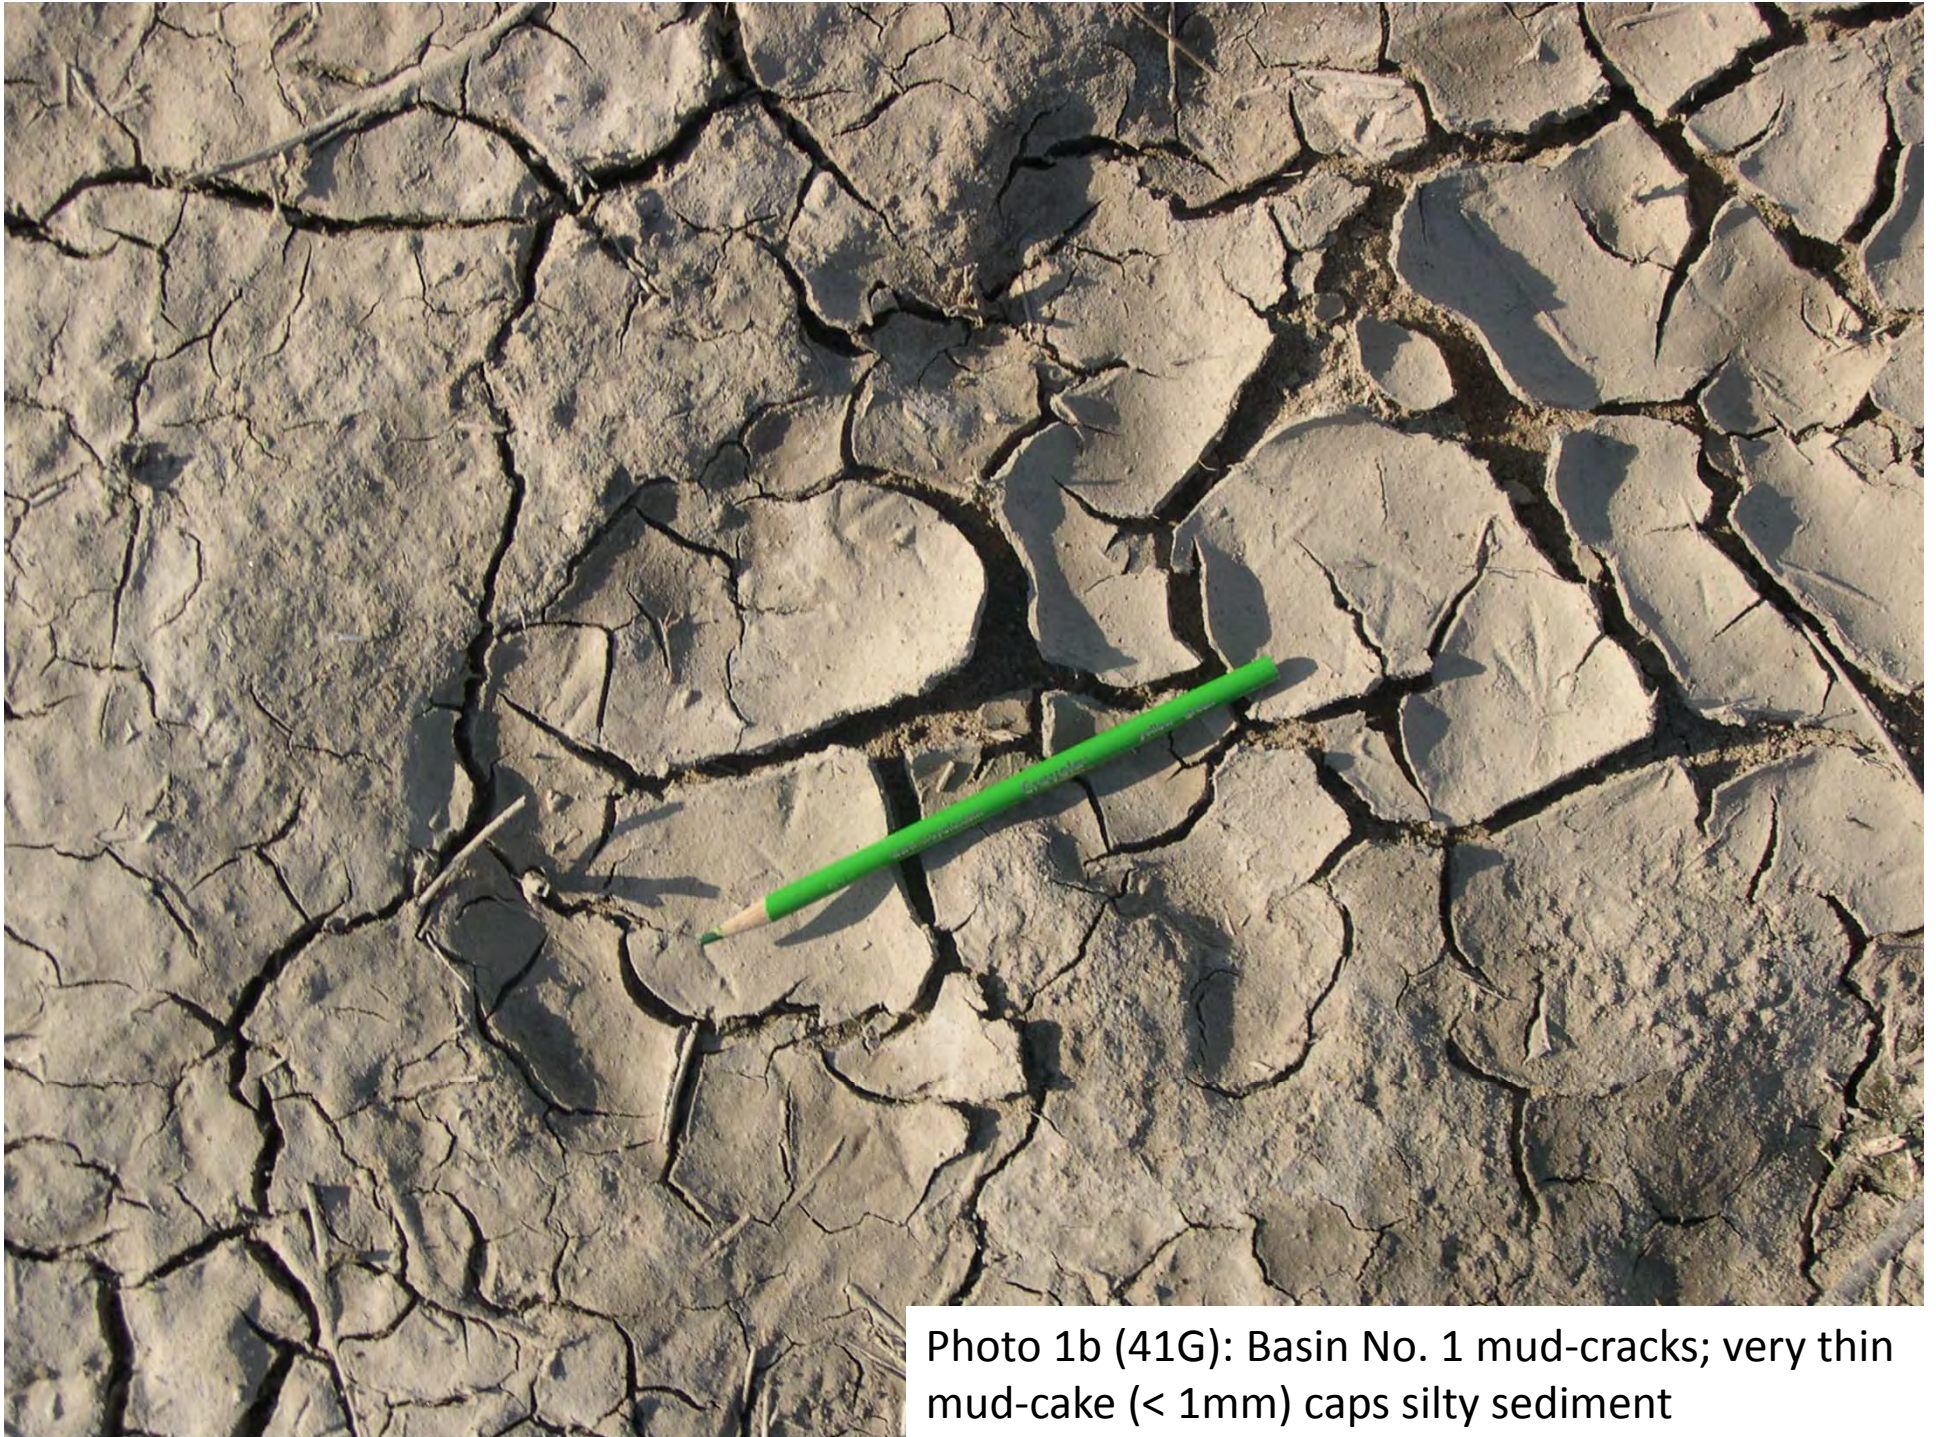
Photo 1b (41G): Basin No. 1 mud-cracks; very thin mud-cake (< 1mm) caps silty sediment

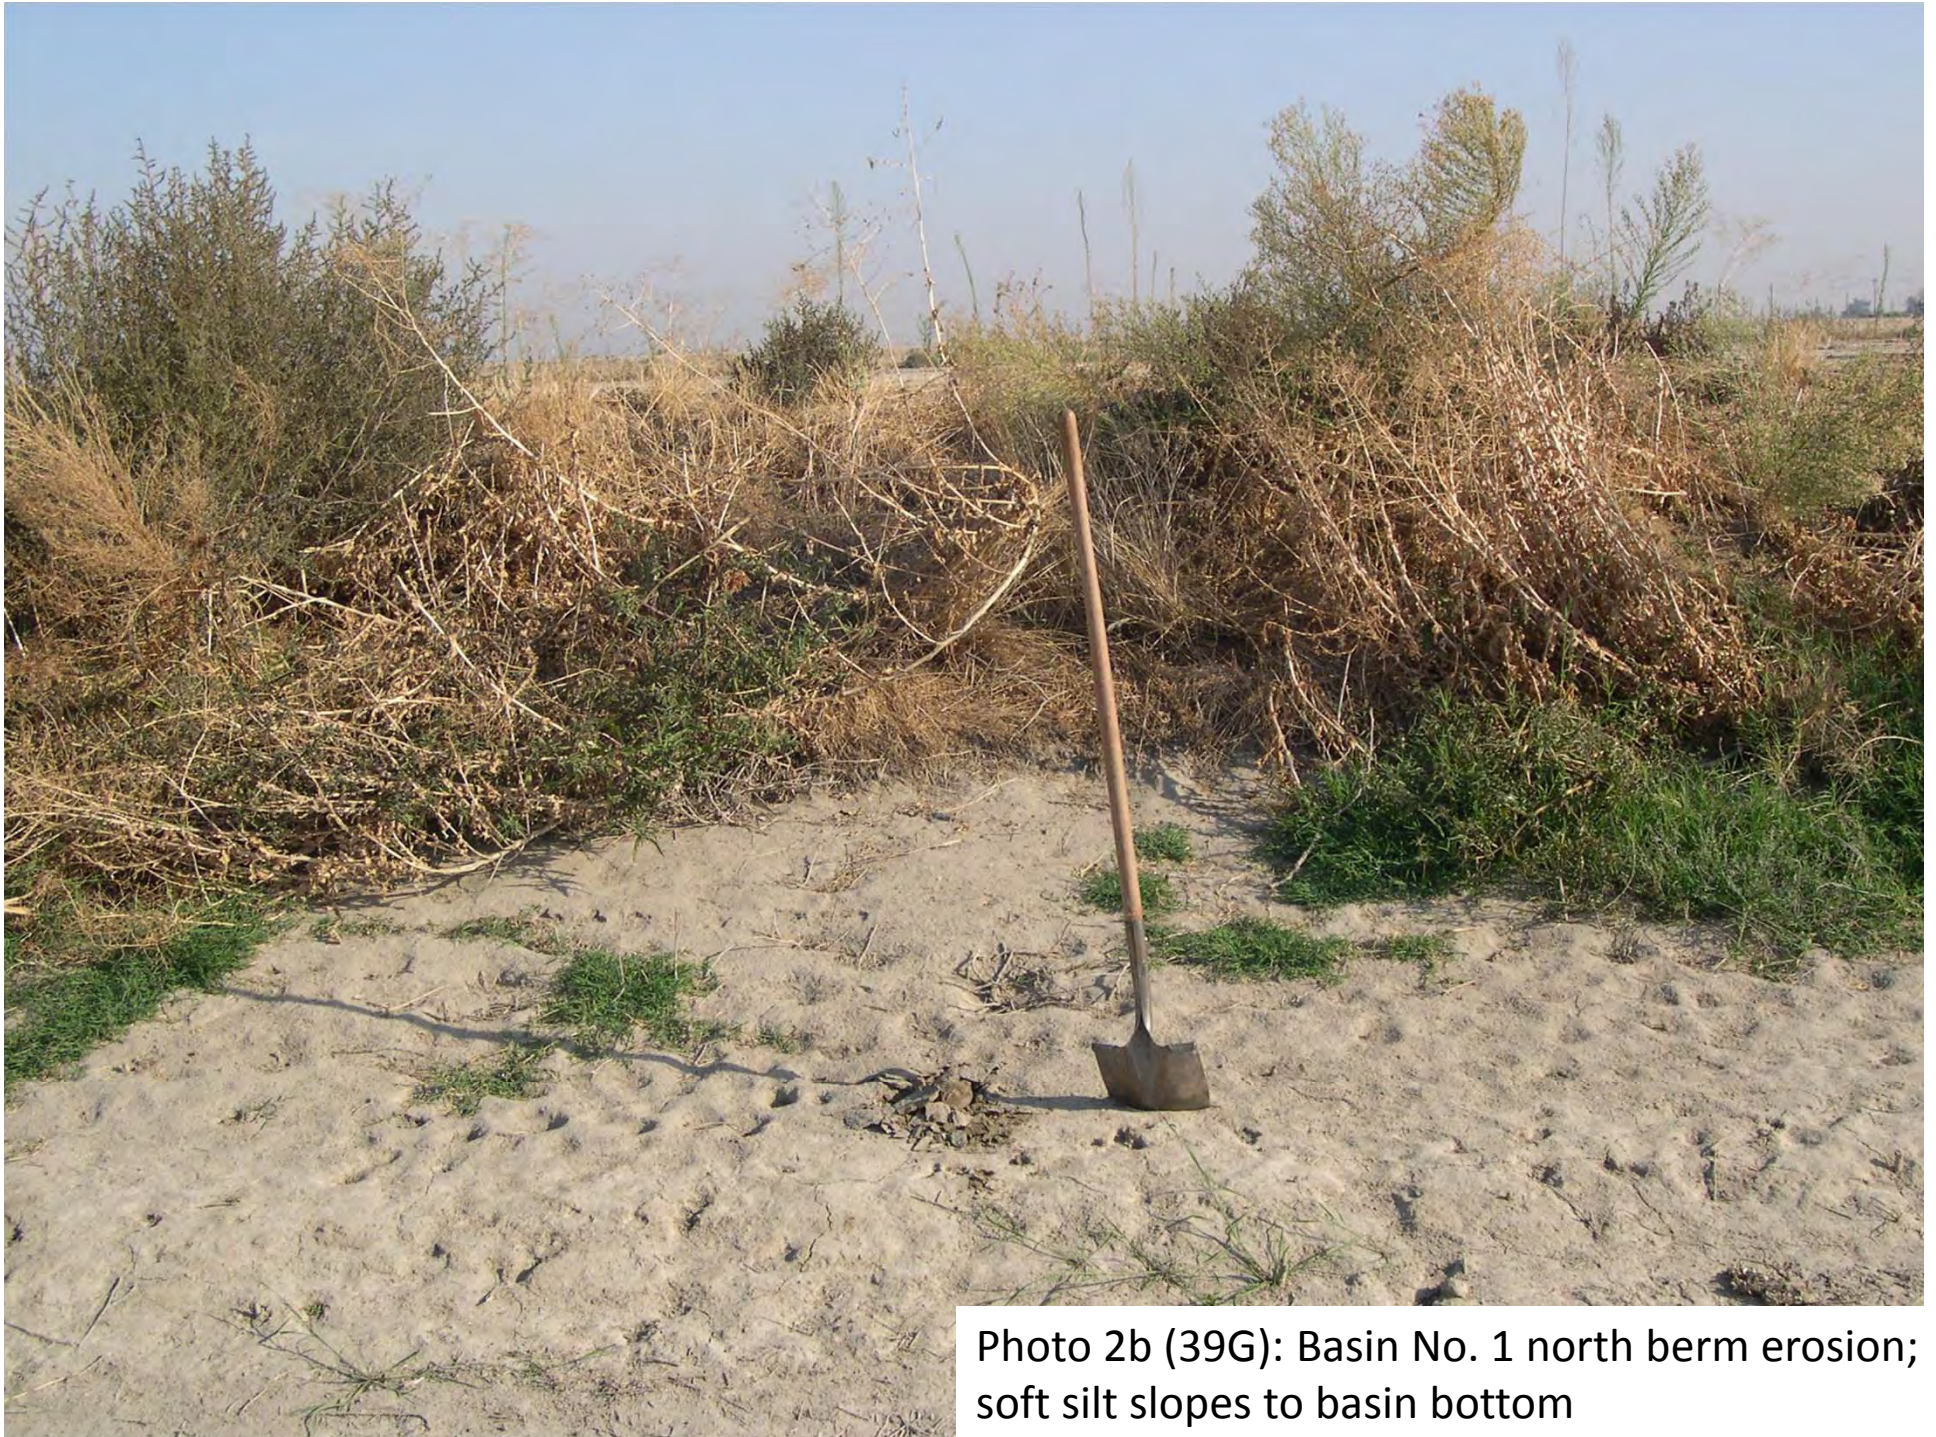
Photo 2b (39G): Basin No. 1 north berm erosion; soft silt slopes to basin bottom

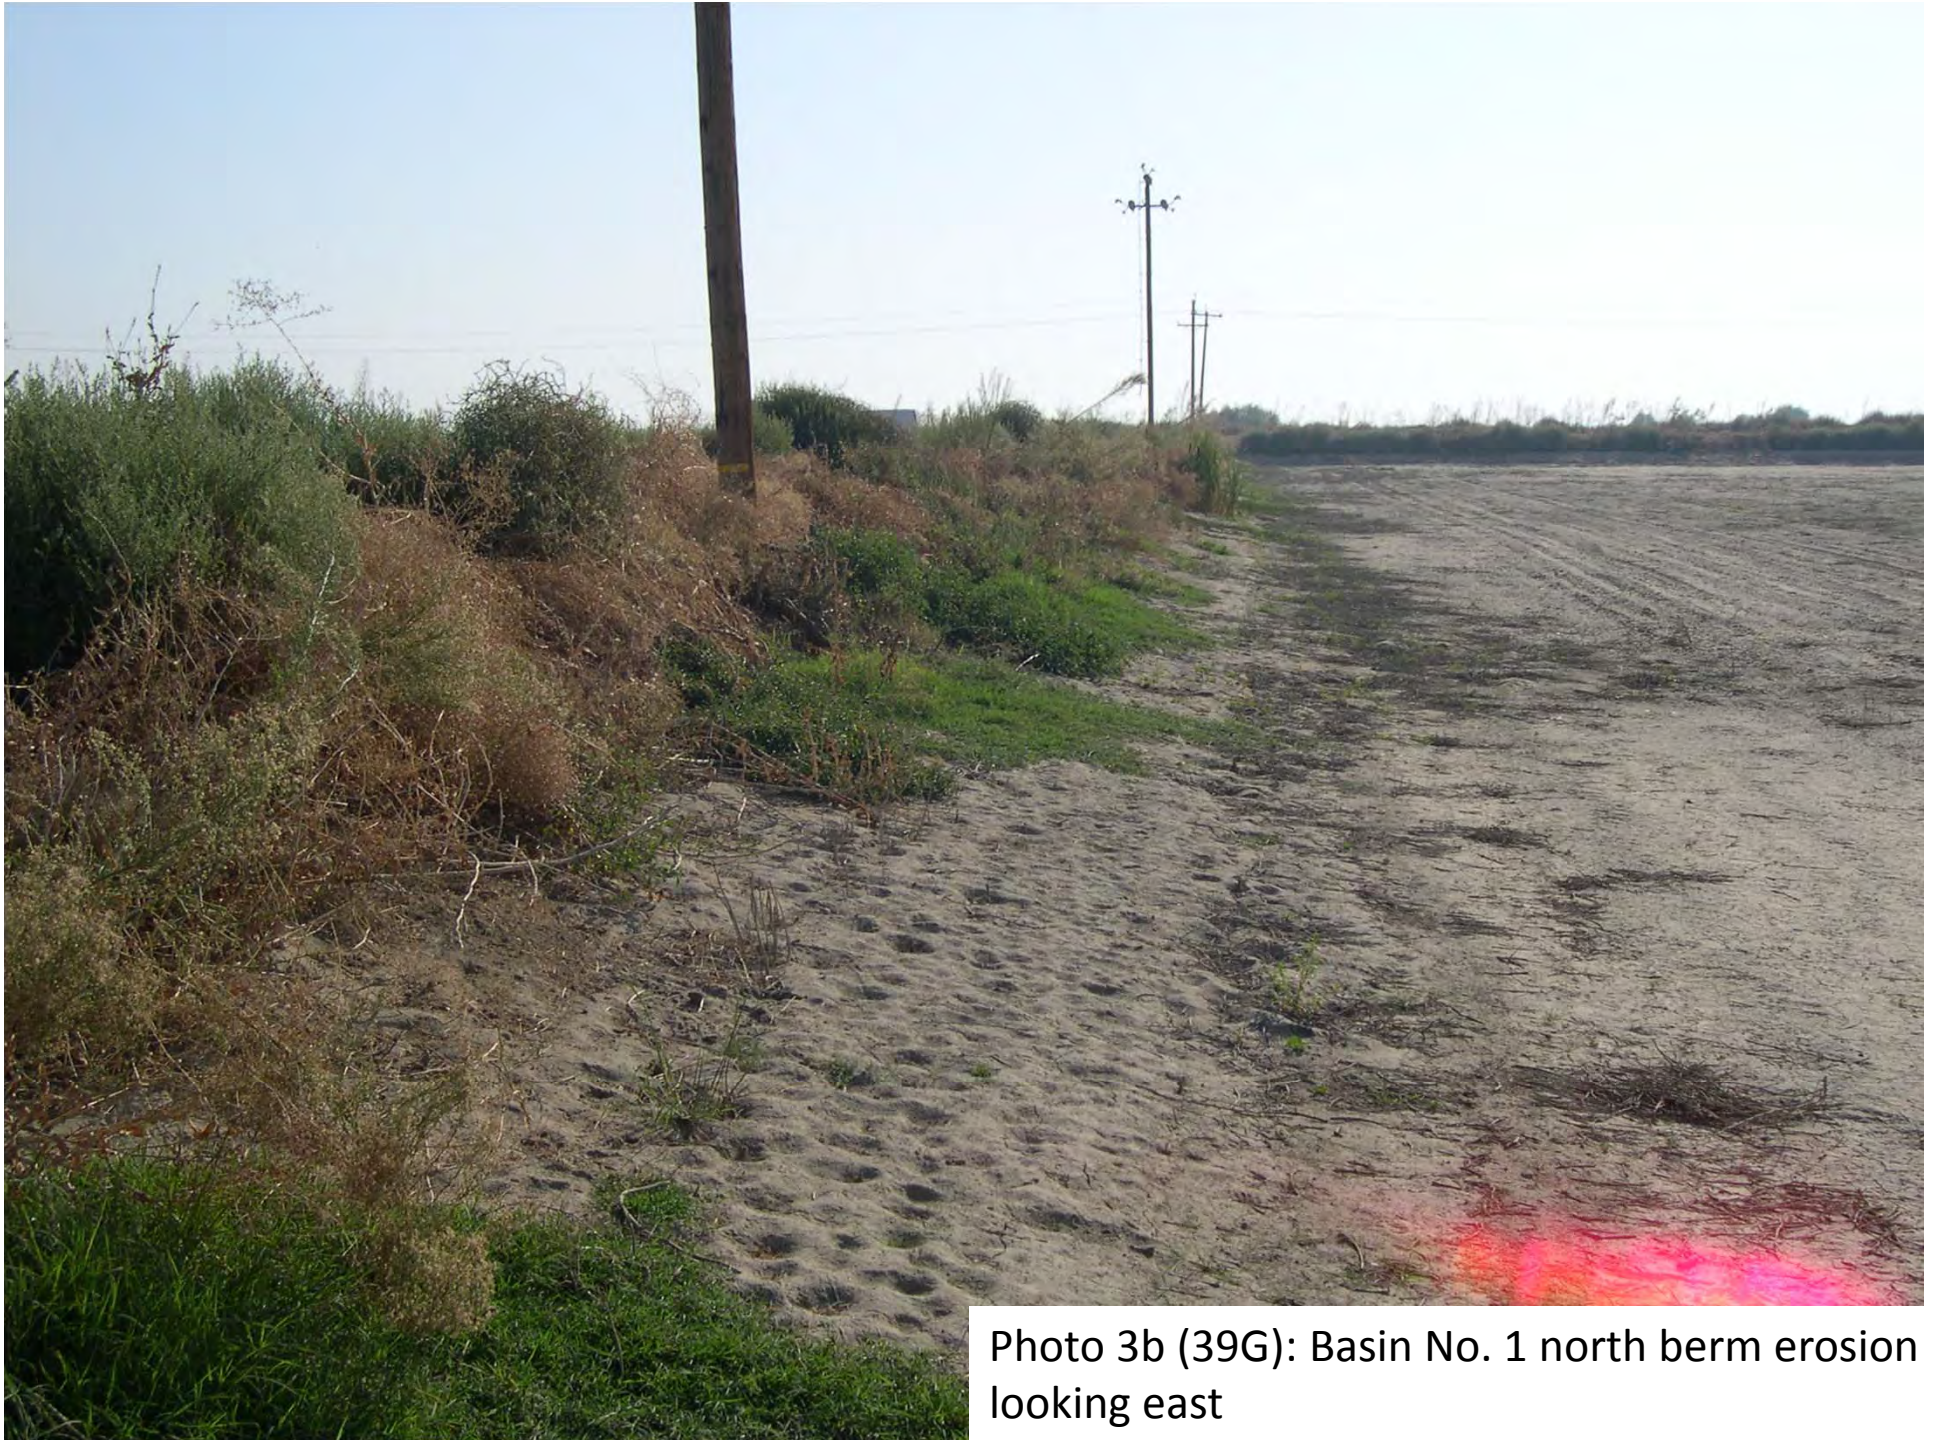
Photo 3b (39G): Basin No. 1 north berm erosion looking east

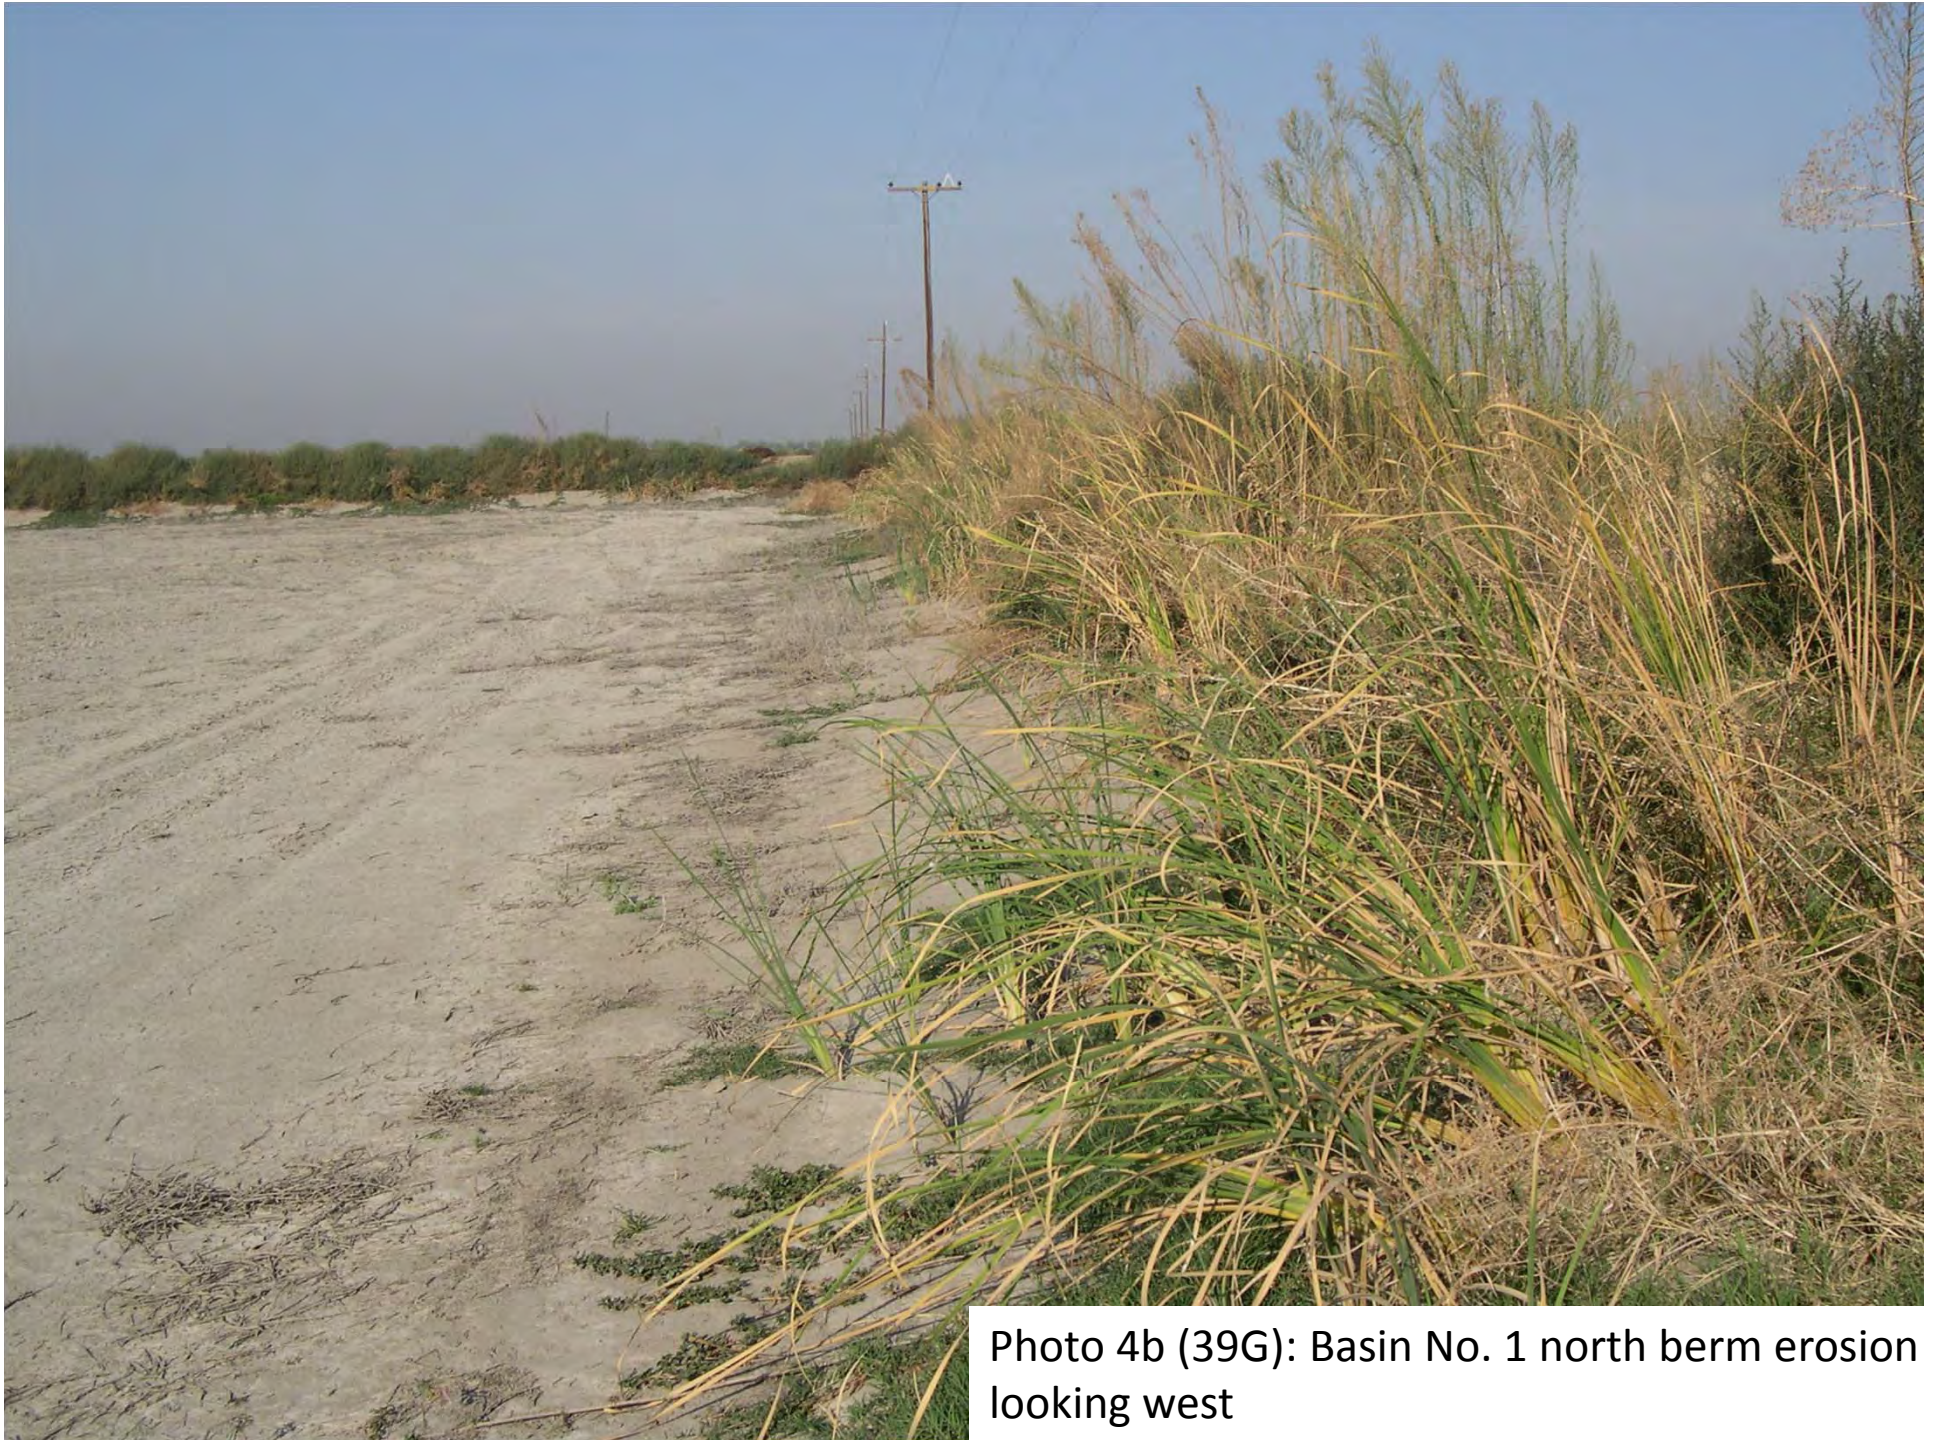
Photo 4b (39G): Basin No. 1 north berm erosion looking west

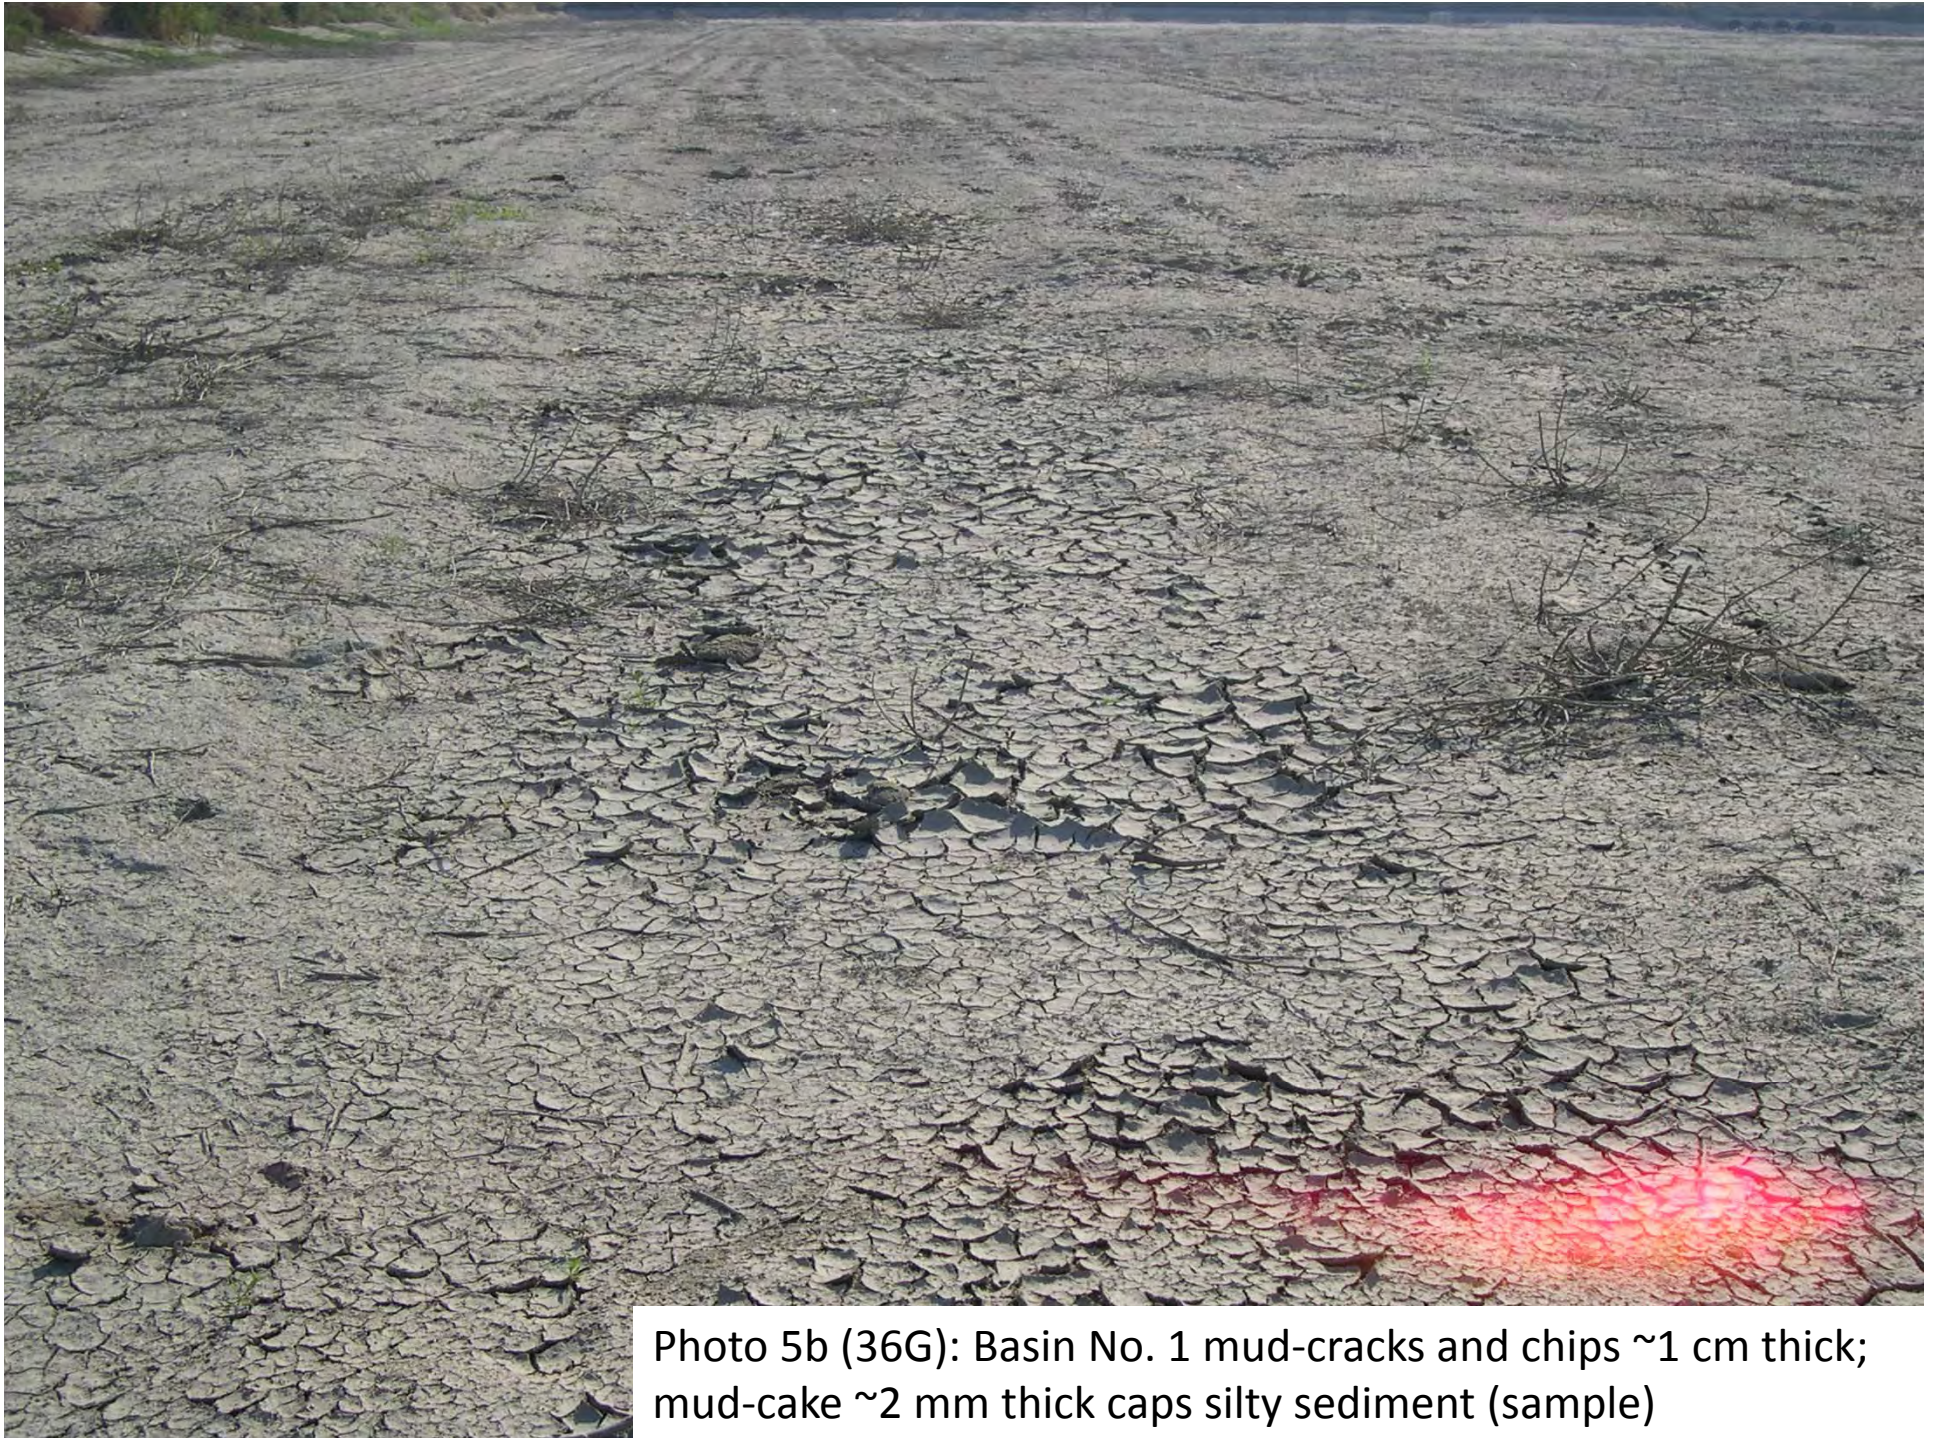
Photo 5b (36G): Basin No. 1 mud-cracks and chips ~1 cm thick; mud-cake ~2 mm thick caps silty sediment (sample)

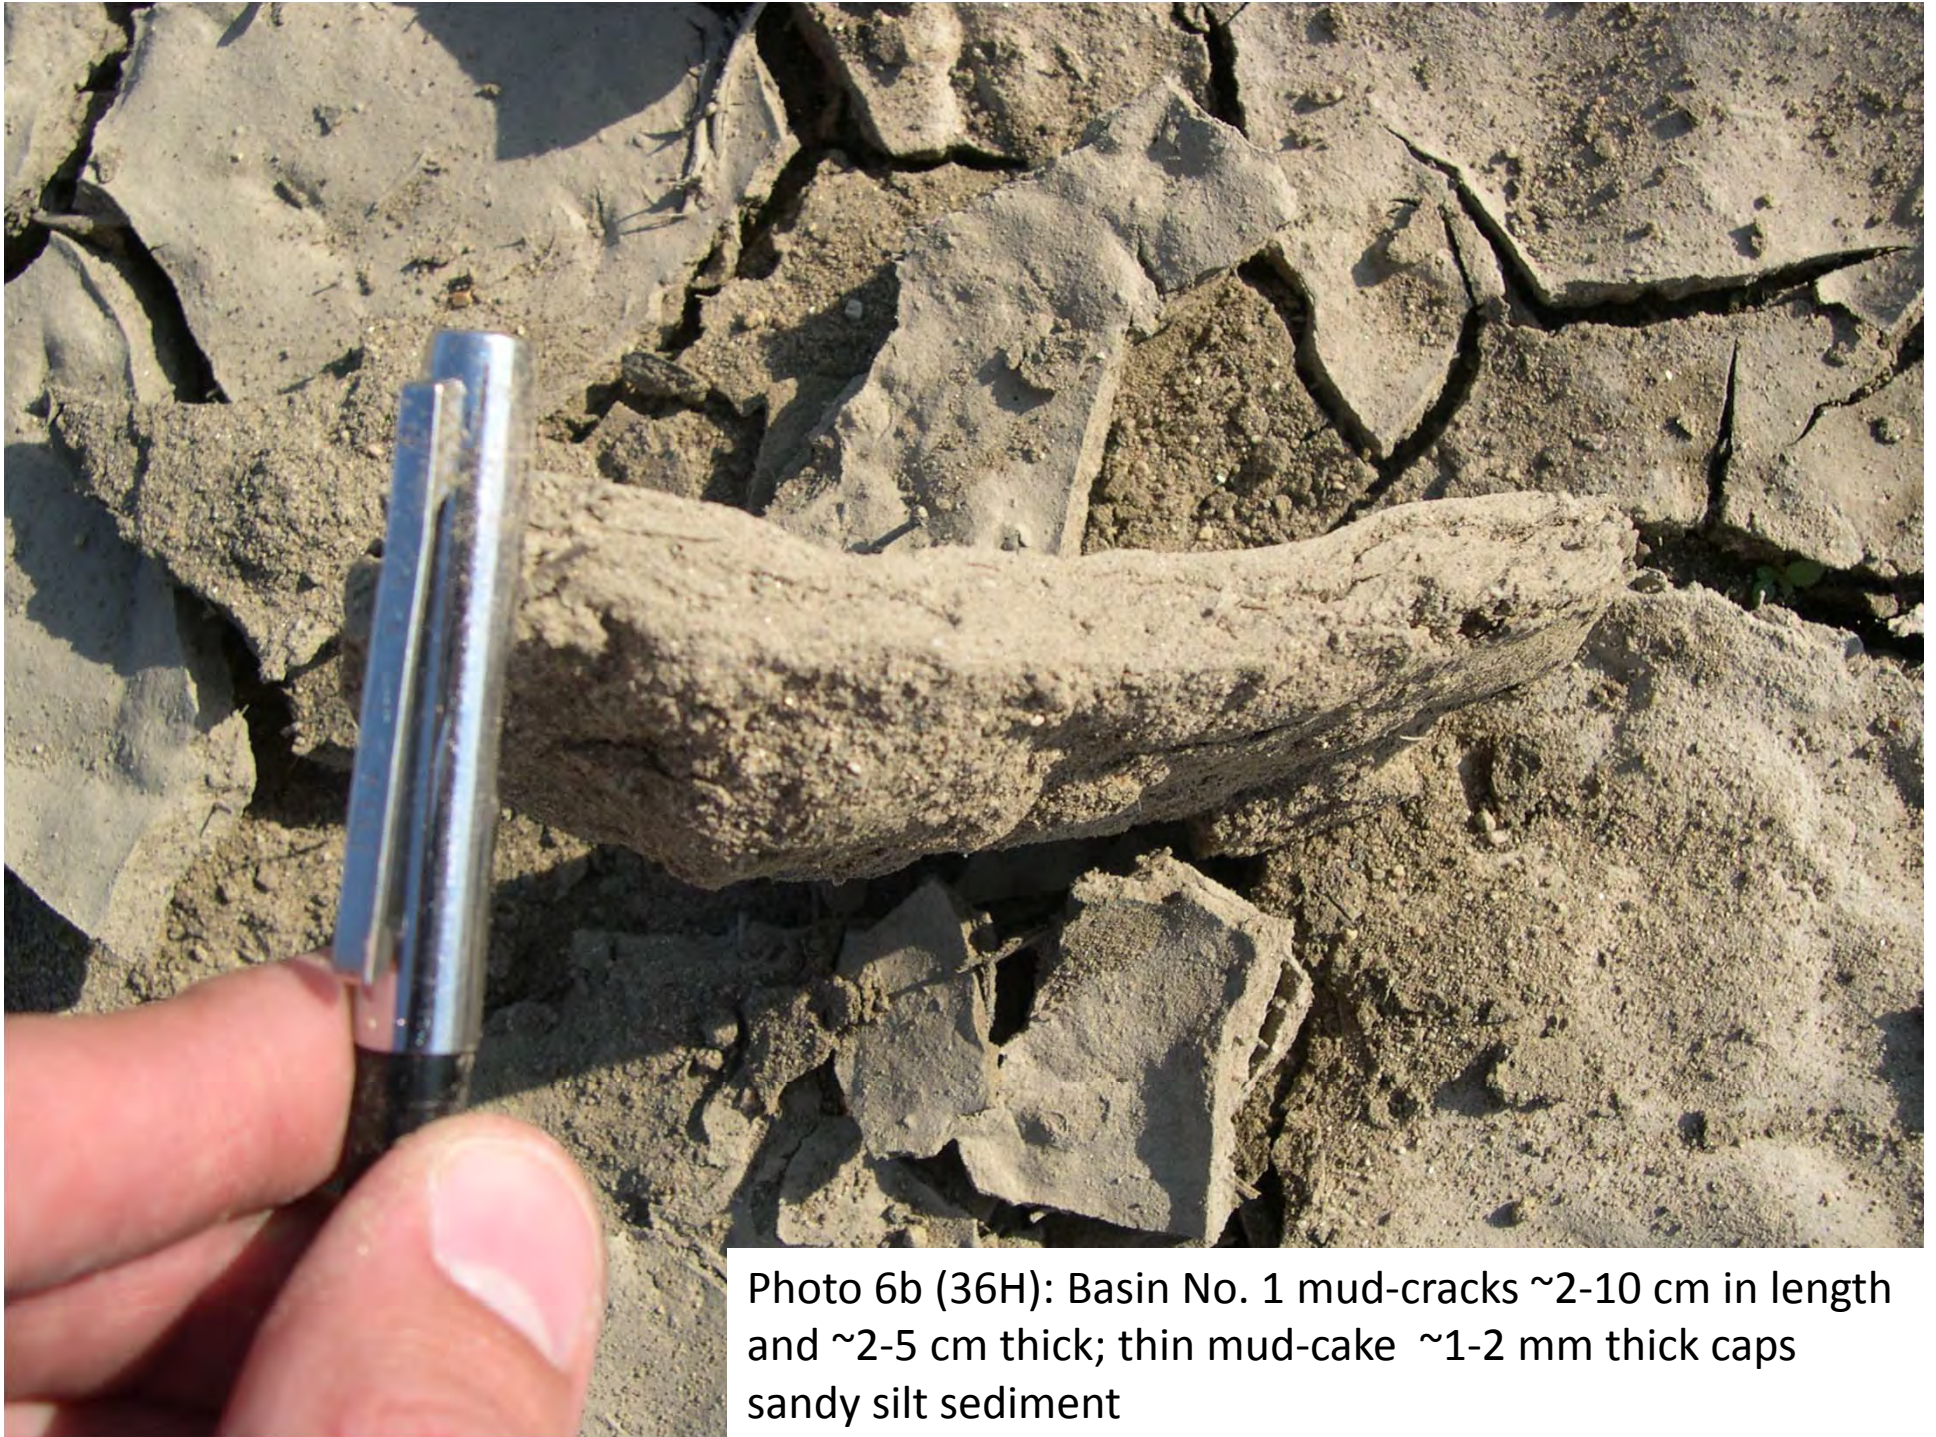
Photo 6b (36H): Basin No. 1 mud-cracks ~2-10 cm in length and ~2-5 cm thick; thin mud-cake ~1-2 mm thick caps sandy silt sediment

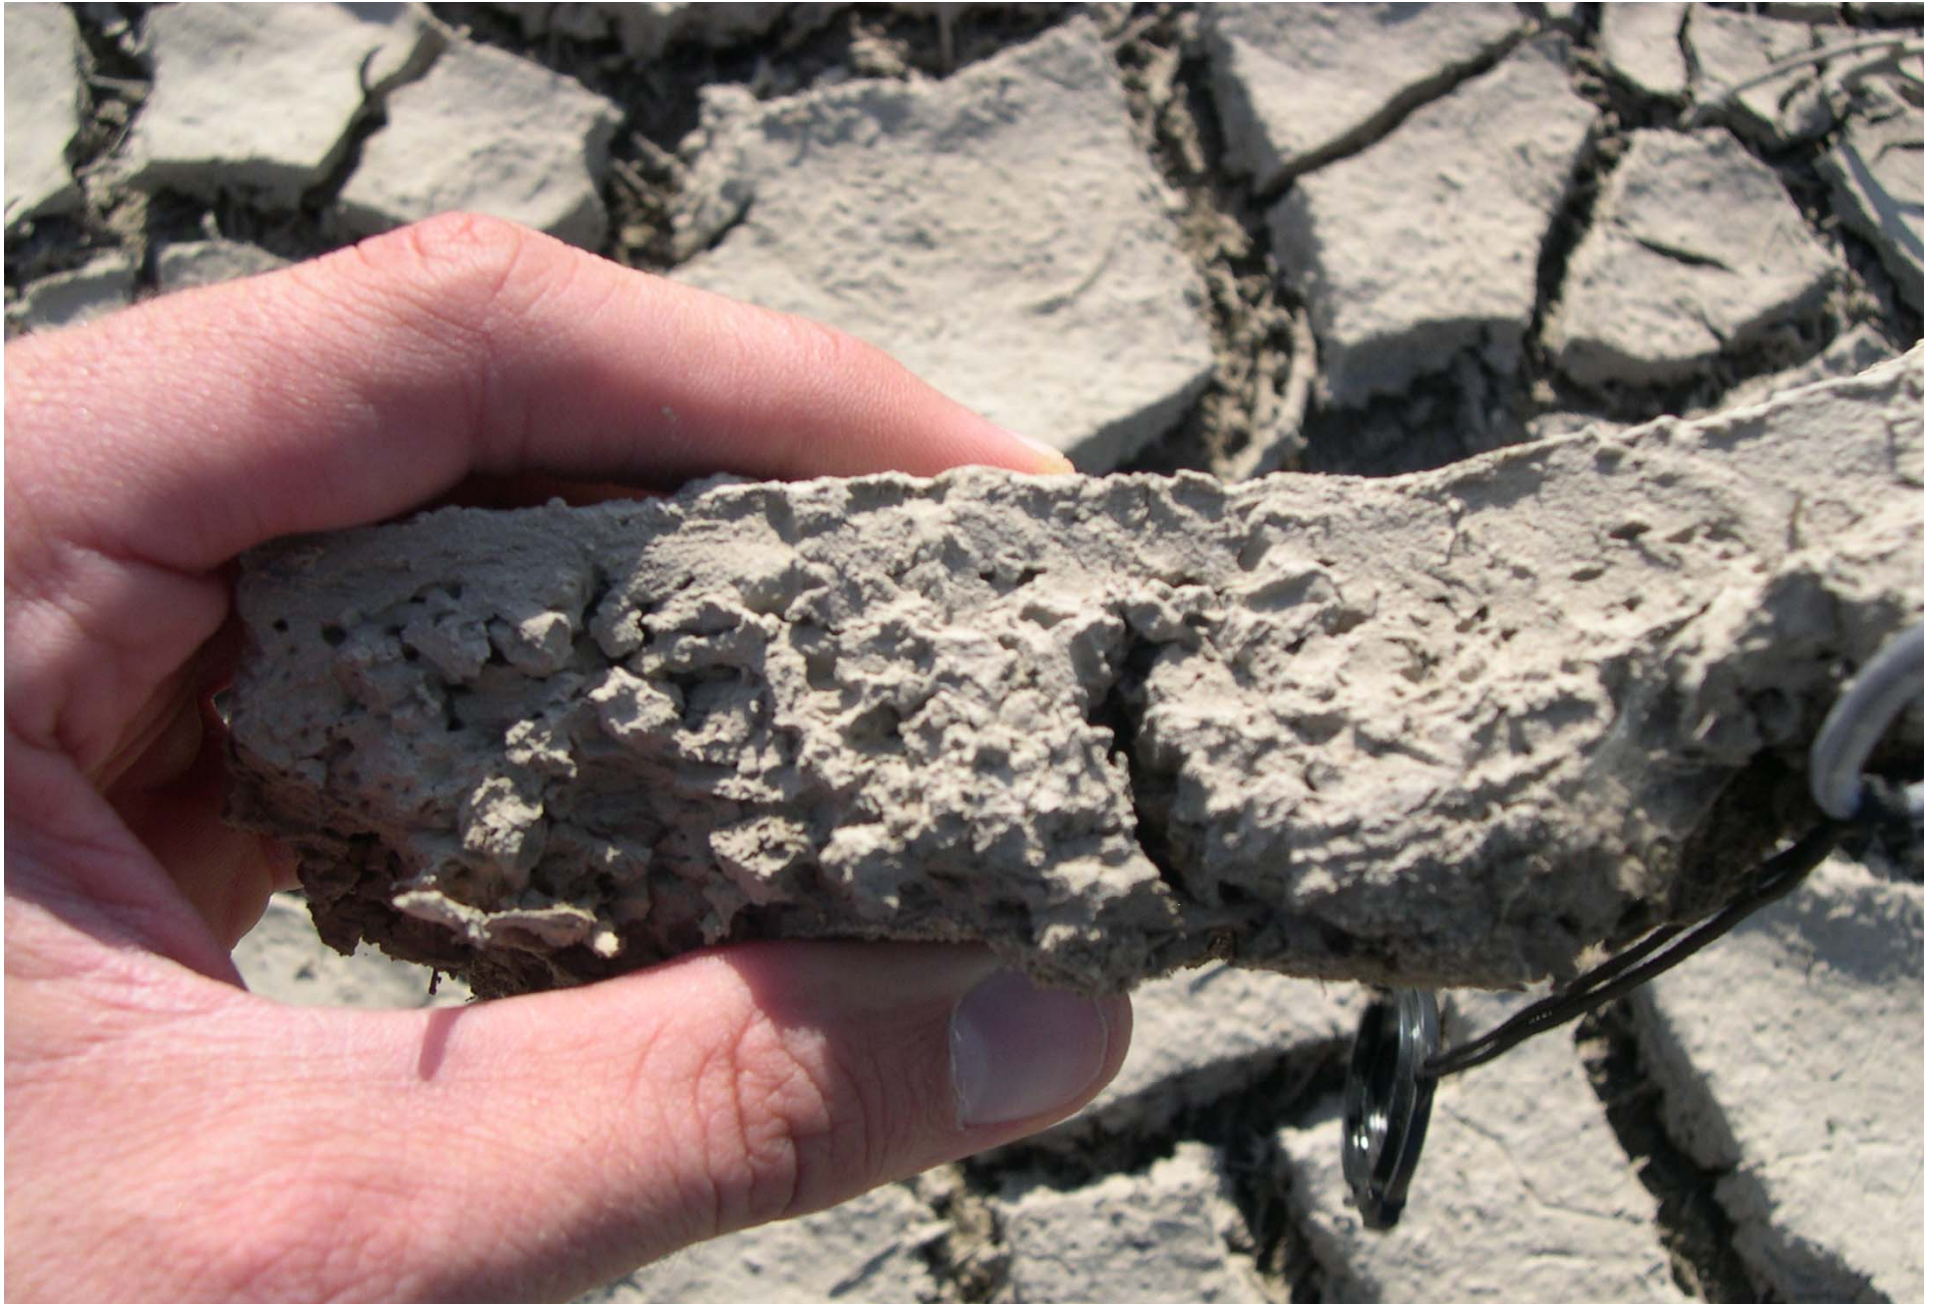
Photo 7b (36N): Basin No. 1 mud-cracks; thin mud-cake ~5 mm thick caps silty sediment; shallow soil shows evidence of biological activity
