October 11, 2011

Irvine Ranch Water District
Attention: Paul Weghorst
15600 Sand Canyon Avenue
Irvine, CA 92618

Subject: *Strand Ranch South Basin Field Reconnaissance and Remediation Recommendations*

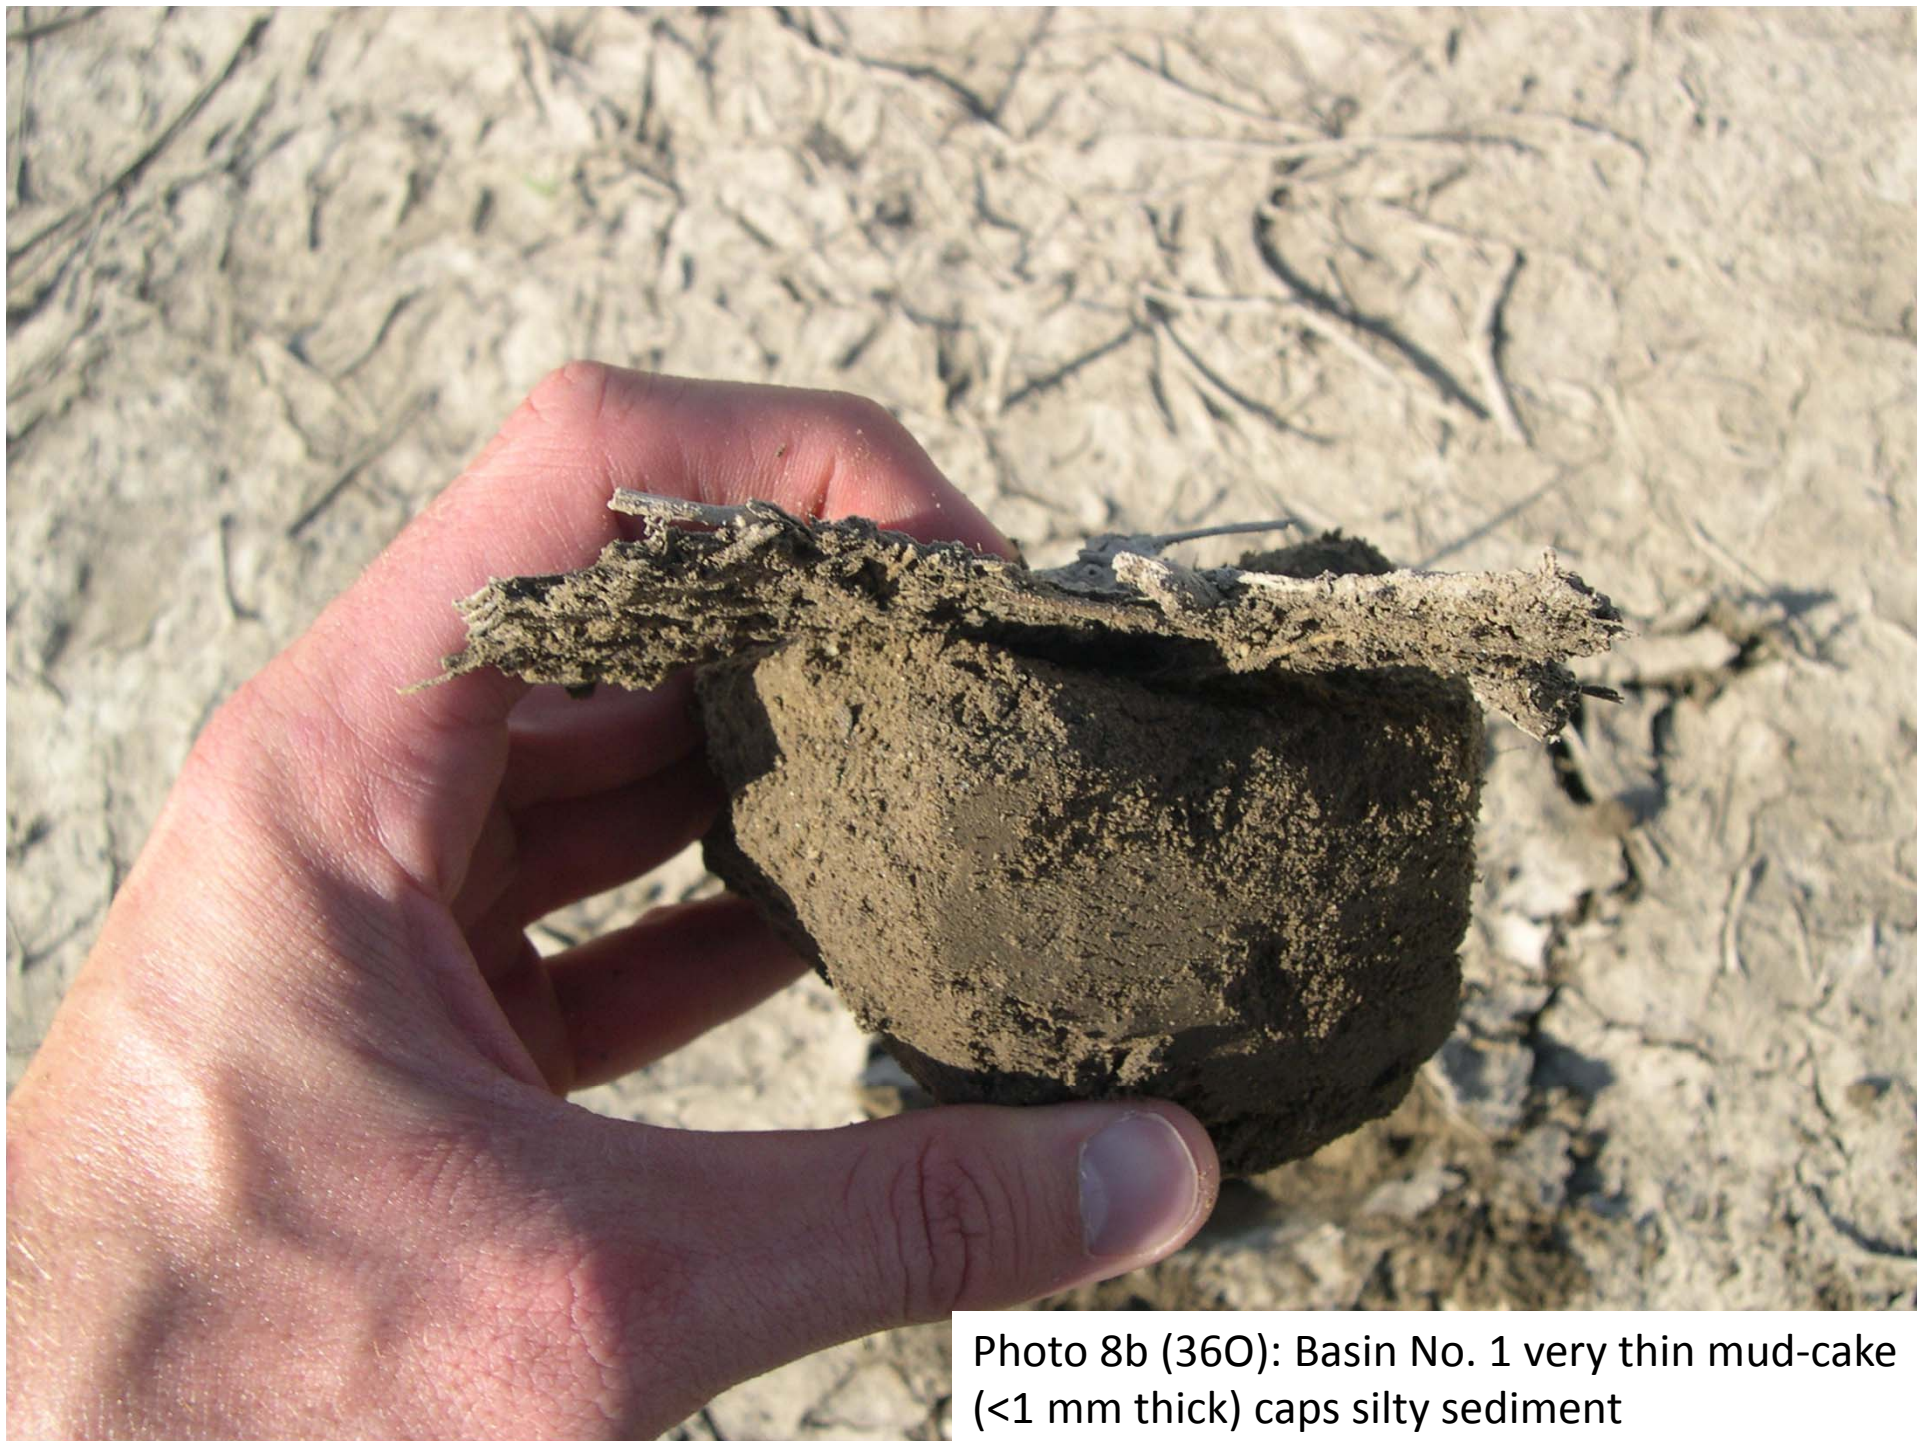
Photo 8b (360): Basin No. 1 very thin mud-cake (<1 mm thick) caps silty sediment

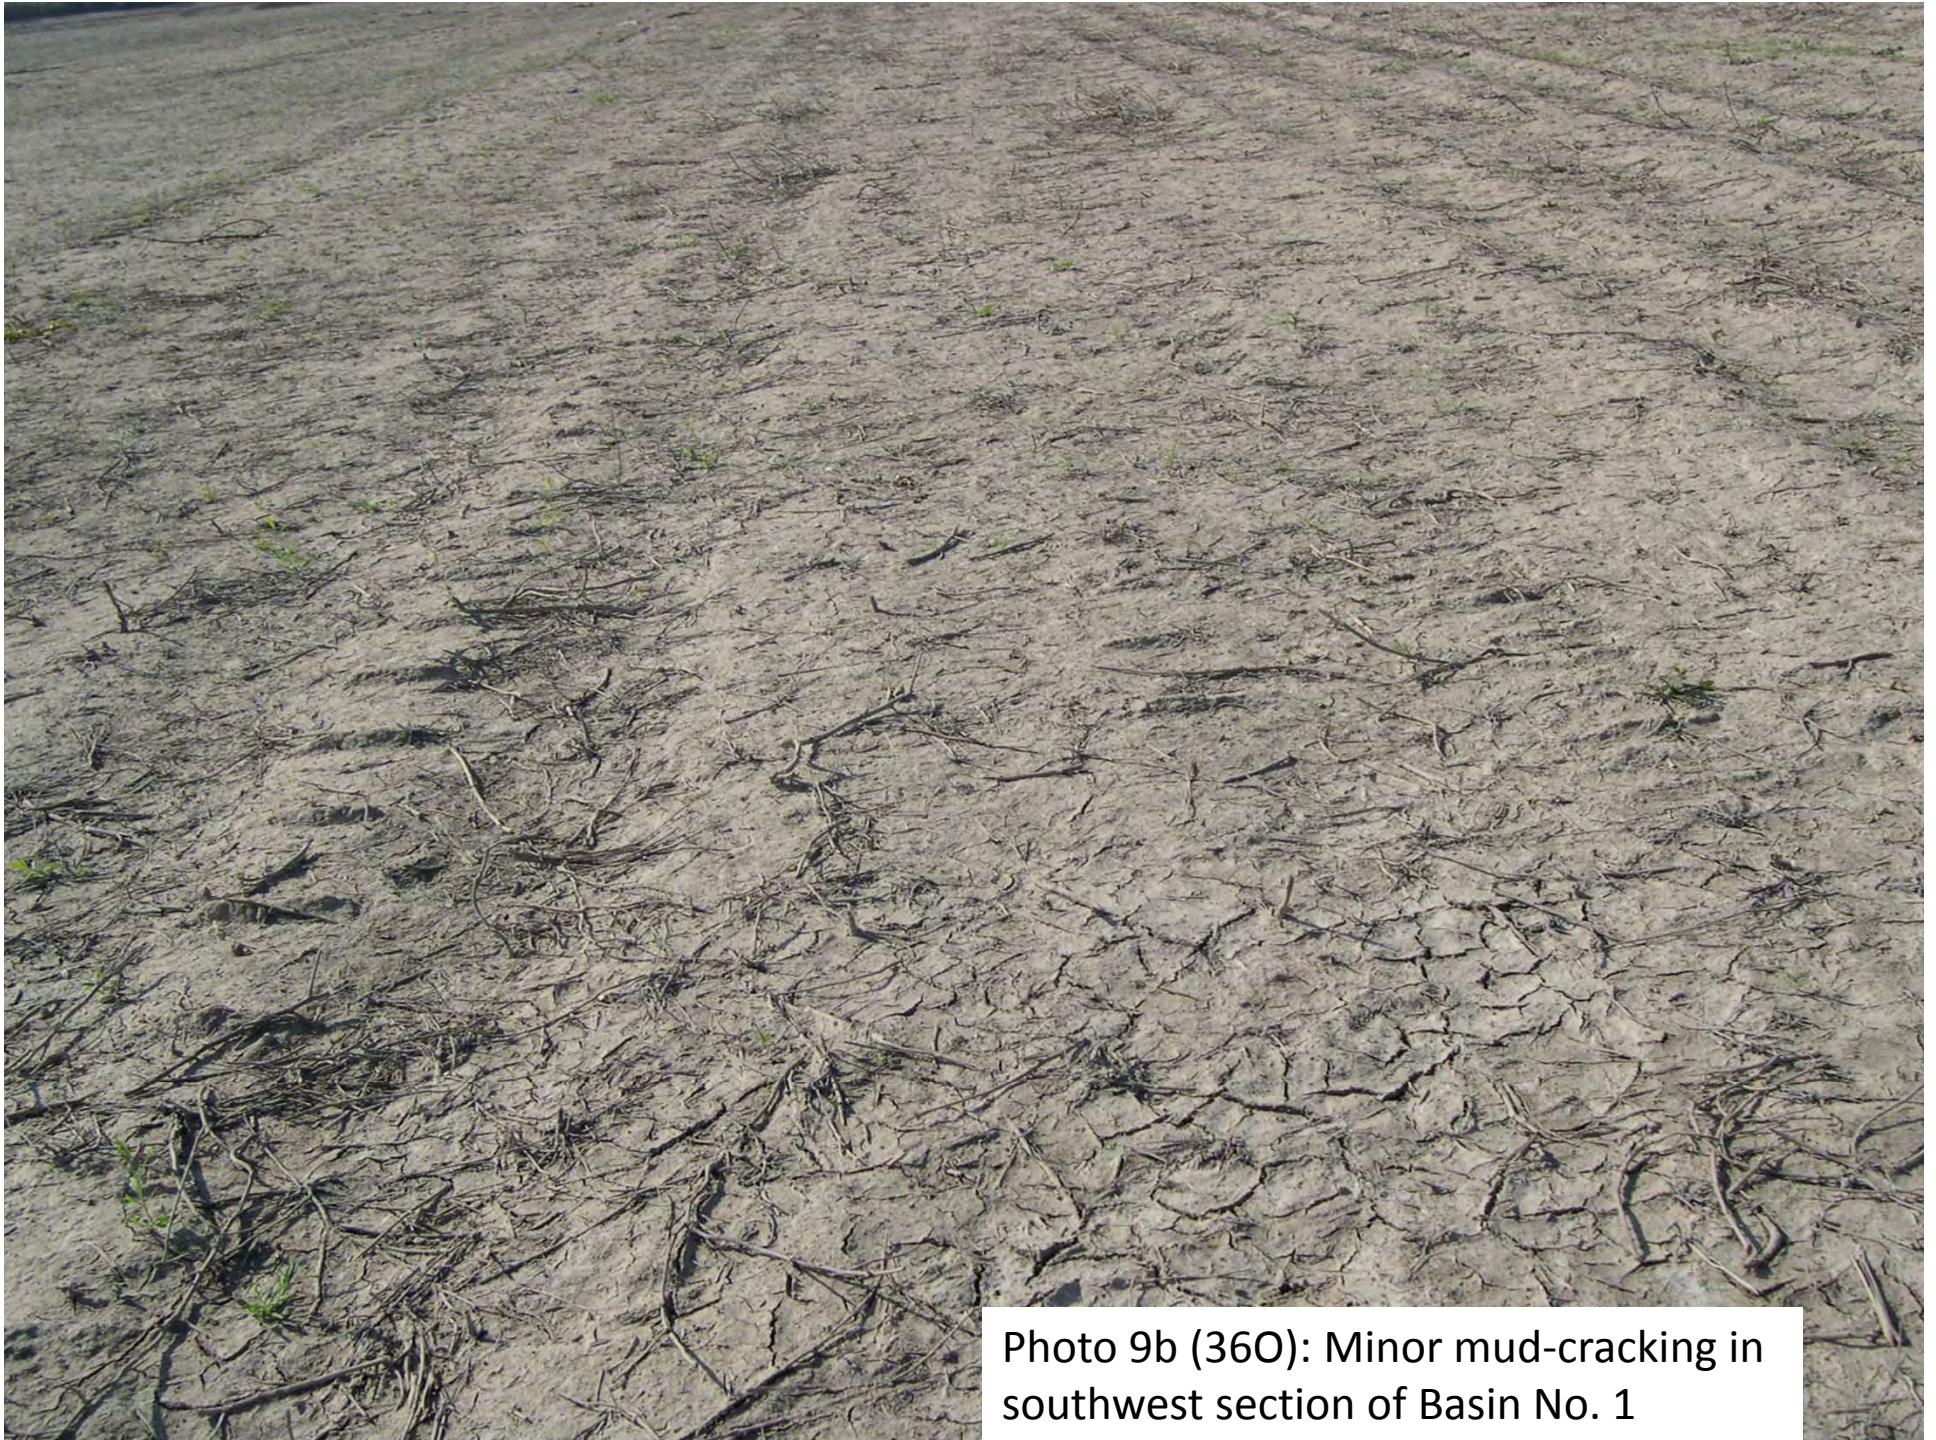
Photo 9b (360): Minor mud-cracking in southwest section of Basin No. 1

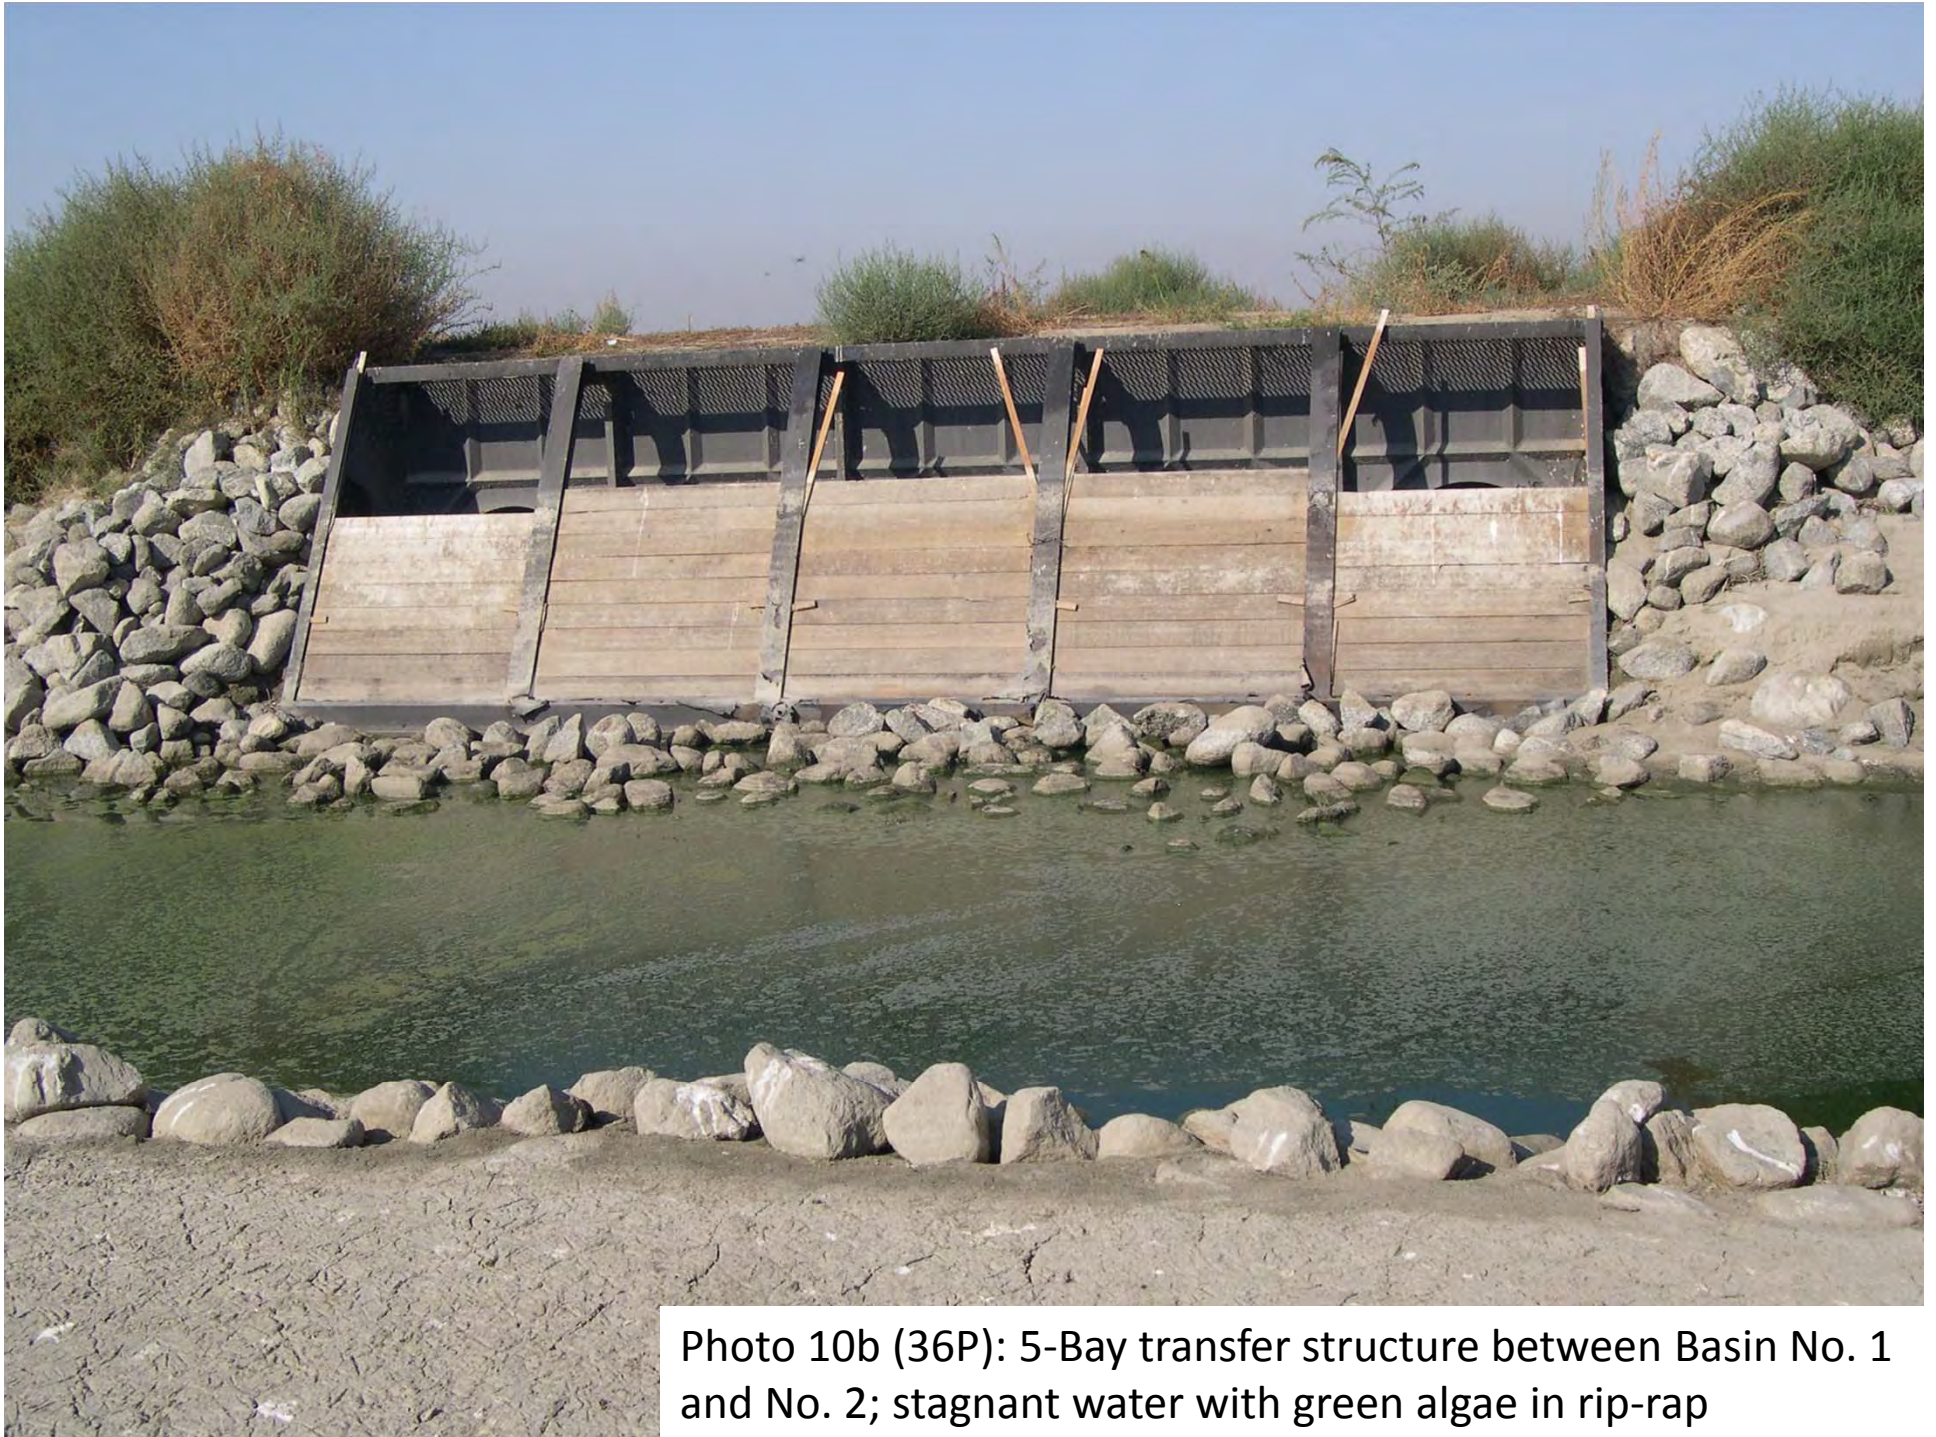
Photo 10b (36P): 5-Bay transfer structure between Basin No. 1 and No. 2; stagnant water with green algae in rip-rap

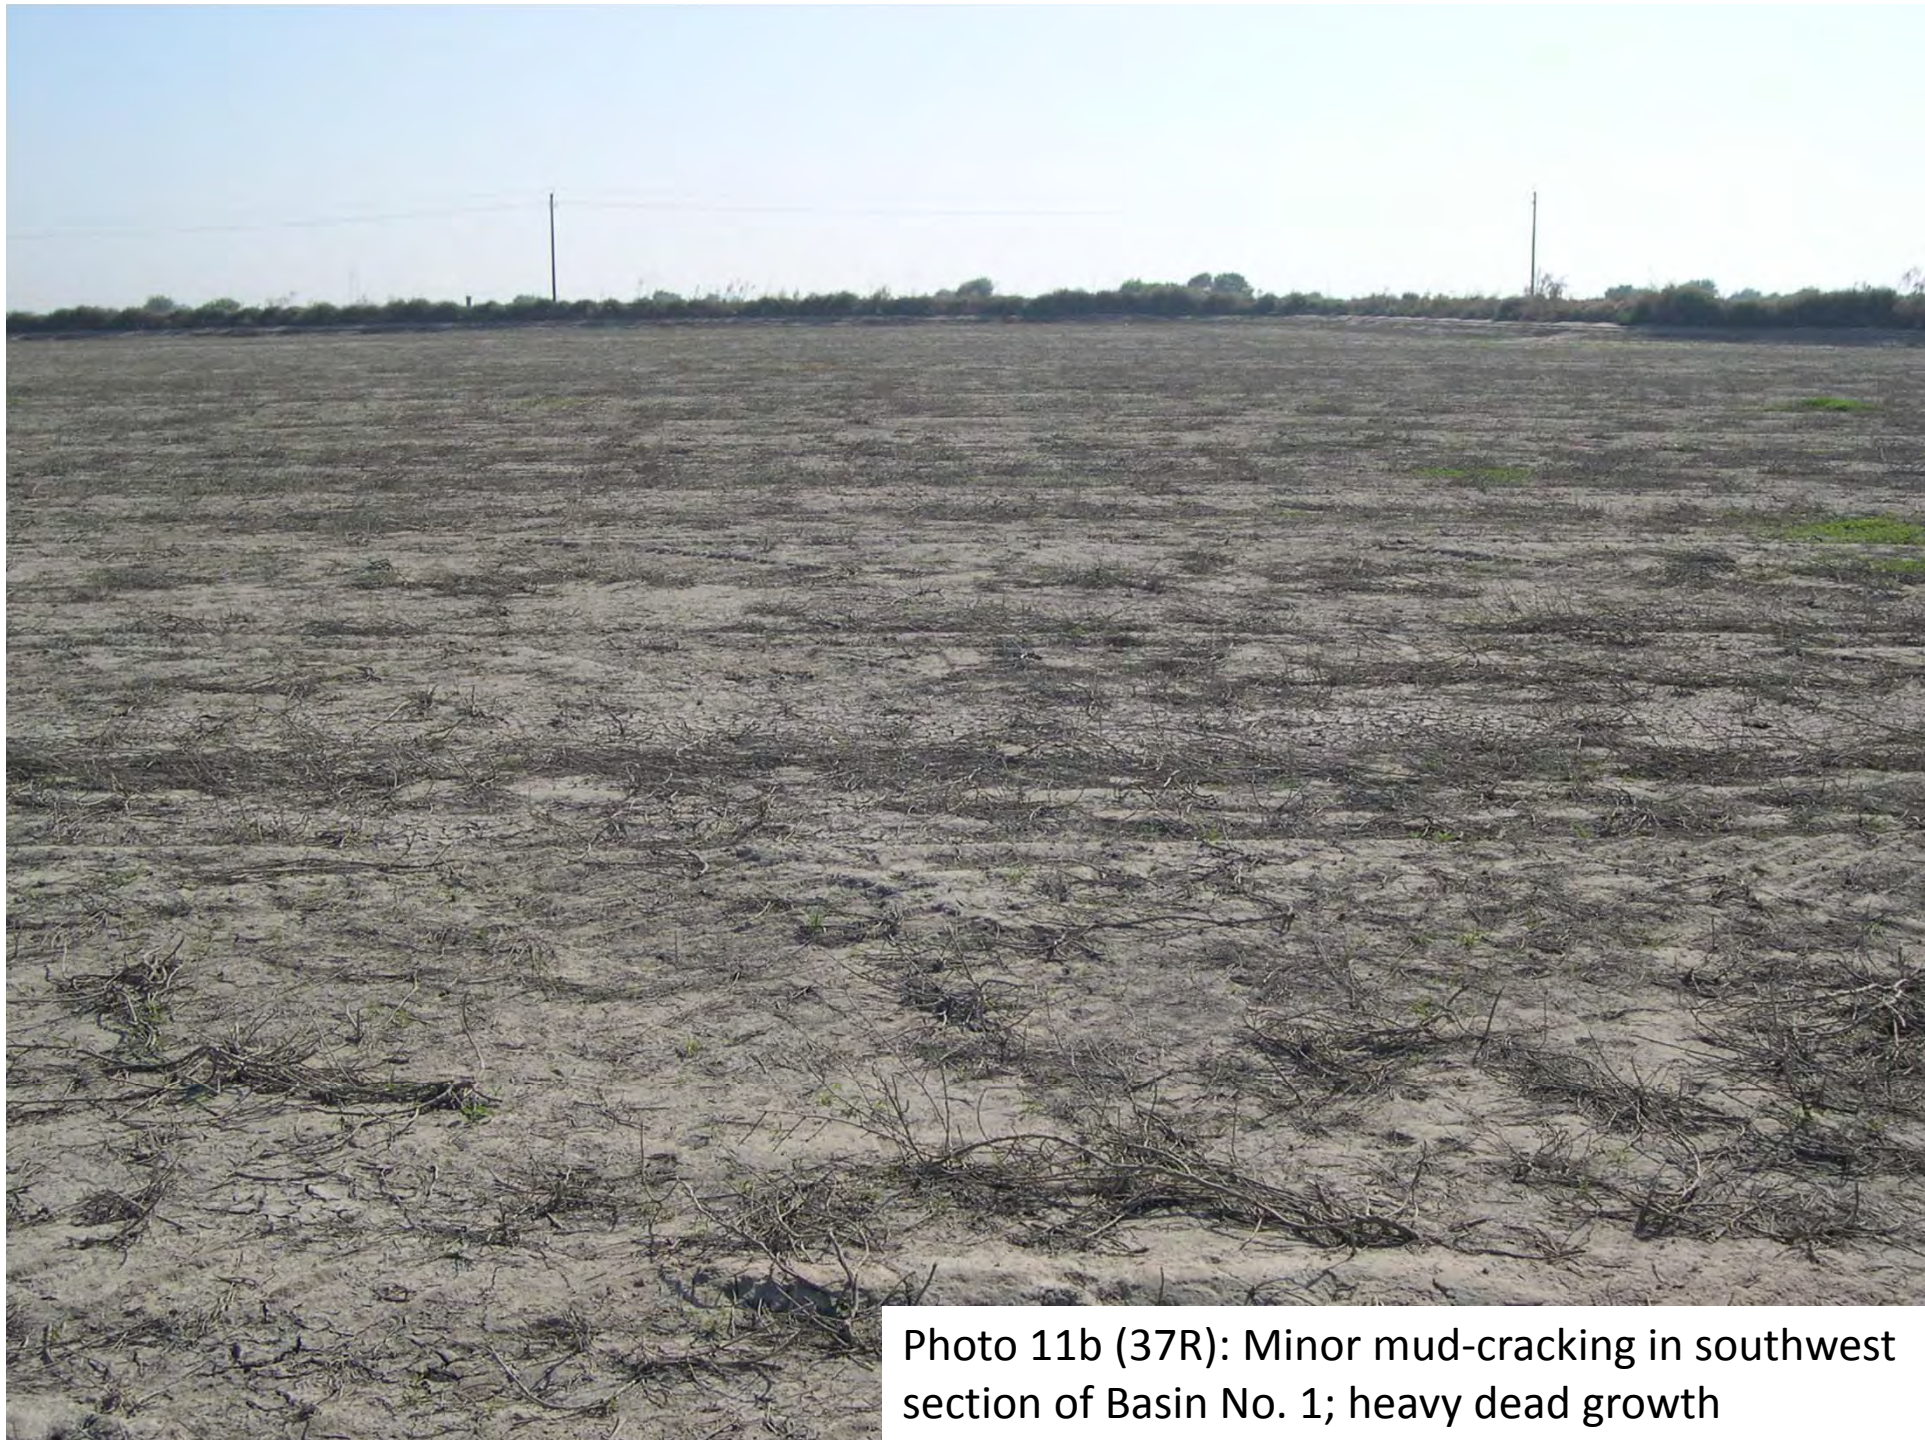
Photo 11b (37R): Minor mud-cracking in southwest section of Basin No. 1; heavy dead growth

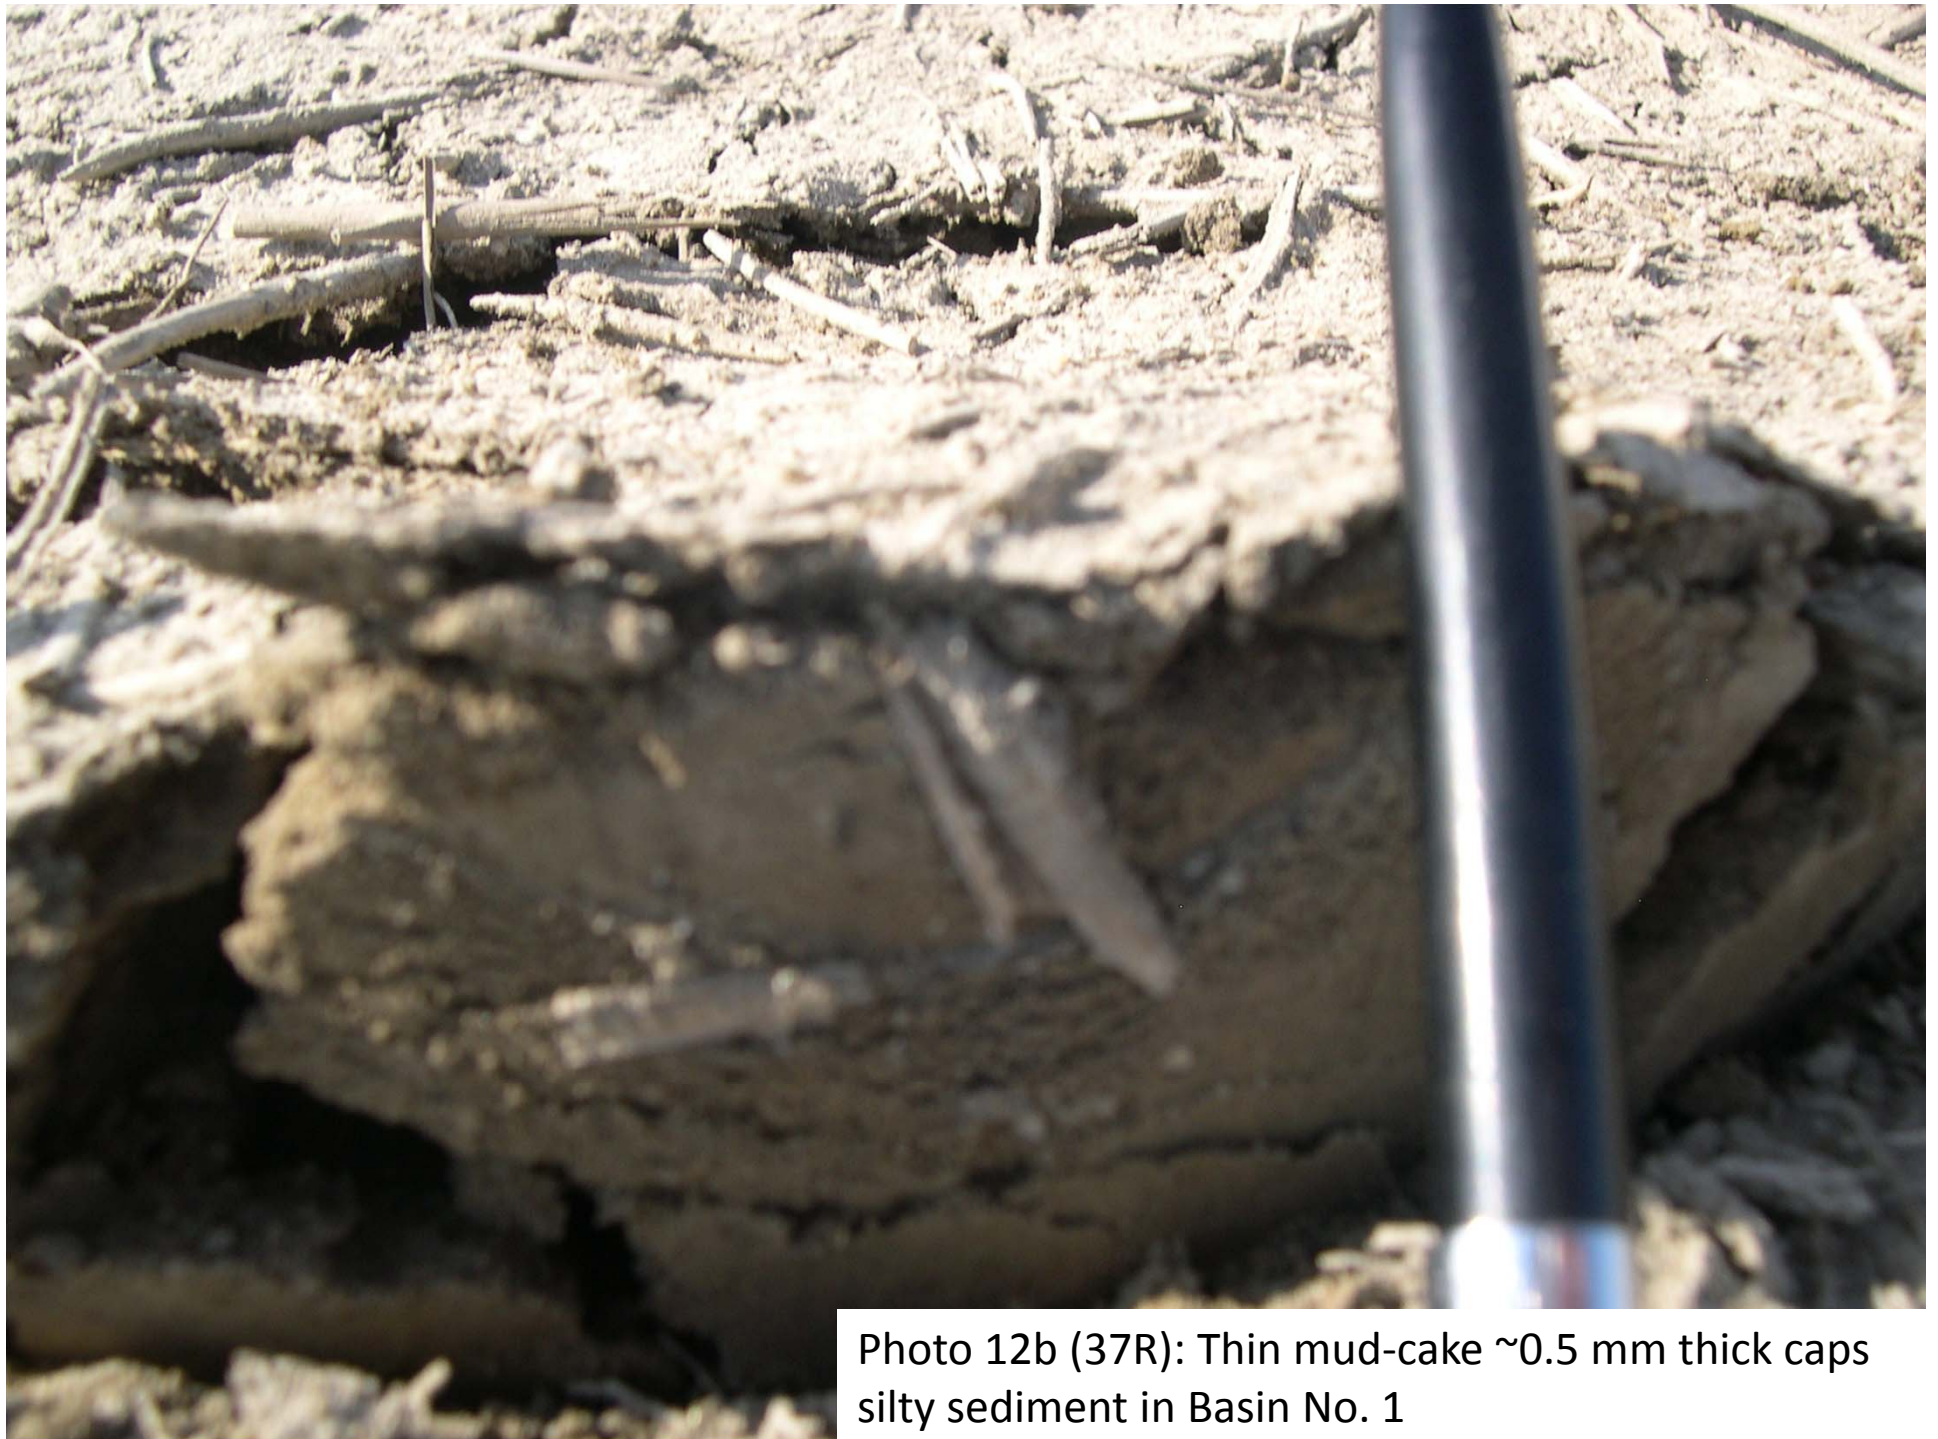
Photo 12b (37R): Thin mud-cake ~0.5 mm thick caps silty sediment in Basin No. 1

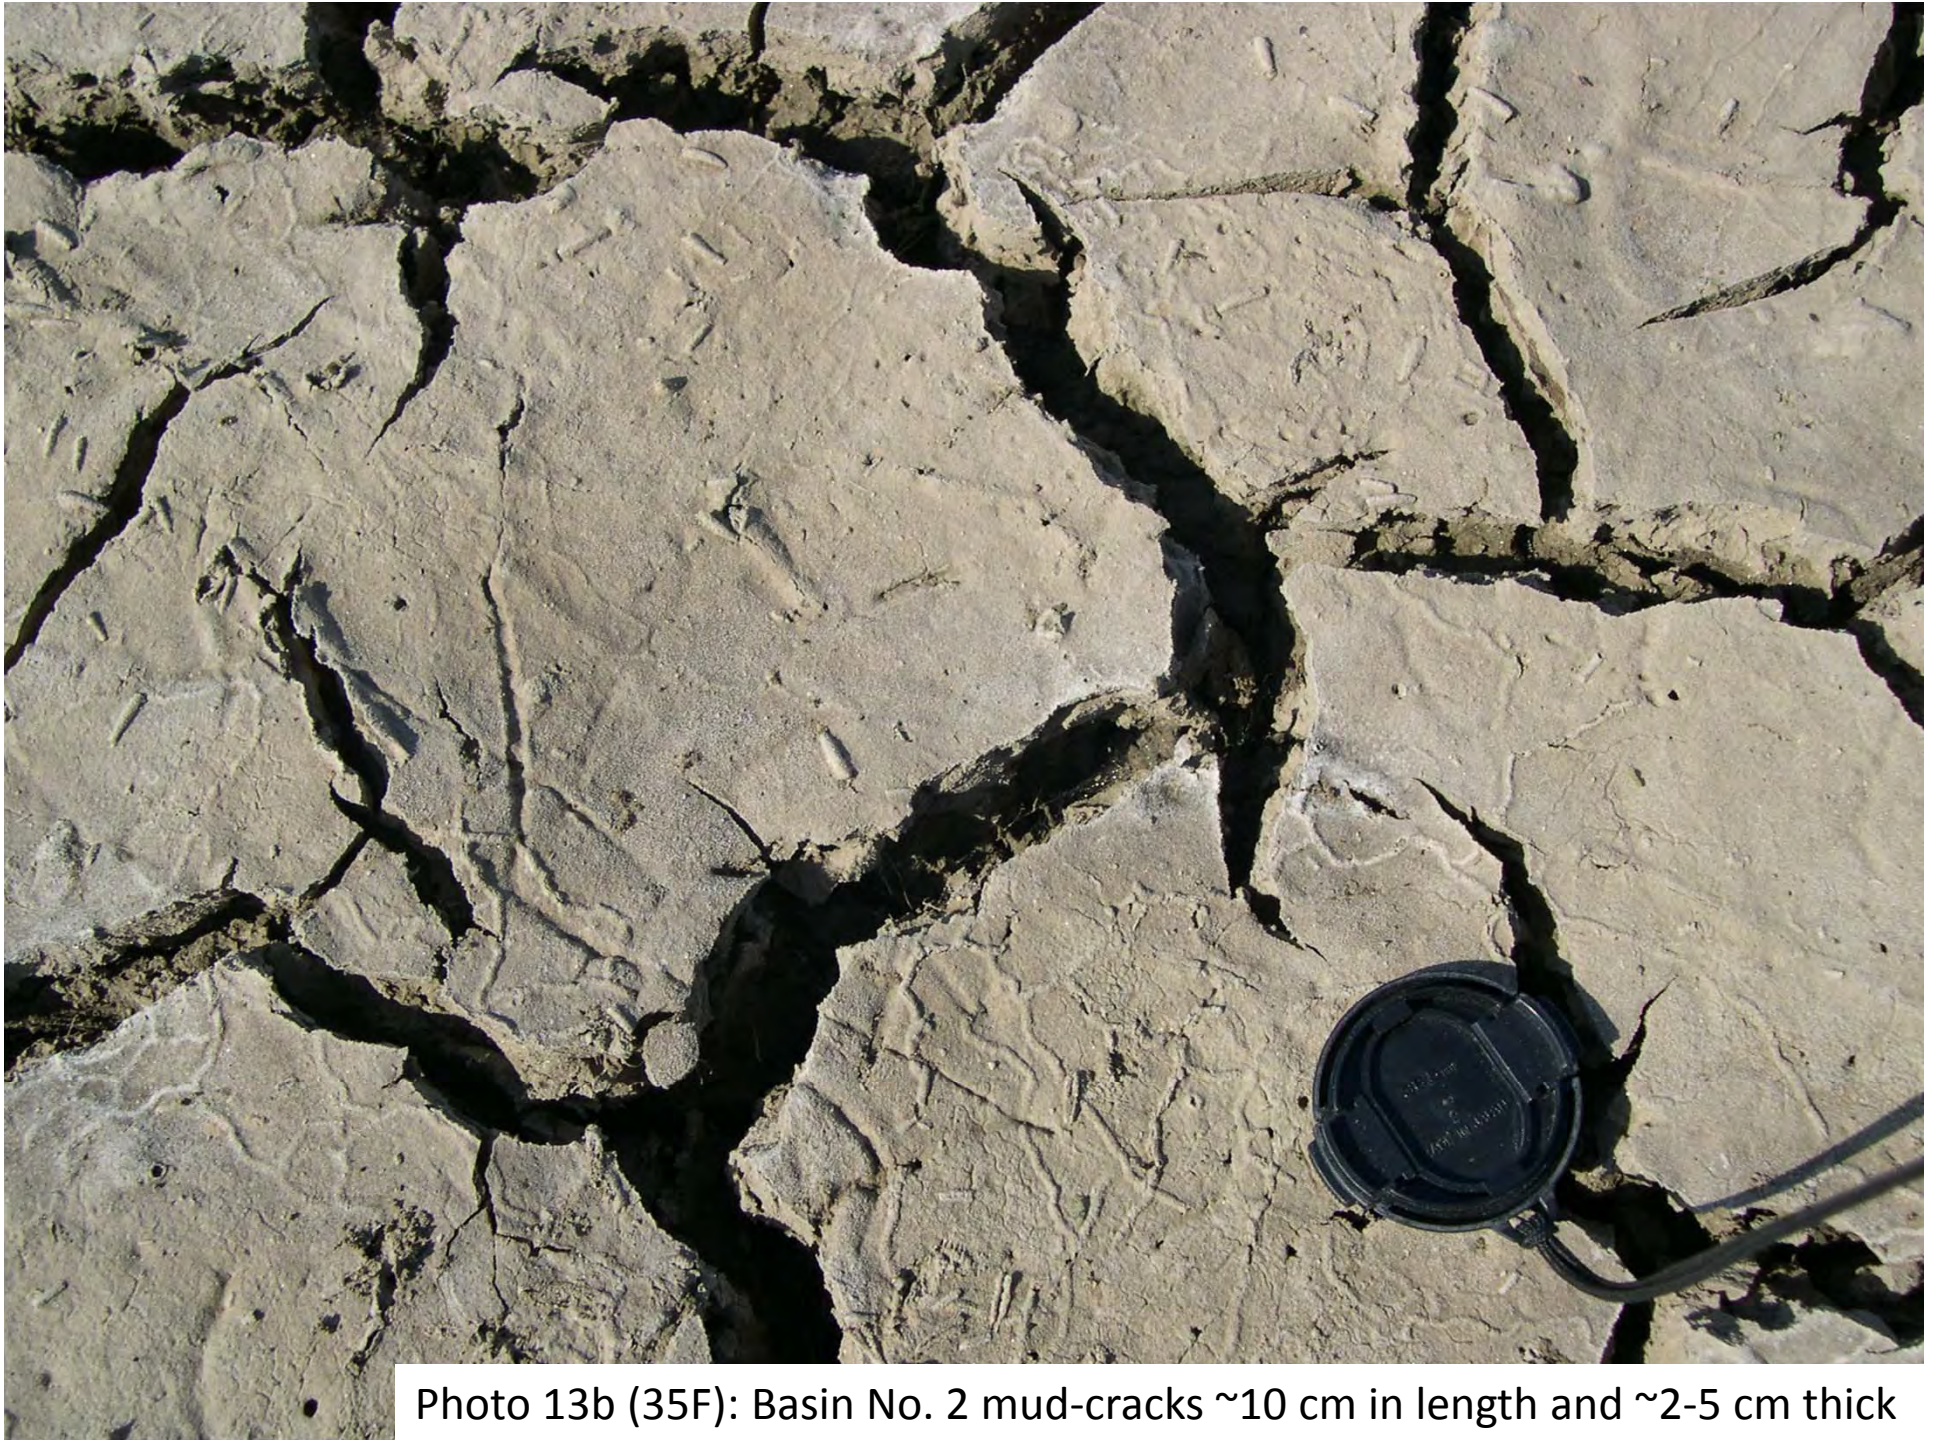
Photo 13b (35F): Basin No. 2 mud-cracks ~10 cm in length and ~2-5 cm thick

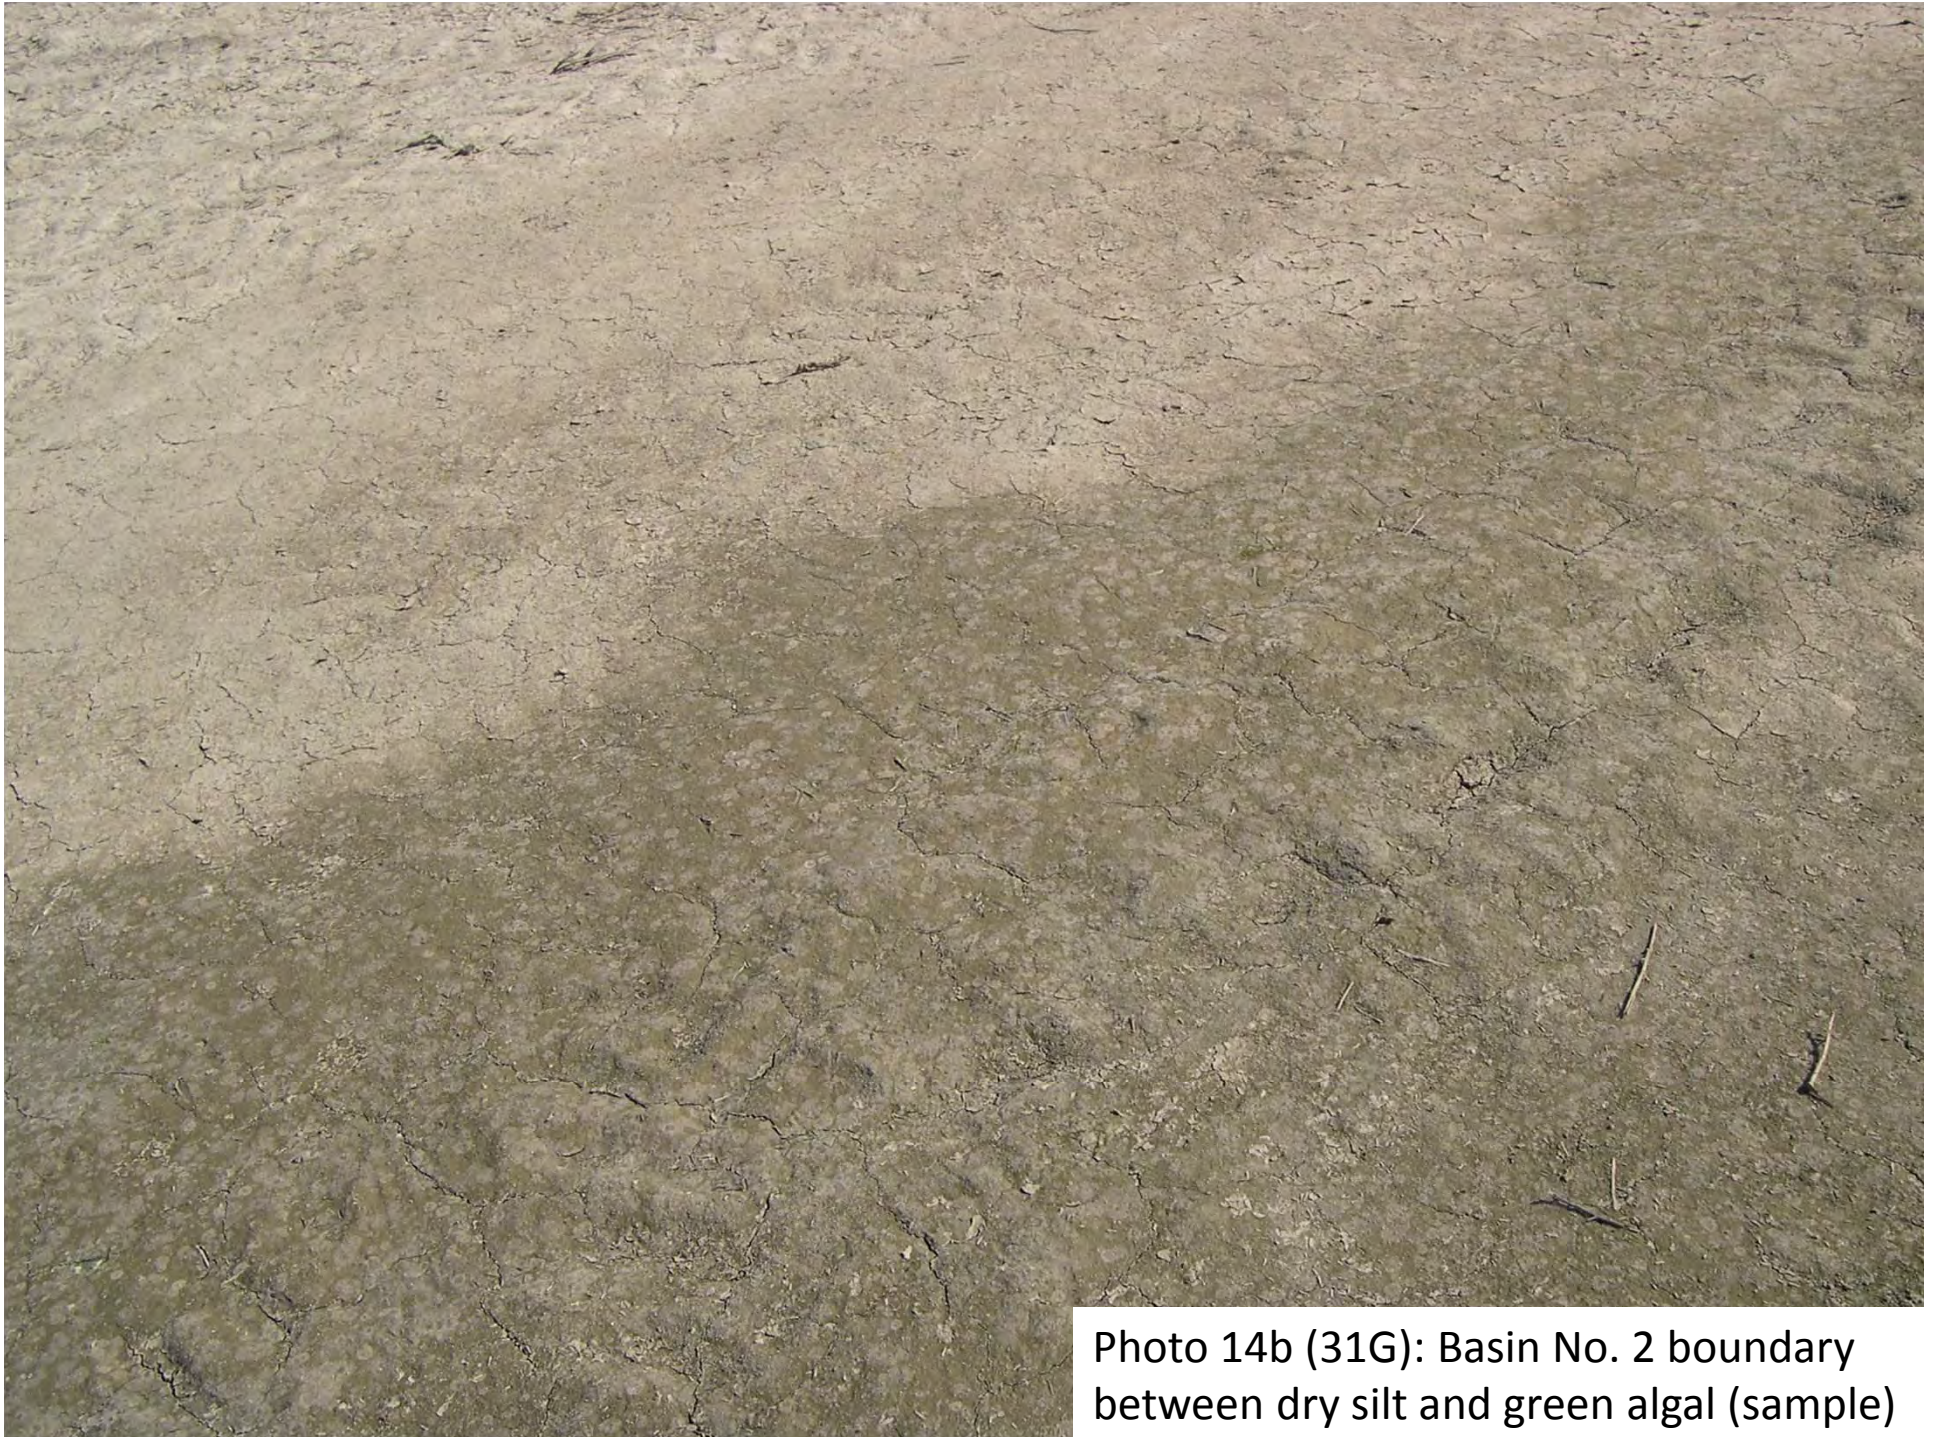
Photo 14b (31G): Basin No. 2 boundary between dry silt and green algal (sample)

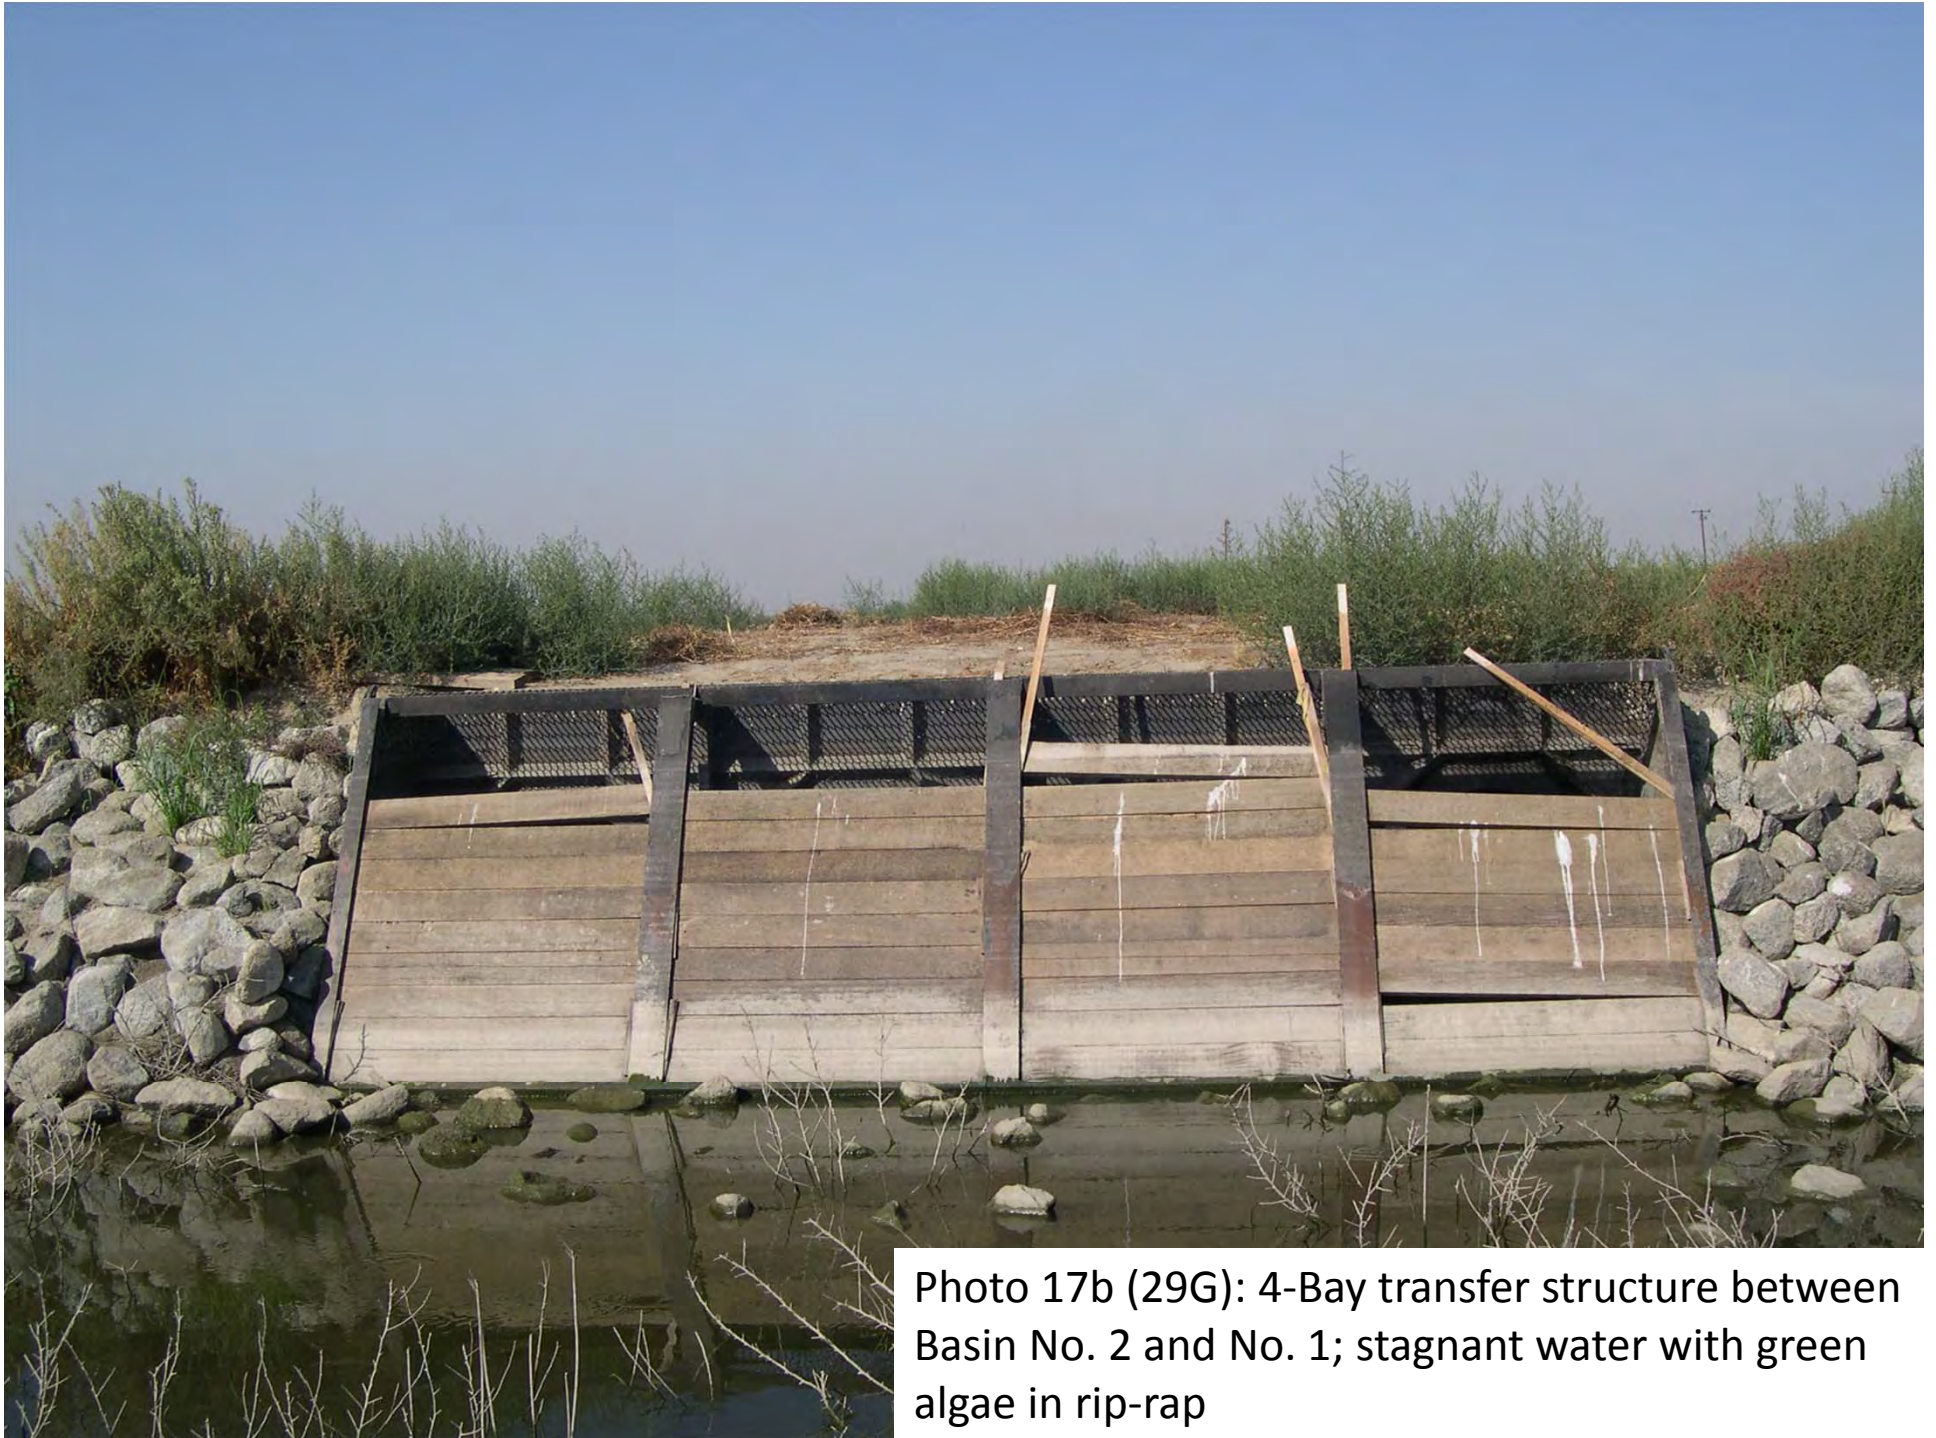
Photo 17b (29G): 4-Bay transfer structure between Basin No. 2 and No. 1; stagnant water with green algae in rip-rap
