October 11, 2011

Irvine Ranch Water District
Attention: Paul Weghorst
15600 Sand Canyon Avenue
Irvine, CA 92618

Subject: *Strand Ranch South Basin Field Reconnaissance and Remediation Recommendations*

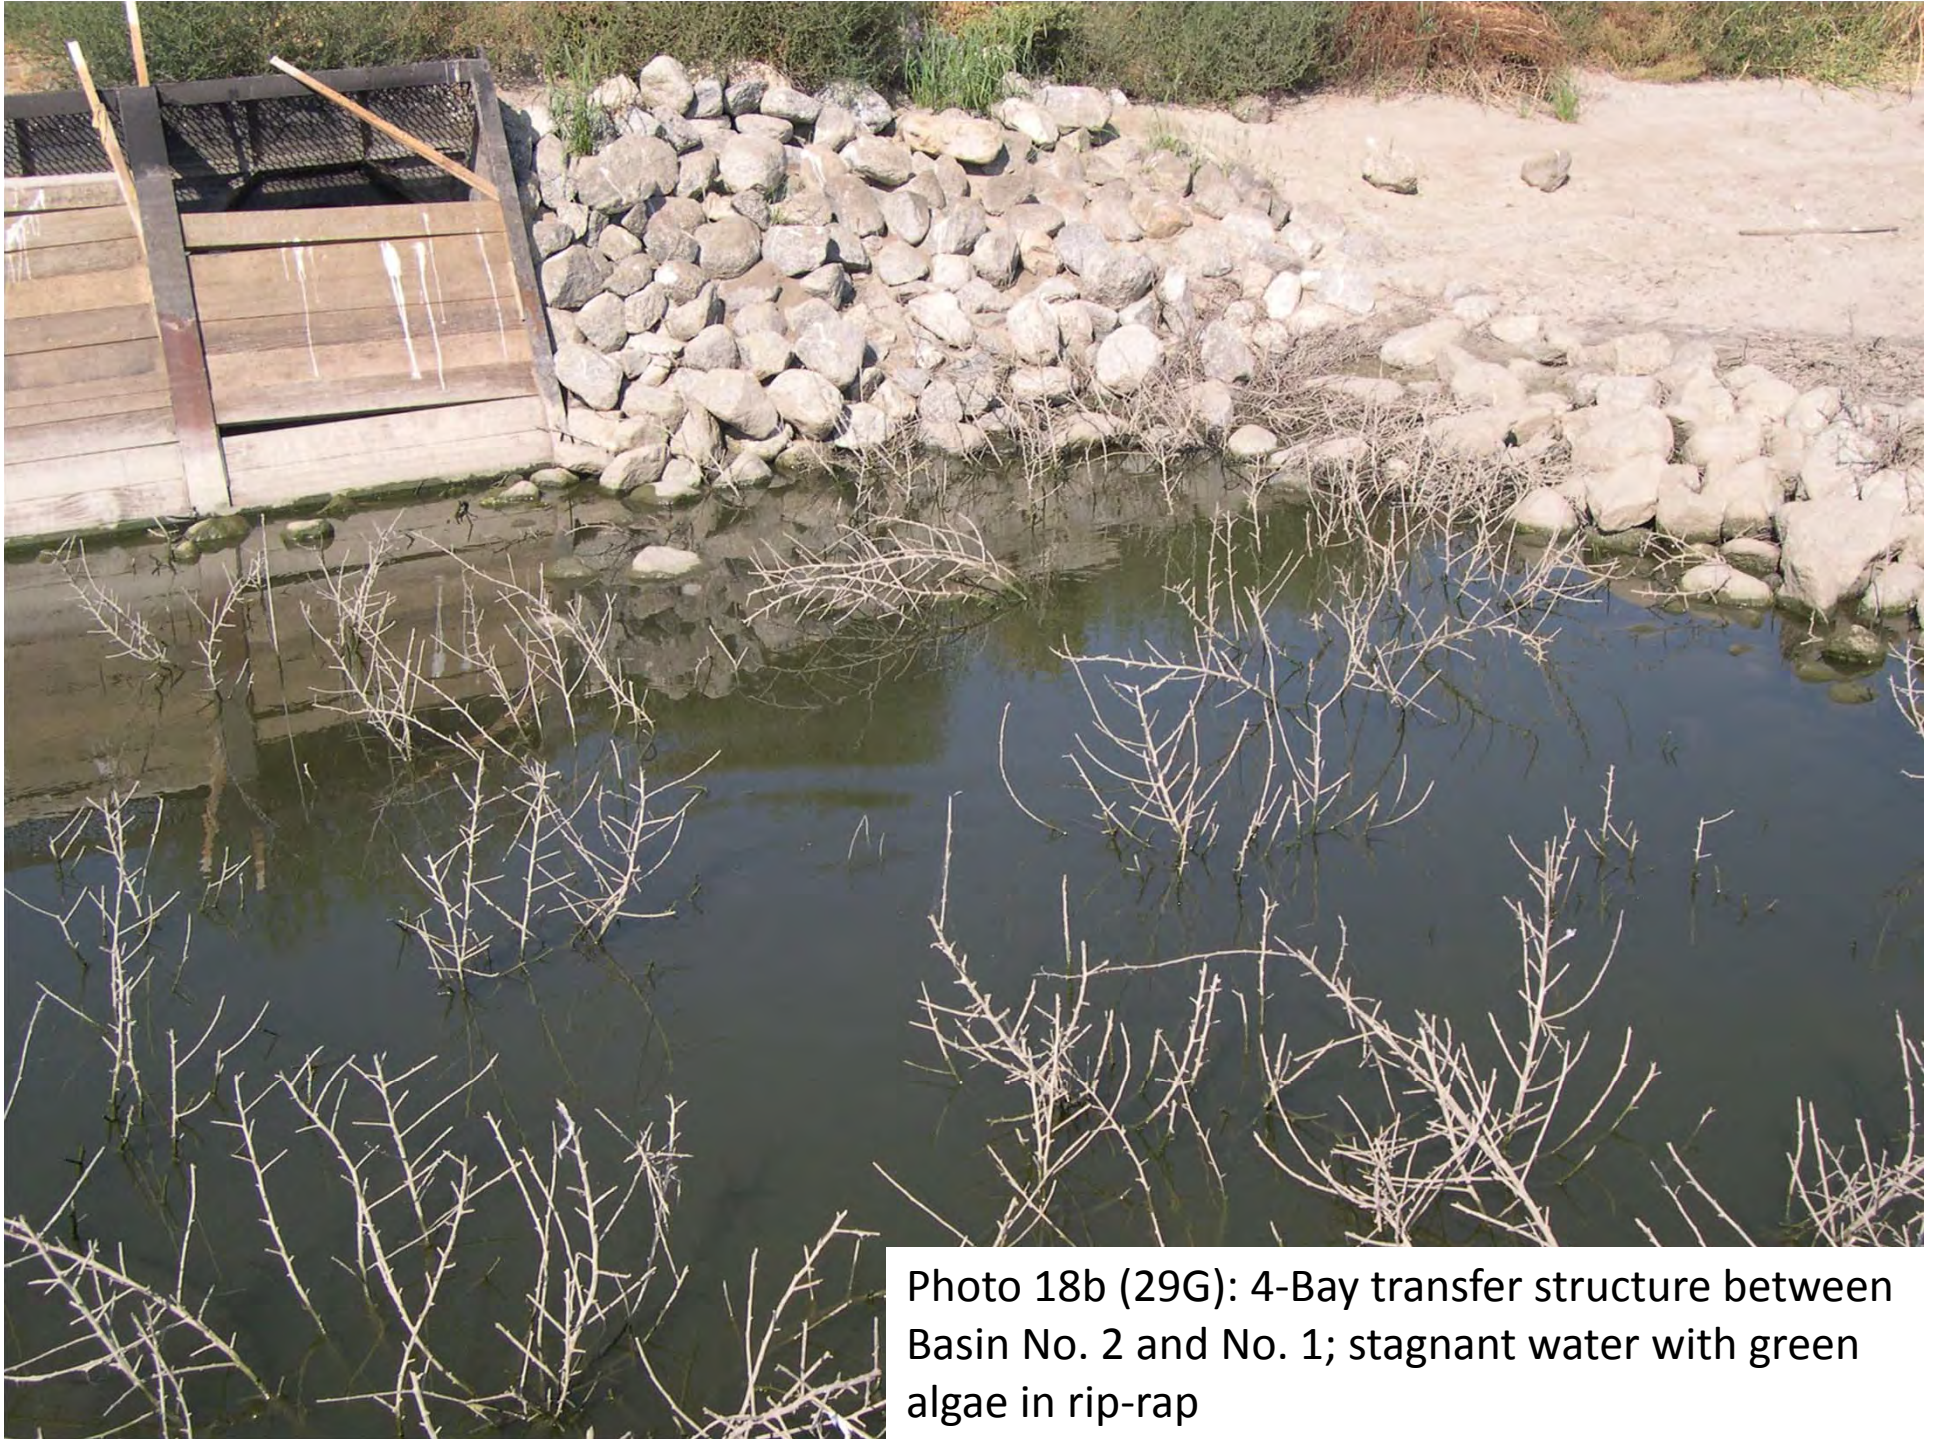
Photo 18b (29G): 4-Bay transfer structure between Basin No. 2 and No. 1; stagnant water with green algae in rip-rap

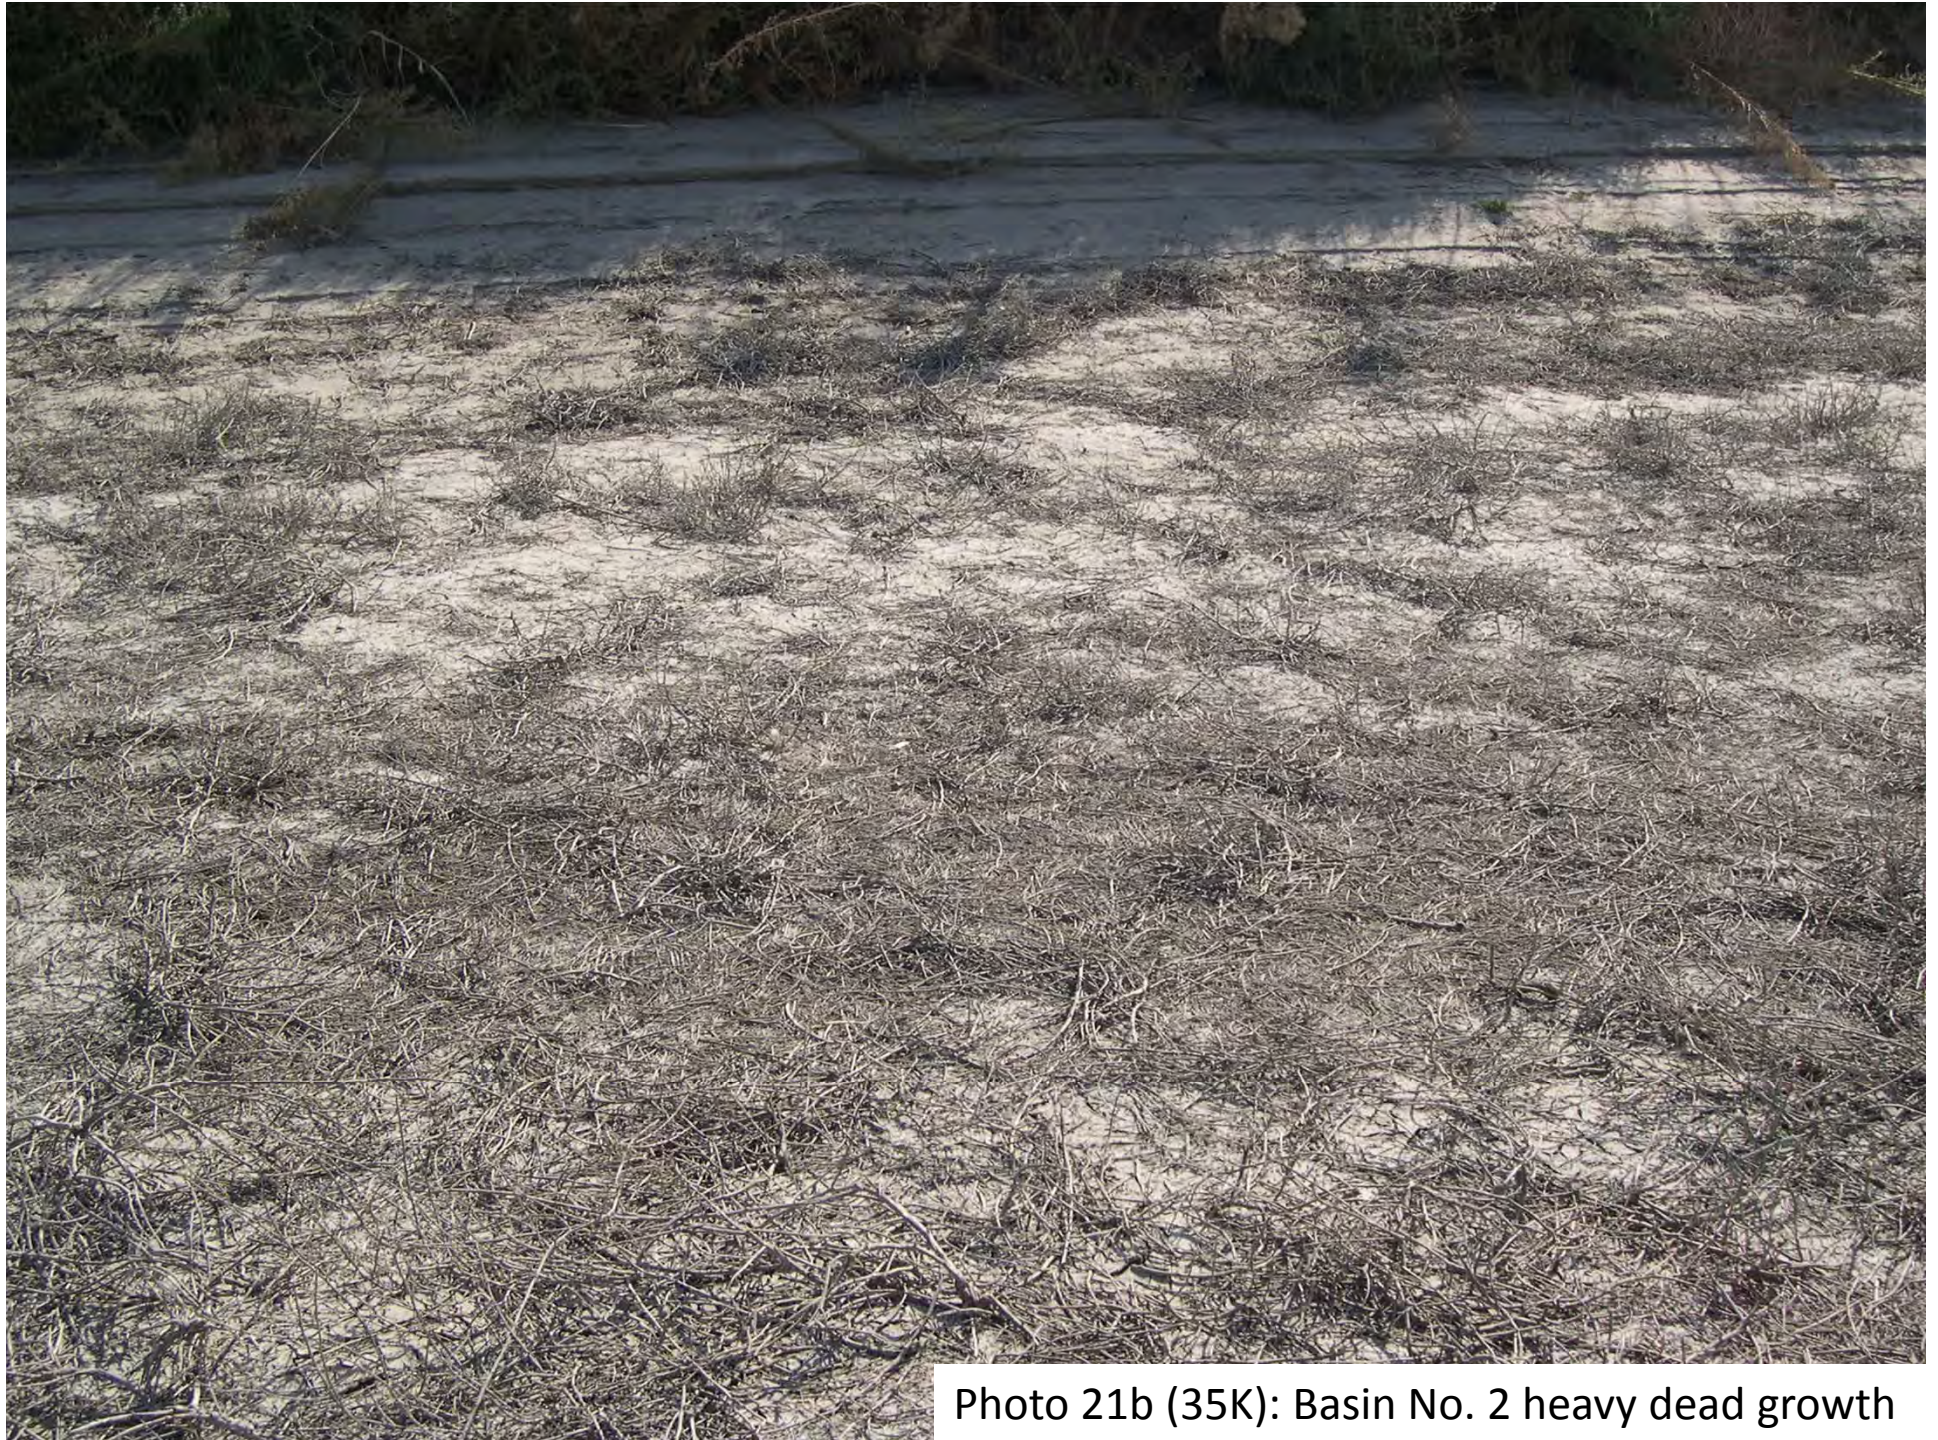
Photo 21b (35K): Basin No. 2 heavy dead growth

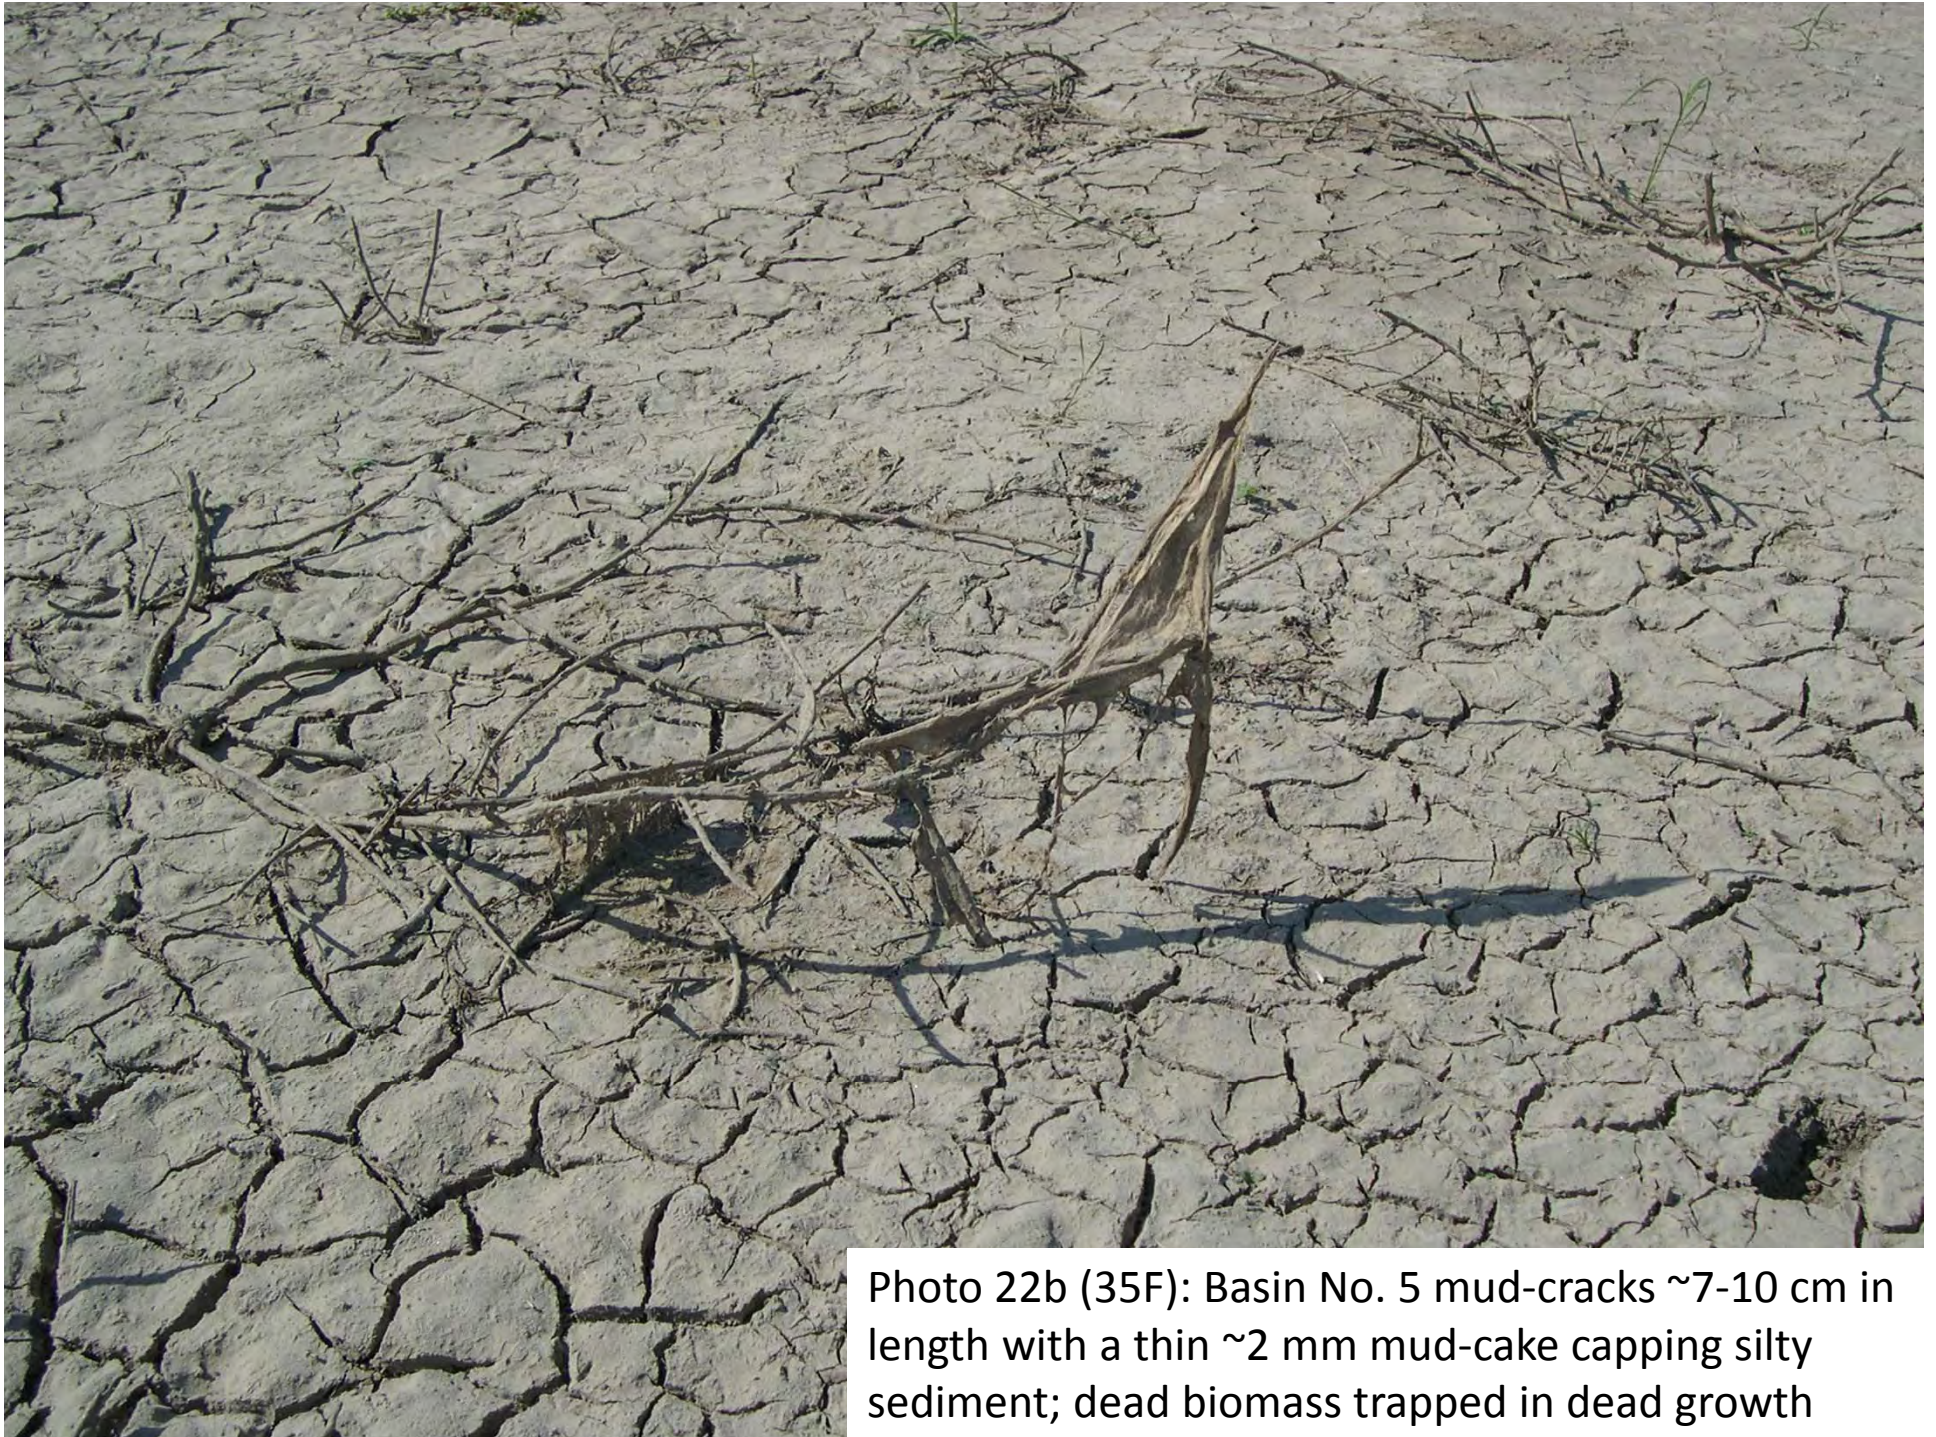
Photo 22b (35F): Basin No. 5 mud-cracks ~7-10 cm in length with a thin ~2 mm mud-cake capping silty sediment; dead biomass trapped in dead growth

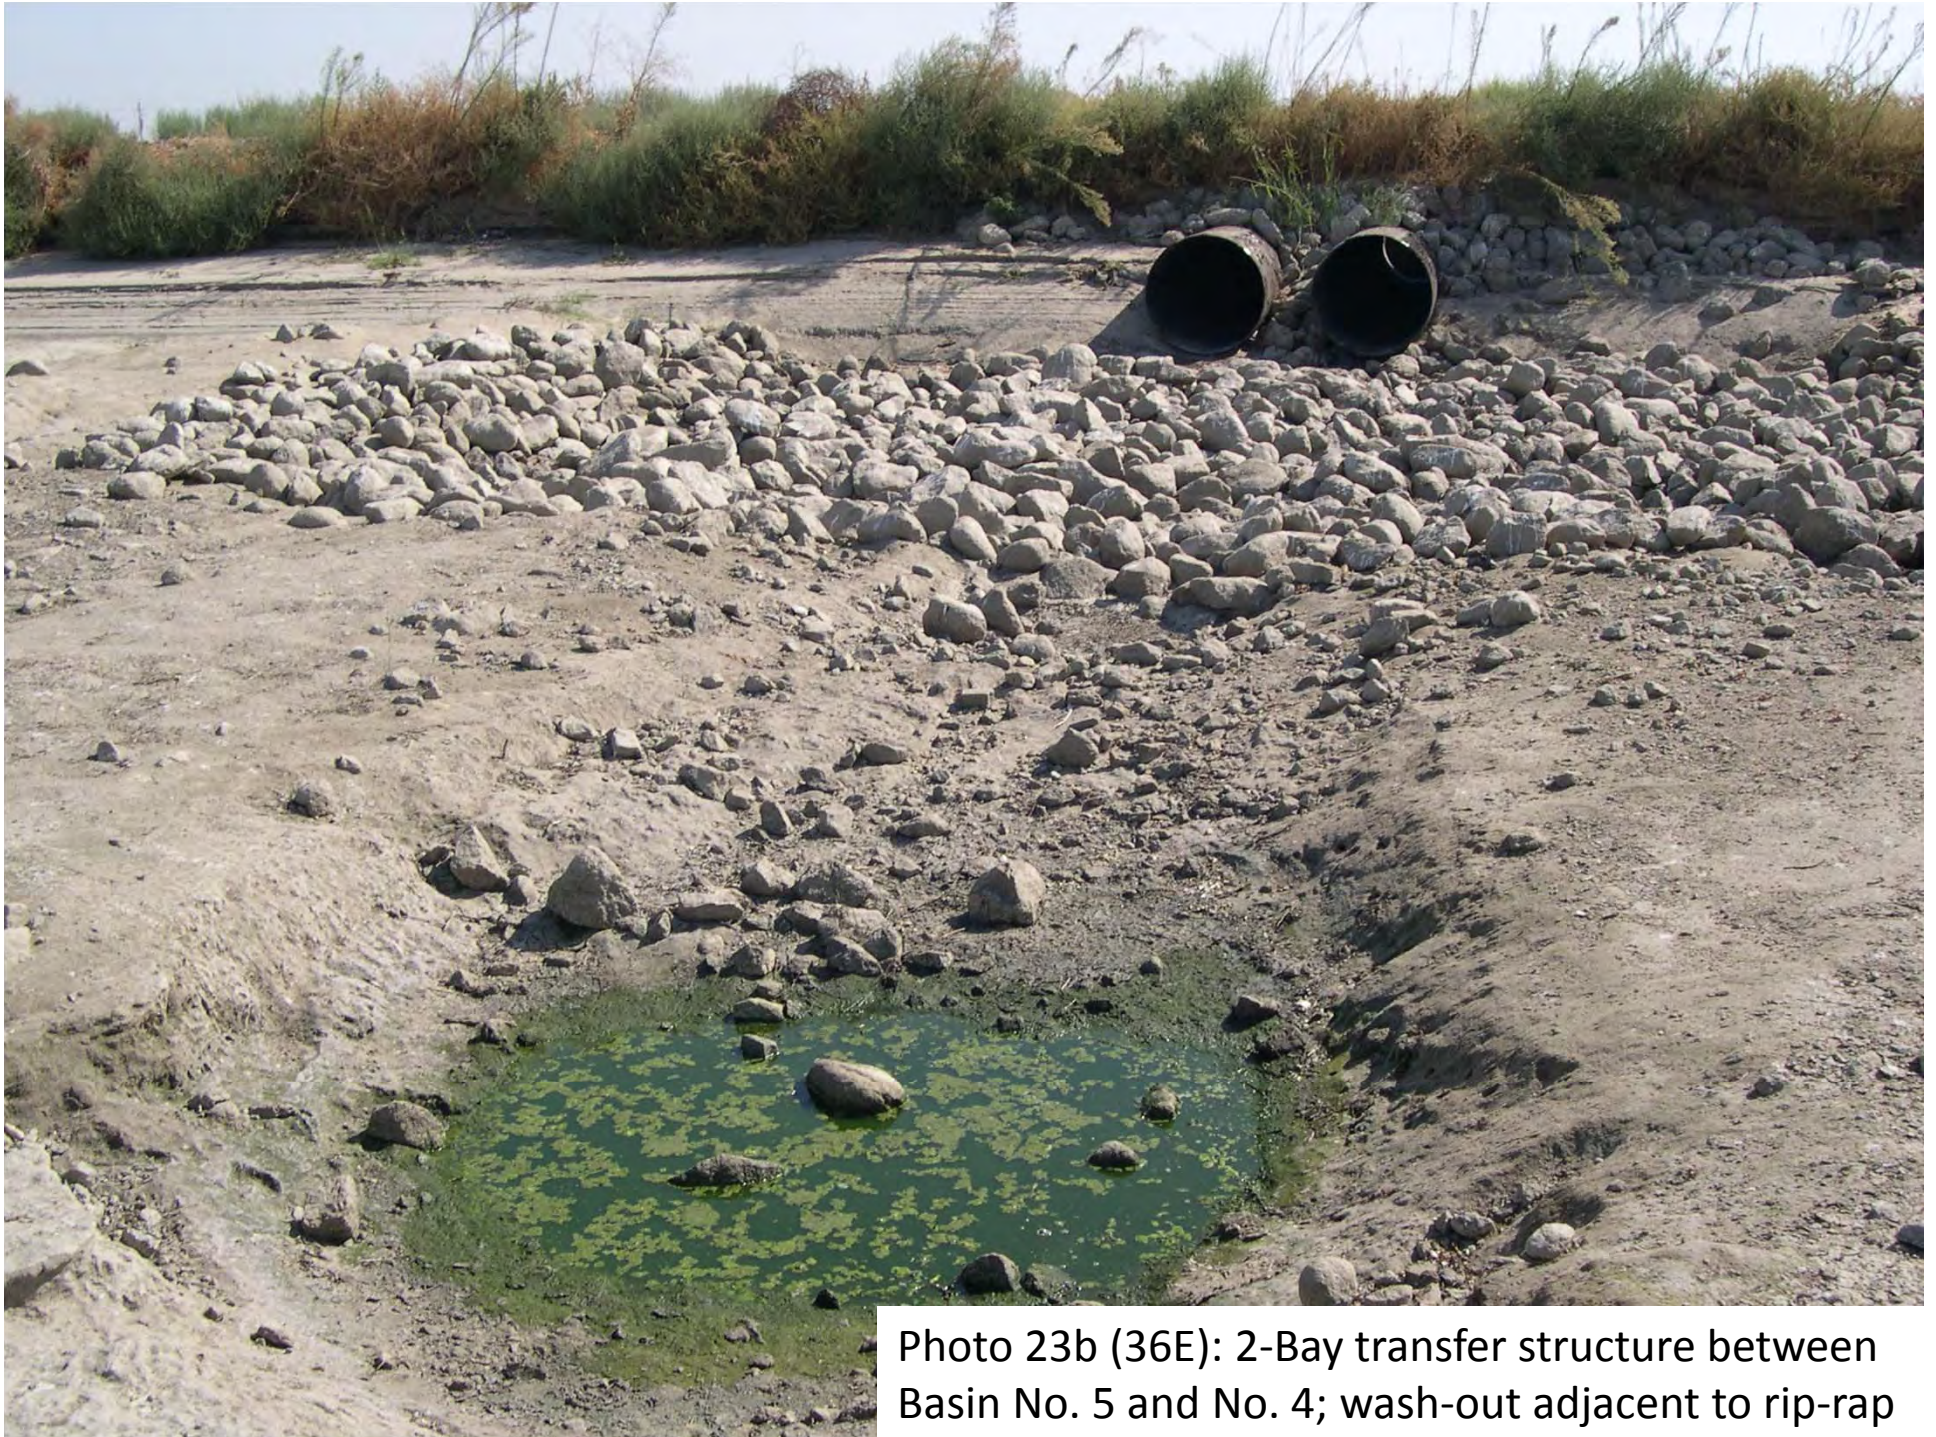
Photo 23b (36E): 2-Bay transfer structure between Basin No. 5 and No. 4; wash-out adjacent to rip-rap

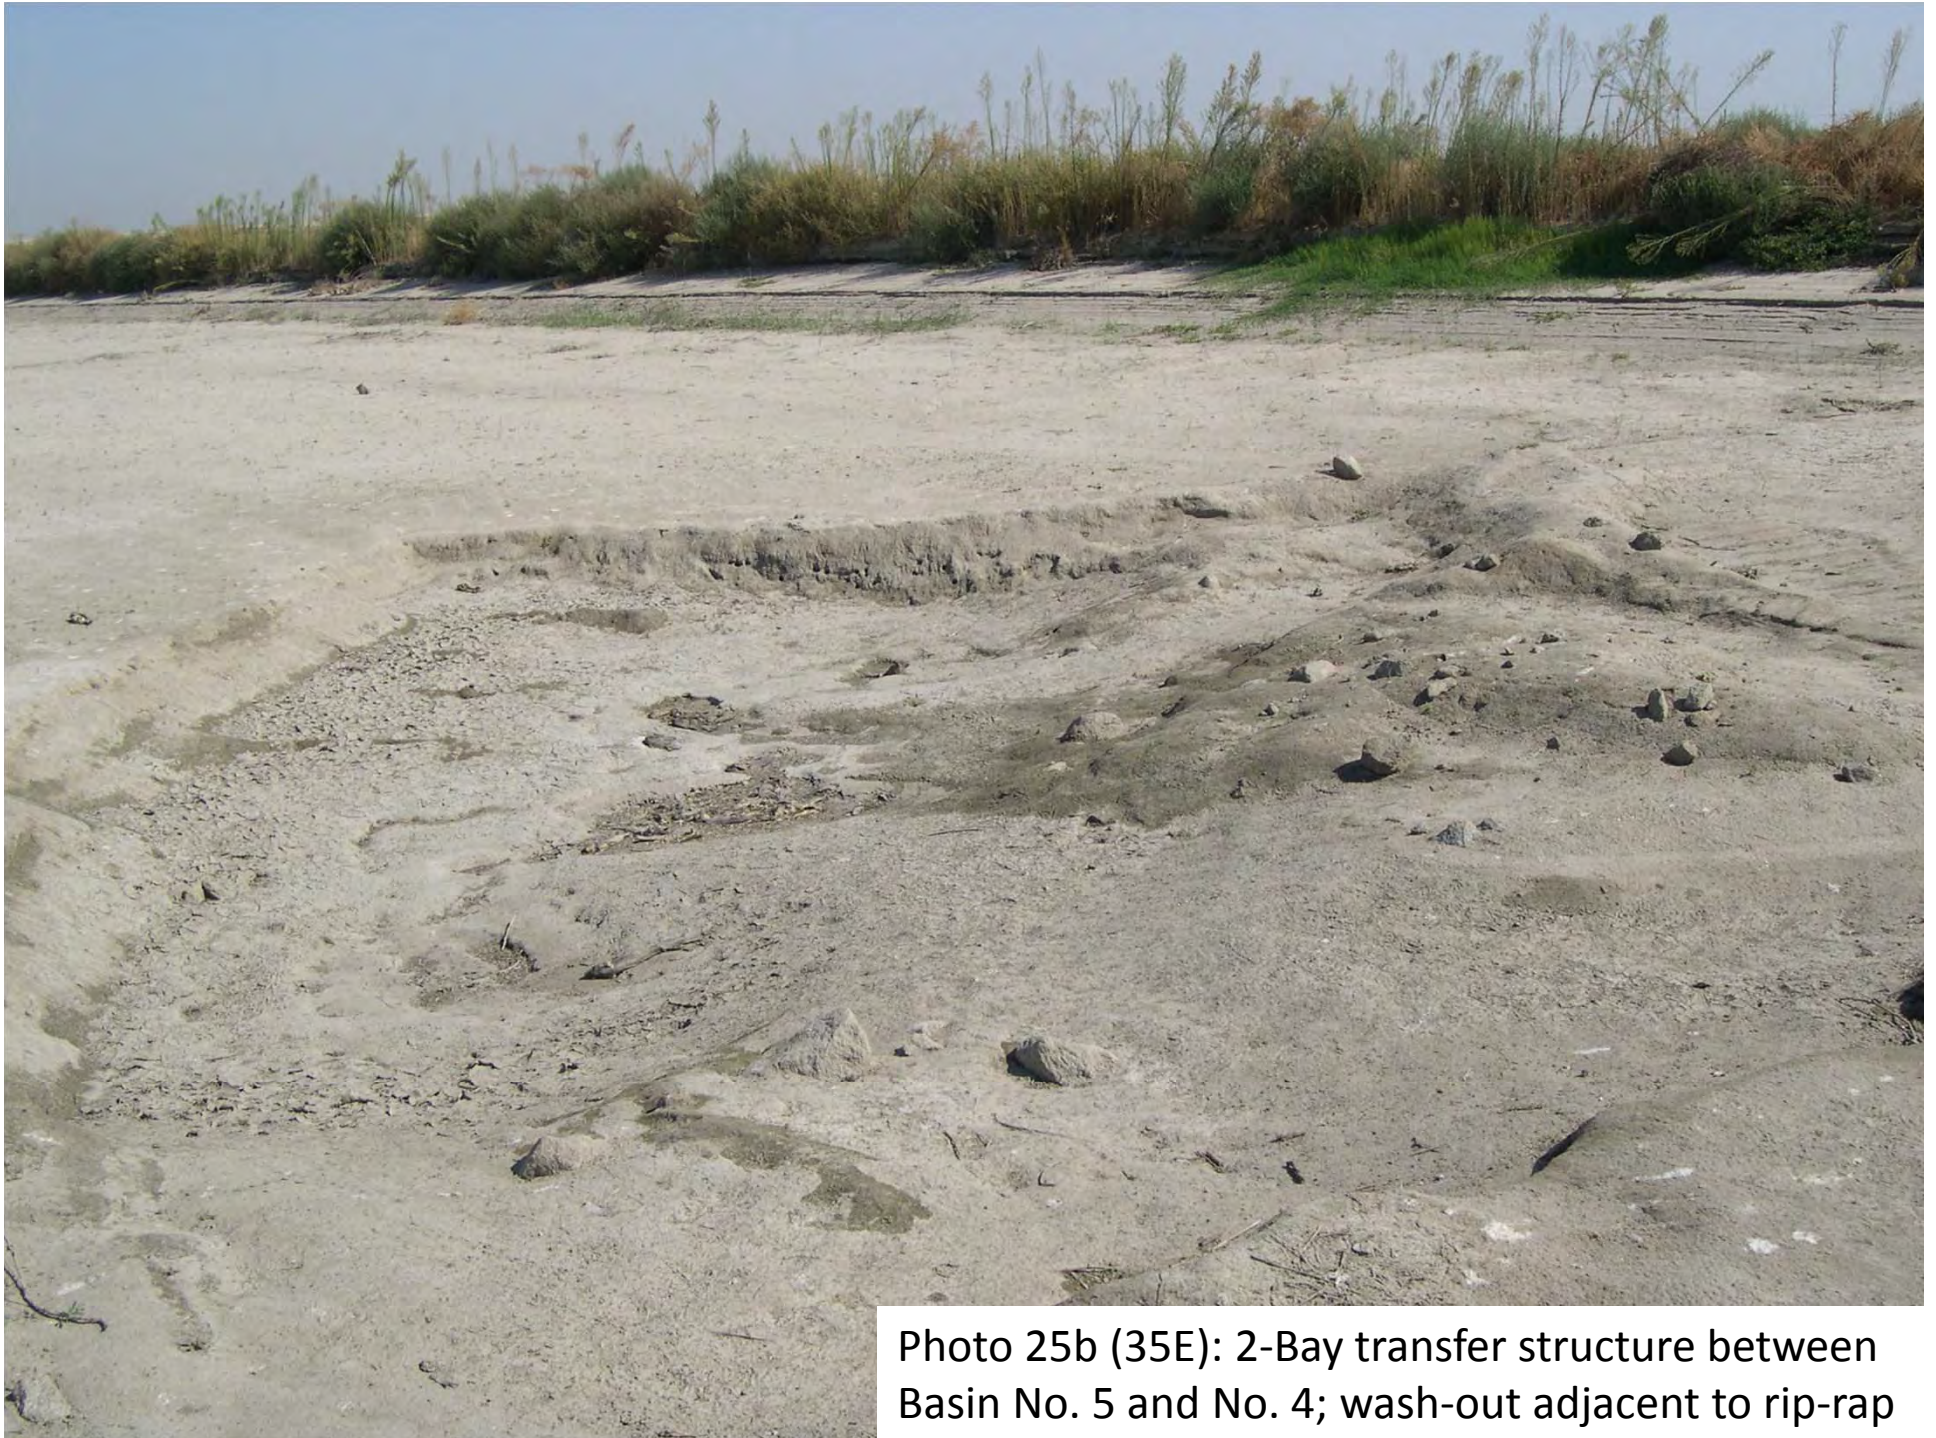
Photo 25b (35E): 2-Bay transfer structure between Basin No. 5 and No. 4; wash-out adjacent to rip-rap

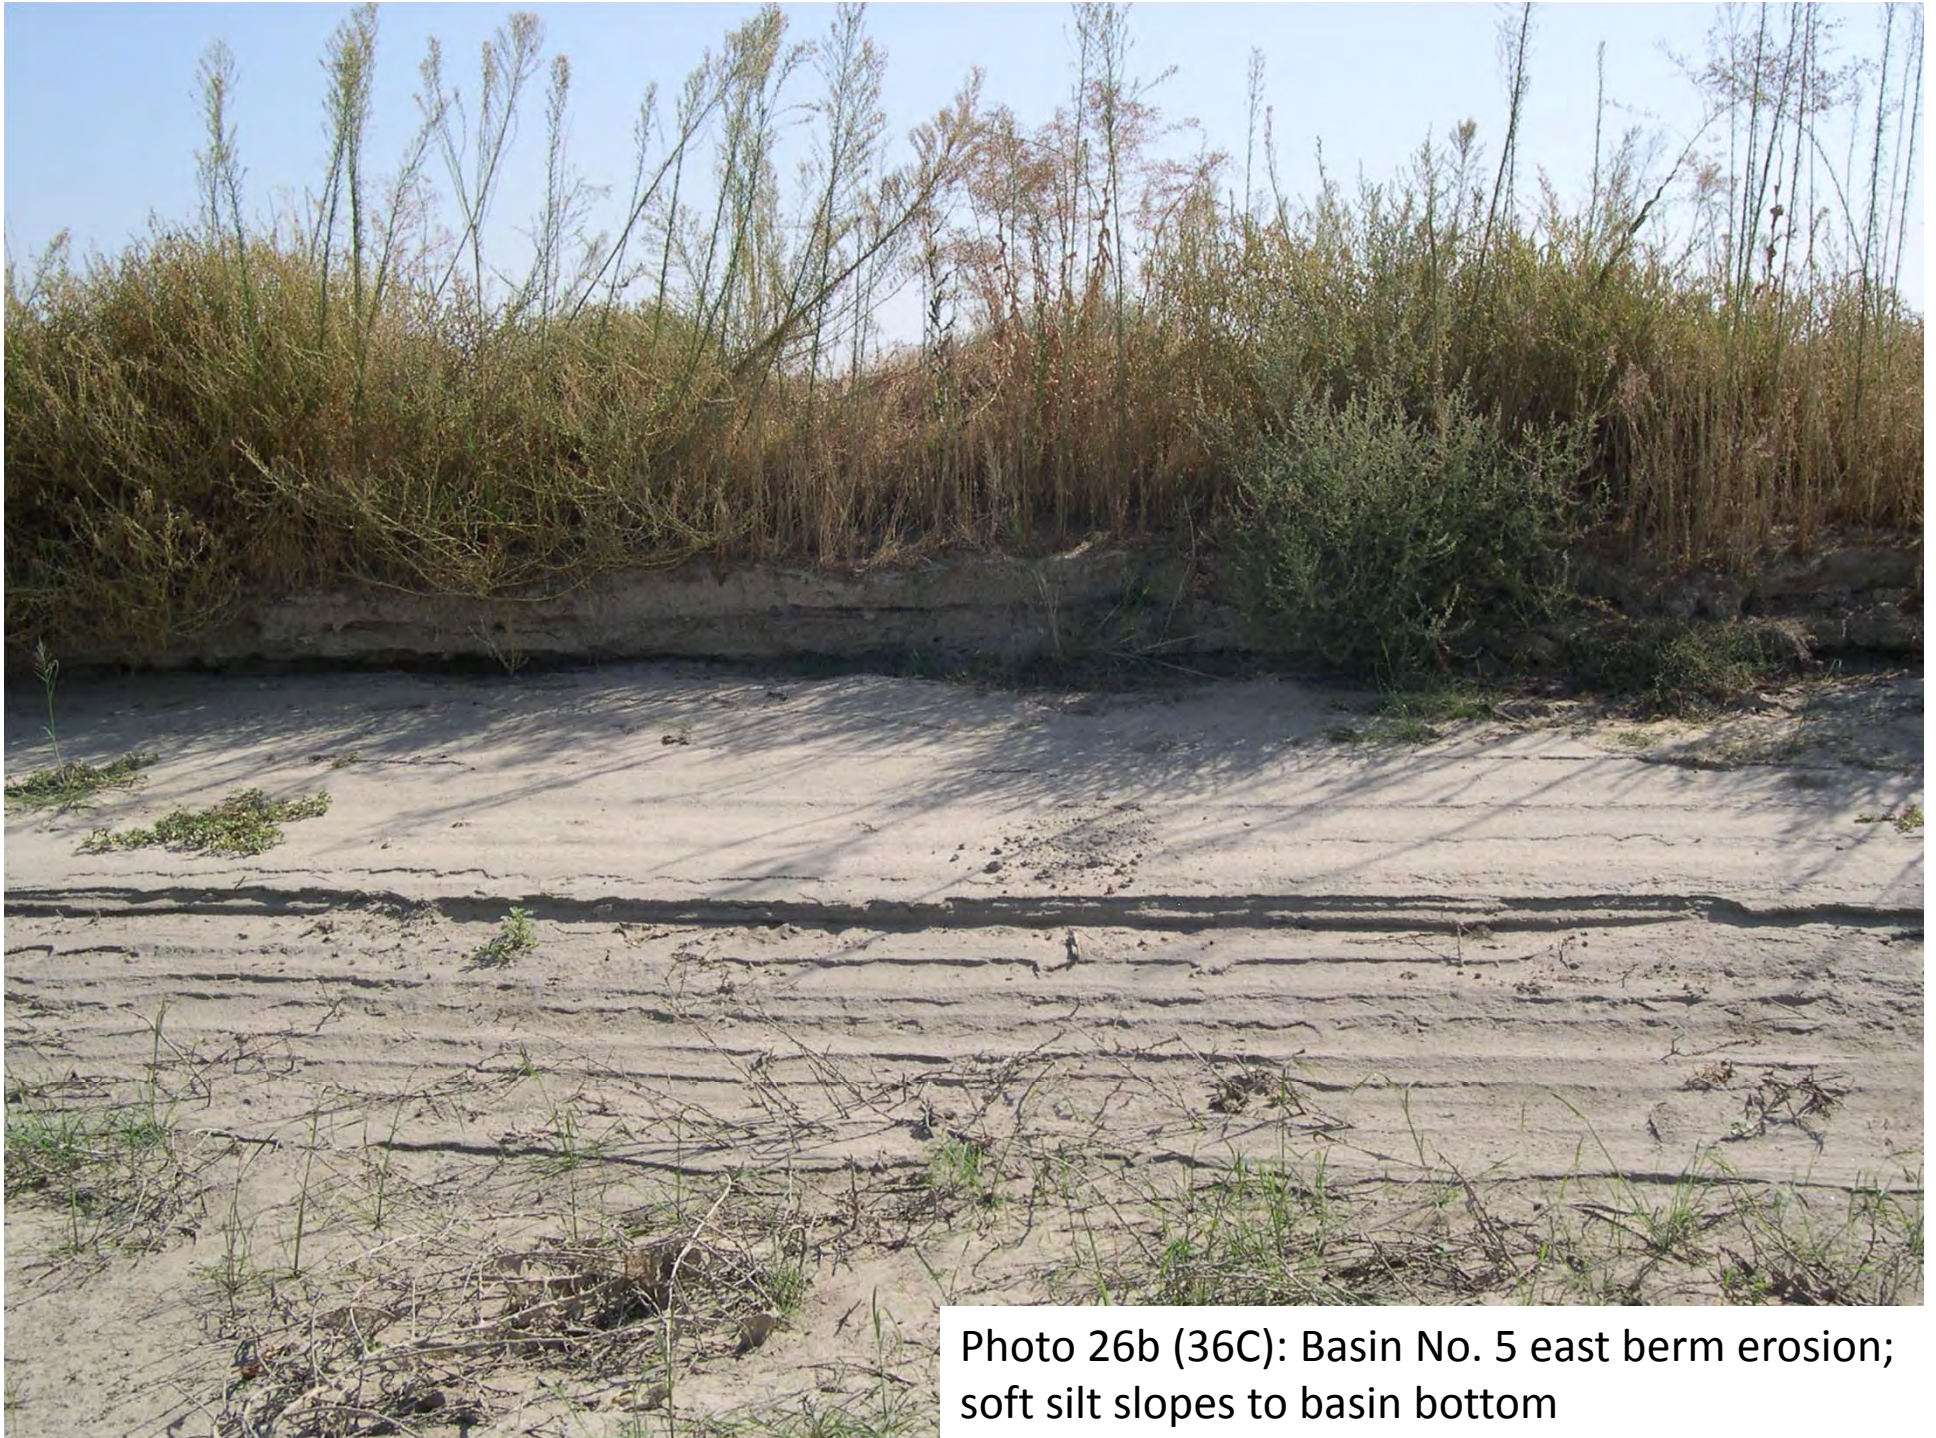
Photo 26b (36C): Basin No. 5 east berm erosion;
soft silt slopes to basin bottom

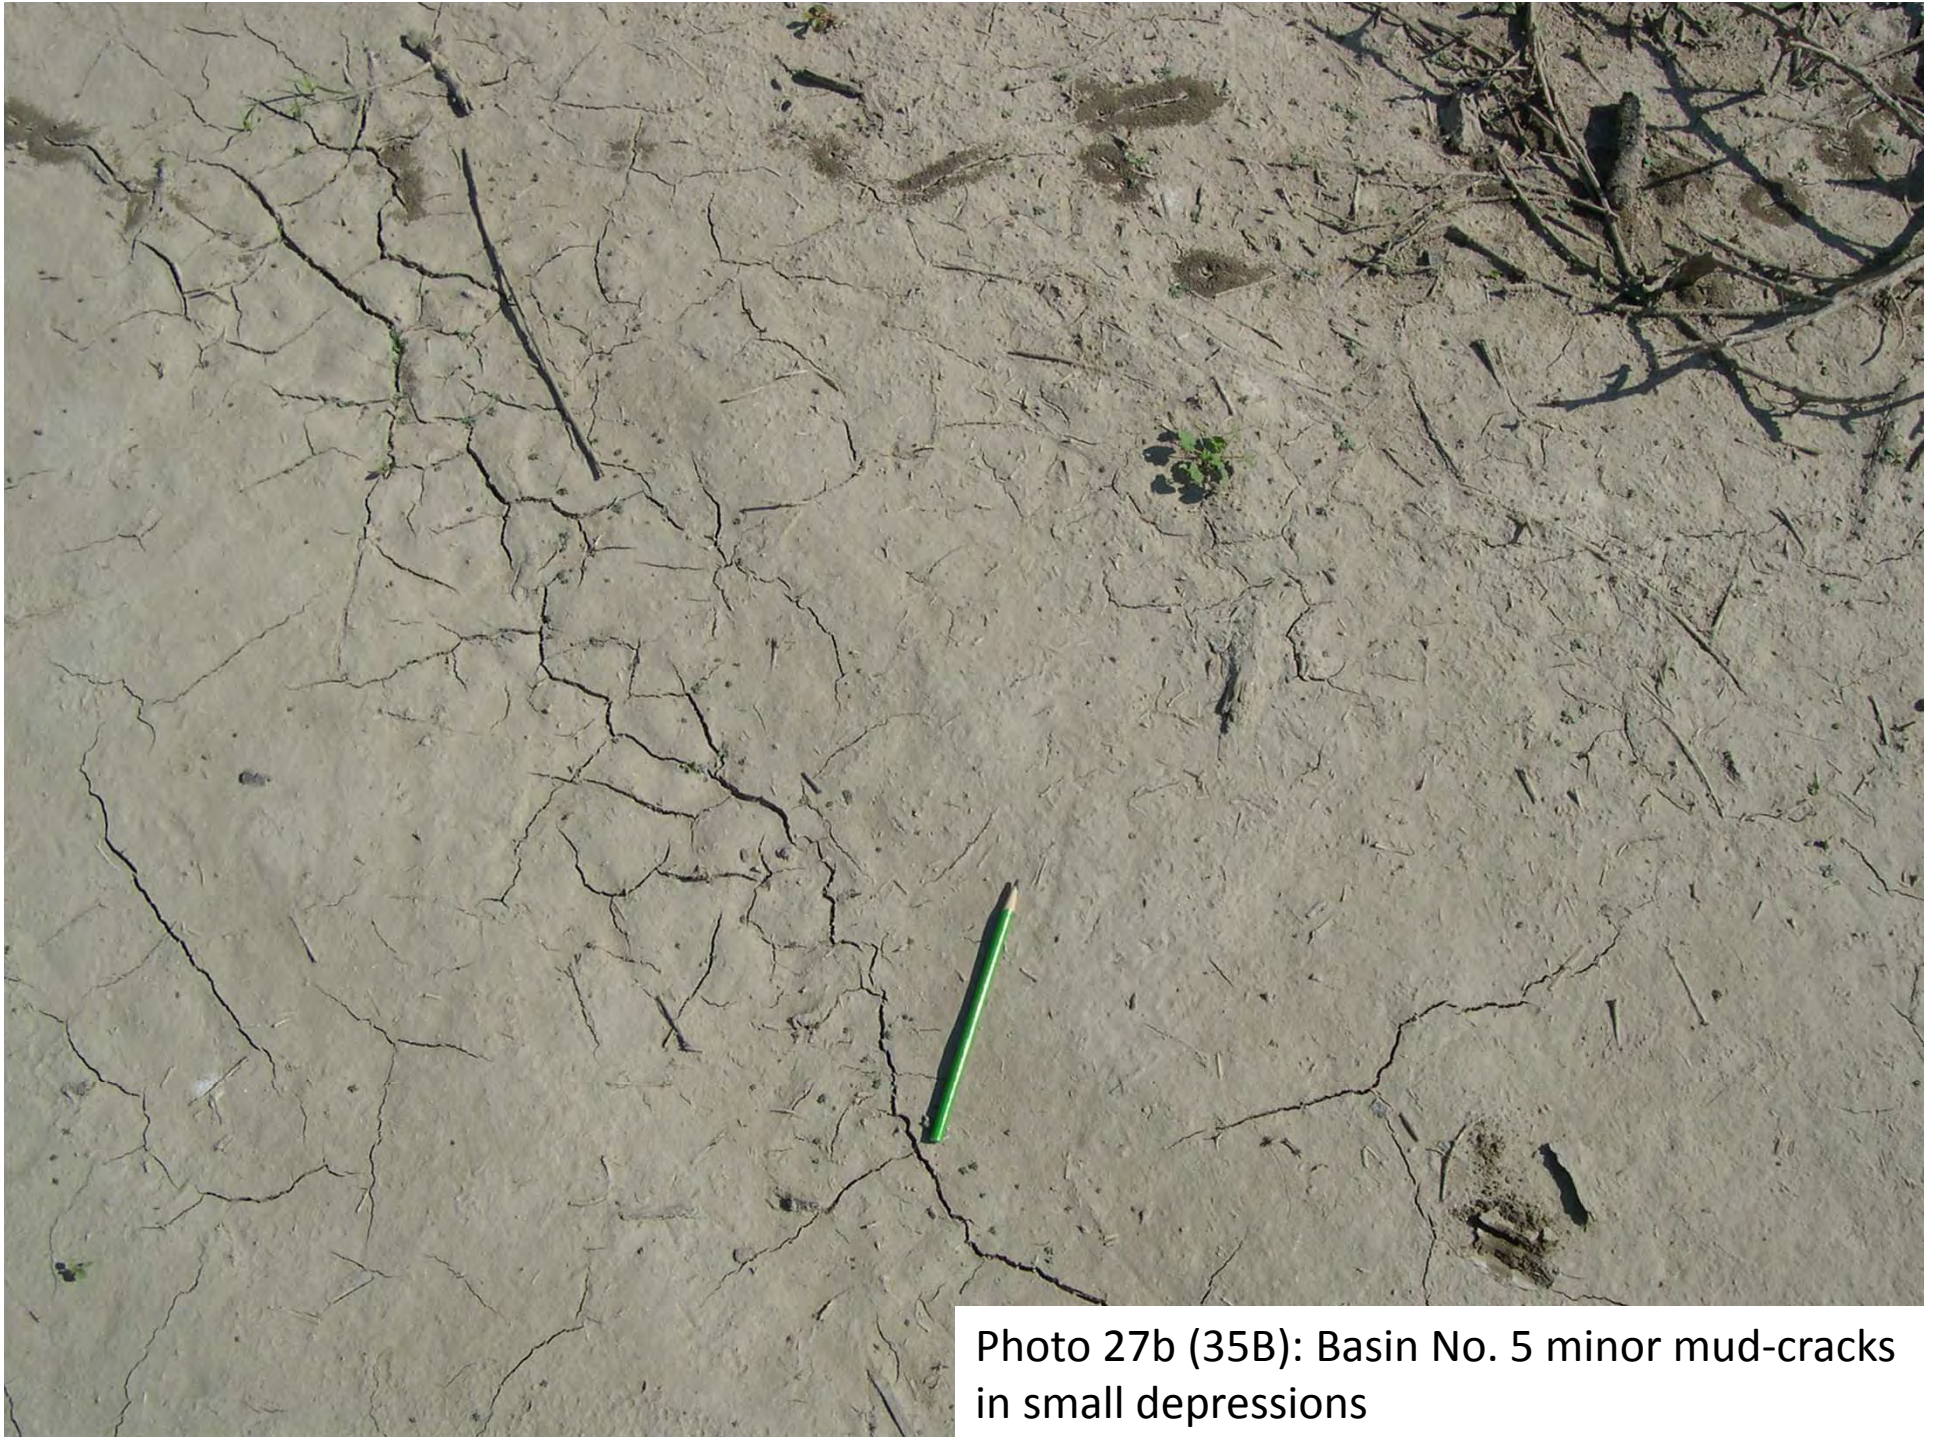
Photo 27b (35B): Basin No. 5 minor mud-cracks in small depressions

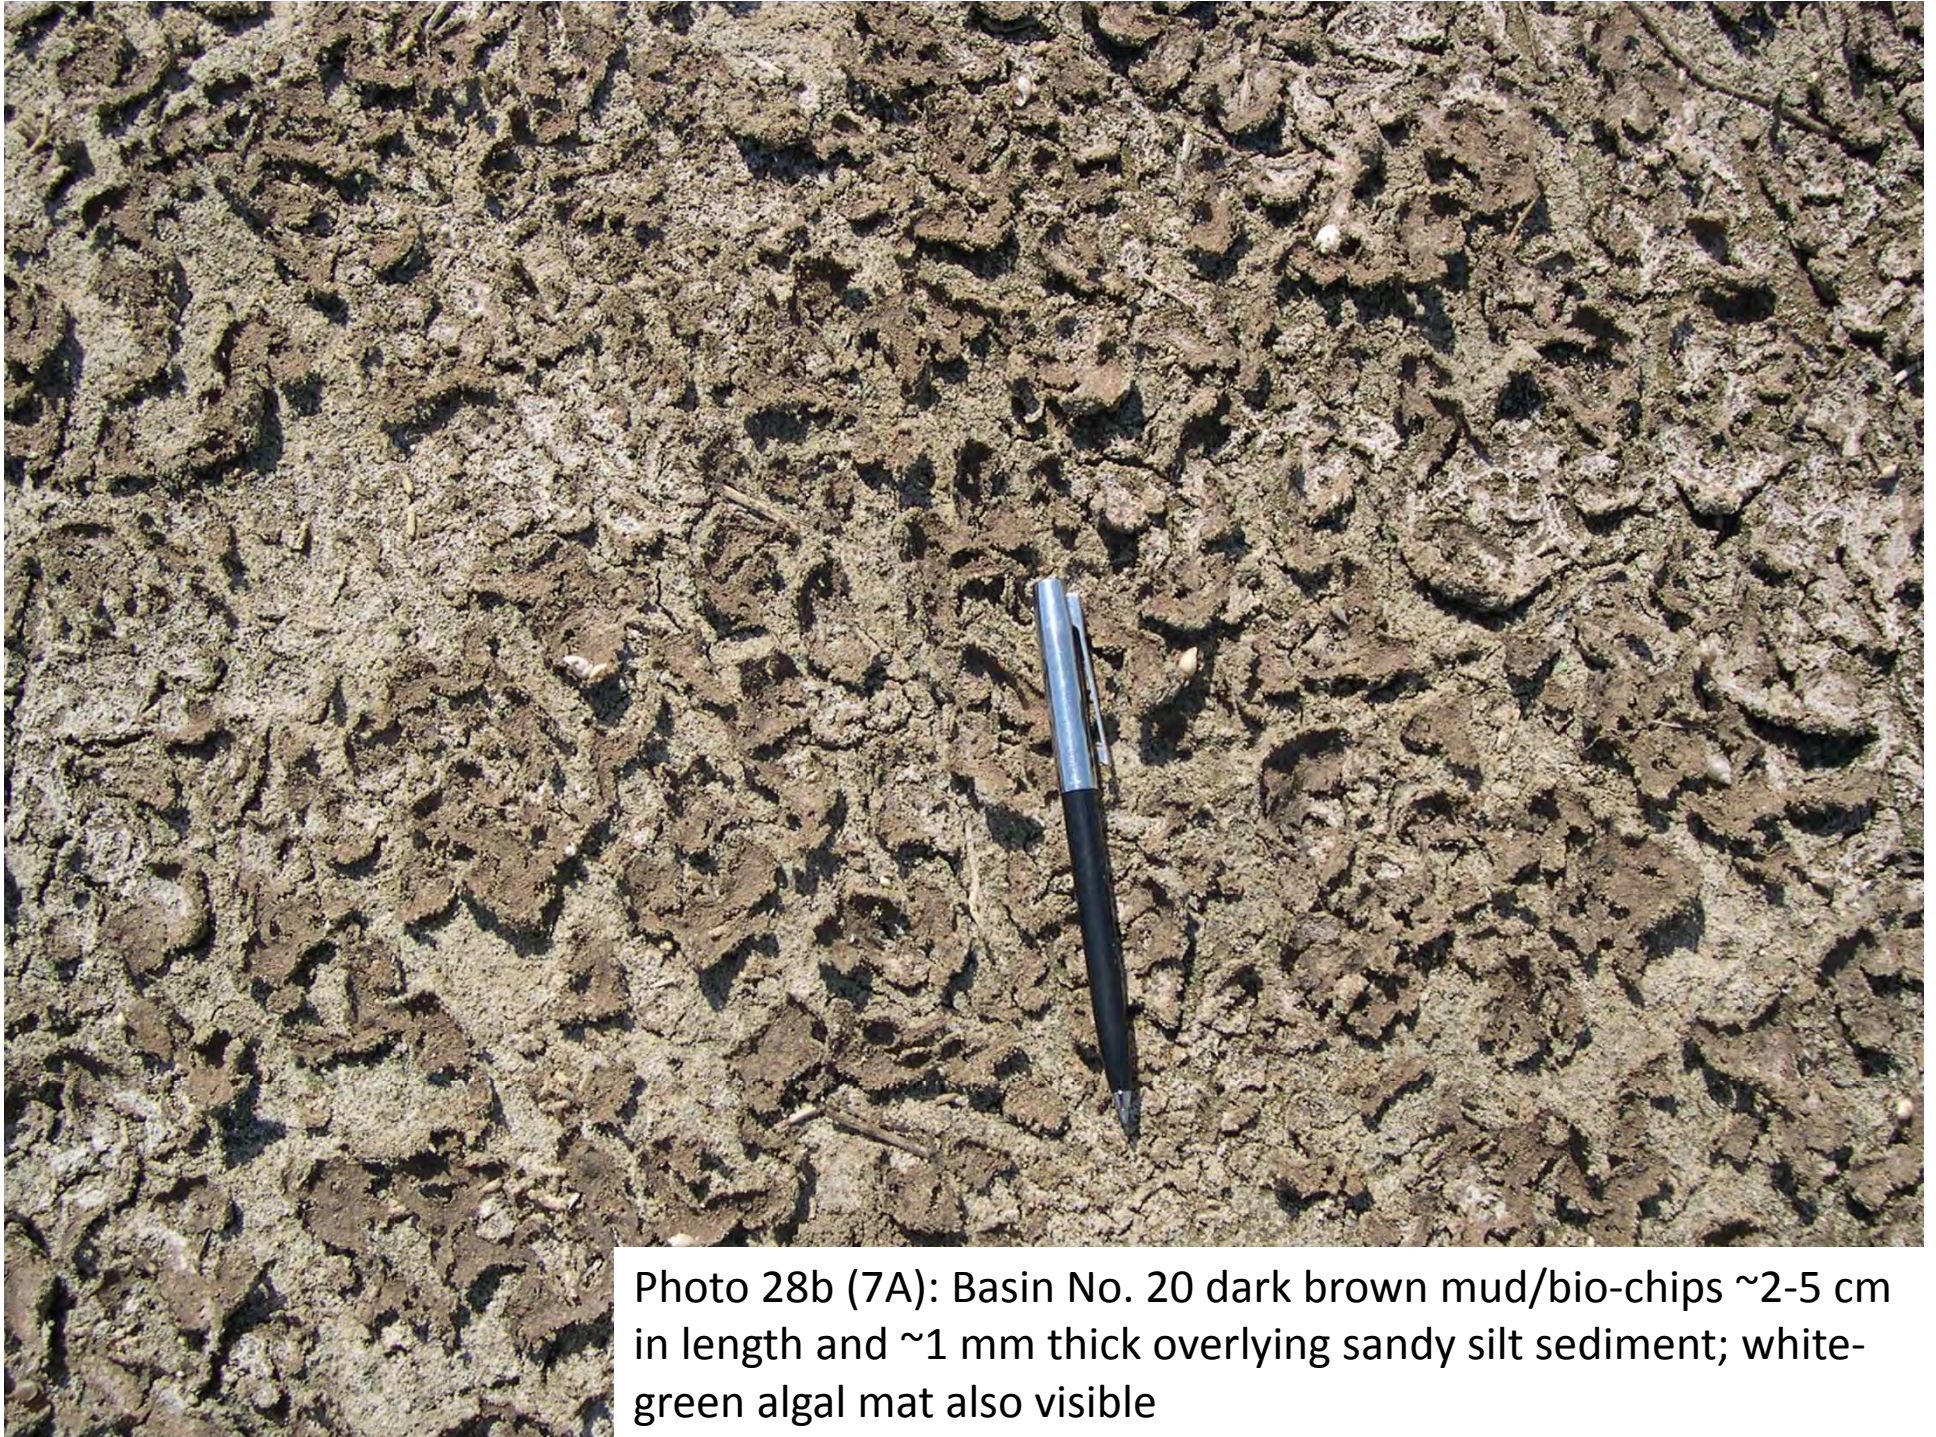
Photo 28b (7A): Basin No. 20 dark brown mud/bio-chips ~2-5 cm in length and ~1 mm thick overlying sandy silt sediment; white-green algal mat also visible
