October 11, 2011

Irvine Ranch Water District
Attention: Paul Weghorst
15600 Sand Canyon Avenue
Irvine, CA 92618

Subject: *Strand Ranch South Basin Field Reconnaissance and Remediation Recommendations*

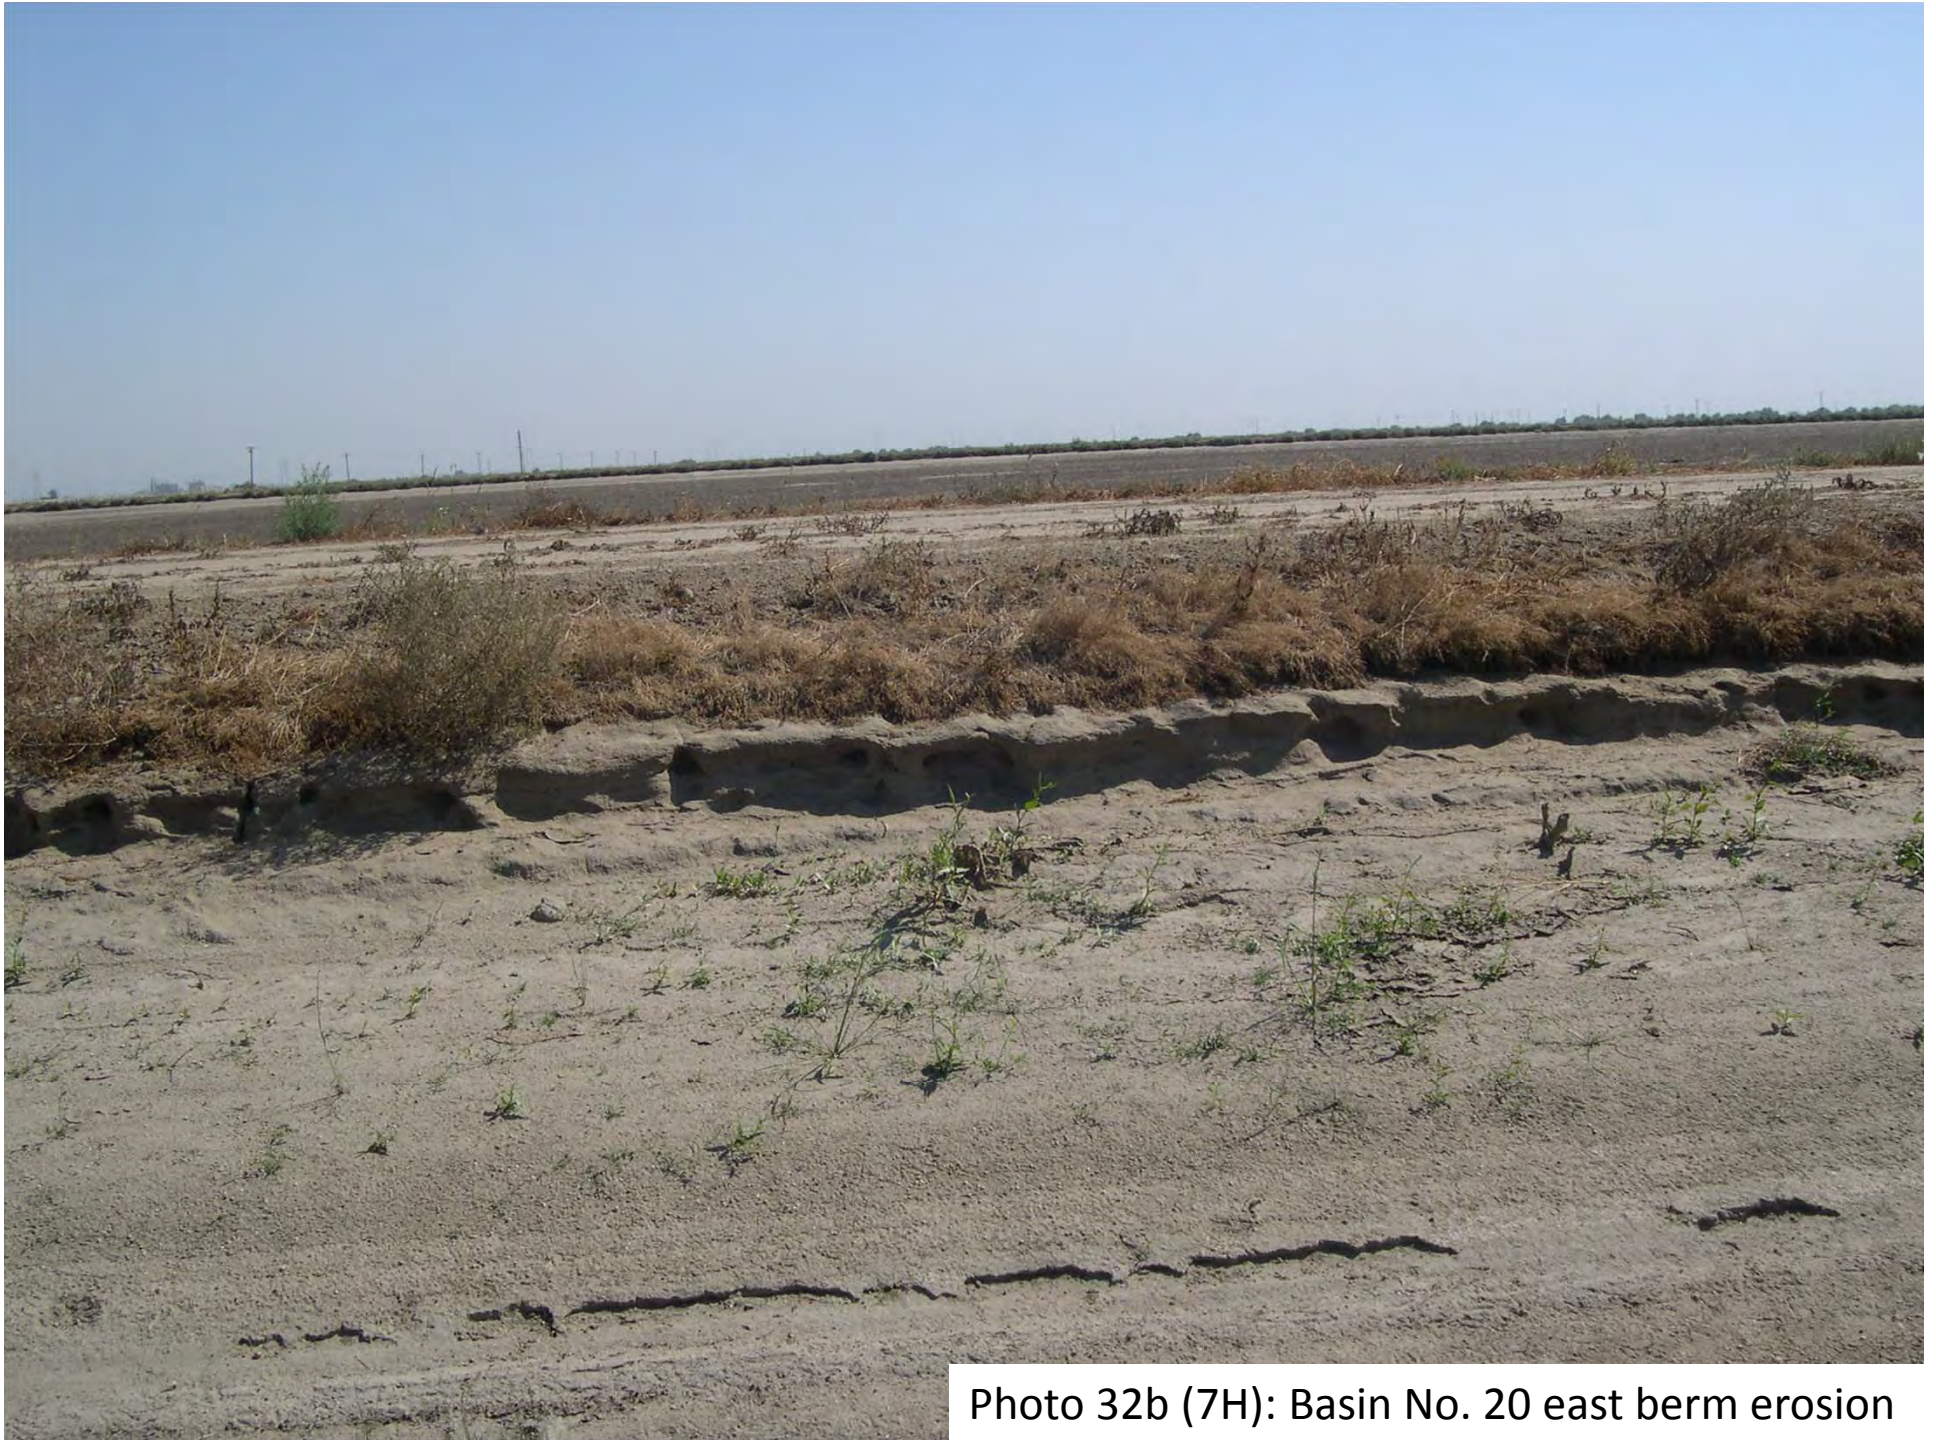
Photo 32b (7H): Basin No. 20 east berm erosion

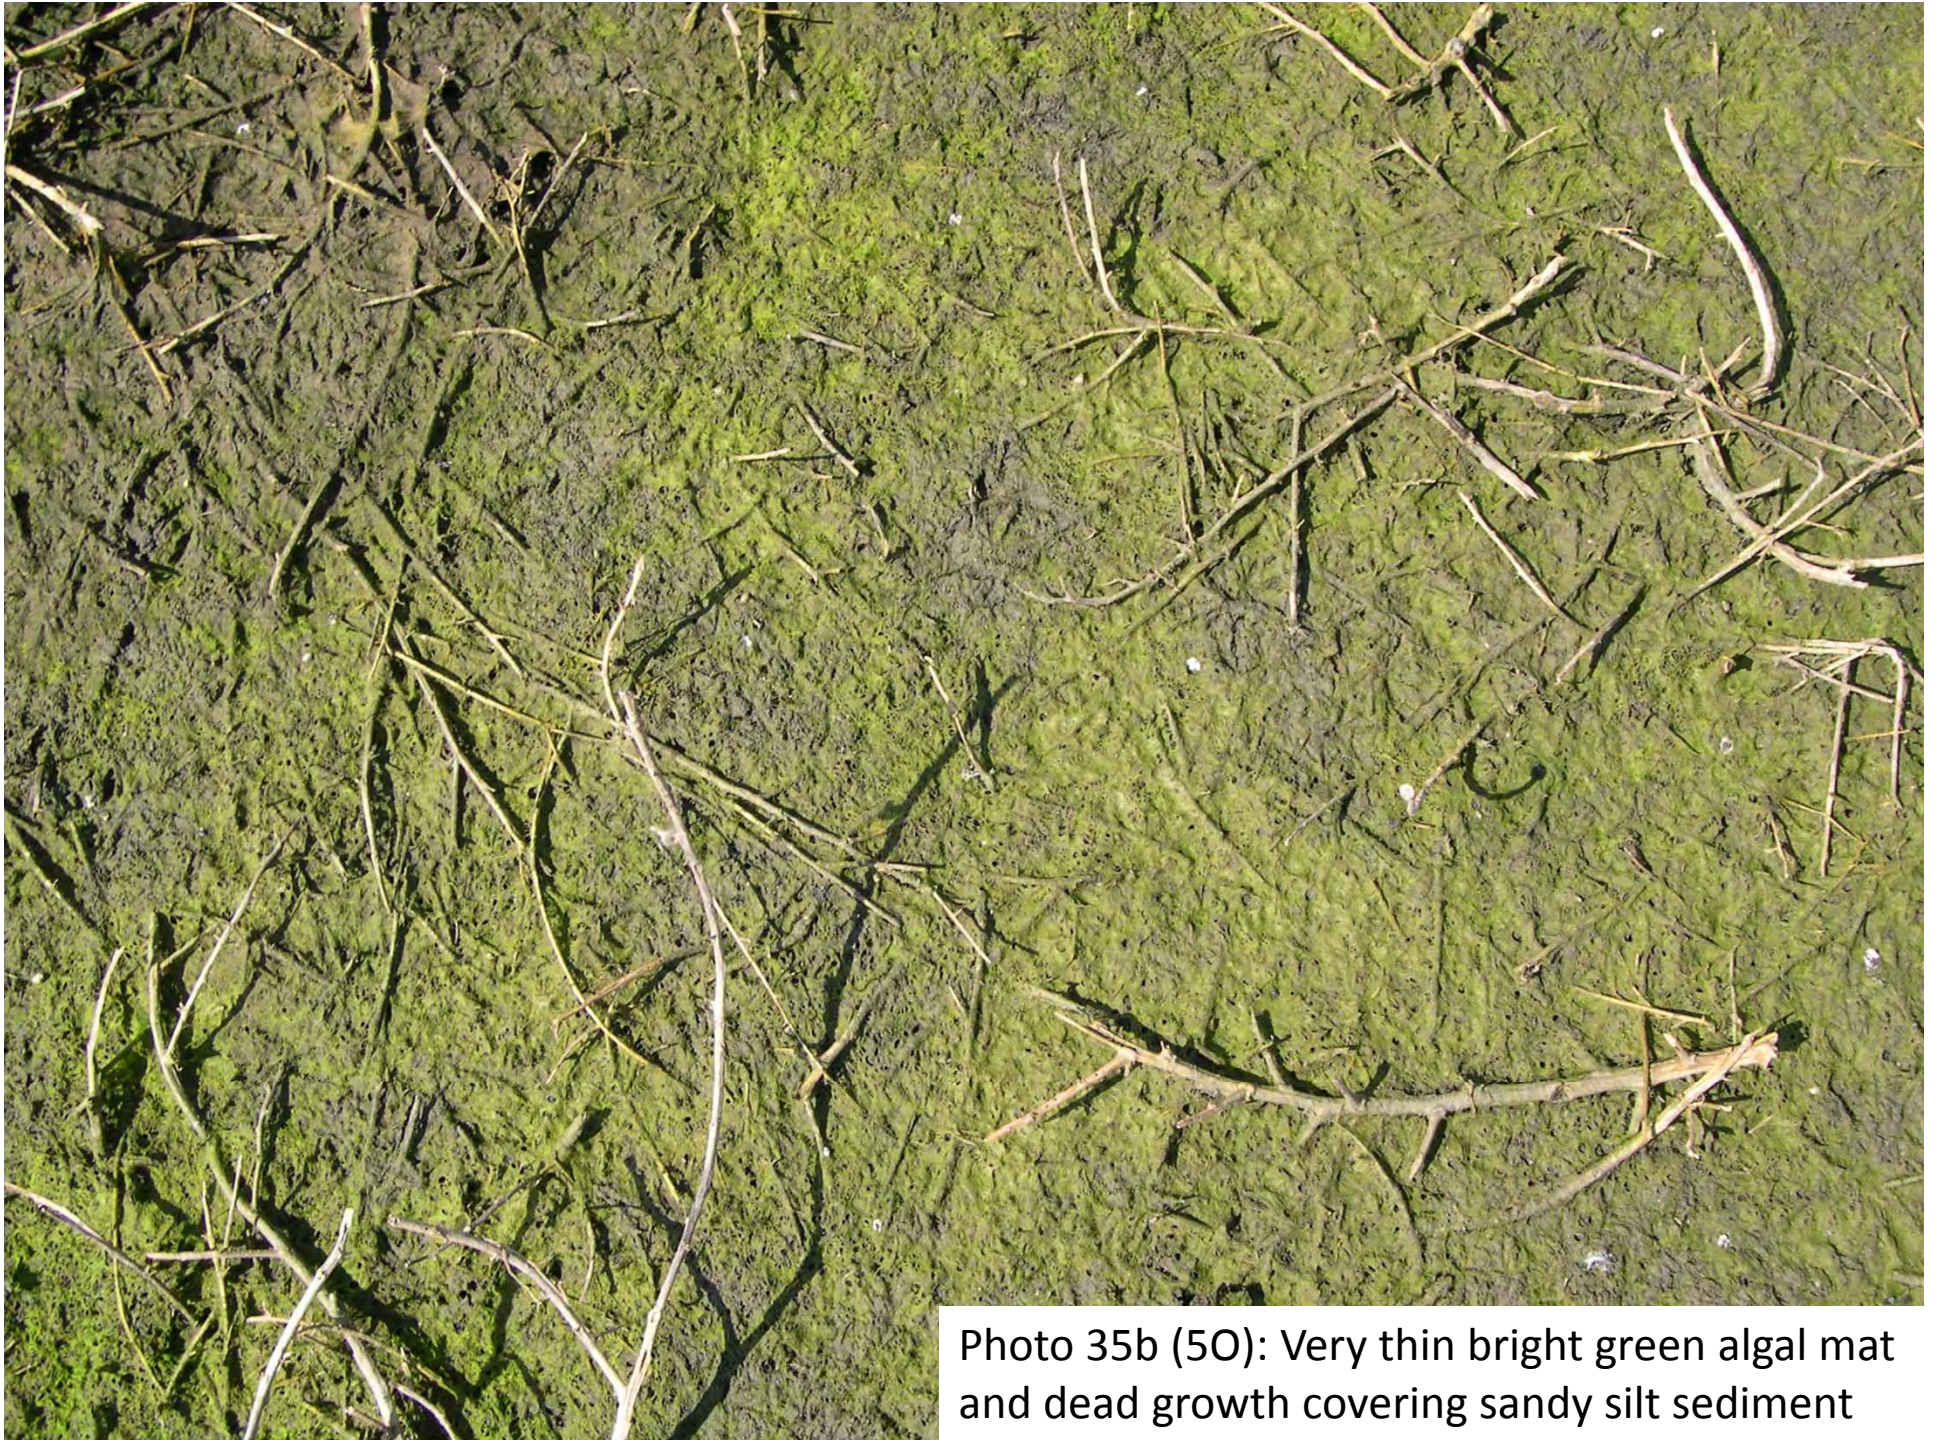
Photo 35b (50): Very thin bright green algal mat and dead growth covering sandy silt sediment

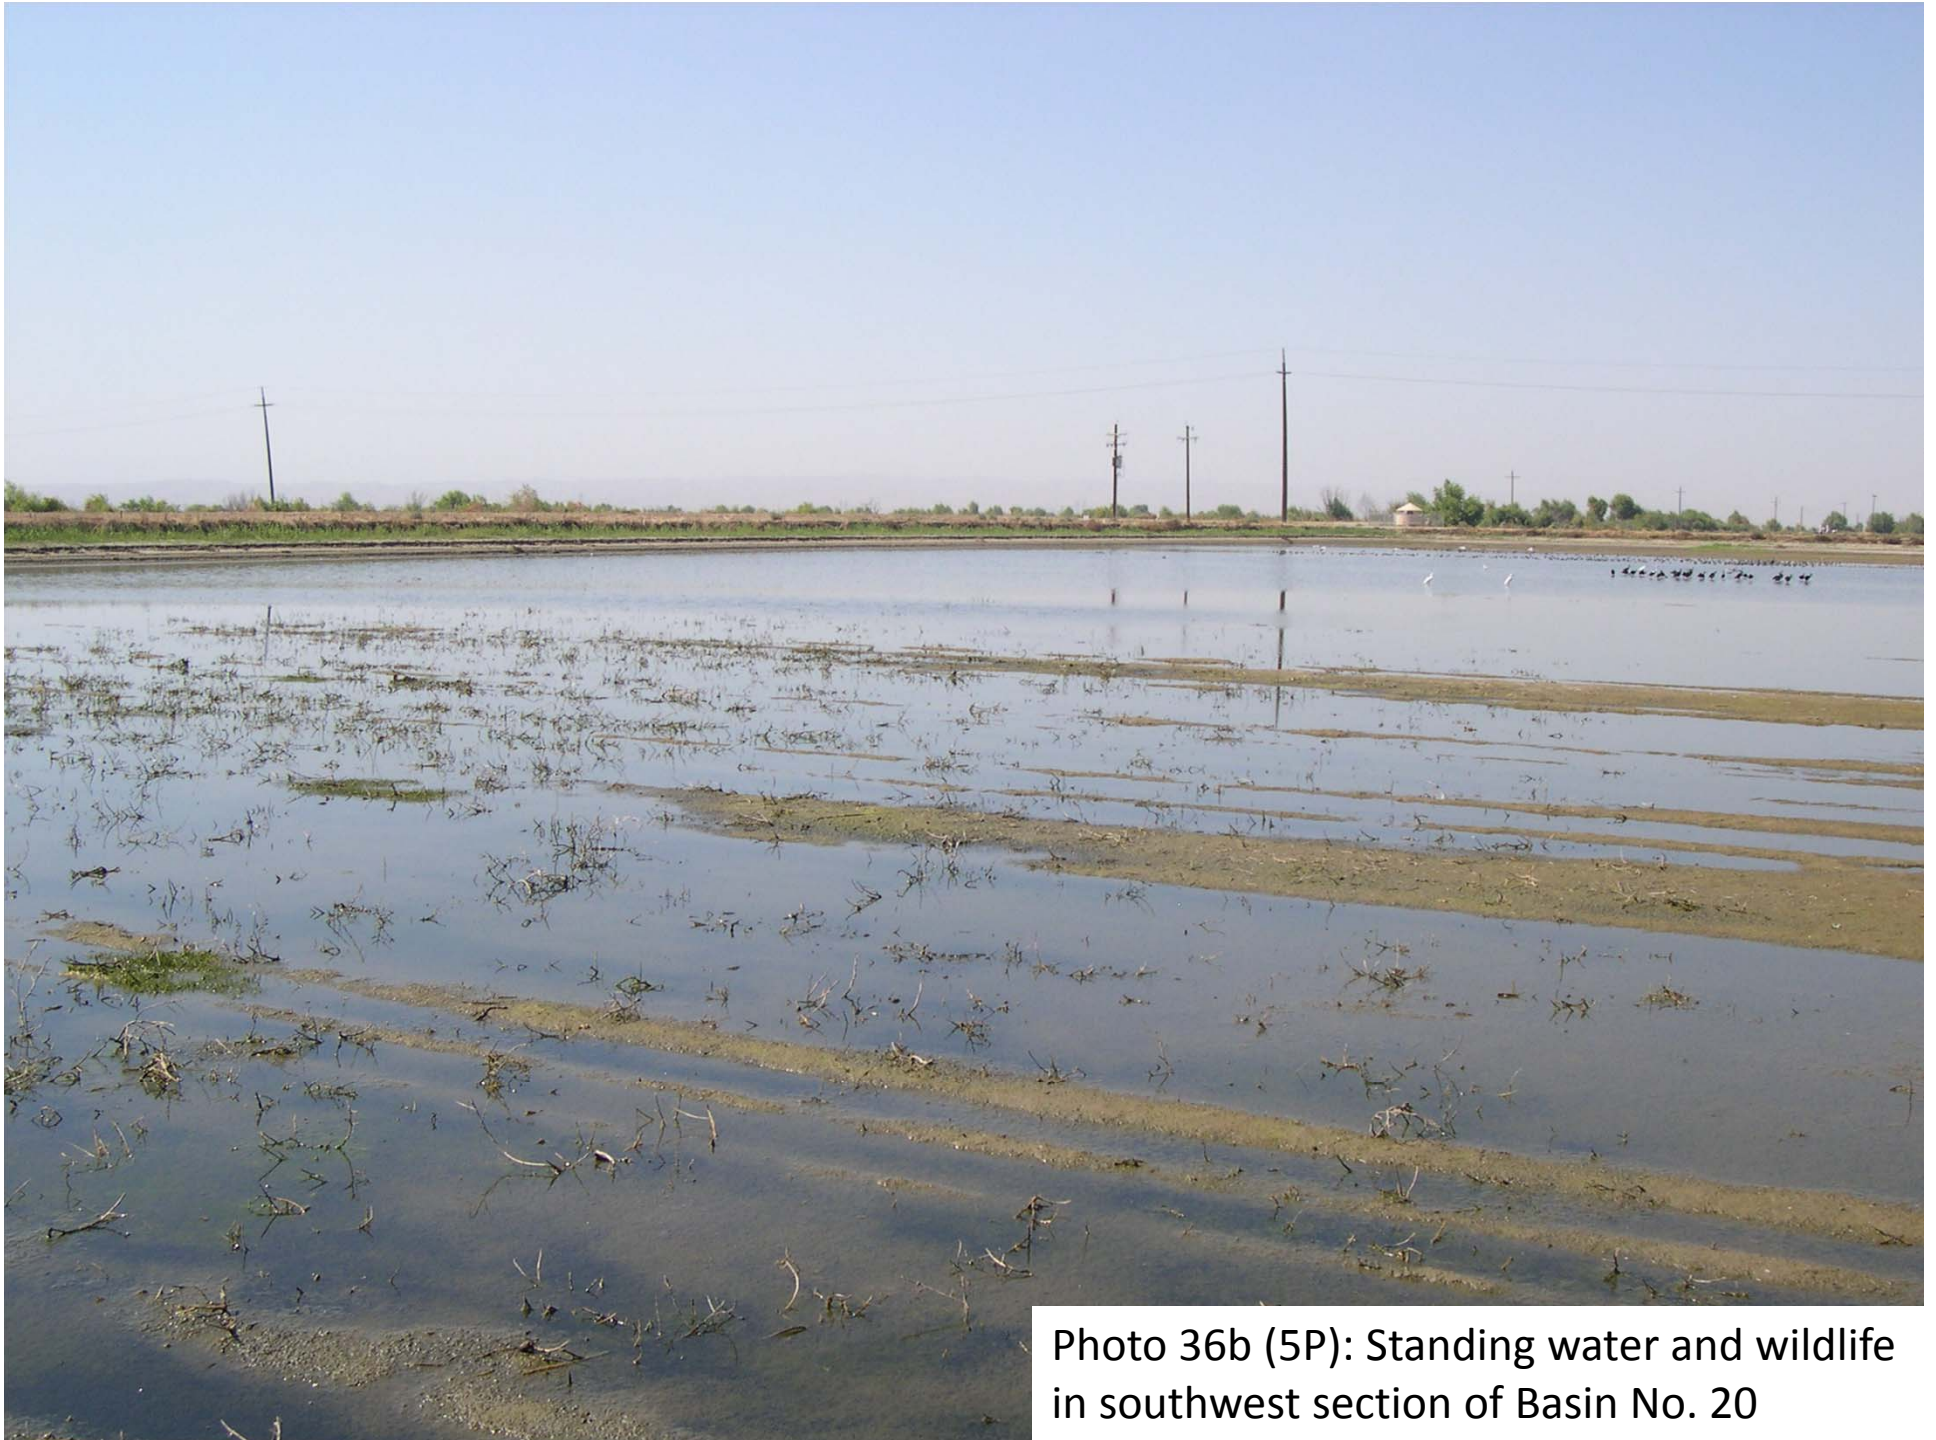
Photo 36b (5P): Standing water and wildlife in southwest section of Basin No. 20

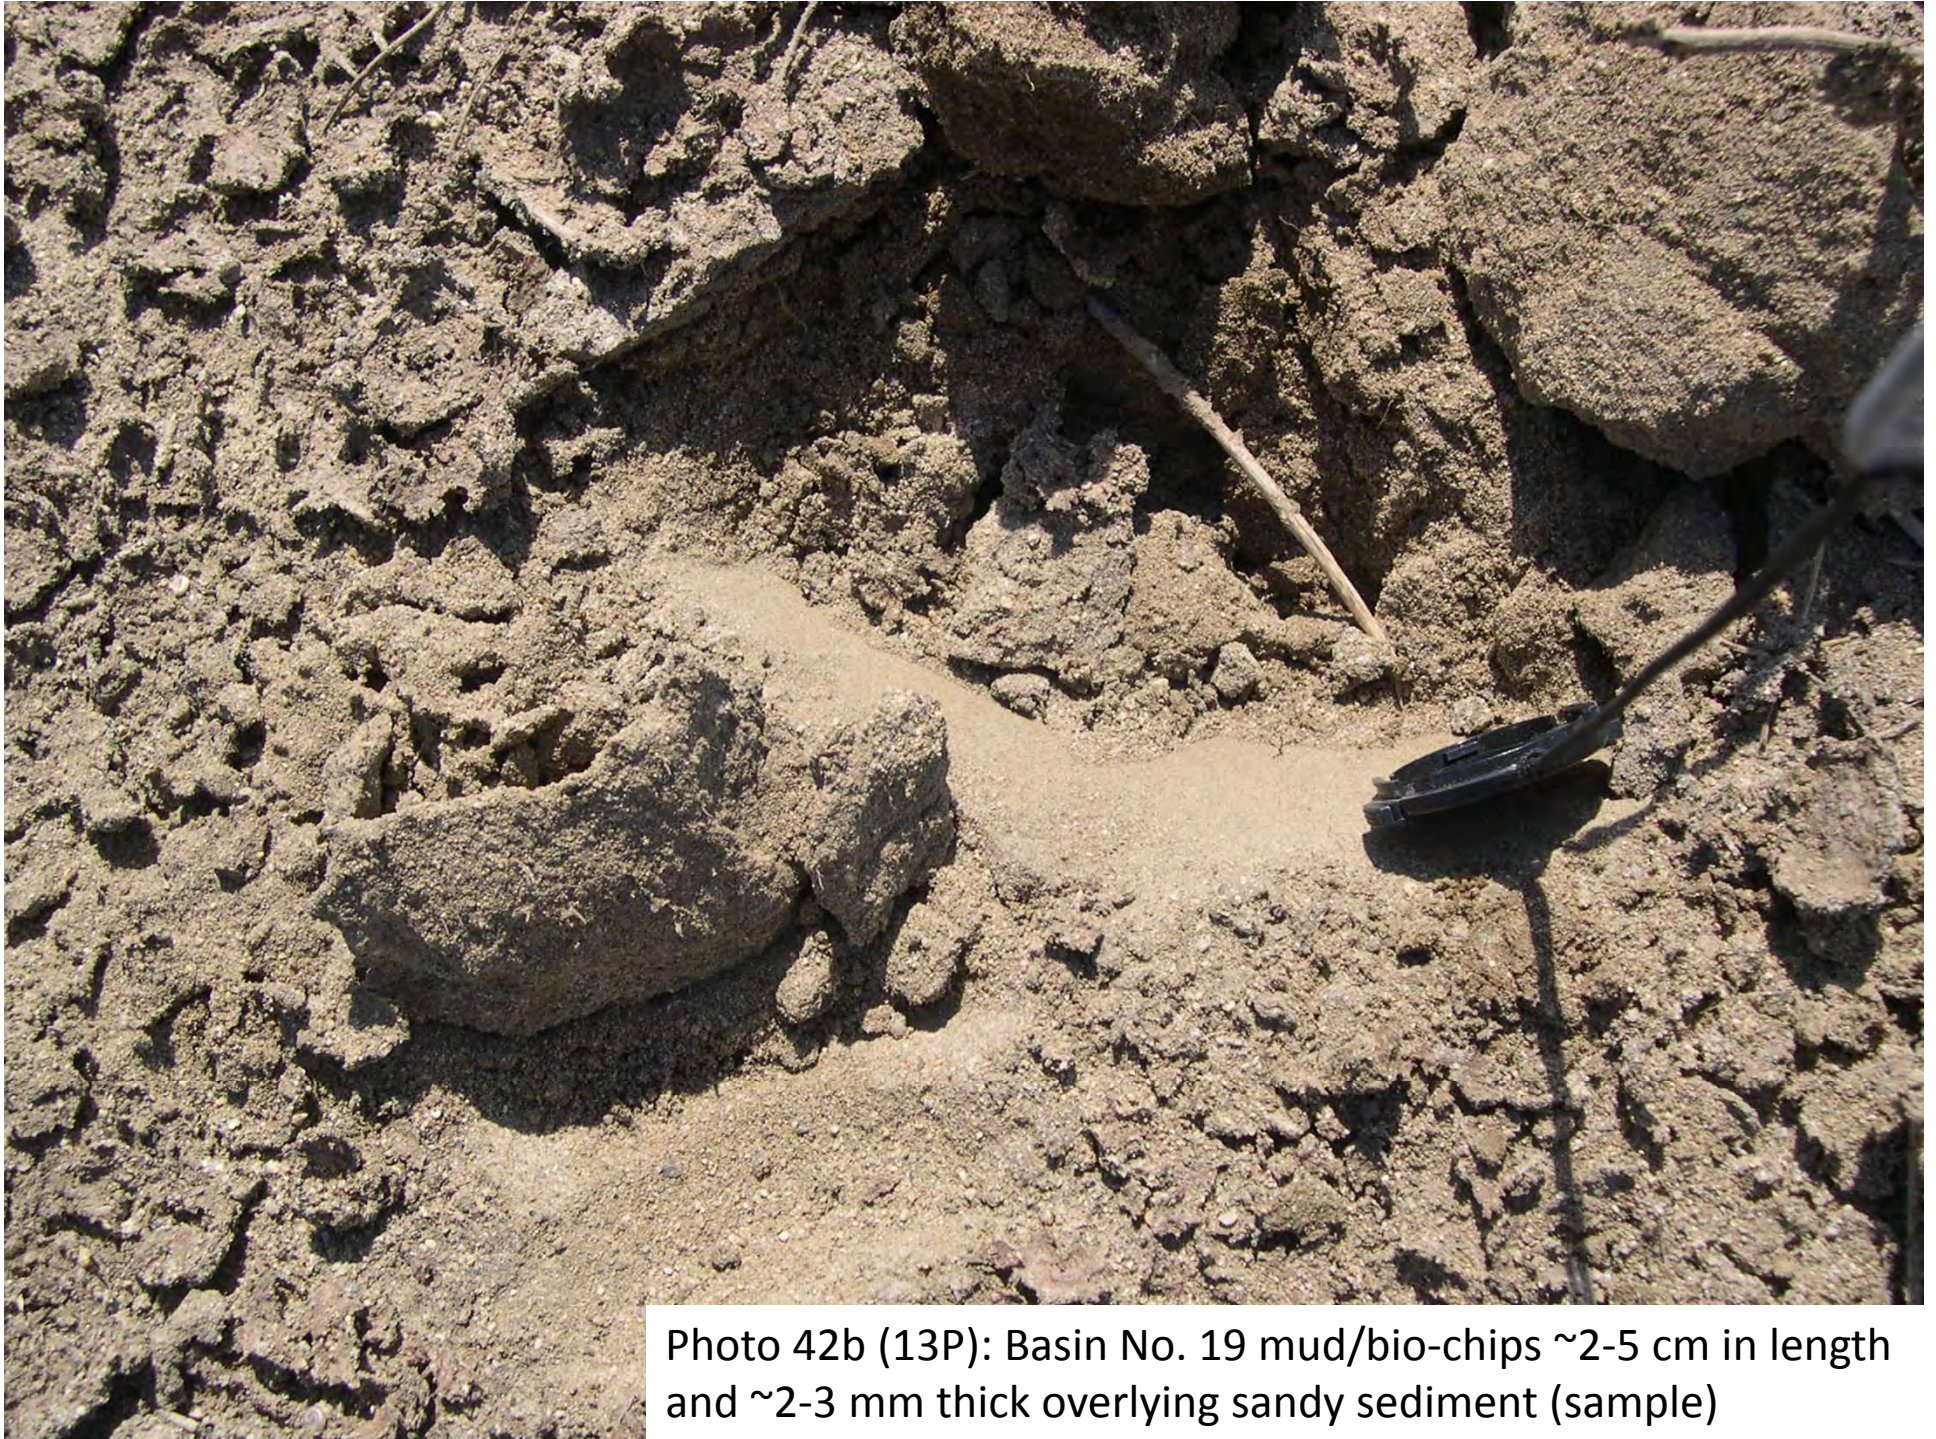
Photo 42b (13P): Basin No. 19 mud/bio-chips ~2-5 cm in length and ~2-3 mm thick overlying sandy sediment (sample)

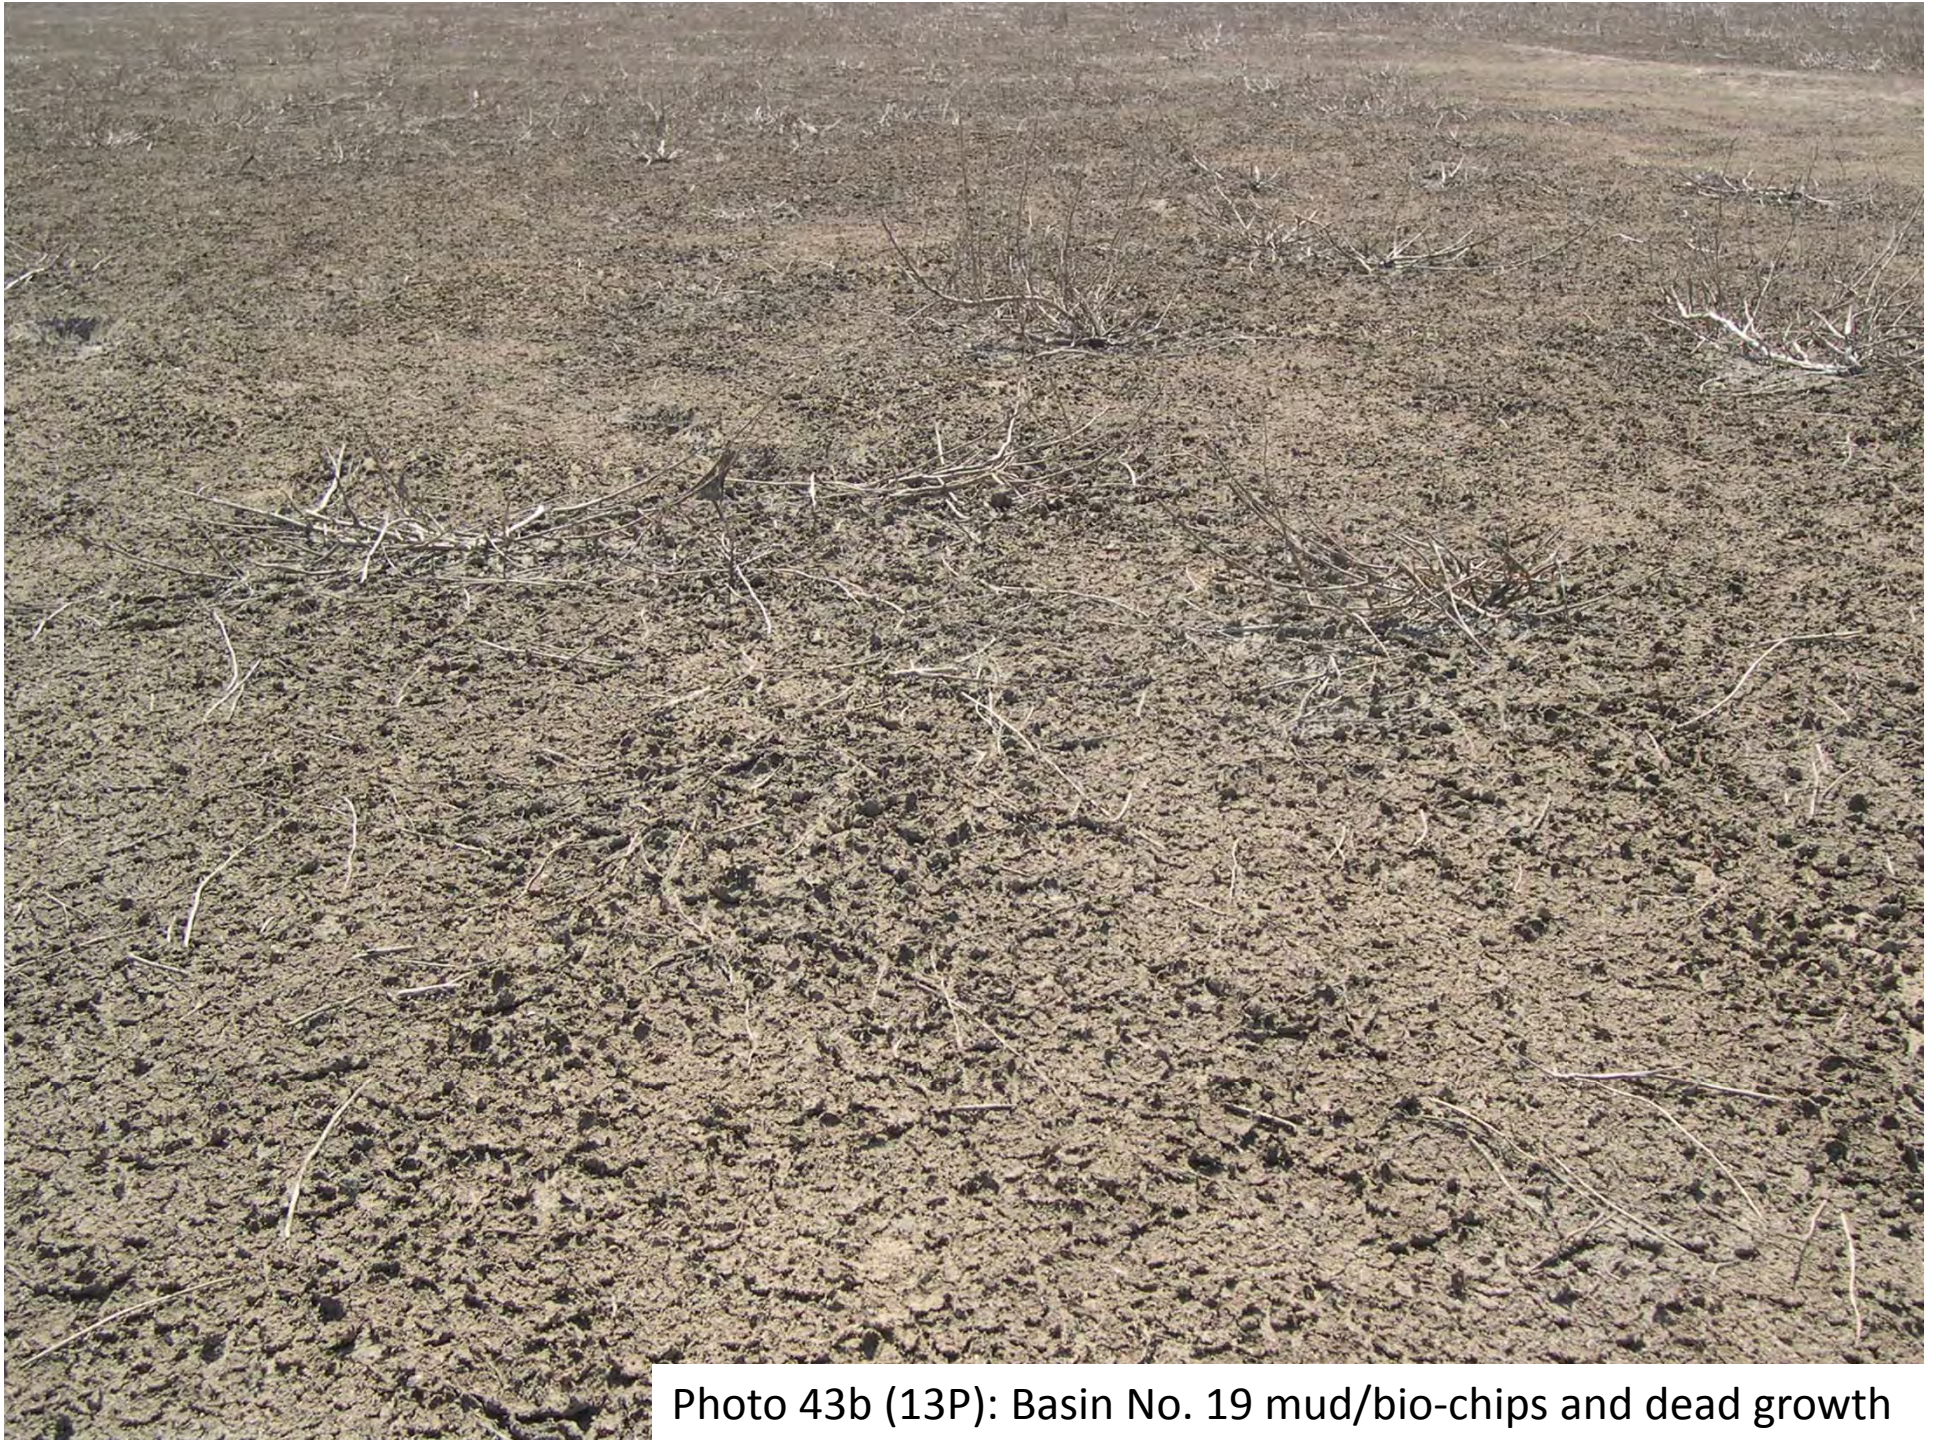
Photo 43b (13P): Basin No. 19 mud/bio-chips and dead growth

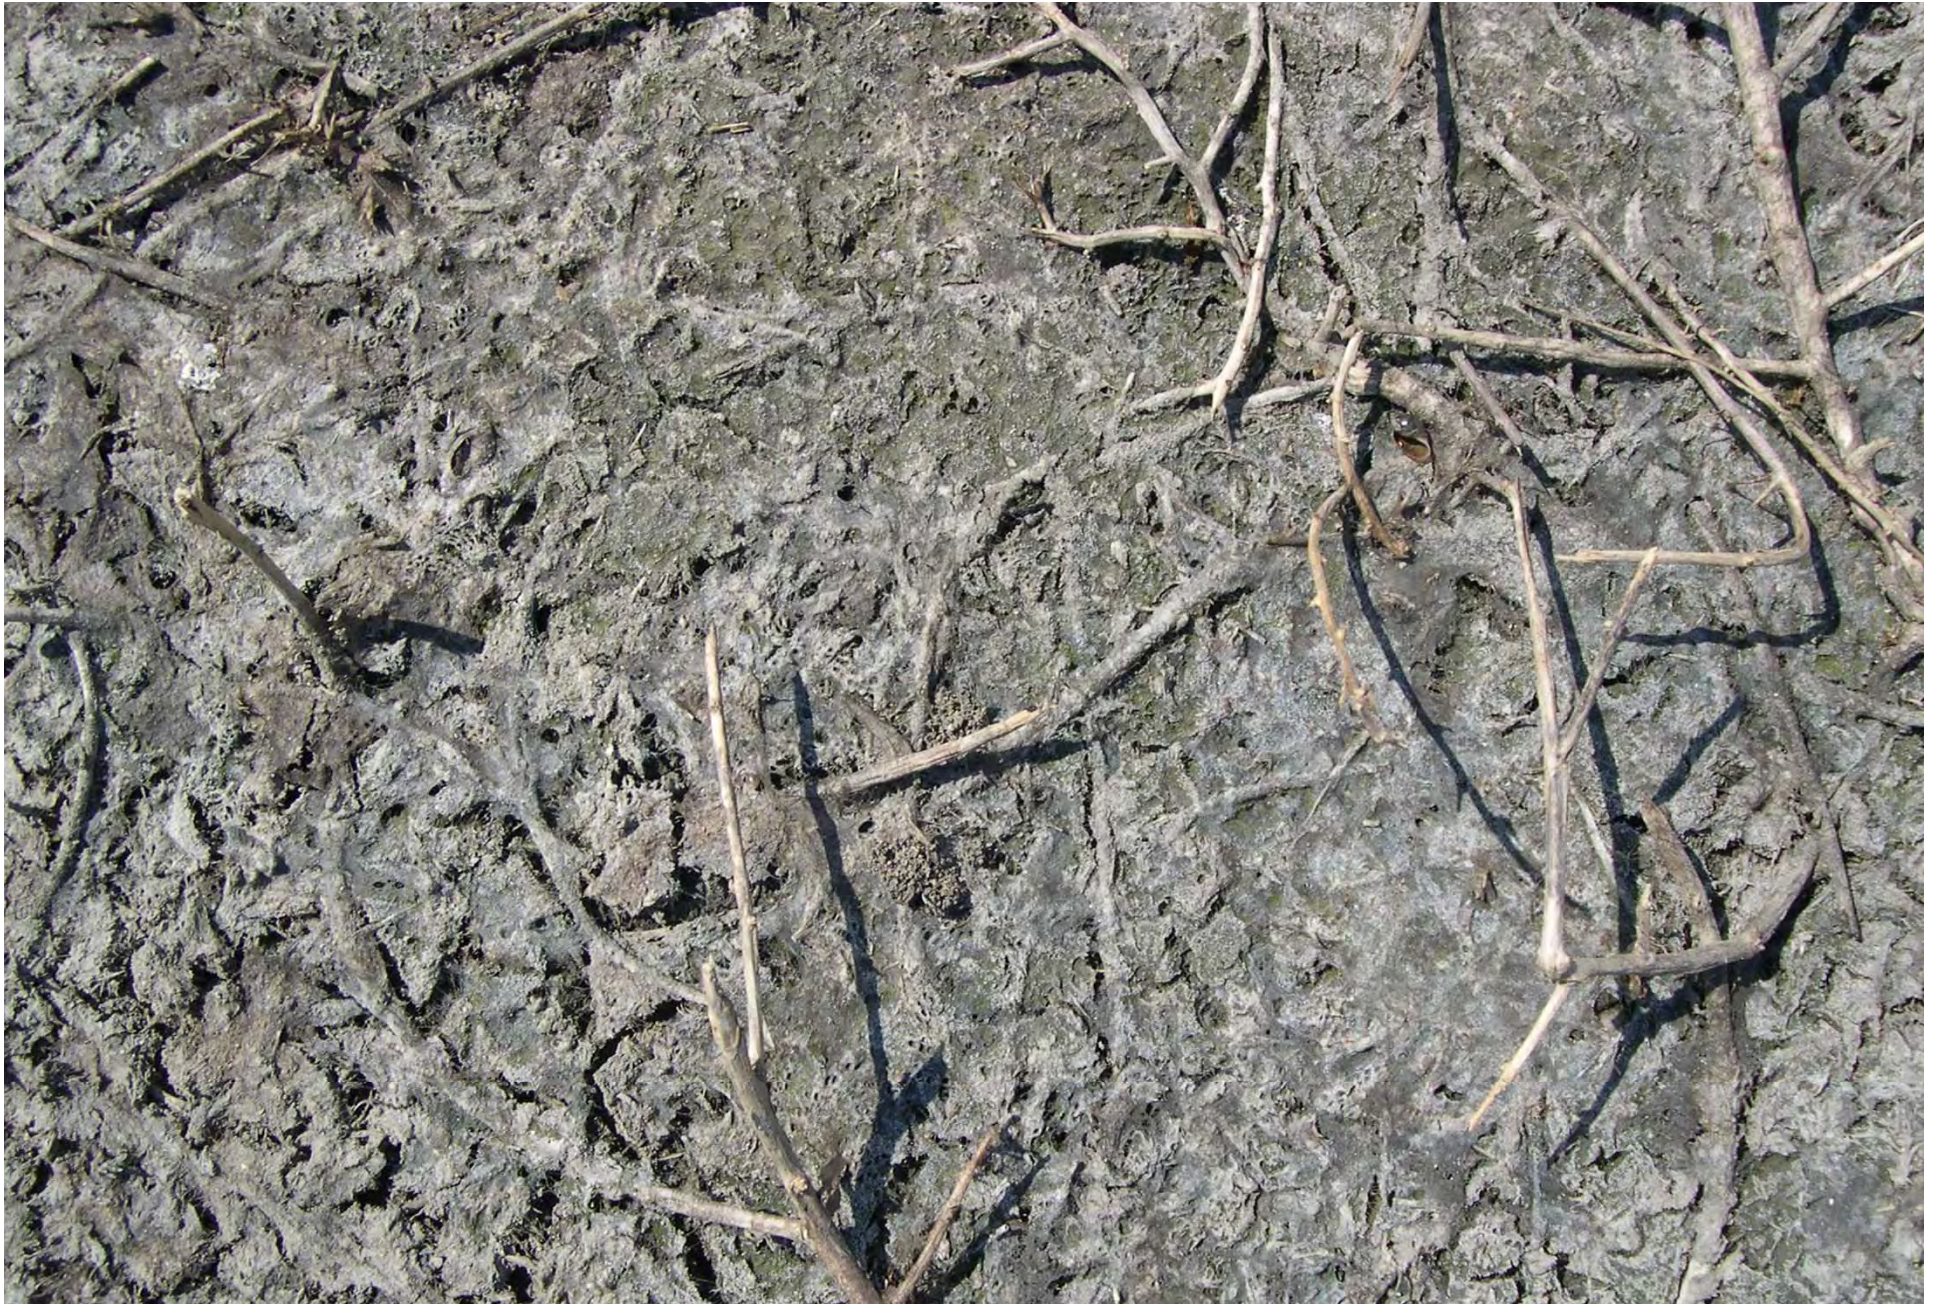
Photo 44b (14P): Basin No. 19 white-green biomass (algae) covers moist dark brown silt

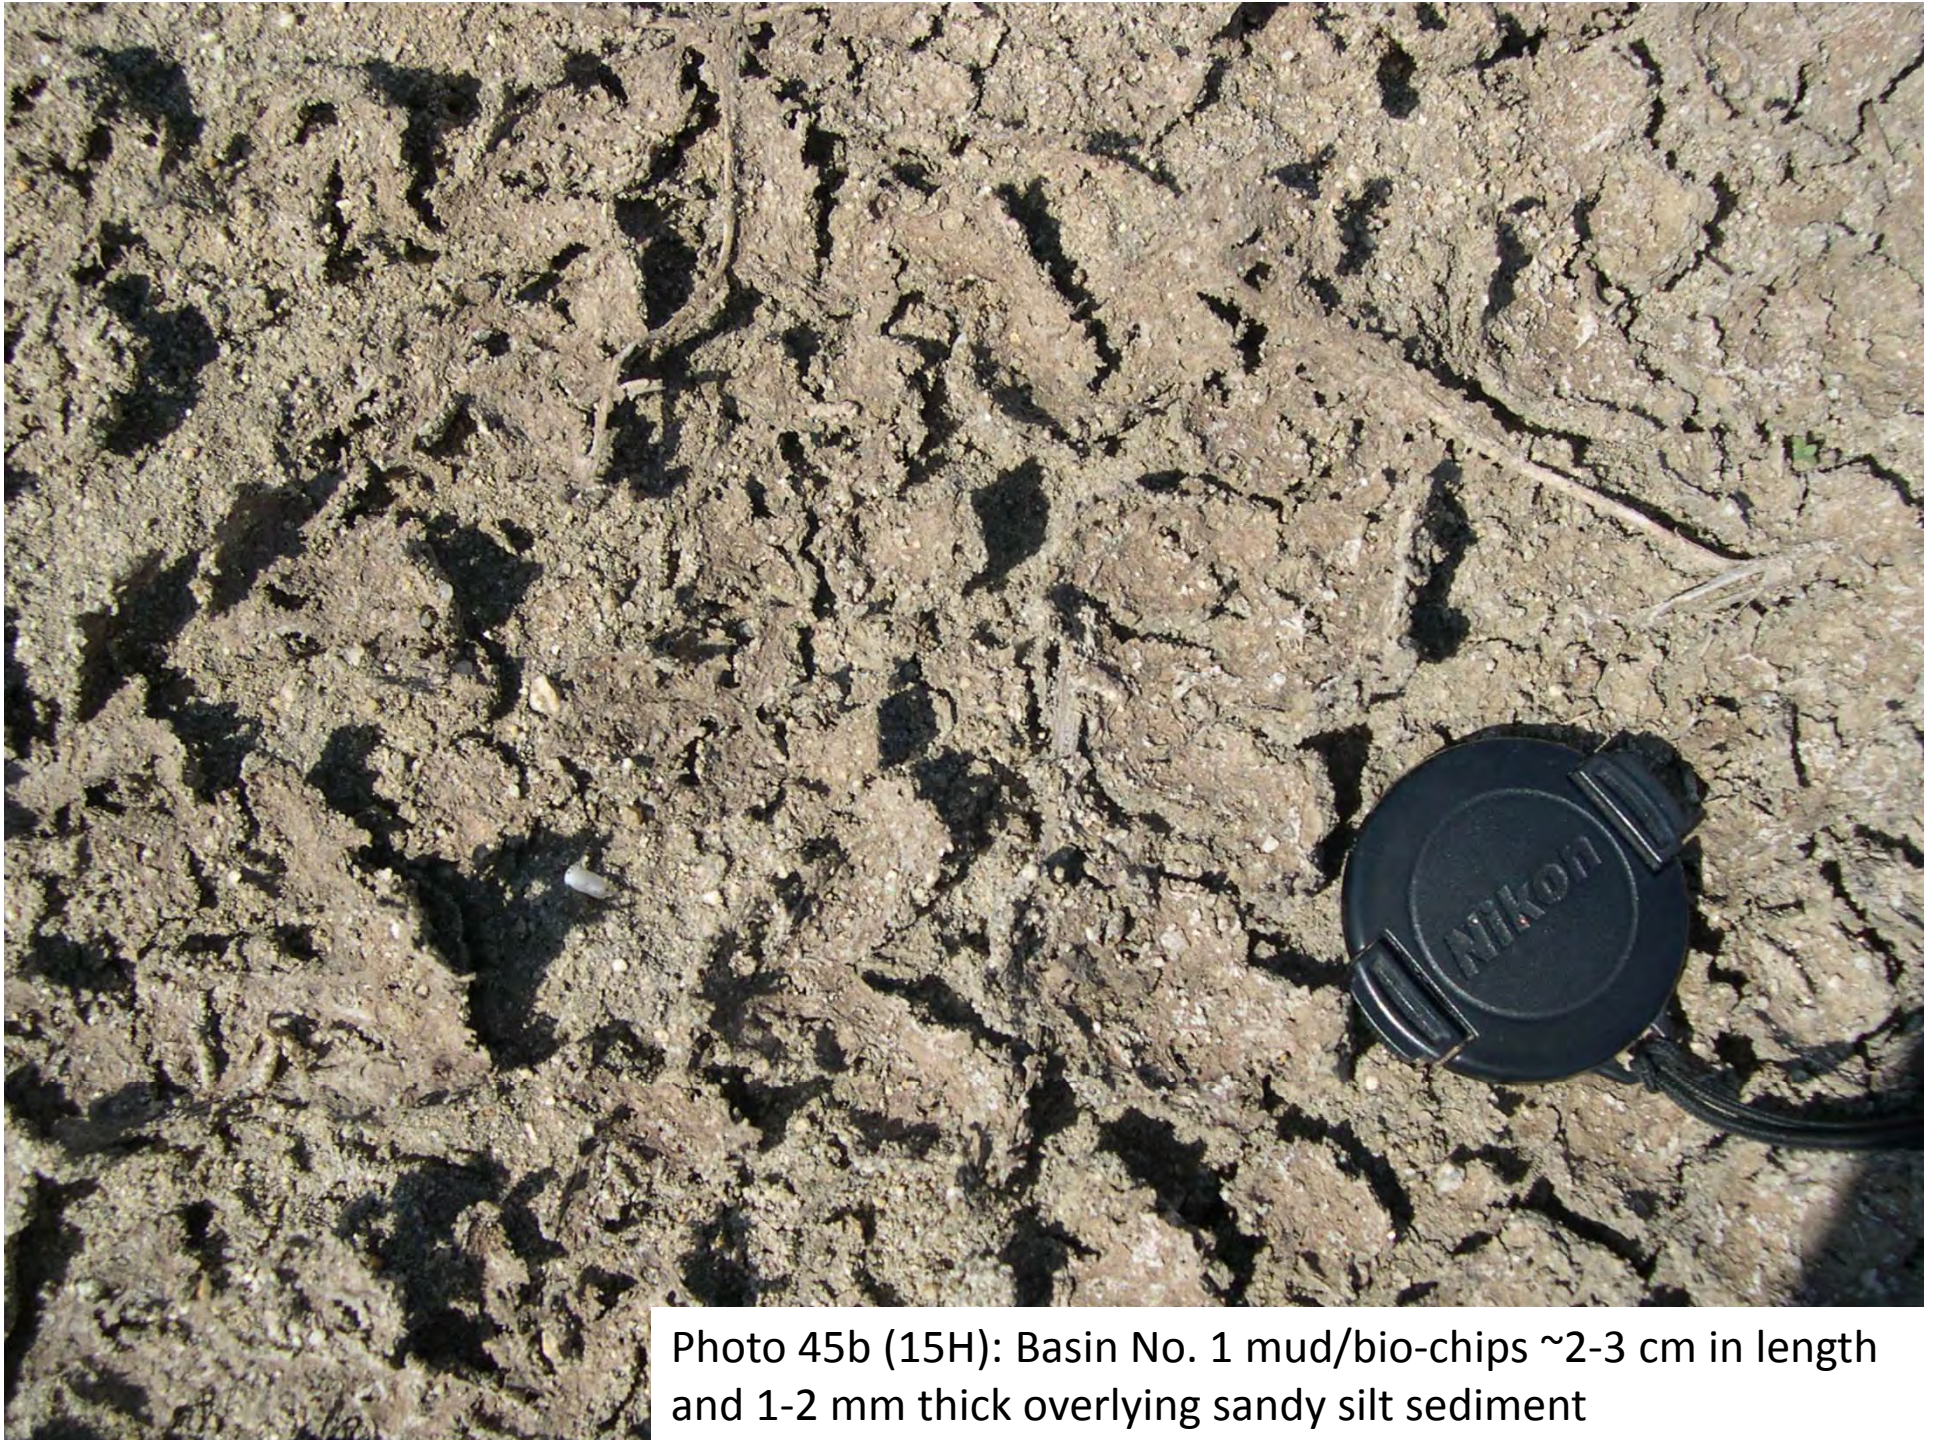
Photo 45b (15H): Basin No. 1 mud/bio-chips ~2-3 cm in length and 1-2 mm thick overlying sandy silt sediment

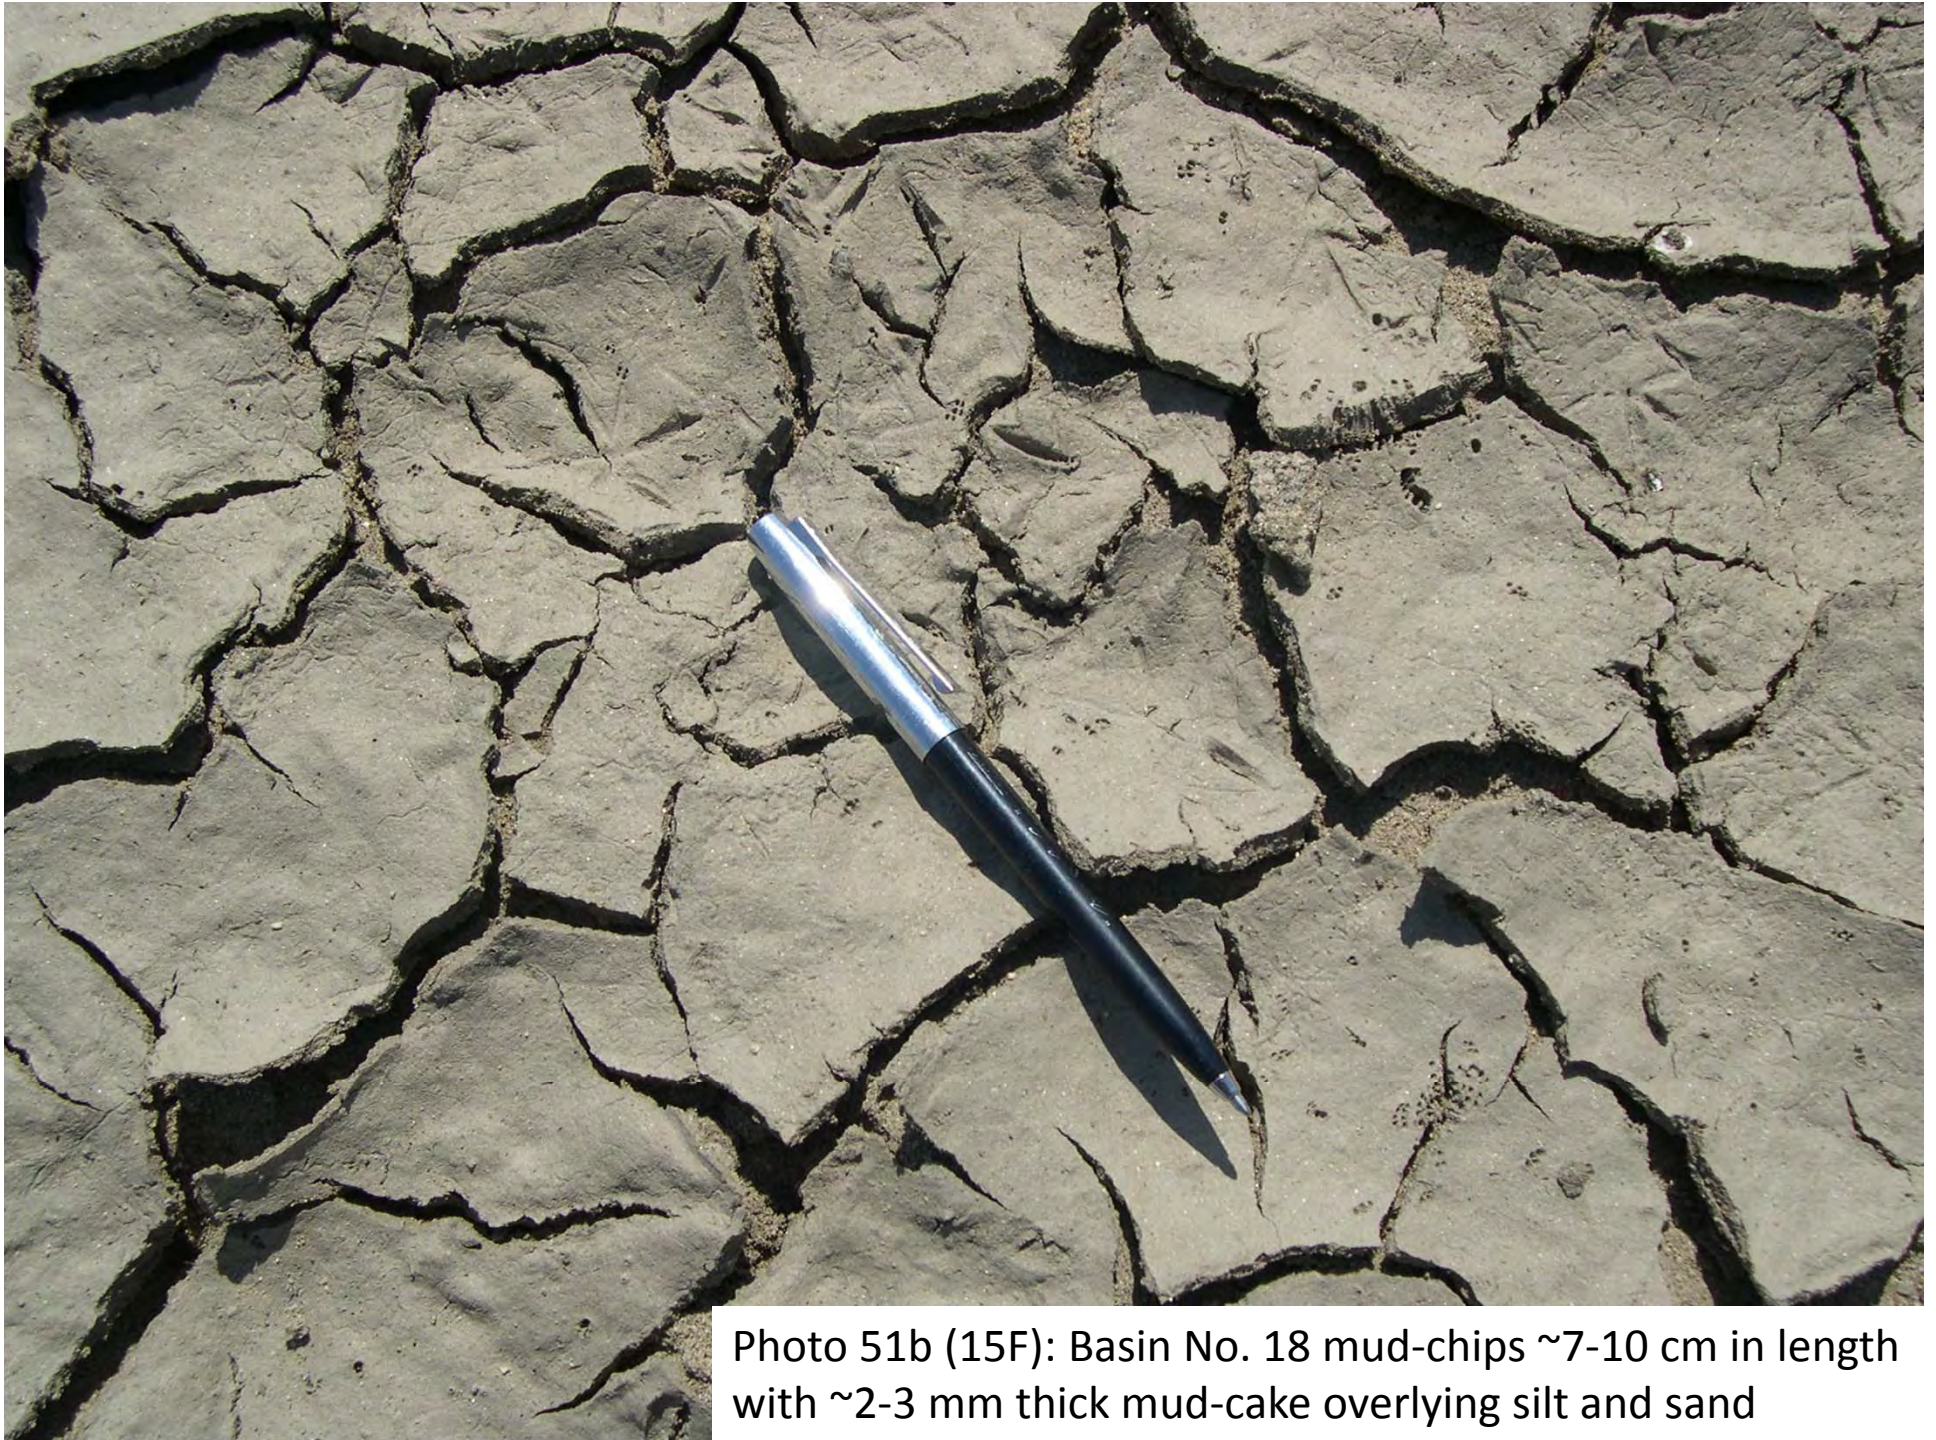
Photo 51b (15F): Basin No. 18 mud-chips ~7-10 cm in length with ~2-3 mm thick mud-cake overlying silt and sand
