October 11, 2011

Irvine Ranch Water District
Attention: Paul Weghorst
15600 Sand Canyon Avenue
Irvine, CA 92618

Subject: *Strand Ranch South Basin Field Reconnaissance and Remediation Recommendations*

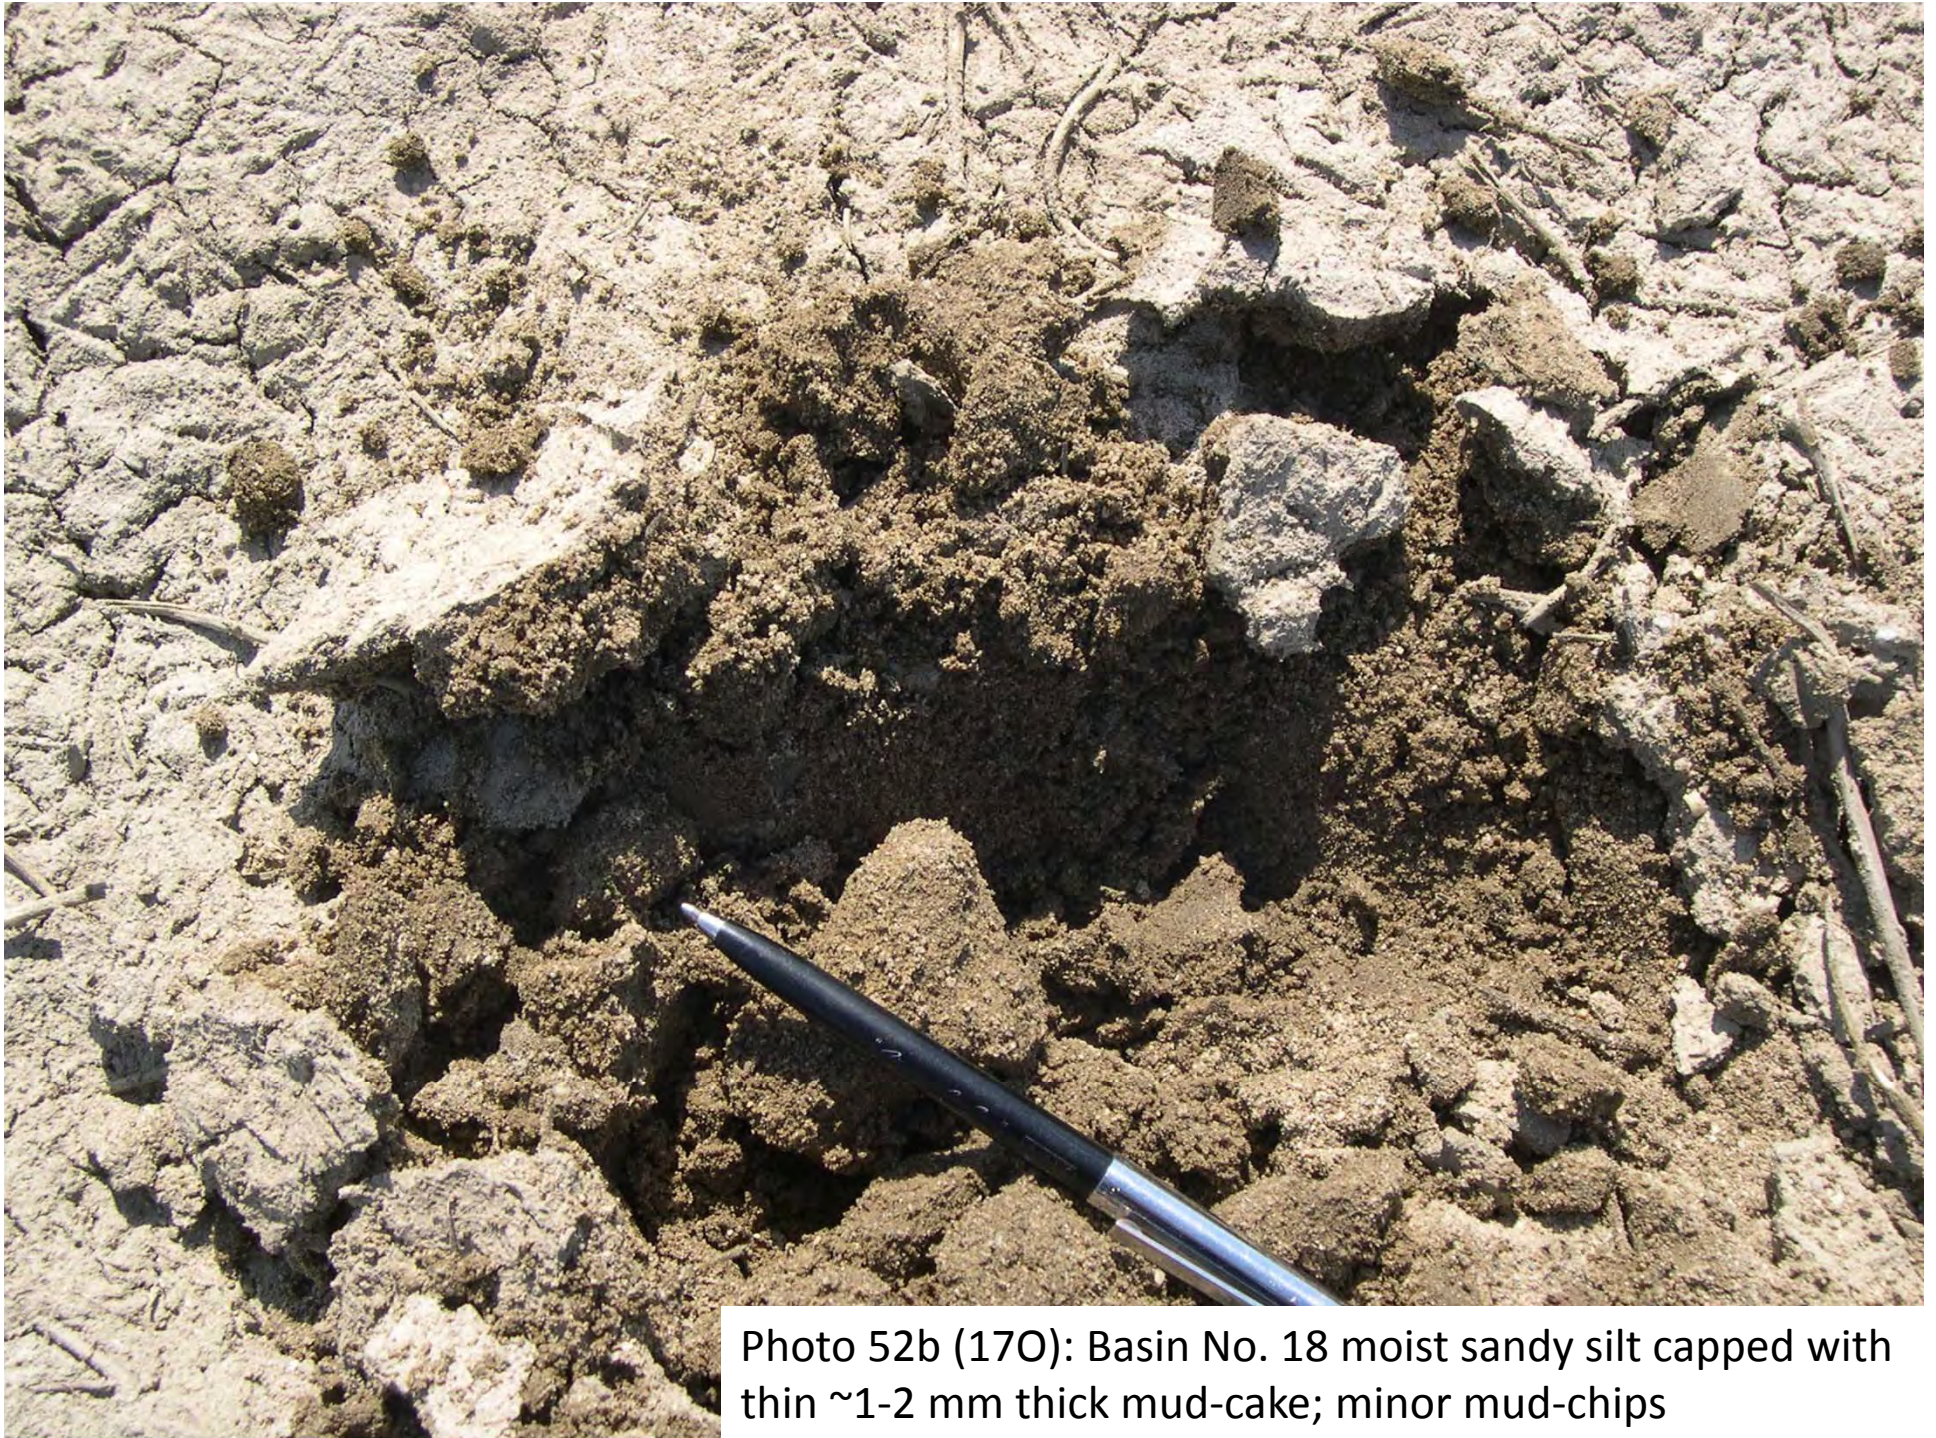
Photo 52b (170): Basin No. 18 moist sandy silt capped with thin ~1-2 mm thick mud-cake; minor mud-chips

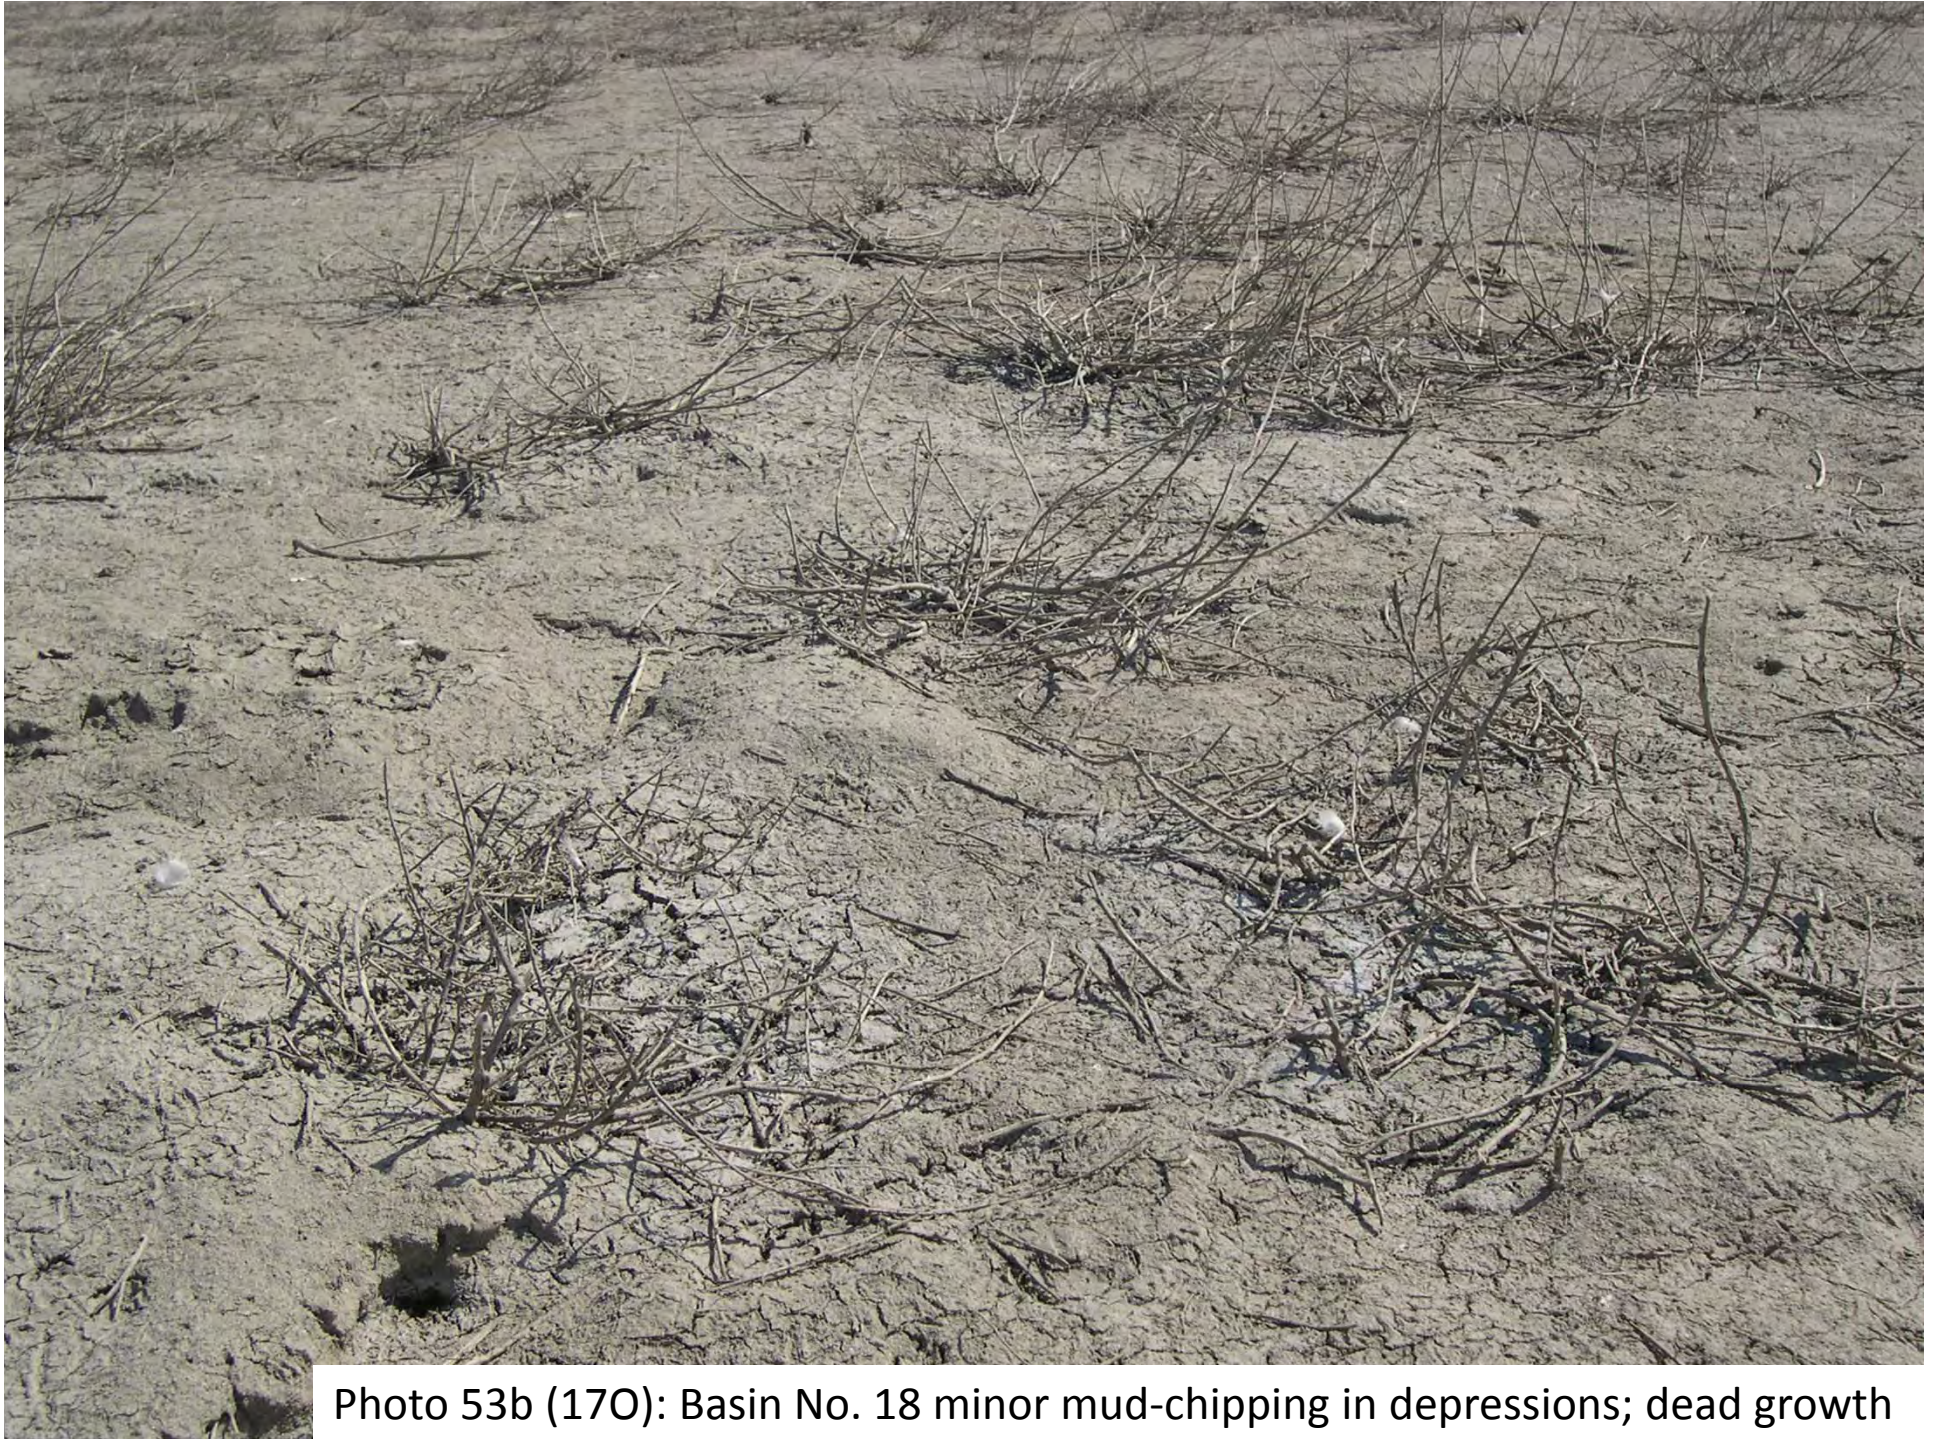
Photo 53b (170): Basin No. 18 minor mud-chipping in depressions; dead growth

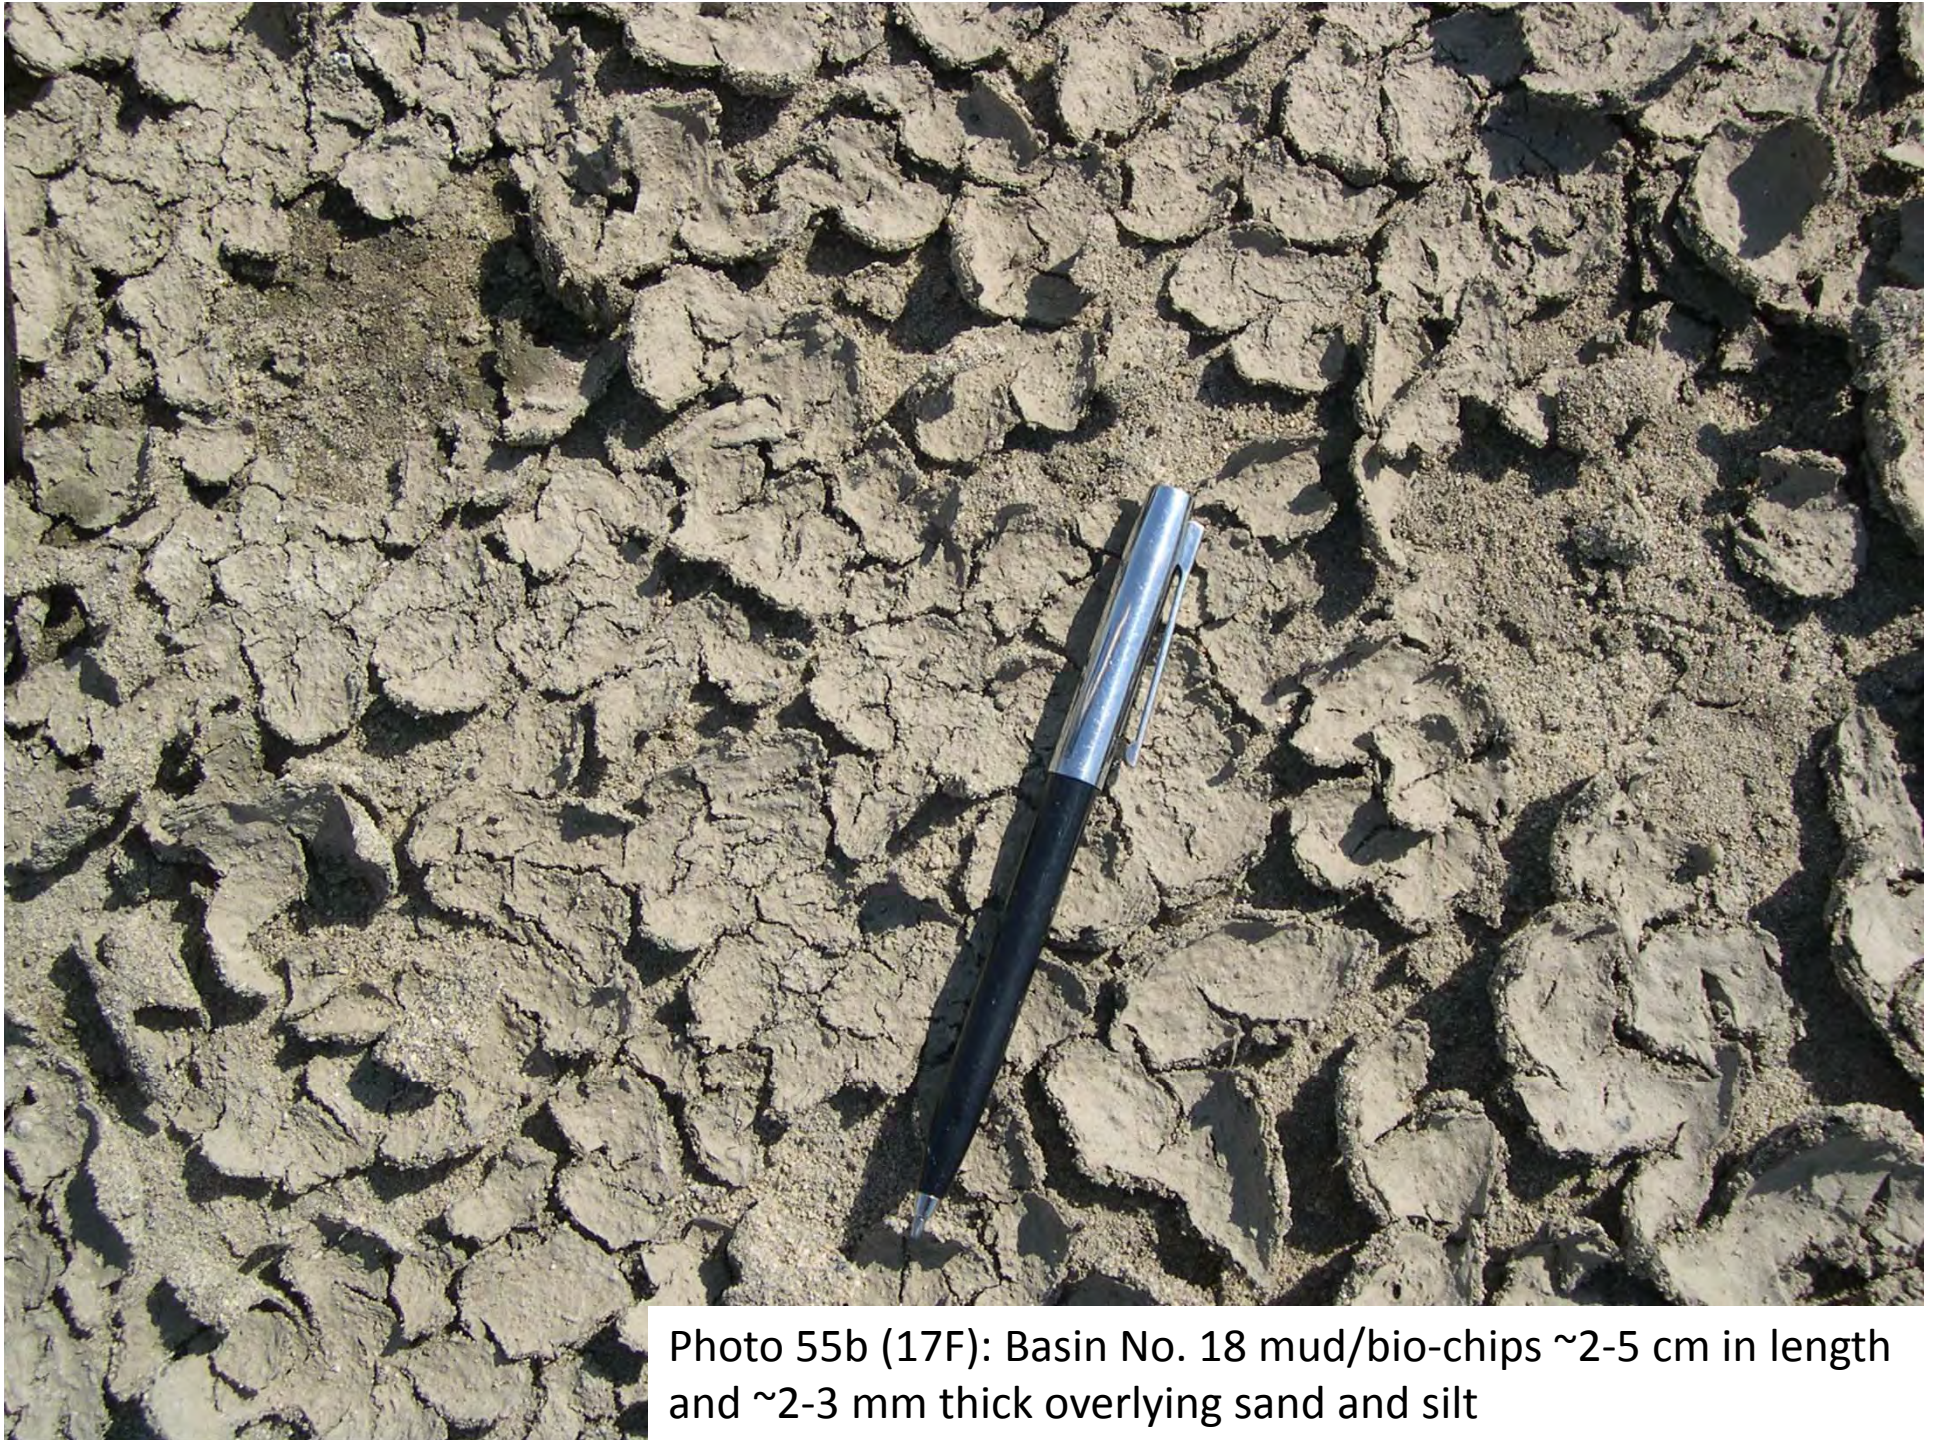
Photo 55b (17F): Basin No. 18 mud/bio-chips ~2-5 cm in length and ~2-3 mm thick overlying sand and silt

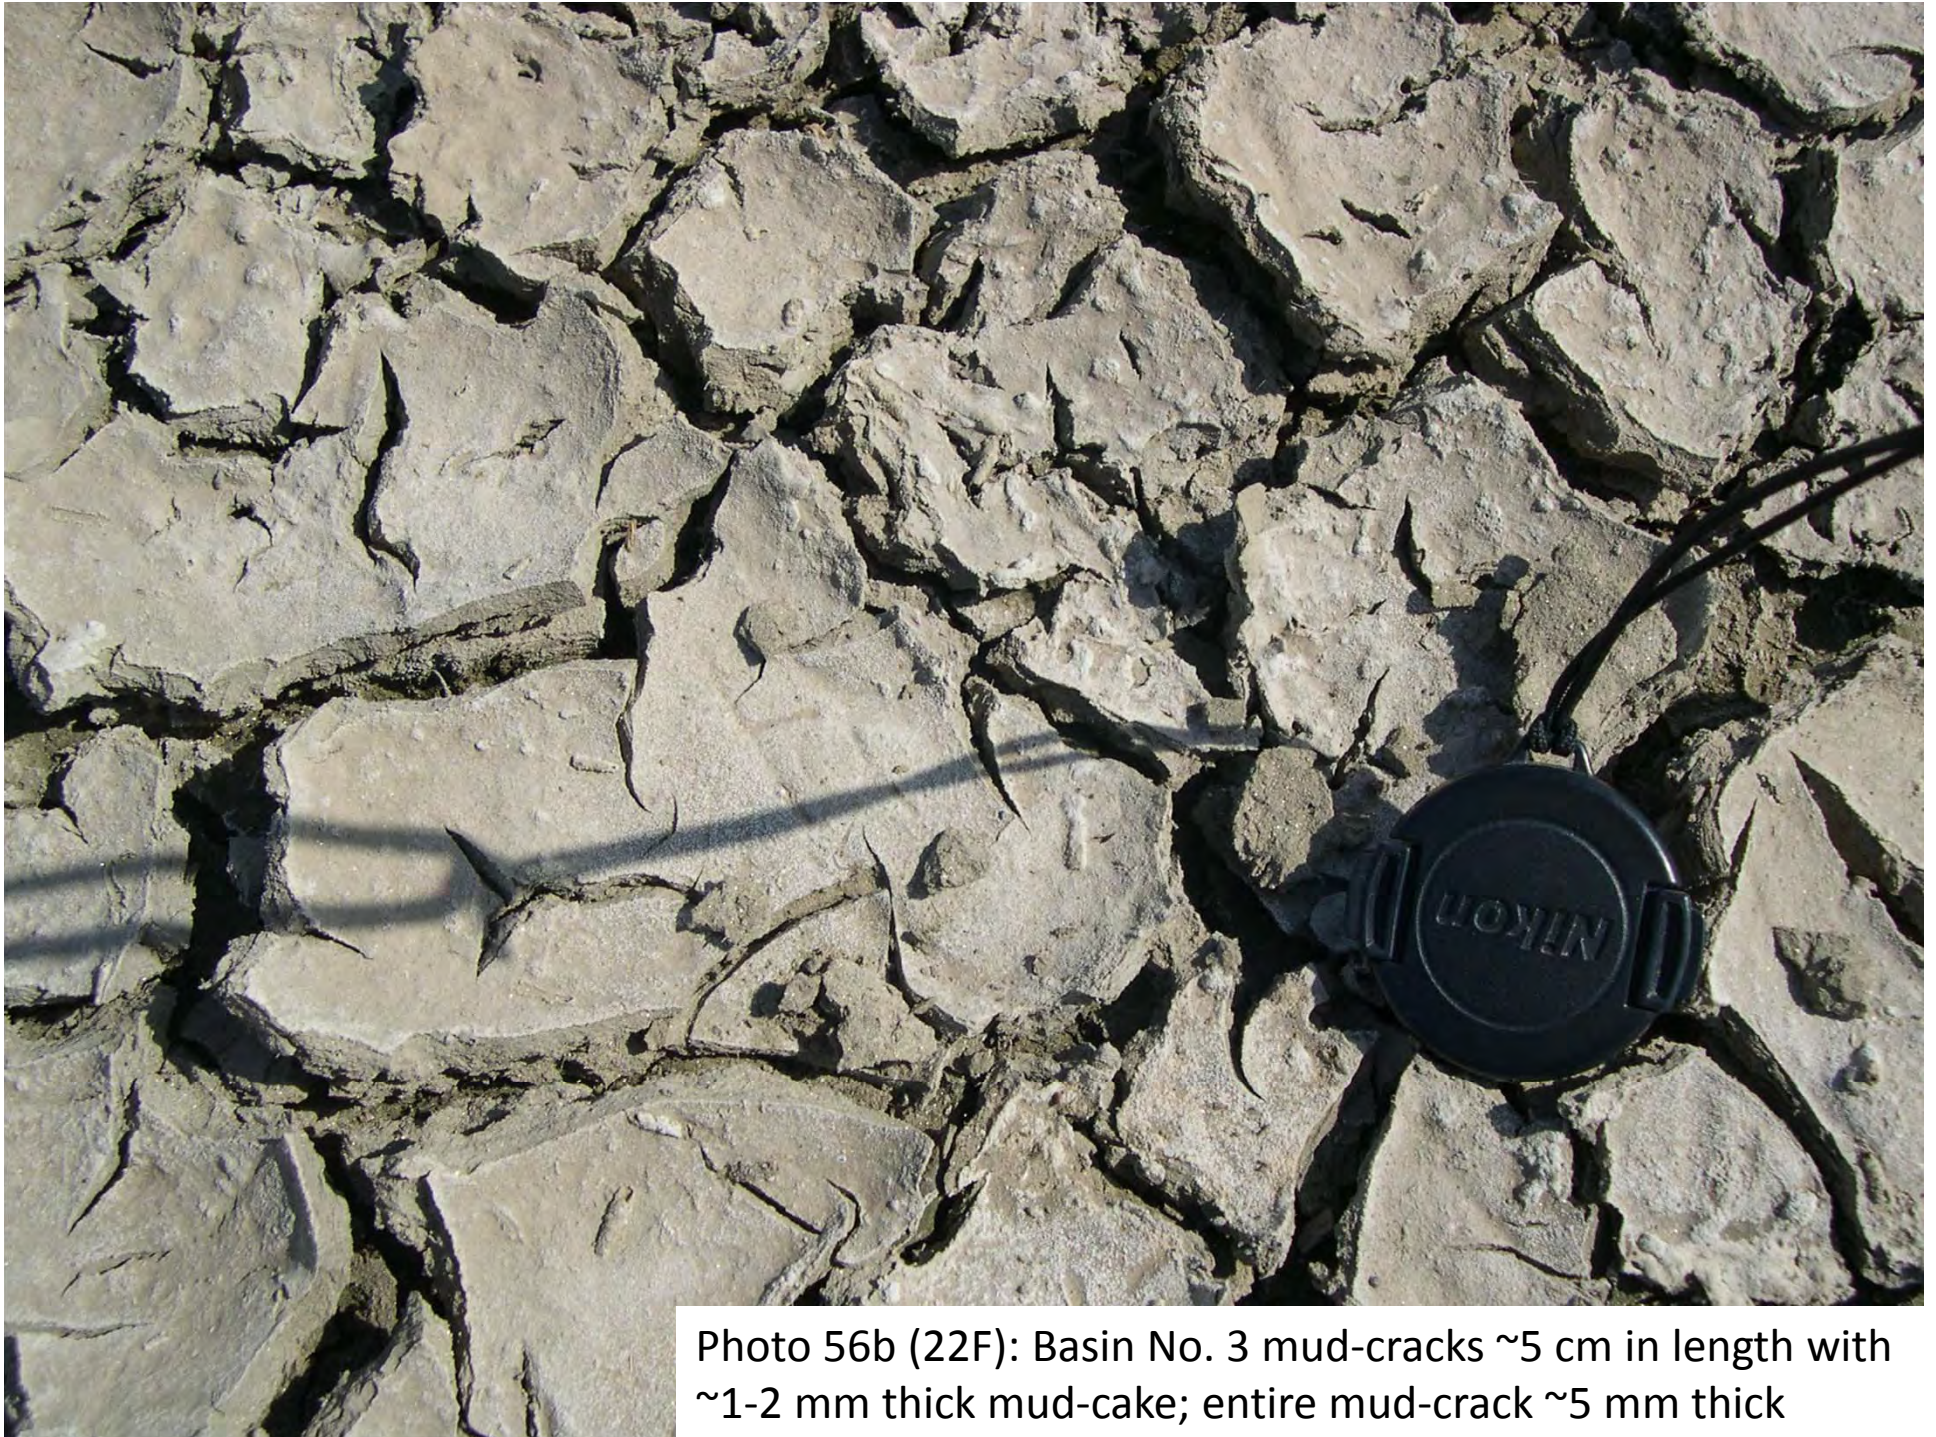
Photo 56b (22F): Basin No. 3 mud-cracks ~5 cm in length with ~1-2 mm thick mud-cake; entire mud-crack ~5 mm thick

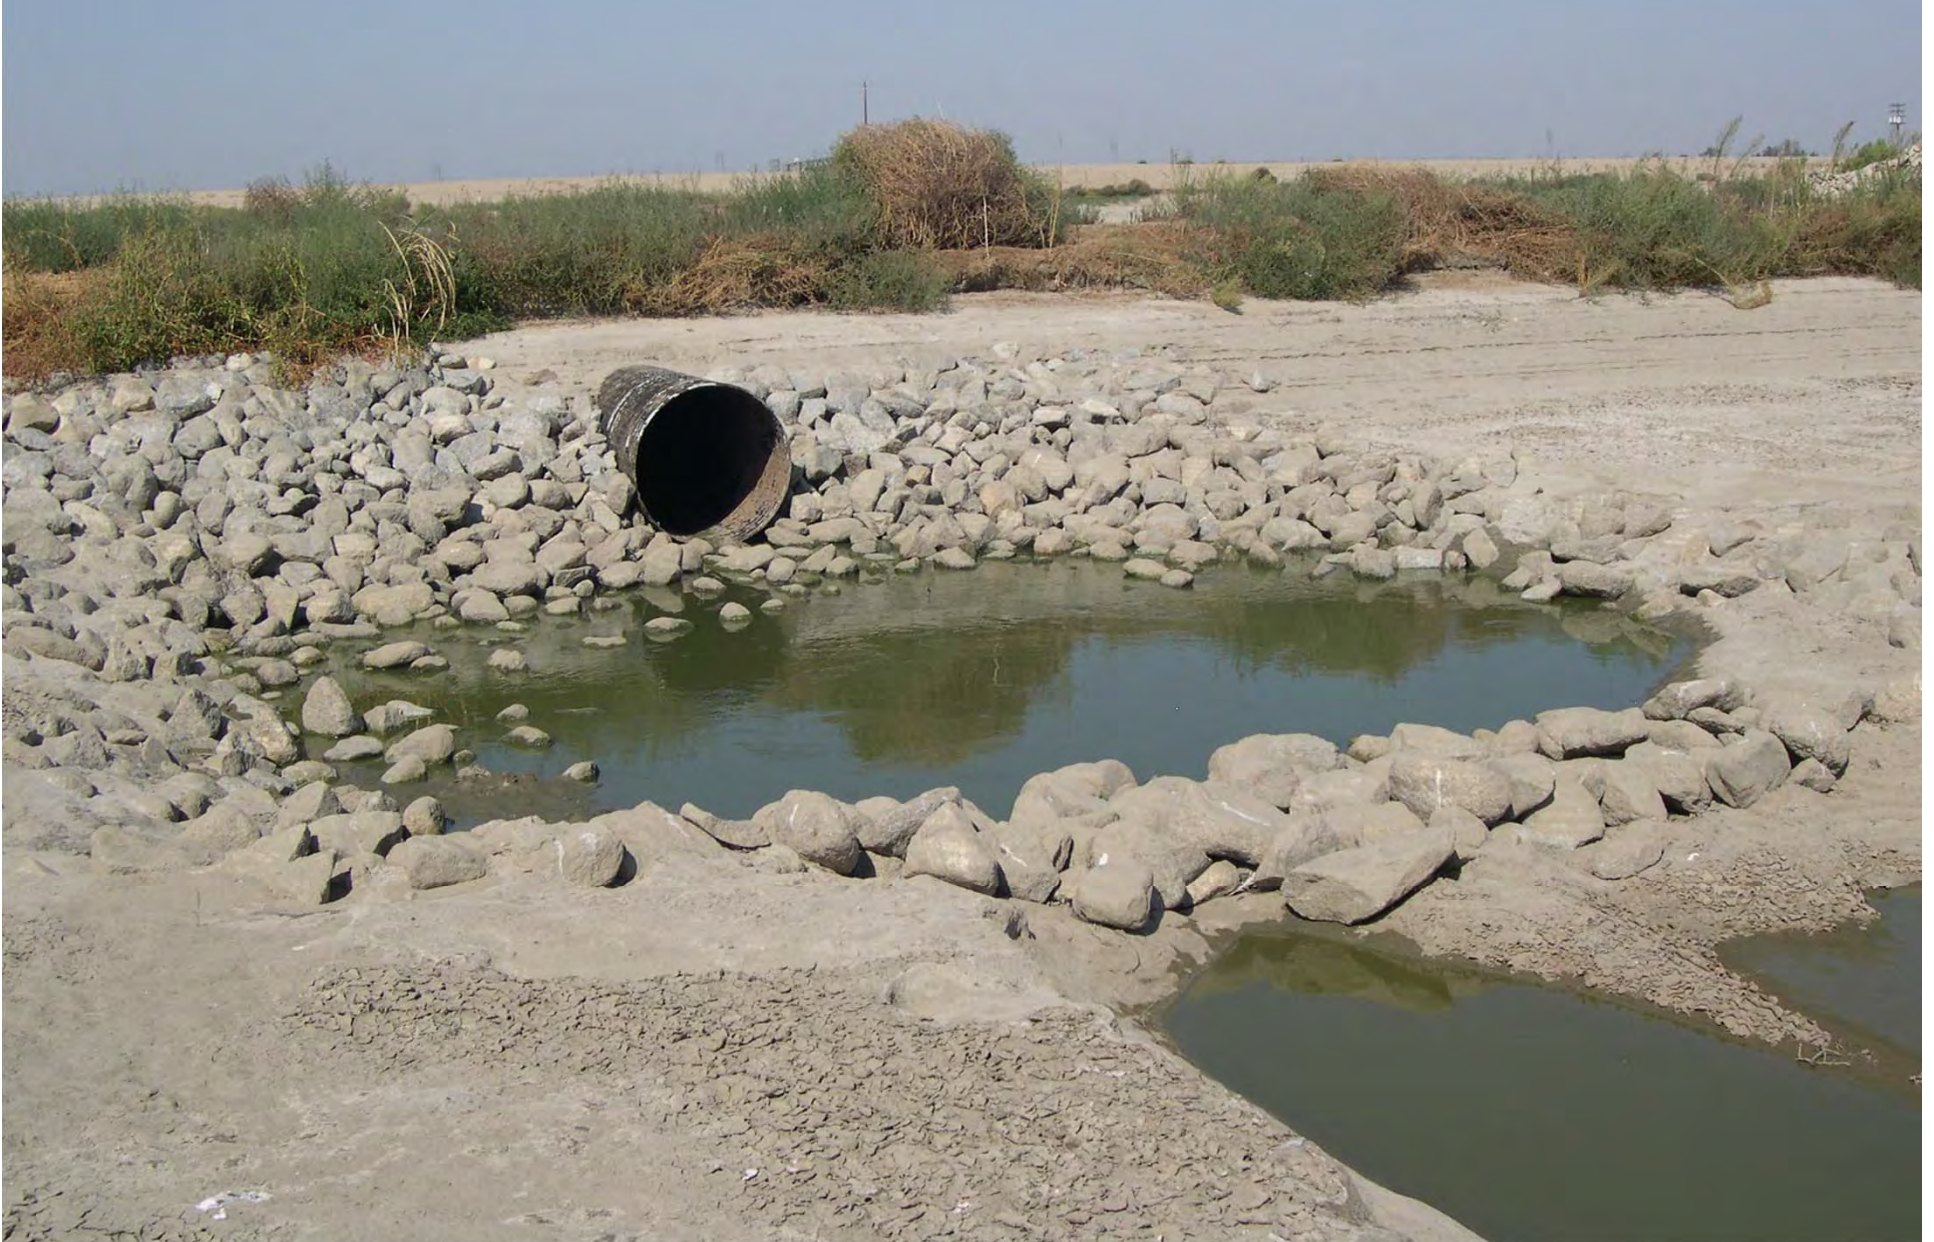
Photo 58b (28G): 4-Bay transfer structure between Basin No. 3 and No. 2; stagnant water with algae in rip-rap; small; some algal mats adjacent to rip-rap

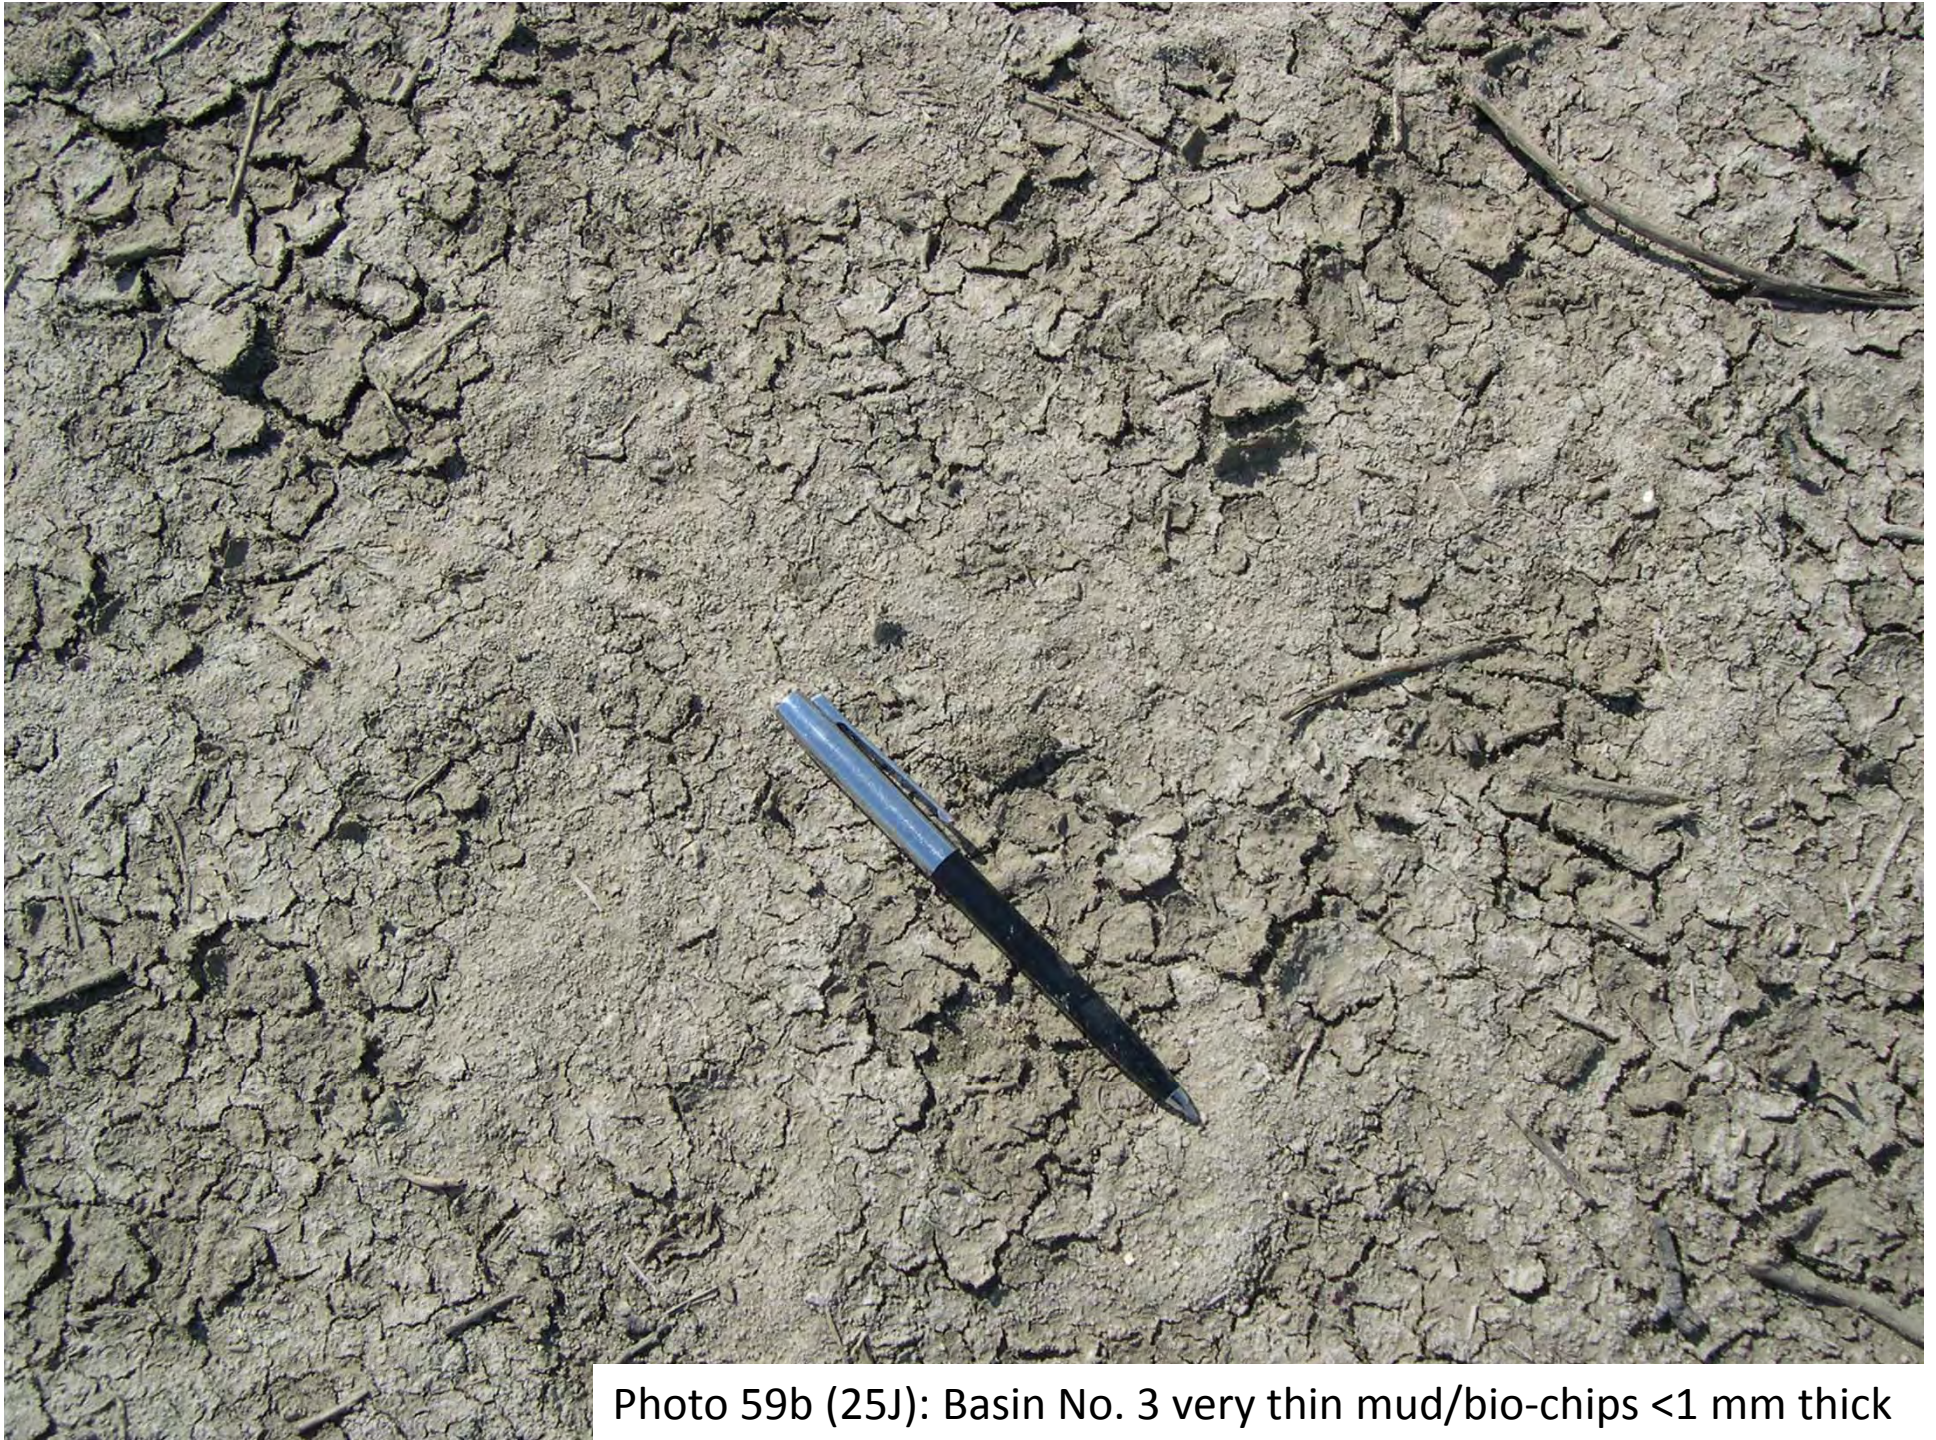
Photo 59b (25J): Basin No. 3 very thin mud/bio-chips <1 mm thick

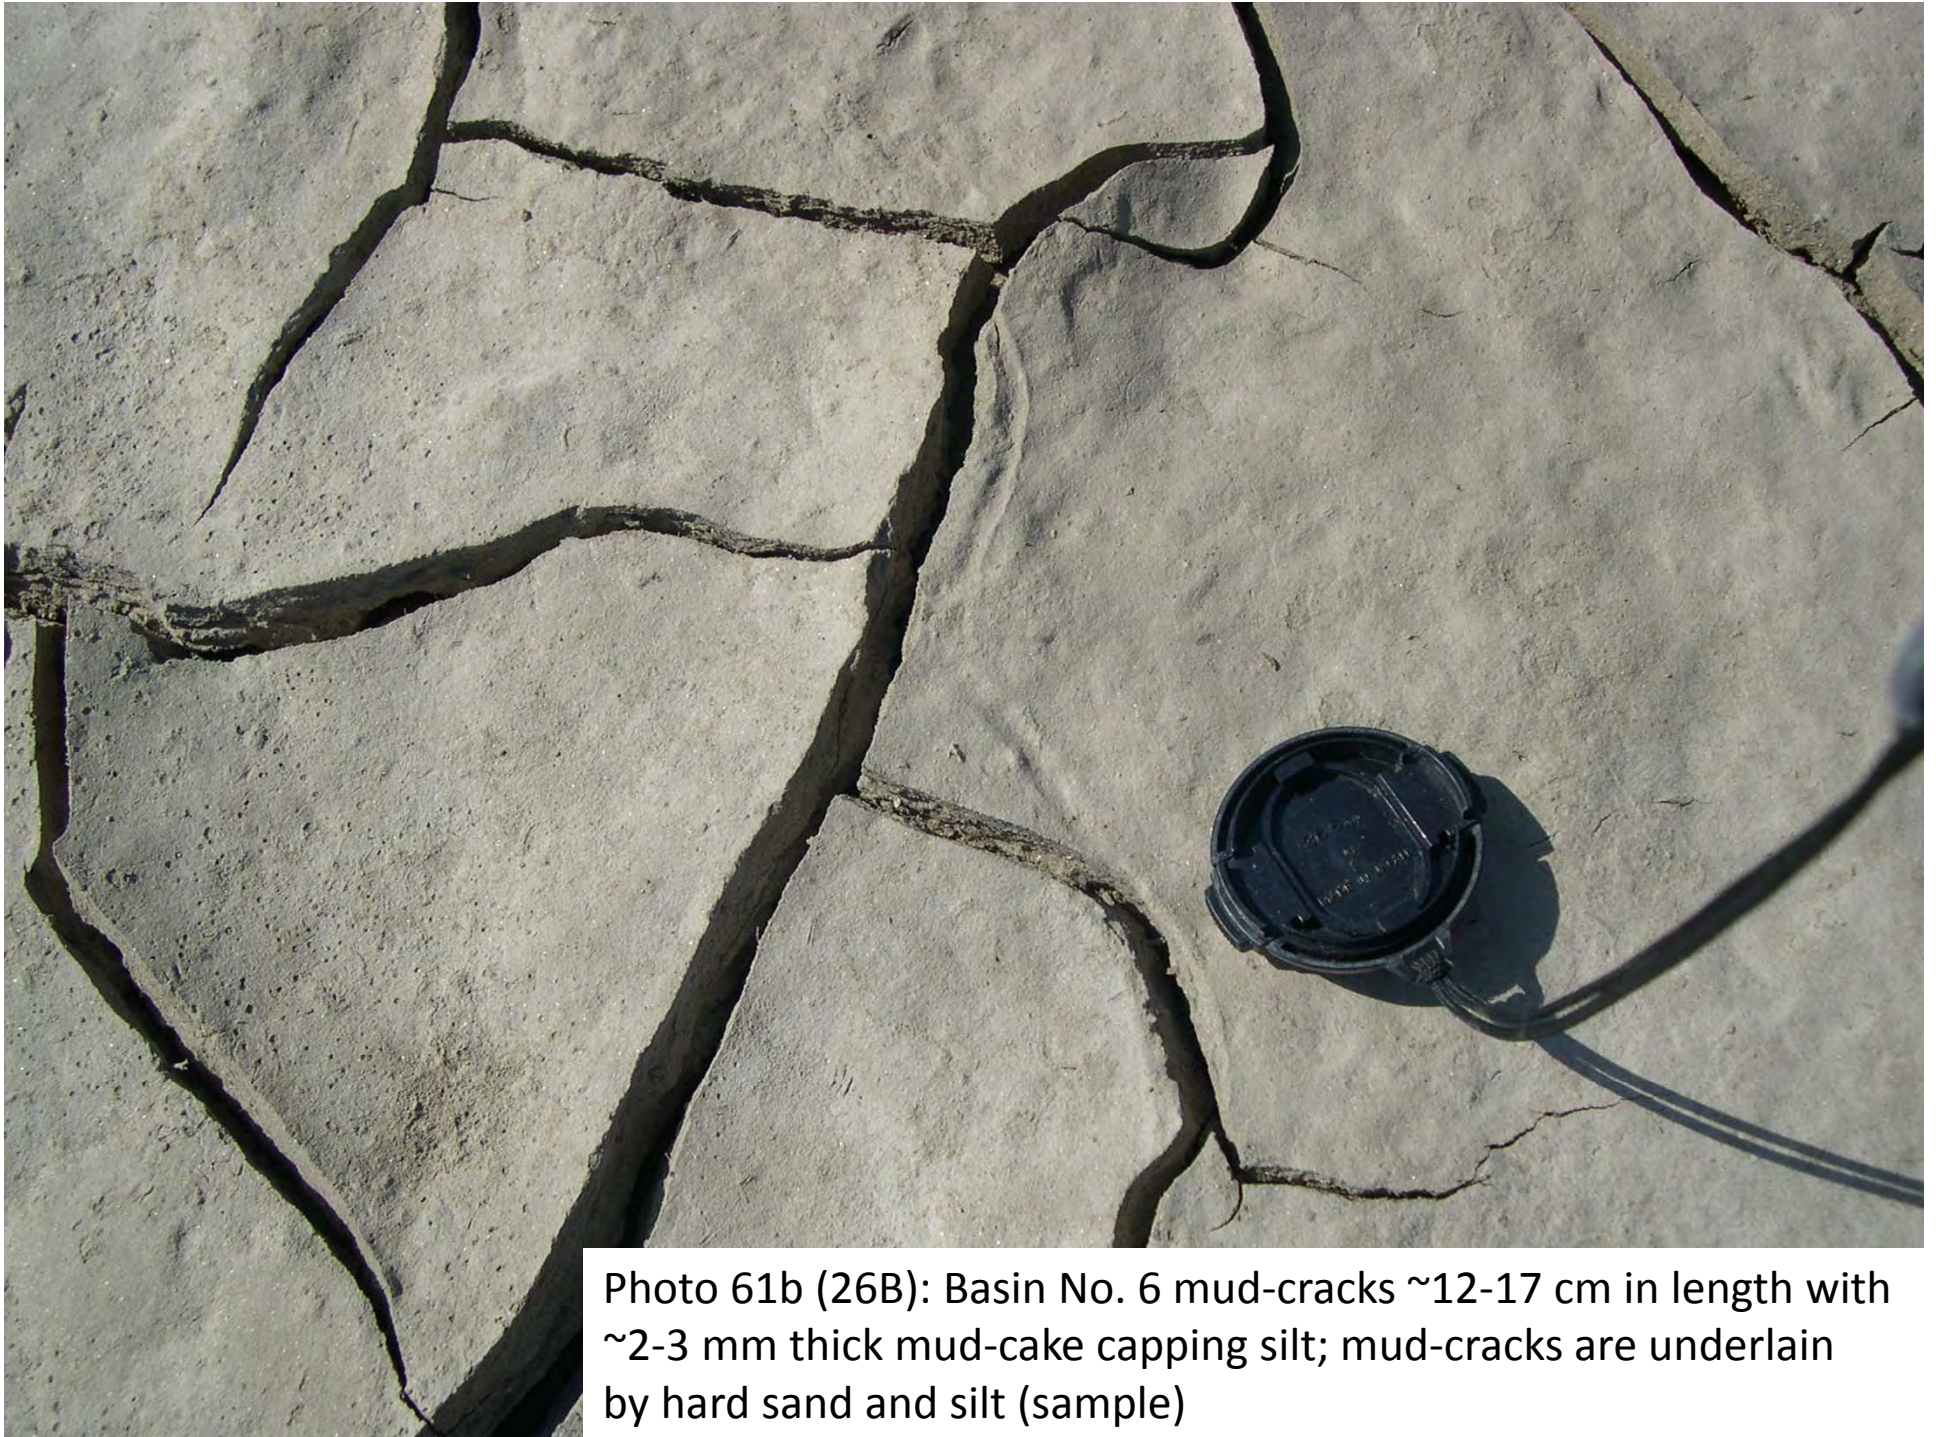
Photo 61b (26B): Basin No. 6 mud-cracks ~12-17 cm in length with ~2-3 mm thick mud-cake capping silt; mud-cracks are underlain by hard sand and silt (sample)

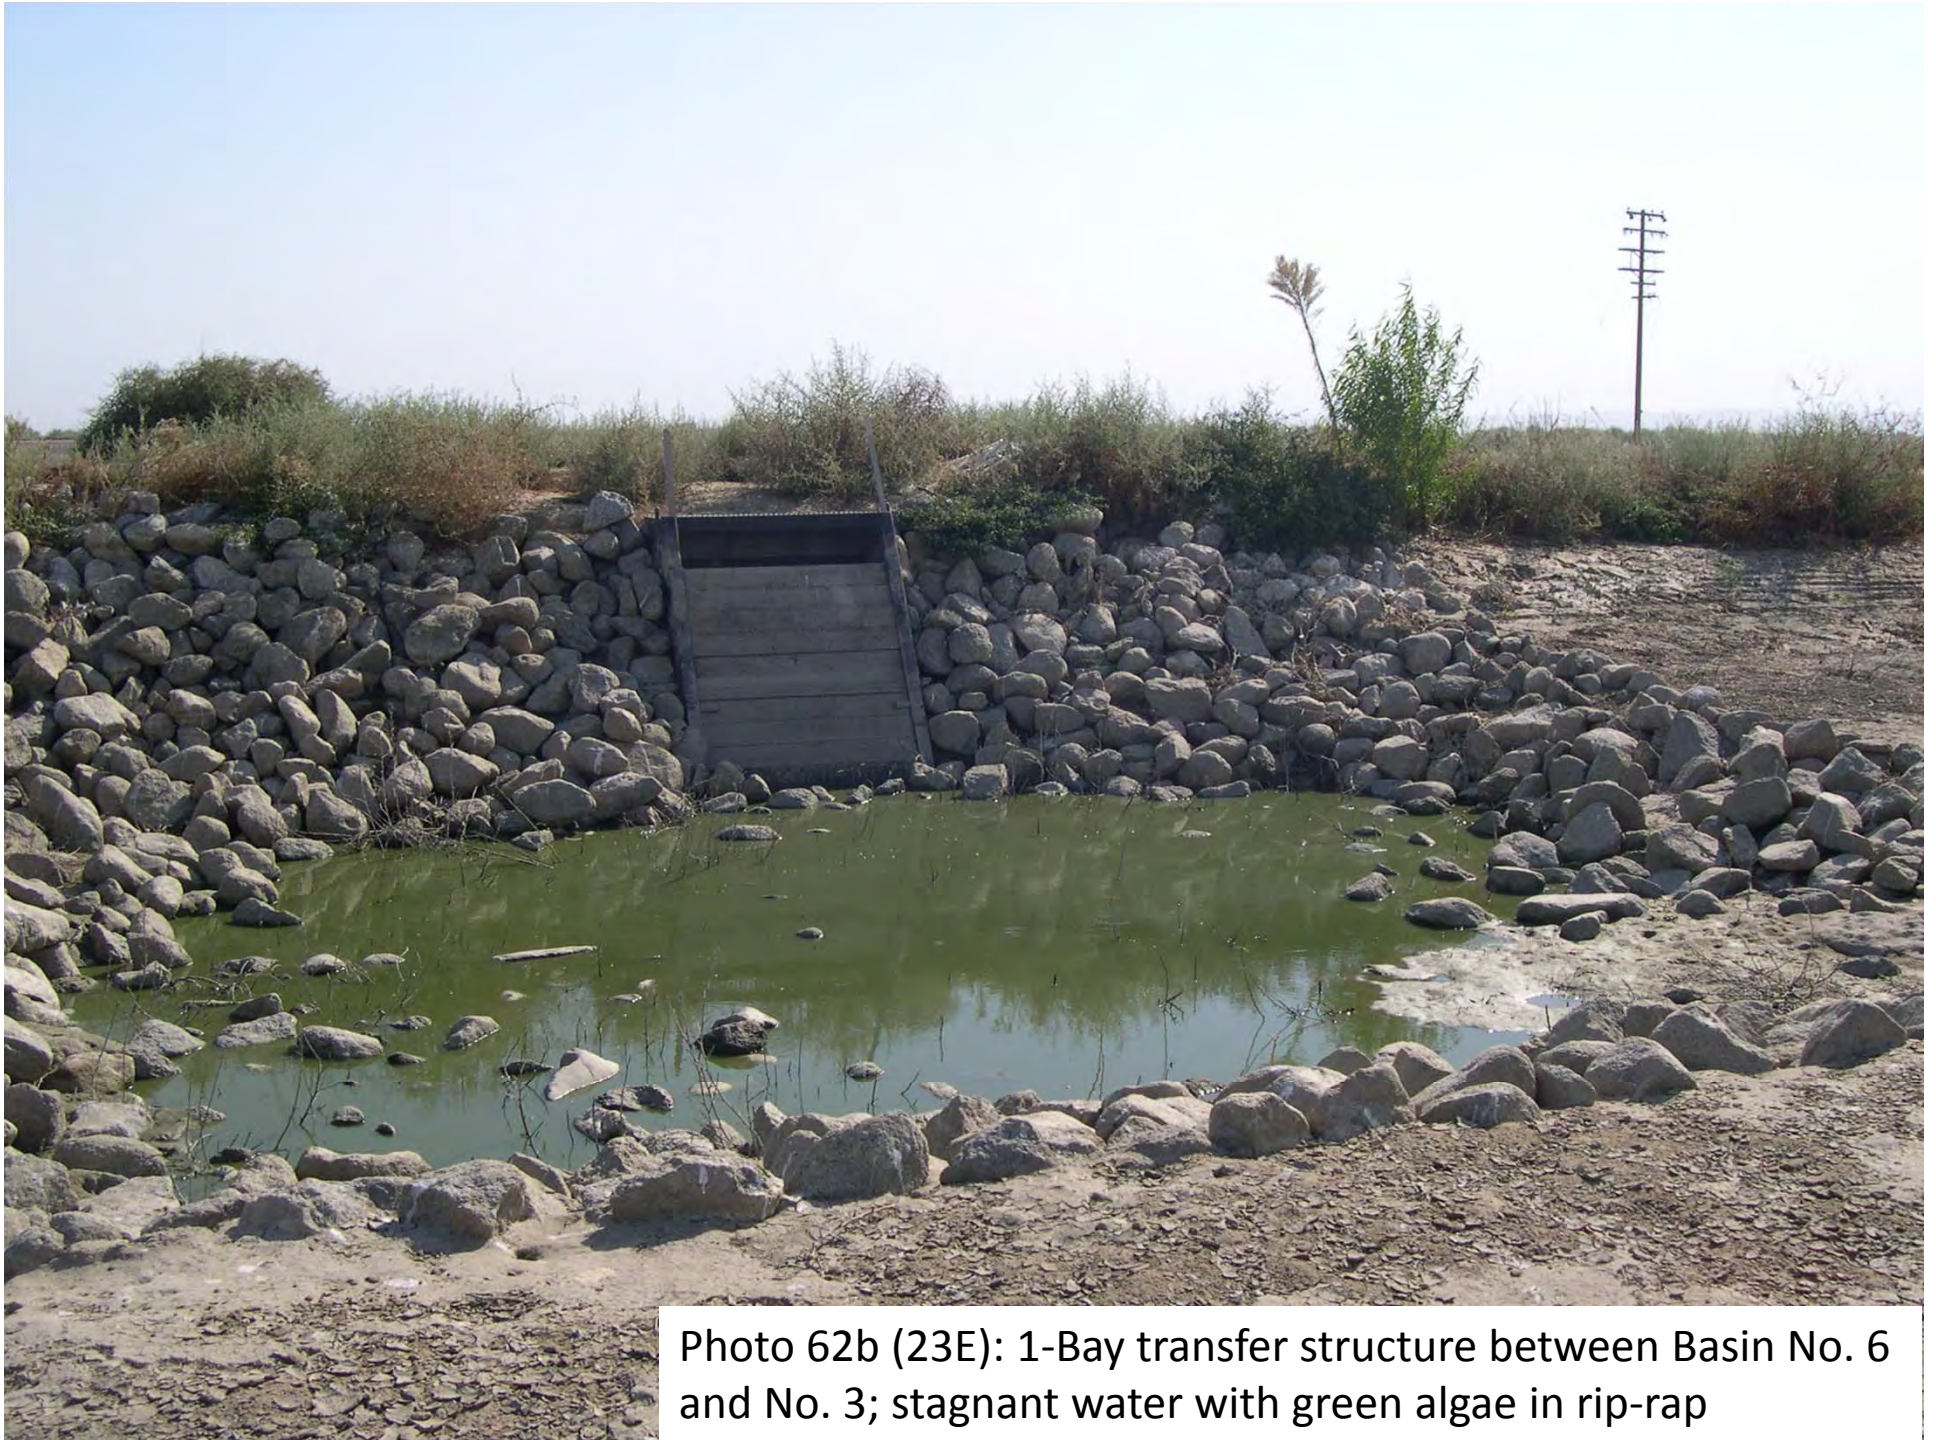
Photo 62b (23E): 1-Bay transfer structure between Basin No. 6 and No. 3; stagnant water with green algae in rip-rap
