# Annual Surveillance Report January 2022 to December 2022 for Sand Canyon Dam DSOD Dam No. 1029-002

Irvine, California

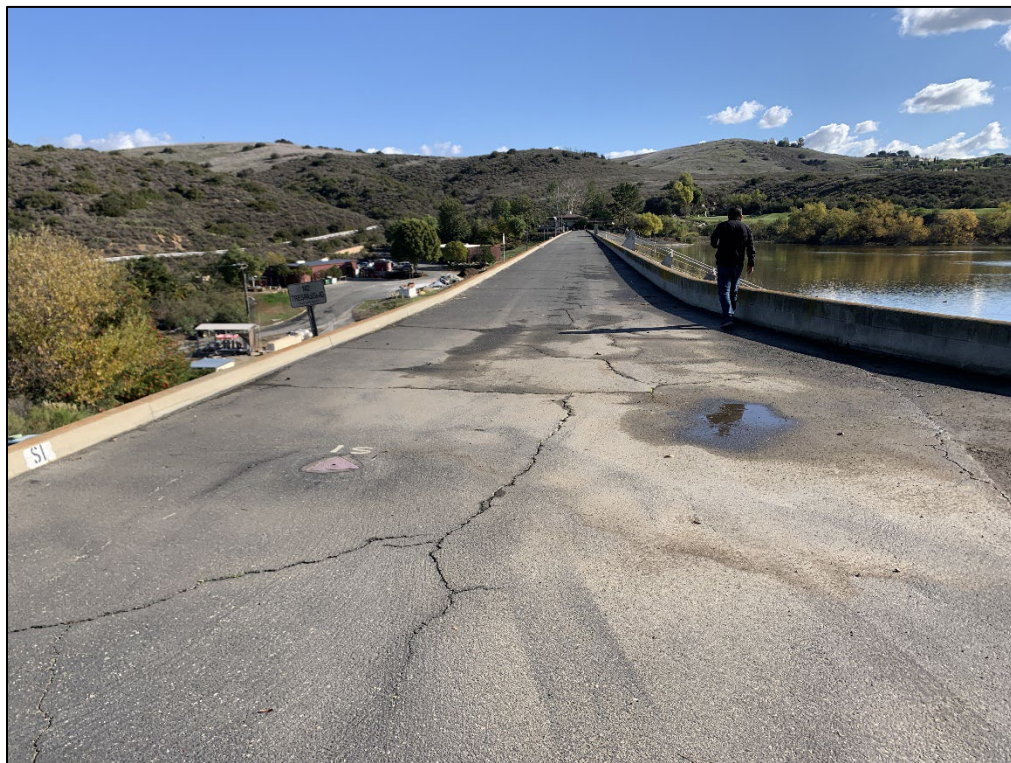
**Photo 2)** Minor AC paving cracking near left abutment looking towards the right abutment.

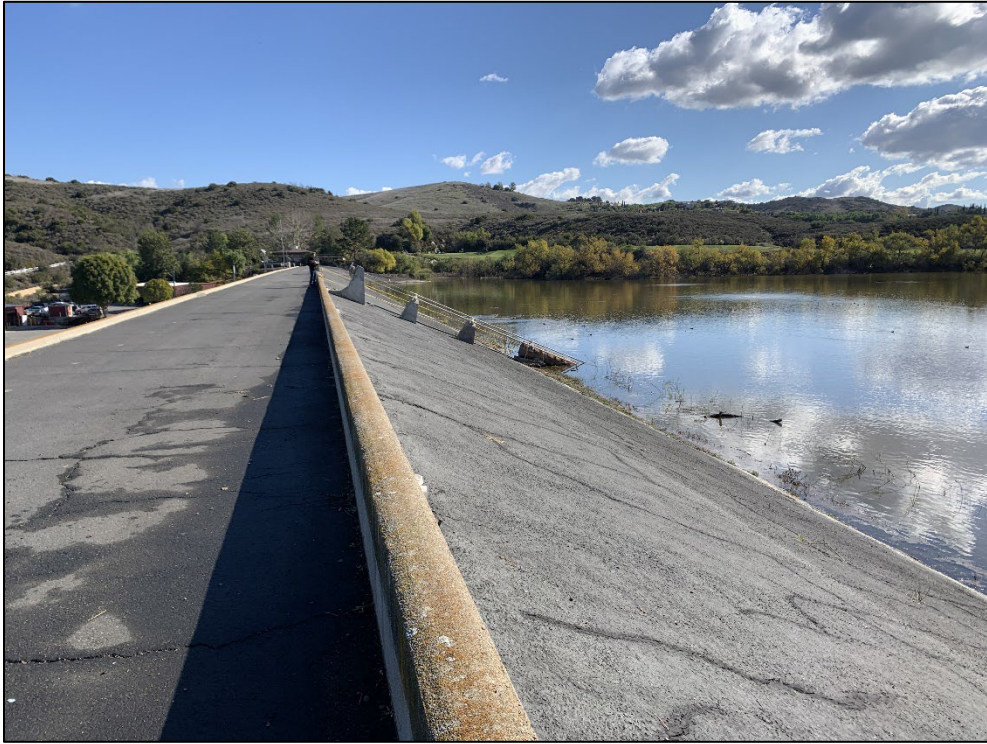
**Photo 3)** AC-lined upstream face looking towards right abutment. Note cracks and brush in reservoir.

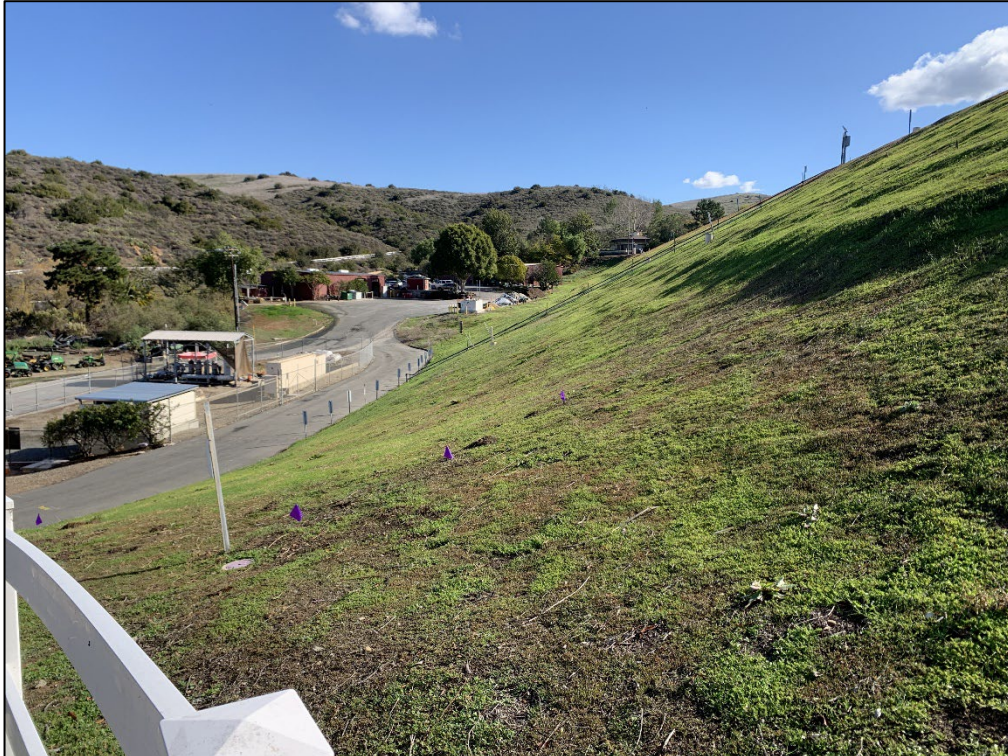
**Photo 4)** Downstream face looking towards right abutment.

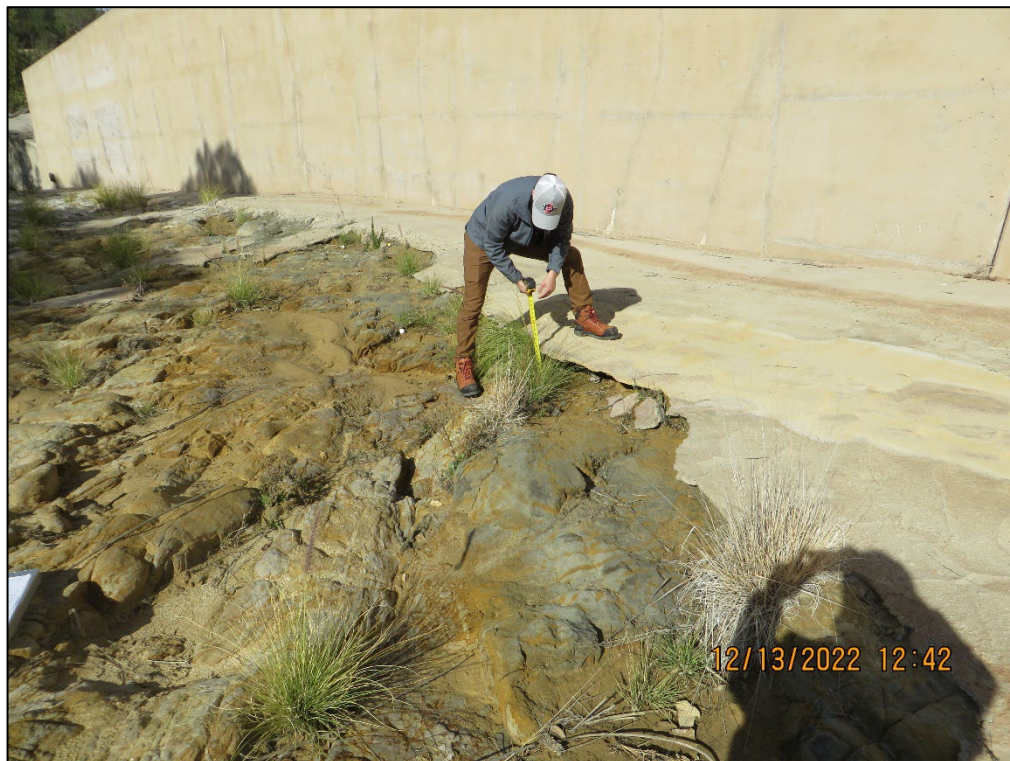
**Photo 12)** Looking downstream at undermining of previous localized concrete repair areas.

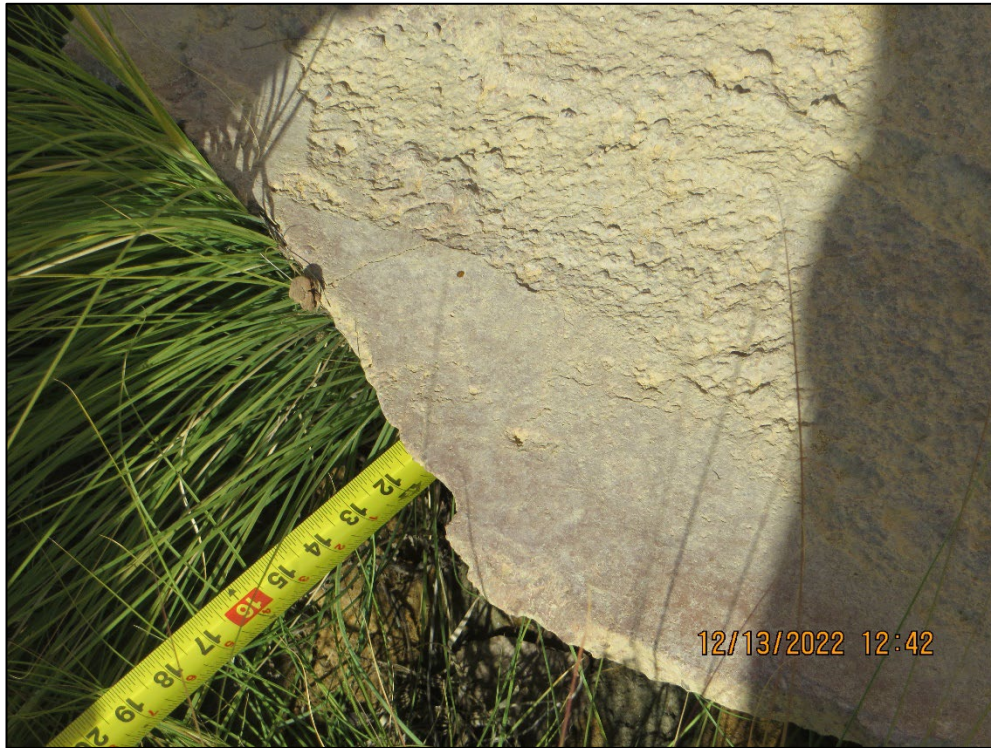
**Photo 13)** Close up view of undermining of recent concrete repair. Undermining is approximately 12-inches wide.

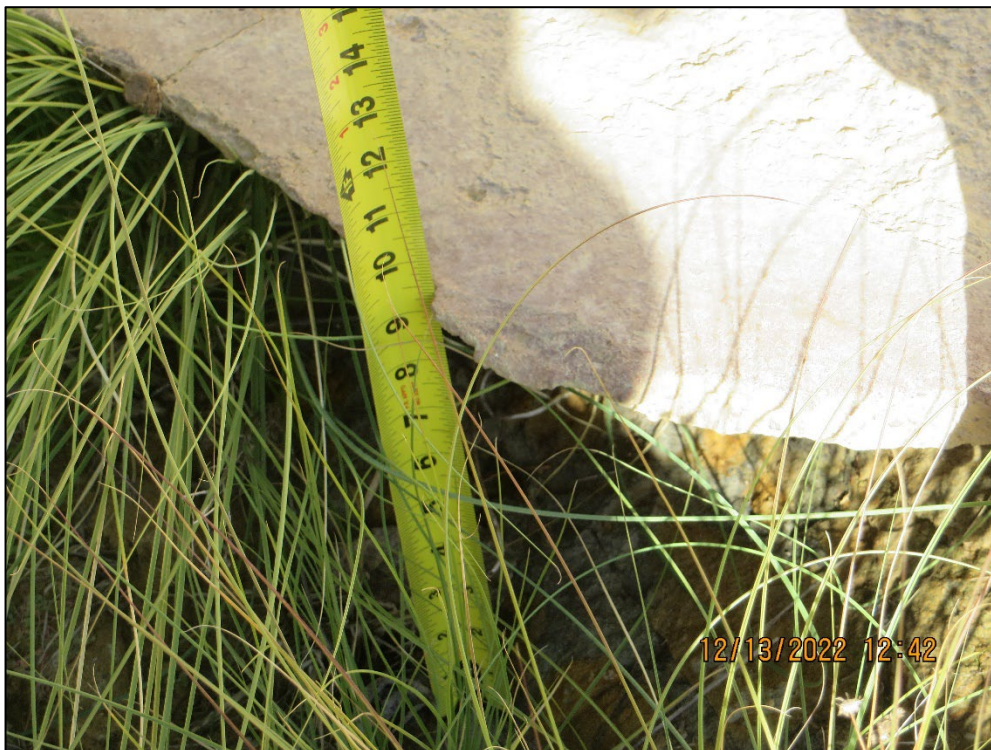
**Photo 14)** Close up view of undermining of recent concrete repair. Undermining is approximately 9-inches in height.

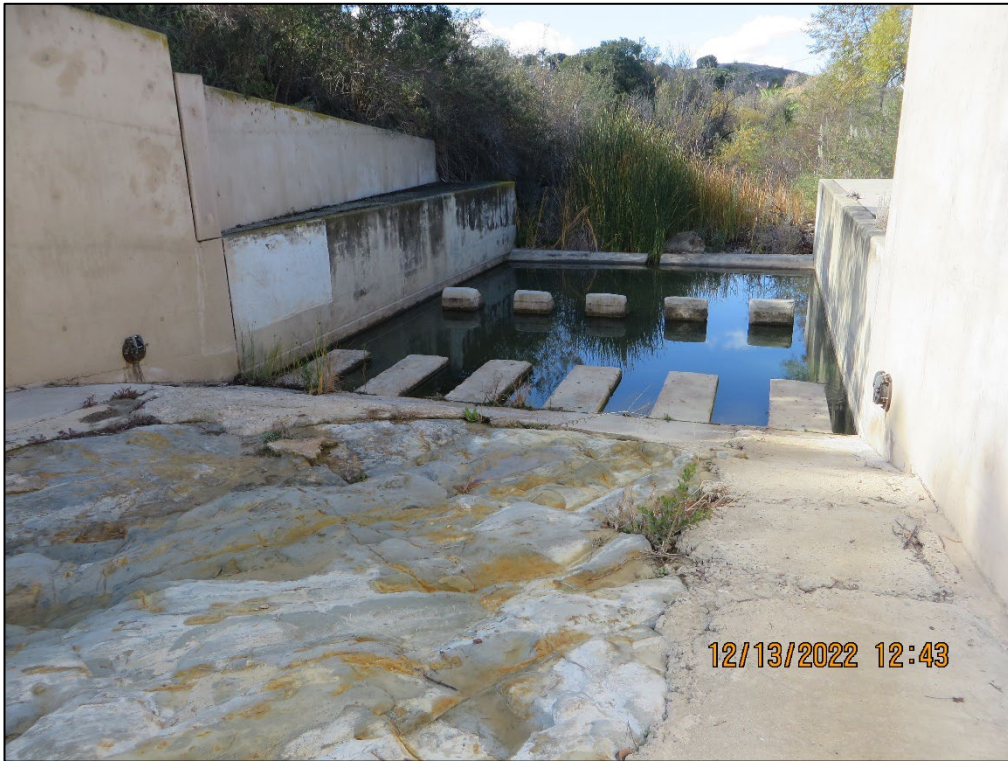
**Photo 15)** Close up view of spillway basin, note brush/tule growth downstream.

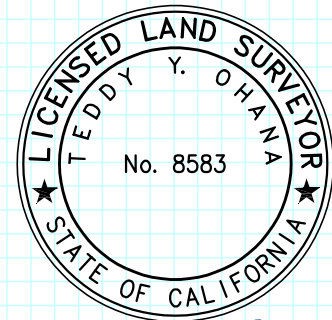
TEDDY Y. OHANA PLS 8583
