# Effectiveness of Pool Covers to Reduce Evaporation from Swimming Pools

Misgana Muleta, Ph.D., P.E., D. WRE  
Department of Civil and Environmental Engineering  
California Polytechnic State University  
San Luis Obispo, California 93407  
Telephone: 805-756-1337  
Email: mmuleta@calpoly.edu

National Plasterers Council  
1000 N. Rand Road, Suite 214  
Wauconda, IL 60084 USA  
Telephone: 847-416-7272  
Email: mail@npconline.org

January, 2016

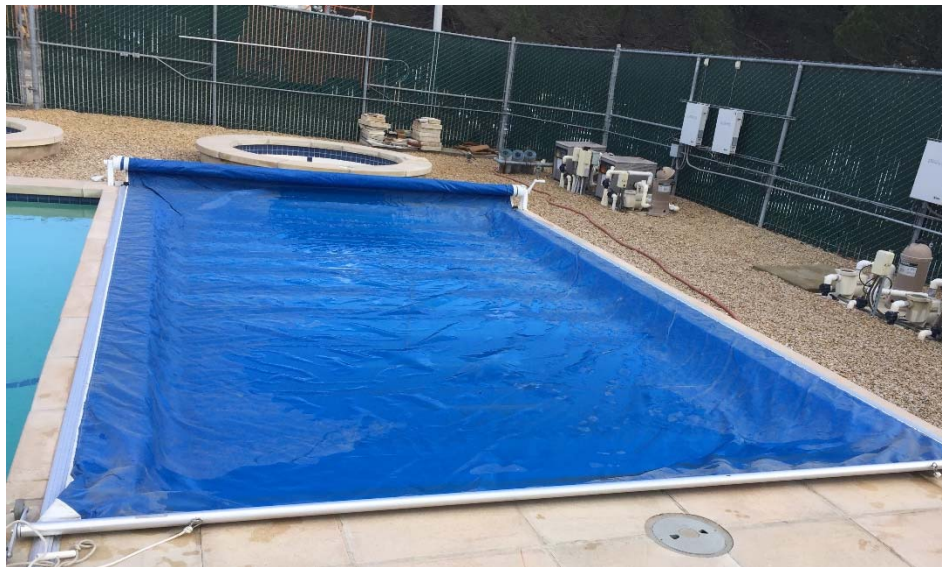
**FIGURE 1. SOLID TRACK COVER MOUNTED TO A POOL AT THE NPIRC**

A solid track cover typically consist of a cover, a reel mounted on one end of the pool, and tracks along two sides of the pool. The reel and tracks provide structural support for the cover and also help with retracting and rolling of the cover, a process that could be automatic, semi-automatic, or manual. The manual solid track cover used in this study (see Figure 1) has a hand-crank attached on one end of the reel to help with retracting the cover. The covers can be made from vinyl, polyethylene, or polypropylene, and have UV inhibitors (US DOE, 2015). The solid track cover used for this study has thickness of 28 mil and is made from a premium grade vinyl reinforced with a strong polyester mesh.

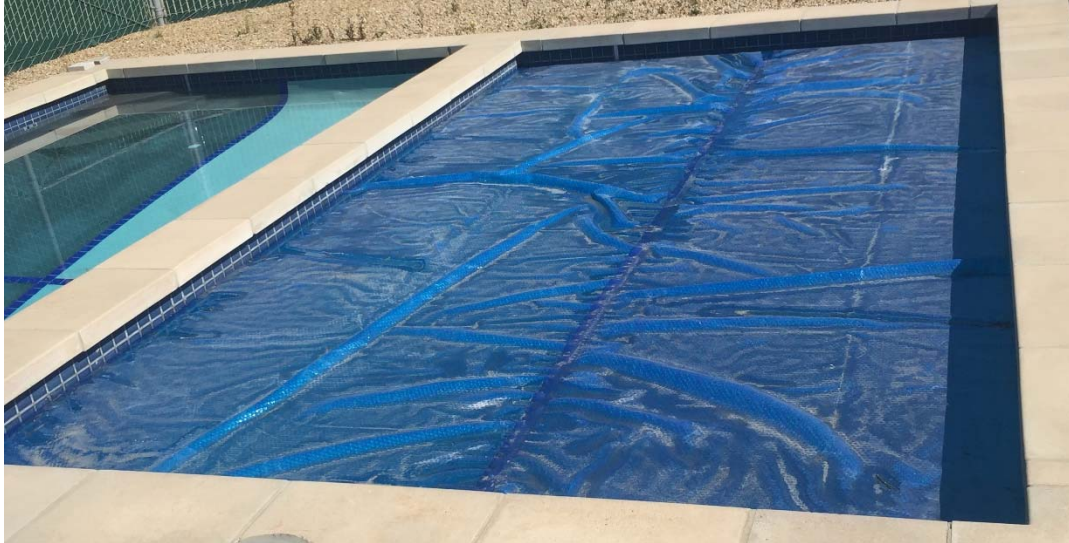
**FIGURE 3. BUBBLE COVER PLACED ON A POOL AT THE NPIRC**

Like foam covers, bubble covers float on the water surface and protect the water from direct exposure to wind and the sun. The covers resemble bubble packaging material but are made from a thicker grade plastic coated with ultraviolet inhibitors to extend service life of the cover (US DOE, 2015). The bubble cover used for the study (Figure 3) is made from polyethylene and is 11 mil thick.

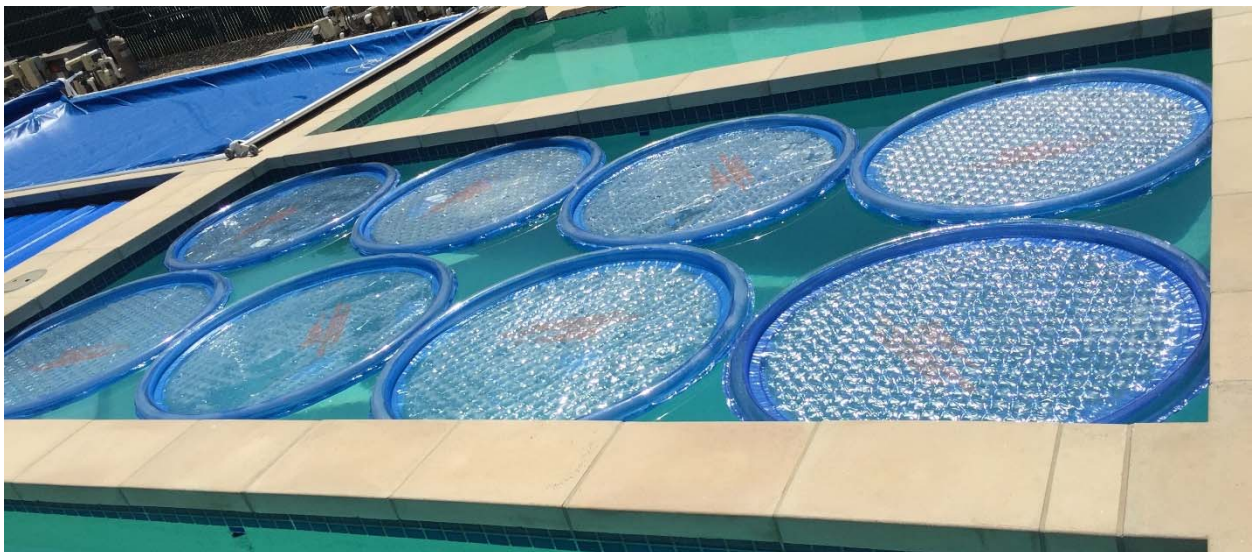
**FIGURE 4. SOLAR DISKS INSTALLED ON A POOL AT THE NPIRC**

Solar disks consist of multiple circular covers that provide partial cover of the water surface. The disks attach to one another via magnets installed on each unit but create small areas of uncovered spaces between the disks as shown in Figure 4. Eight solar disks of five feet diameter each were used for this study. The disks are made from two layers of UV resistant vinyl and are 2.5-inches thick as inflated. The eight disks protect close to 73% of the pool surface area. Evaporation reduction efficiency of solar disks is not expected to be as high as solid covers that provide complete coverage of the water surface area.

The covers were either donated by the manufacturers or purchased. Eight solar disks of 5-ft diameter each were used. Total surface area of eight solar disks is about 157.1 ft<sup>2</sup>. Because each pool has surface area of 216.7 ft<sup>2</sup>, eight disks cover 72.5 percent of the water surface area. All solid covers came in blue so that reflectivity (i.e., albedo) of the covers is not influenced by color. Albedo describes the fraction of incoming solar radiation that would be reflected back to the atmosphere, and it depends on surface characteristics including color.

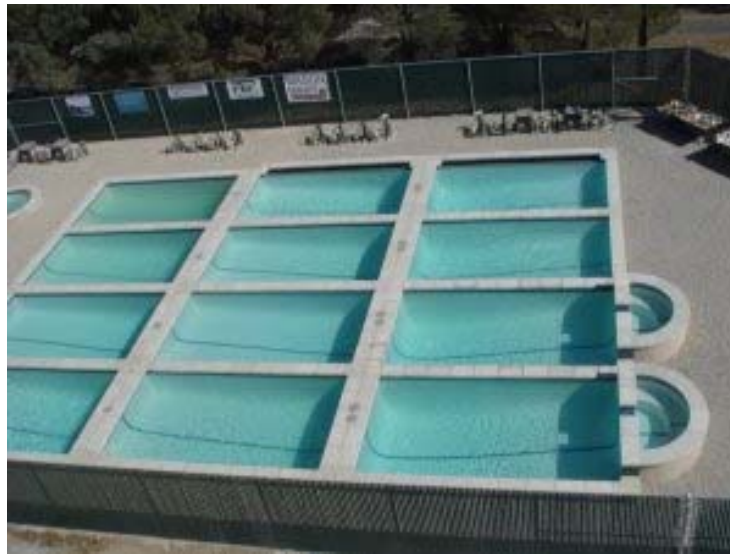
**FIGURE 5. POOLS AND SPAS AT THE NATIONAL POOL INDUSTRY RESEARCH CENTER ON CAL POLY CAMPUS**

Rate of evaporation from water bodies such as swimming pools depends on local climate variables including wind velocity, solar radiation, differences in vapor pressure between a water surface and the overlying air, and temperature. A comparative evaporation study such as the one pursued here has to ensure that these factors are identical for the pools used to test the covers. The National Pool Industry Research Center (NPIRC) facility used for this study consists of twelve pools and four spas as shown in Figure 5. All twelve pools have identical shape, size, and exposure to wind and sun making the facility suitable for the comparative study. NPIRC is located on the campus of California Polytechnic State University (Cal Poly).

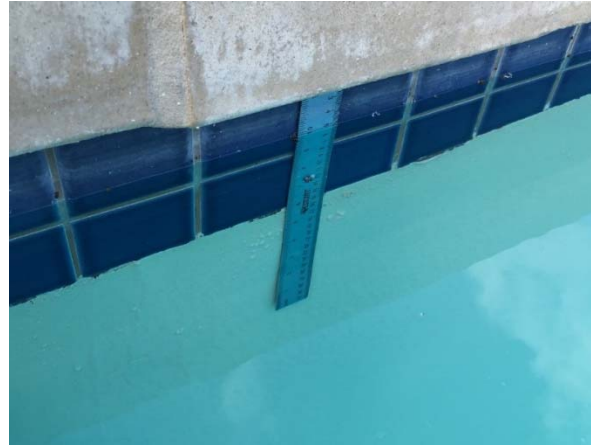
**FIGURE 6. A STAINLESS STEEL RULER FIXED TO A POOL AT THE NPIRC**

Water levels in the test pools were monitored daily. Stainless steel rulers were mounted on the four walls of each test pool to measure the distance from the top of the pool to the water level. Figure 6 shows a ruler attached to the side of a pool. Accordingly, four daily water level readings were taken for each test pool to minimize measurement error. The readings were made in the mornings, typically between 7 and 9 am, when the wind is often calm and the water surface is tranquil. However, there were days when the wind was too strong in the

mornings to take accurate water level readings. On those days, as many as three attempts to measure the water levels were made at different times of the day. If the wind was too strong during all attempts, then no water level measurements were taken on that day. The measurements taken the next day would represent cumulative water loss since the last reading.

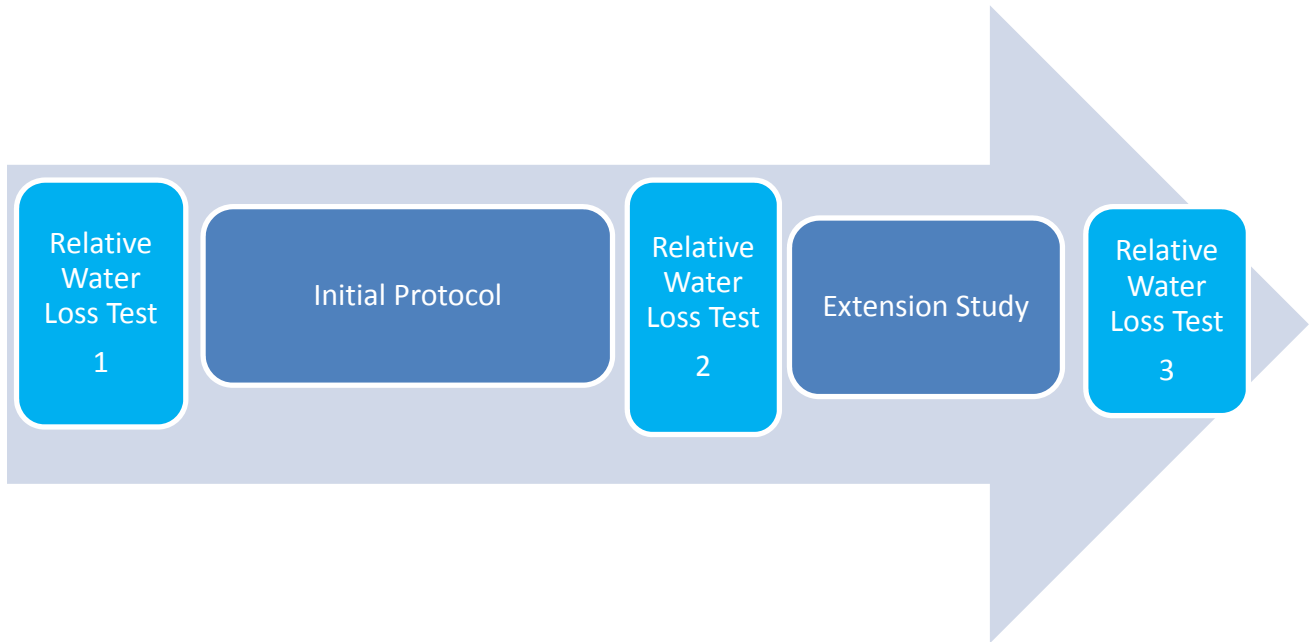
**FIGURE 8. SEQUENCE OF THE DATA COLLECTION PHASES**

It was determined that the data collected from the leaking pool before the crack was sealed was impacted and not valid. Subsequently, the NPC decided to extend the initial protocol by four weeks to collect more data for the liquid covers (i.e., LES A and LES B). A third relative water loss testing was carried-out at the end of the extension study. The objective of the relative water loss tests was to compare water loss from each pool and to evaluate if the pools exhibit leakage via plumbing or structural cracks. No covers were applied to the pools during the relative water loss tests — evaporation should be identical for all pools. Therefore, any difference in water loss that the pools exhibit during the relative water loss test should be due to leakage. Assuming leakages in all pools are steady during the study, the water loss data gathered during the study could be corrected for leakage based on the relative water loss test. The leakage correction approach is described in more detail later in the report. However, if leakage rates for some or all pools change (i.e., increase or decrease) with time, then the relative water loss test might not characterize the leakage rates accurately. The data collection phases are illustrated in Figure 8, and are further described next.

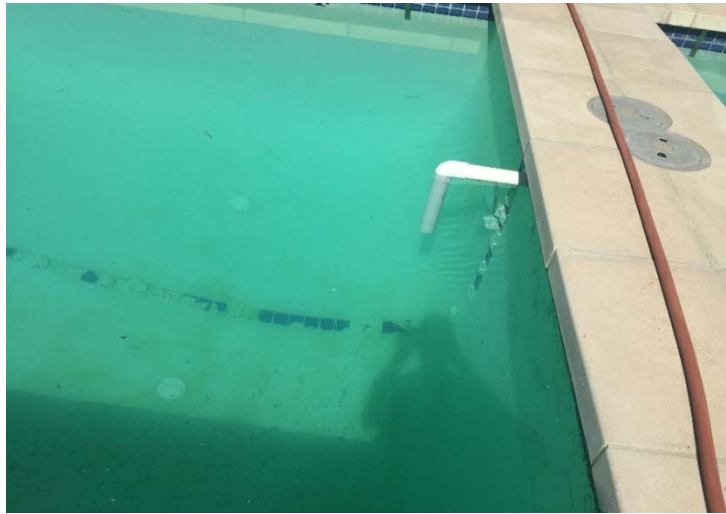
**FIGURE 9. A SYPHON INSTALLED IN POOL 1**

The initial water loss test result helped with pool selection. Table 4 shows the pools used for the initial protocol and the cover types tested using each pools. Pool 1 (i.e., the primary control pool) has no coping — it is susceptible to overflow via its spillway, especially on windy days. Consequently, water level in Pool 1 had to be kept low to decrease the likelihood of overflow. A low water level, resulting in inadequate water flow to the pool skimmer, would result in heat damage to the filtration system, specifically the pool pump, as well as plumbing and valves in the vicinity of the pump. Therefore the water level in this pool had to be maintained within a narrow range. As a work around, a syphon was installed in the Pool (see Figure 9) to bypass the skimmer and ensure the filtration process remains active even when water level is lower than crest elevation of the skimmer. As extra precaution, Pool 12 was used as secondary control to back-up data from Pool 1 during a portion of the initial protocol.

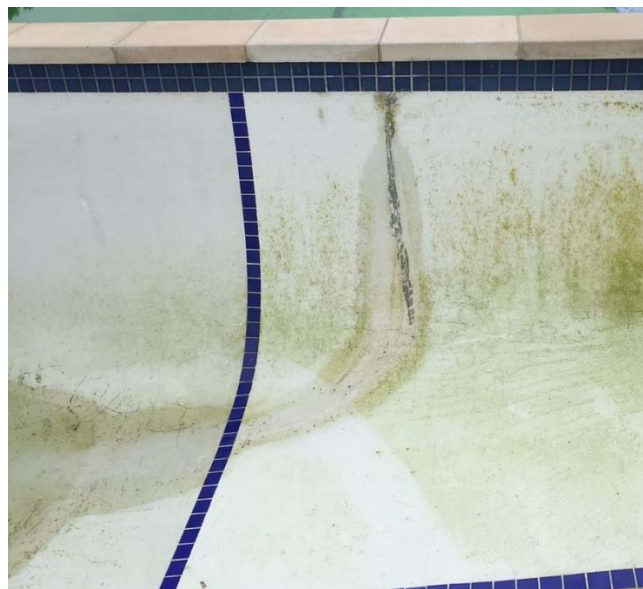
**FIGURE 10: LEAKAGE FROM POOL 3 TO POOL 4**

Leakage from Pool 3 to Pool 4 was detected midway through the initial protocol (see Figure 10). Pool 4 was not filled with water as it was not used for the protocol. As soon as the leak was detected, several corrective measures were taken. These include,

- The crack was sealed.
- Pool 4 was filled with water to reduce the difference in water levels of the two pools thereby restricting leakage between the two pools in case there were more cracks.
- In addition to Pool 3, we started to test LES B using Pool 12.

As previously described, leakage was detected in Pool 3 during the last week of August. The crack was sealed on September 1<sup>st</sup>. The data collected from Pool 3 before September 1<sup>st</sup> was deemed unreliable and was not used to evaluate performance of LES B, the cover type tested using Pool 3. In addition, LES B was tested on Pool 12 starting August 27.

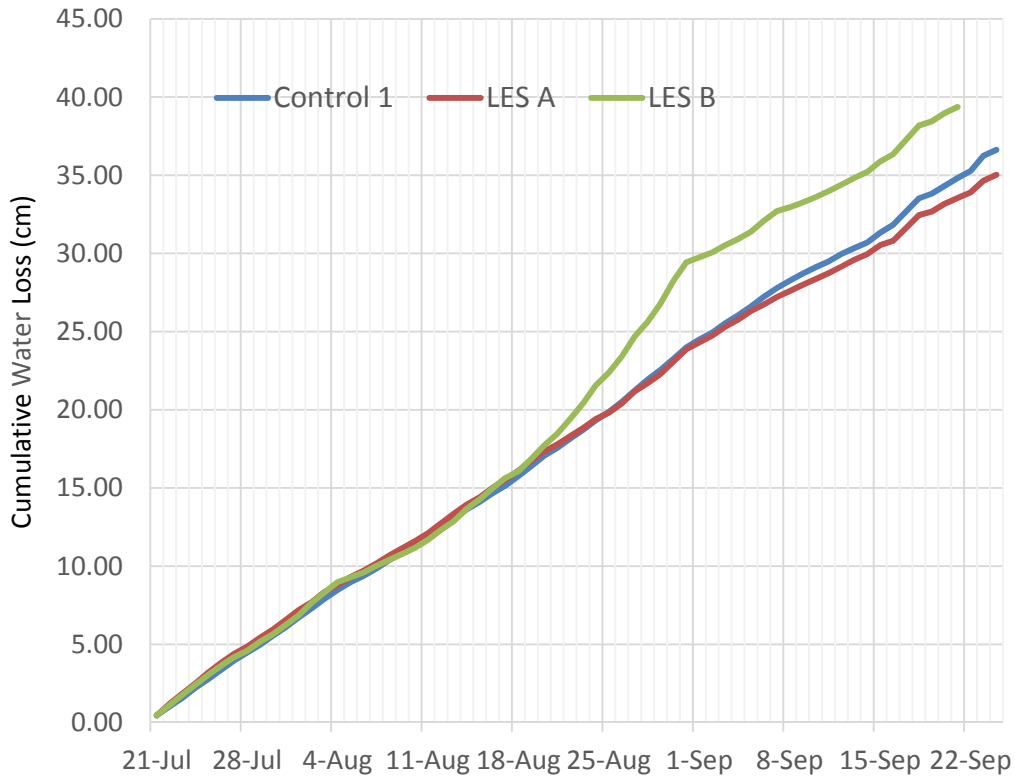
**FIGURE 11. COMPARISON OF WATER LOSS FROM THE CONTROL POOL, AND POOLS 2 AND 3**

A closer look at the data given in Appendix B reveals that performances of both LES A and LES B are noticeably different before and after September 1<sup>st</sup>, the day the crack detected on Pool 3 was sealed. Figure 11 illustrates the discrepancy. Cumulative water loss from Pool 3 (i.e., the pool covered by LES B), is quite similar with cumulative water loss from the control pool until about August 20, and then it considerably increased until the crack was sealed on September 1<sup>st</sup>. This suggests that the leakage detected in Pool 3 was intensified around August 20. Performance of LES B has improved after the crack was sealed. Likewise, cumulative water loss for Pool 2 (i.e., the pool covered by LES A) was fairly identical to that of the control pool until September 1<sup>st</sup>, and the water loss began to decline after the crack in Pool 3 was sealed. This indicates that the leakage in Pool 3 might have impacted rate of water loss in Pool 2 as well. As such, the data collected for Pool 2 and Pool 3 before September 1<sup>st</sup> were not used to analyze the effectiveness of LES A and LES B, respectively.

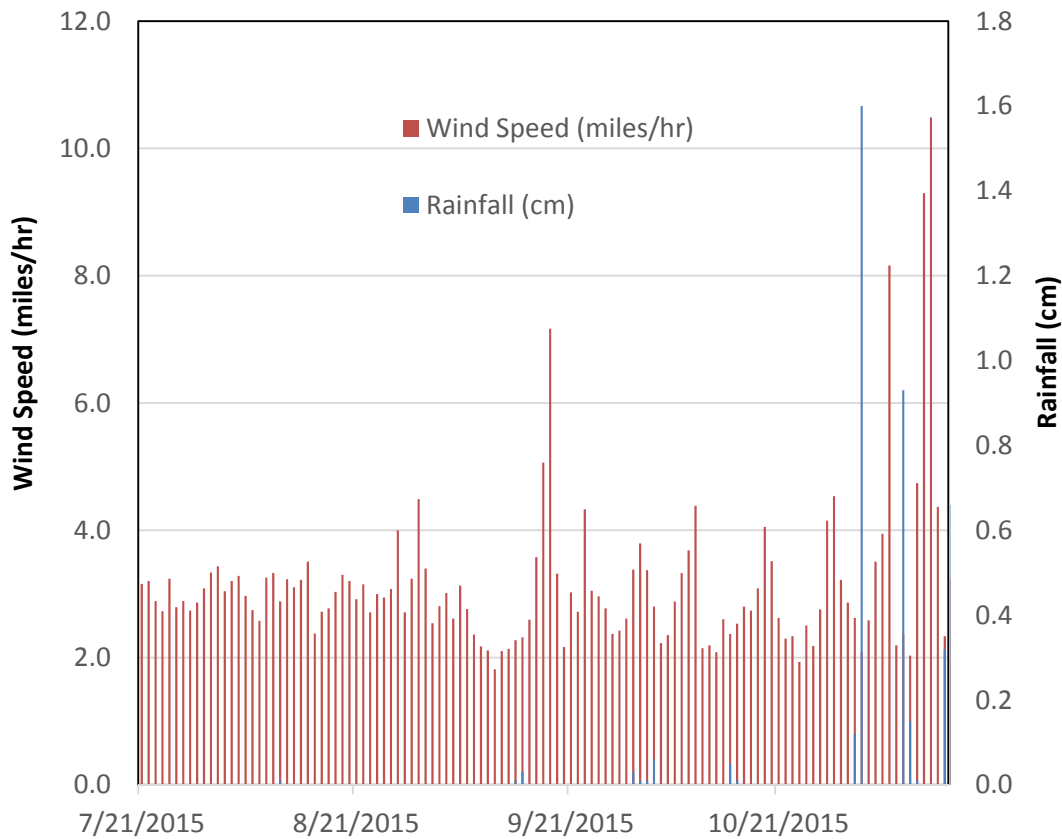
**FIGURE 14. AVERAGE DAILY WIND SPEED AND TOTAL DAILY RAINFALL DURING THE INITIAL PROTOCOL AND THE EXTENSION STUDY**

Evaluating efficiency of the bubble cover was tricky for the extension study. The region received 3.79 cm of rainfall during the extension study compared to only 0.05 cm during the initial protocol period. All of the rain occurred between November 1 and November 15, the period the bubble cover was tested. We noticed that after a rain event, the rainwater sits on the bubble cover and raises water level in the pool by buoyancy effect. The water sitting on the cover evaporates at the rate dictated by environmental factors thus dropping water level in Pool 2 faster than it would had there been no rain. In addition, it is not clear what fraction of the rain is captured by the cover, what fraction flows over the cover and enter the pool, or what fraction may splash off the cover to another pool or ground. This issue has caused doubt

on how to calculate efficiency of the bubble cover for the extension. The efficiency given in Table 11 for bubble cover (i.e., 86.3%) was calculated with the arbitrary assumption that only twenty five percent of the rainfall would enter the pool while the remaining 75% would be captured by the cover and evaporate at a rate identical to uncovered pools. For the sake of comparison, if none of the rainwater is assumed to enter the pool, then efficiency of the bubble cover would be 97.2% which is more consistent with the efficiency obtained for the cover during the initial protocol.
