October 11, 2011

Irvine Ranch Water District
Attention: Paul Weghorst
15600 Sand Canyon Avenue
Irvine, CA 92618

Subject: *Strand Ranch South Basin Field Reconnaissance and Remediation Recommendations*

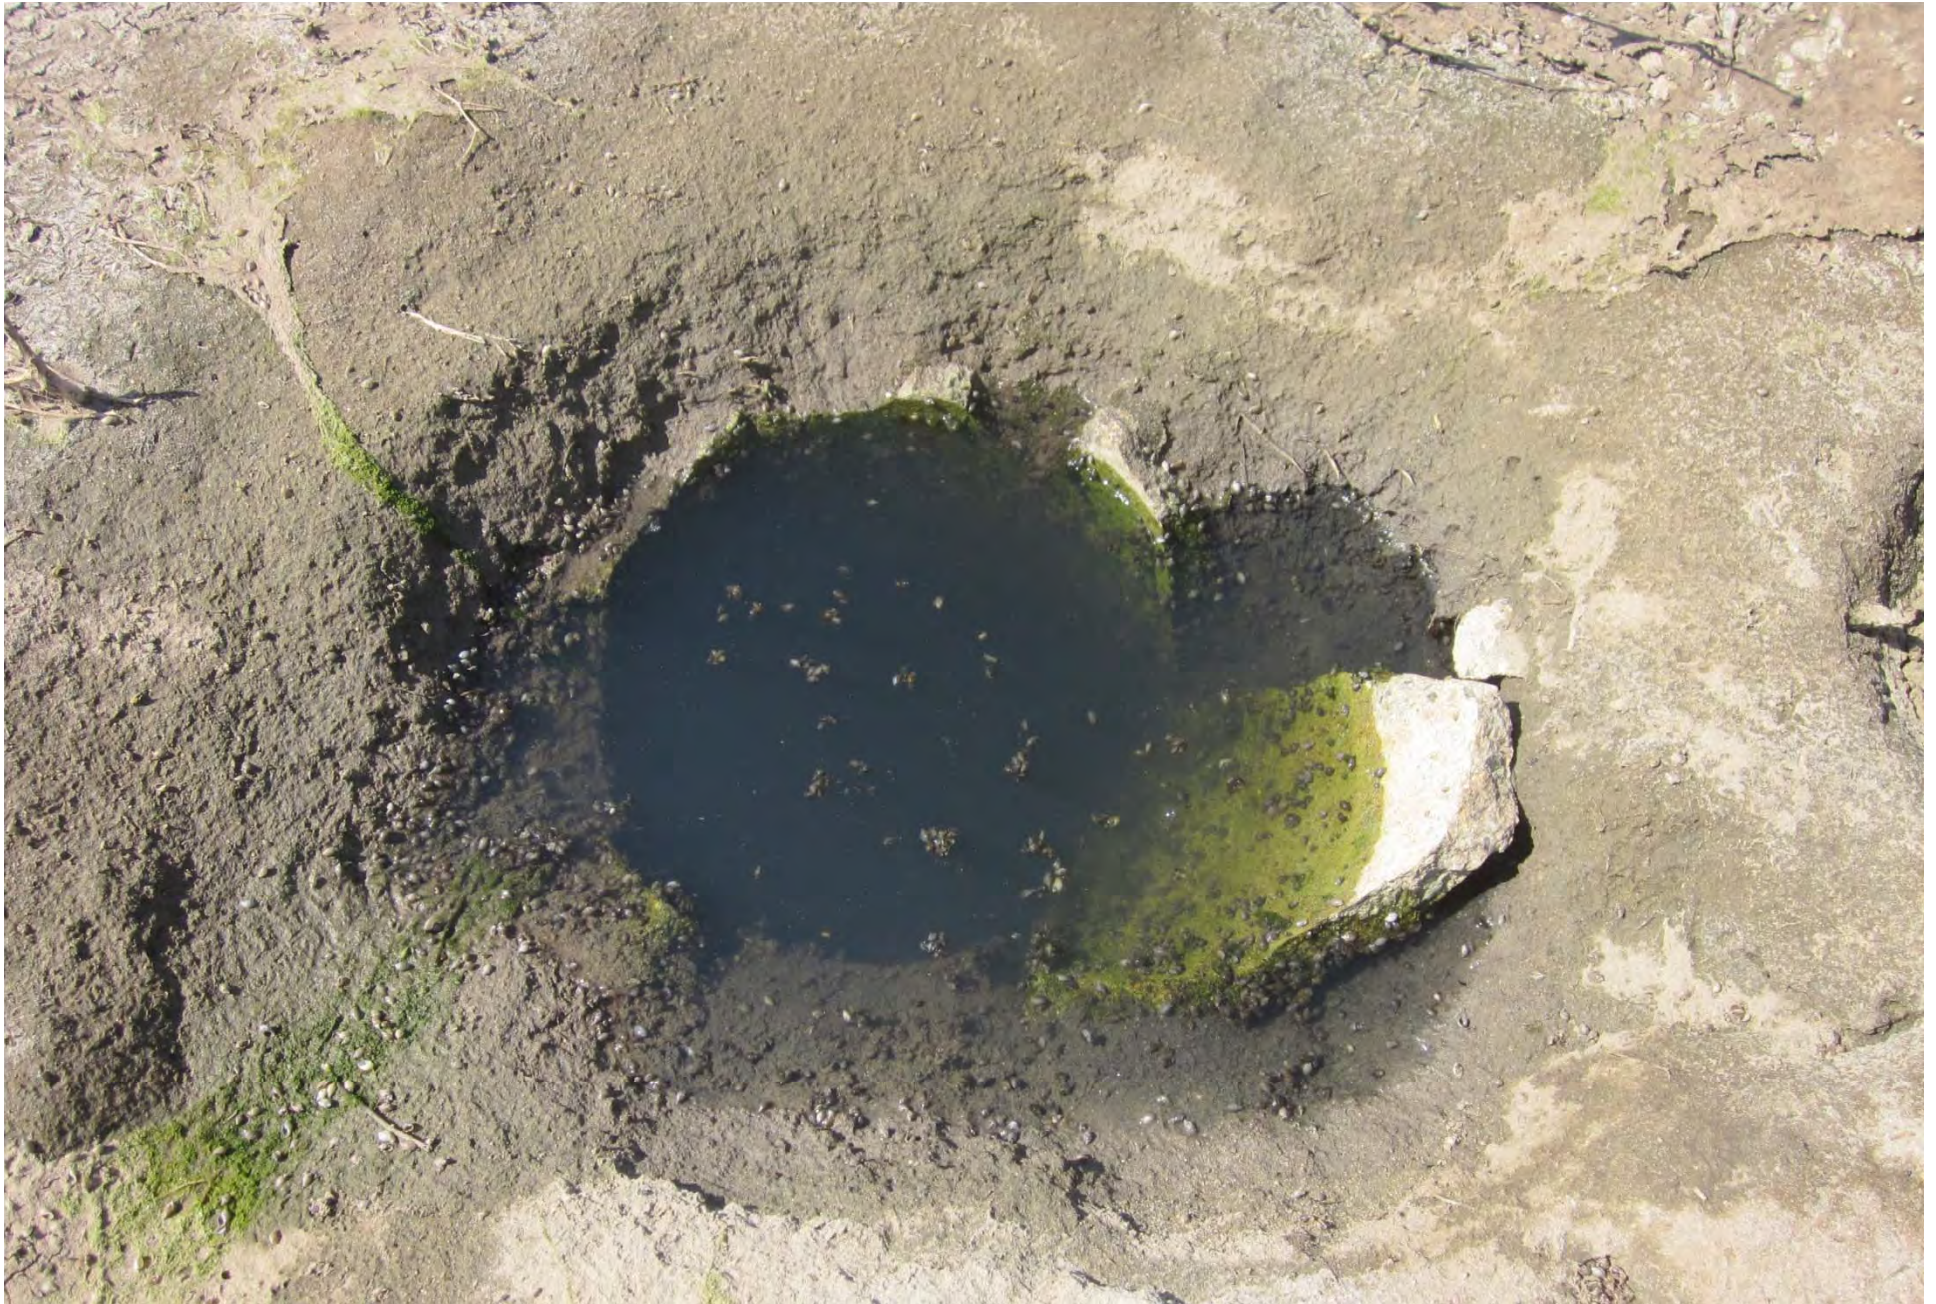
Photo 35 (5F): Old irrigated pipe filled with water in Basin No. 20; a second old pipe is barley visible to the right

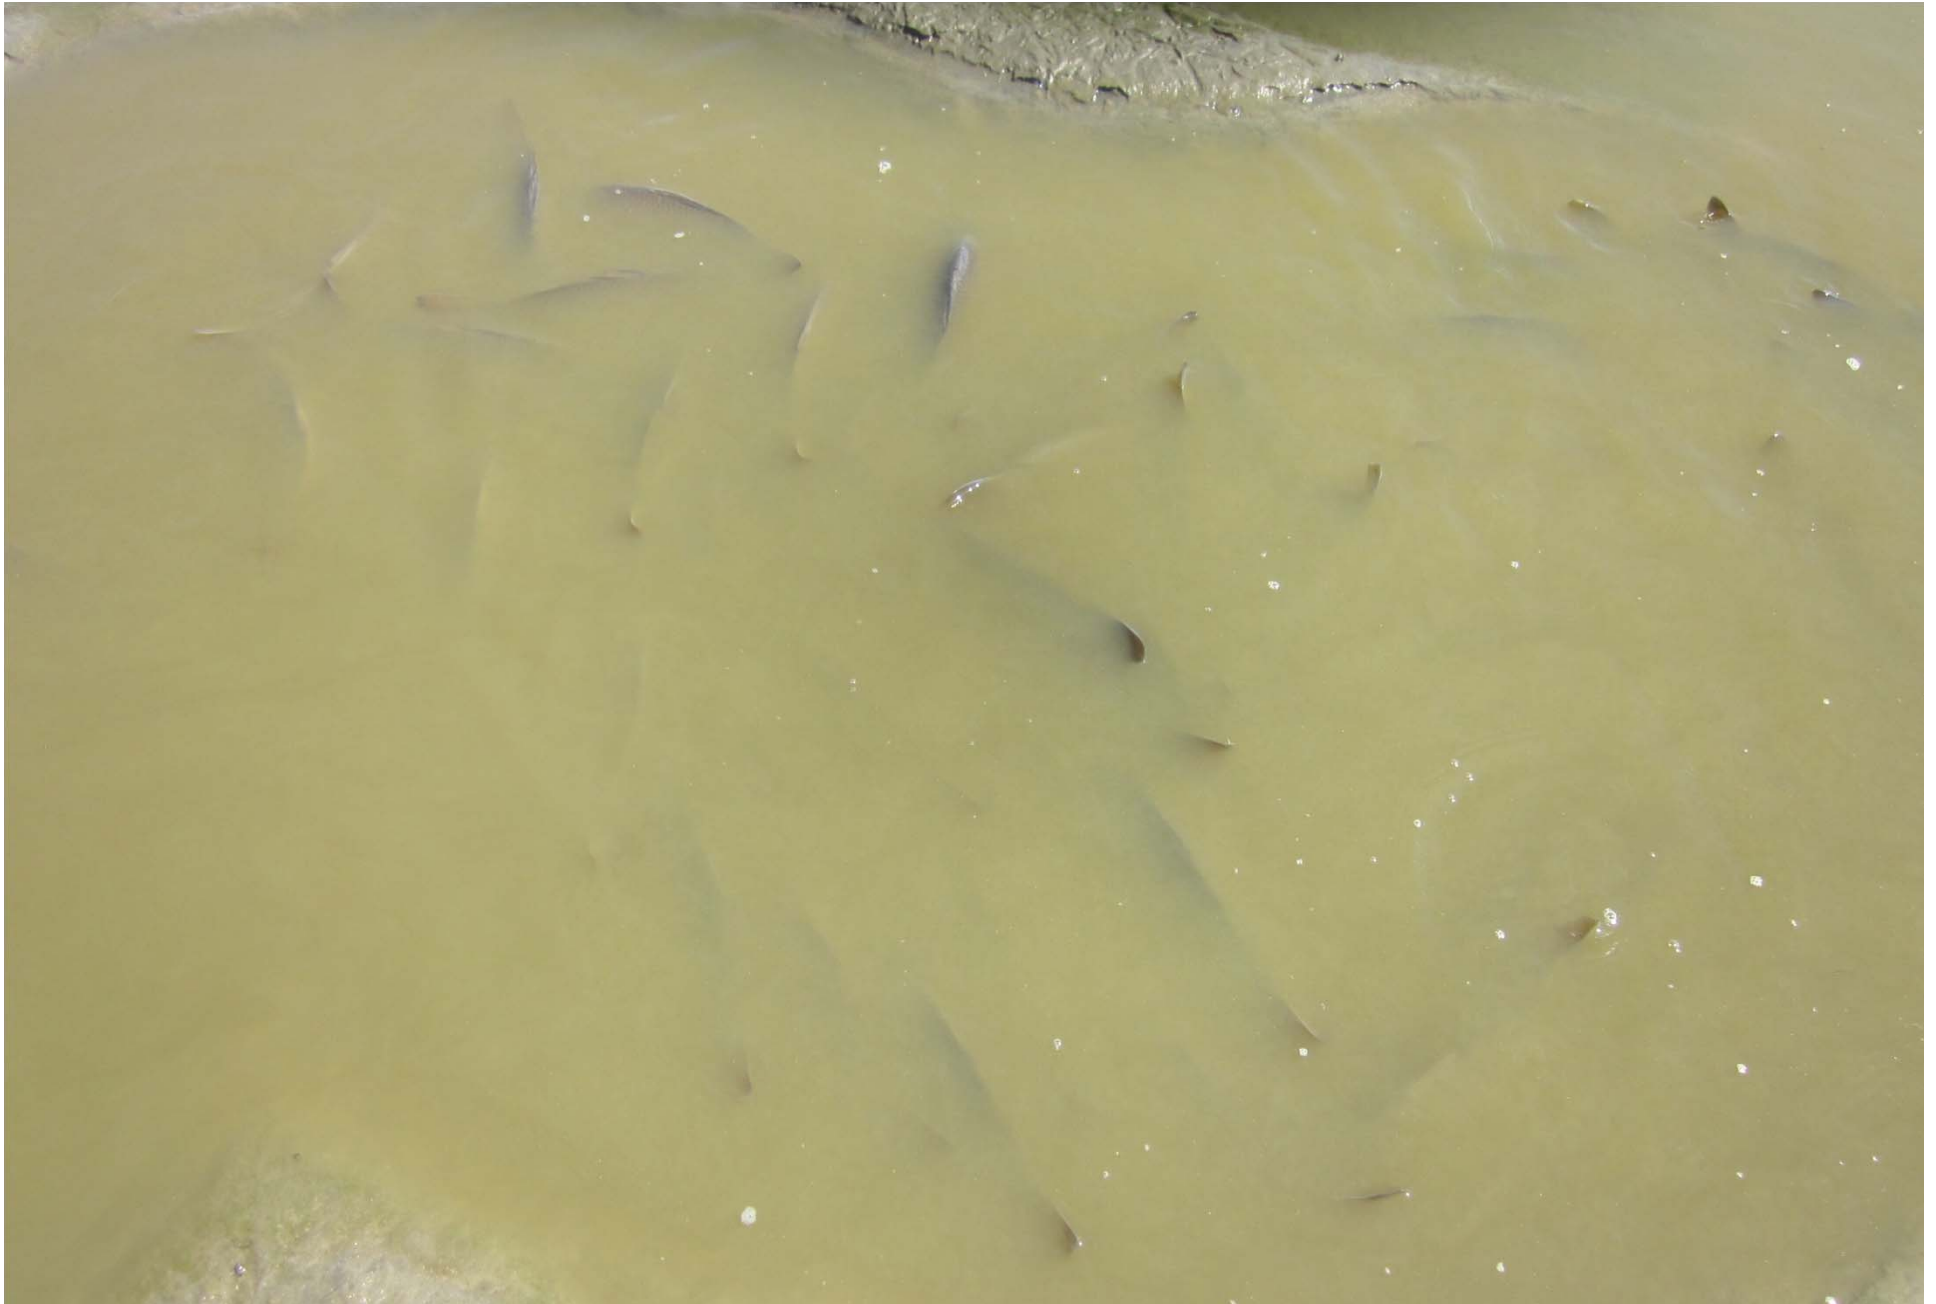
Photo 48 (8G): Fish in stagnant water (heavy algae) adjacent to 1-Bay transfer structure in Basin No. 19

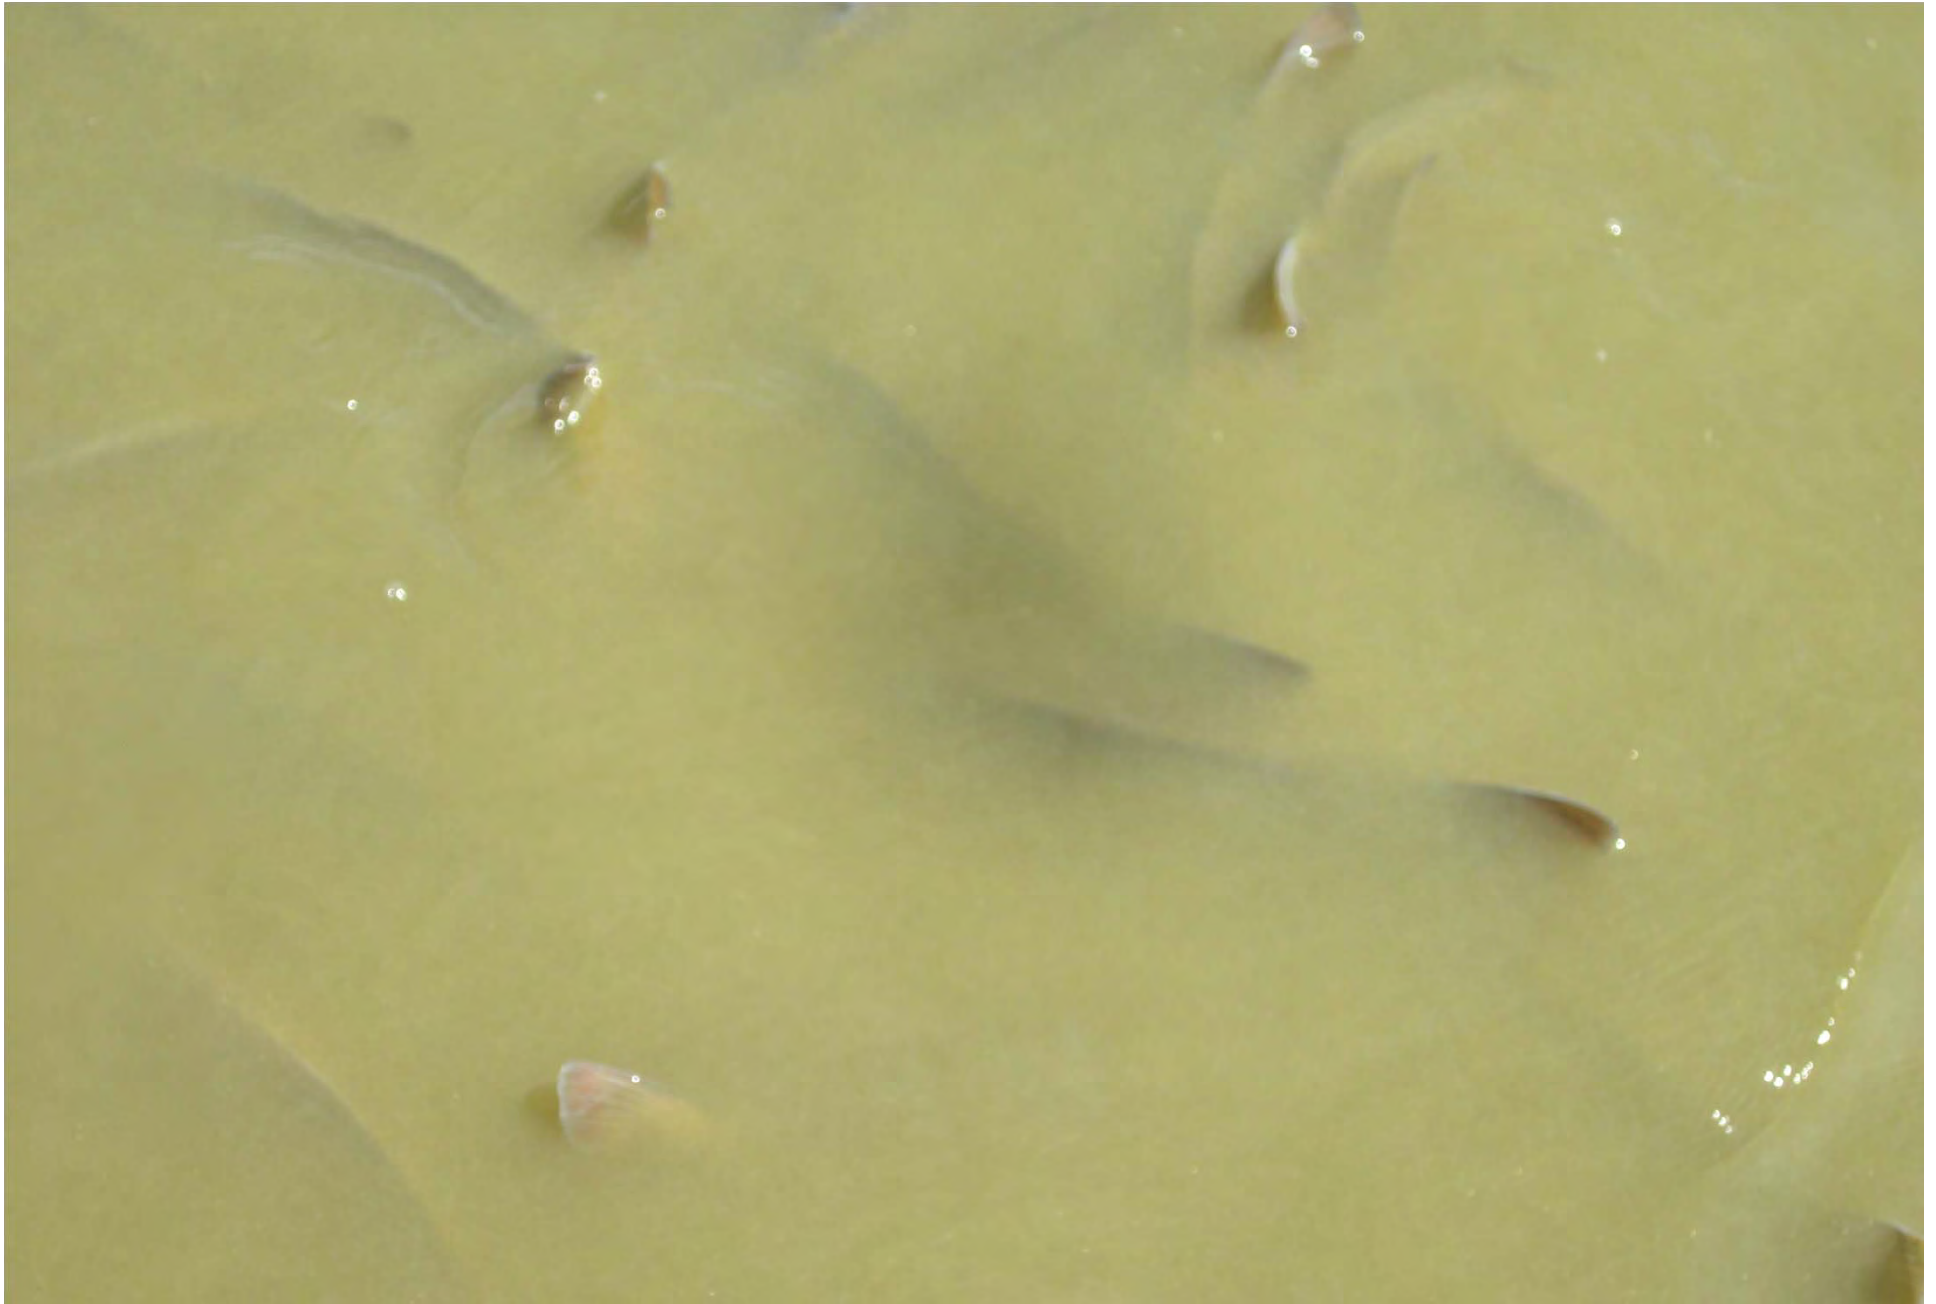
Photo 49 (8G): Fish in stagnant water (heavy algae) adjacent to 1-Bay transfer structure in Basin No. 19

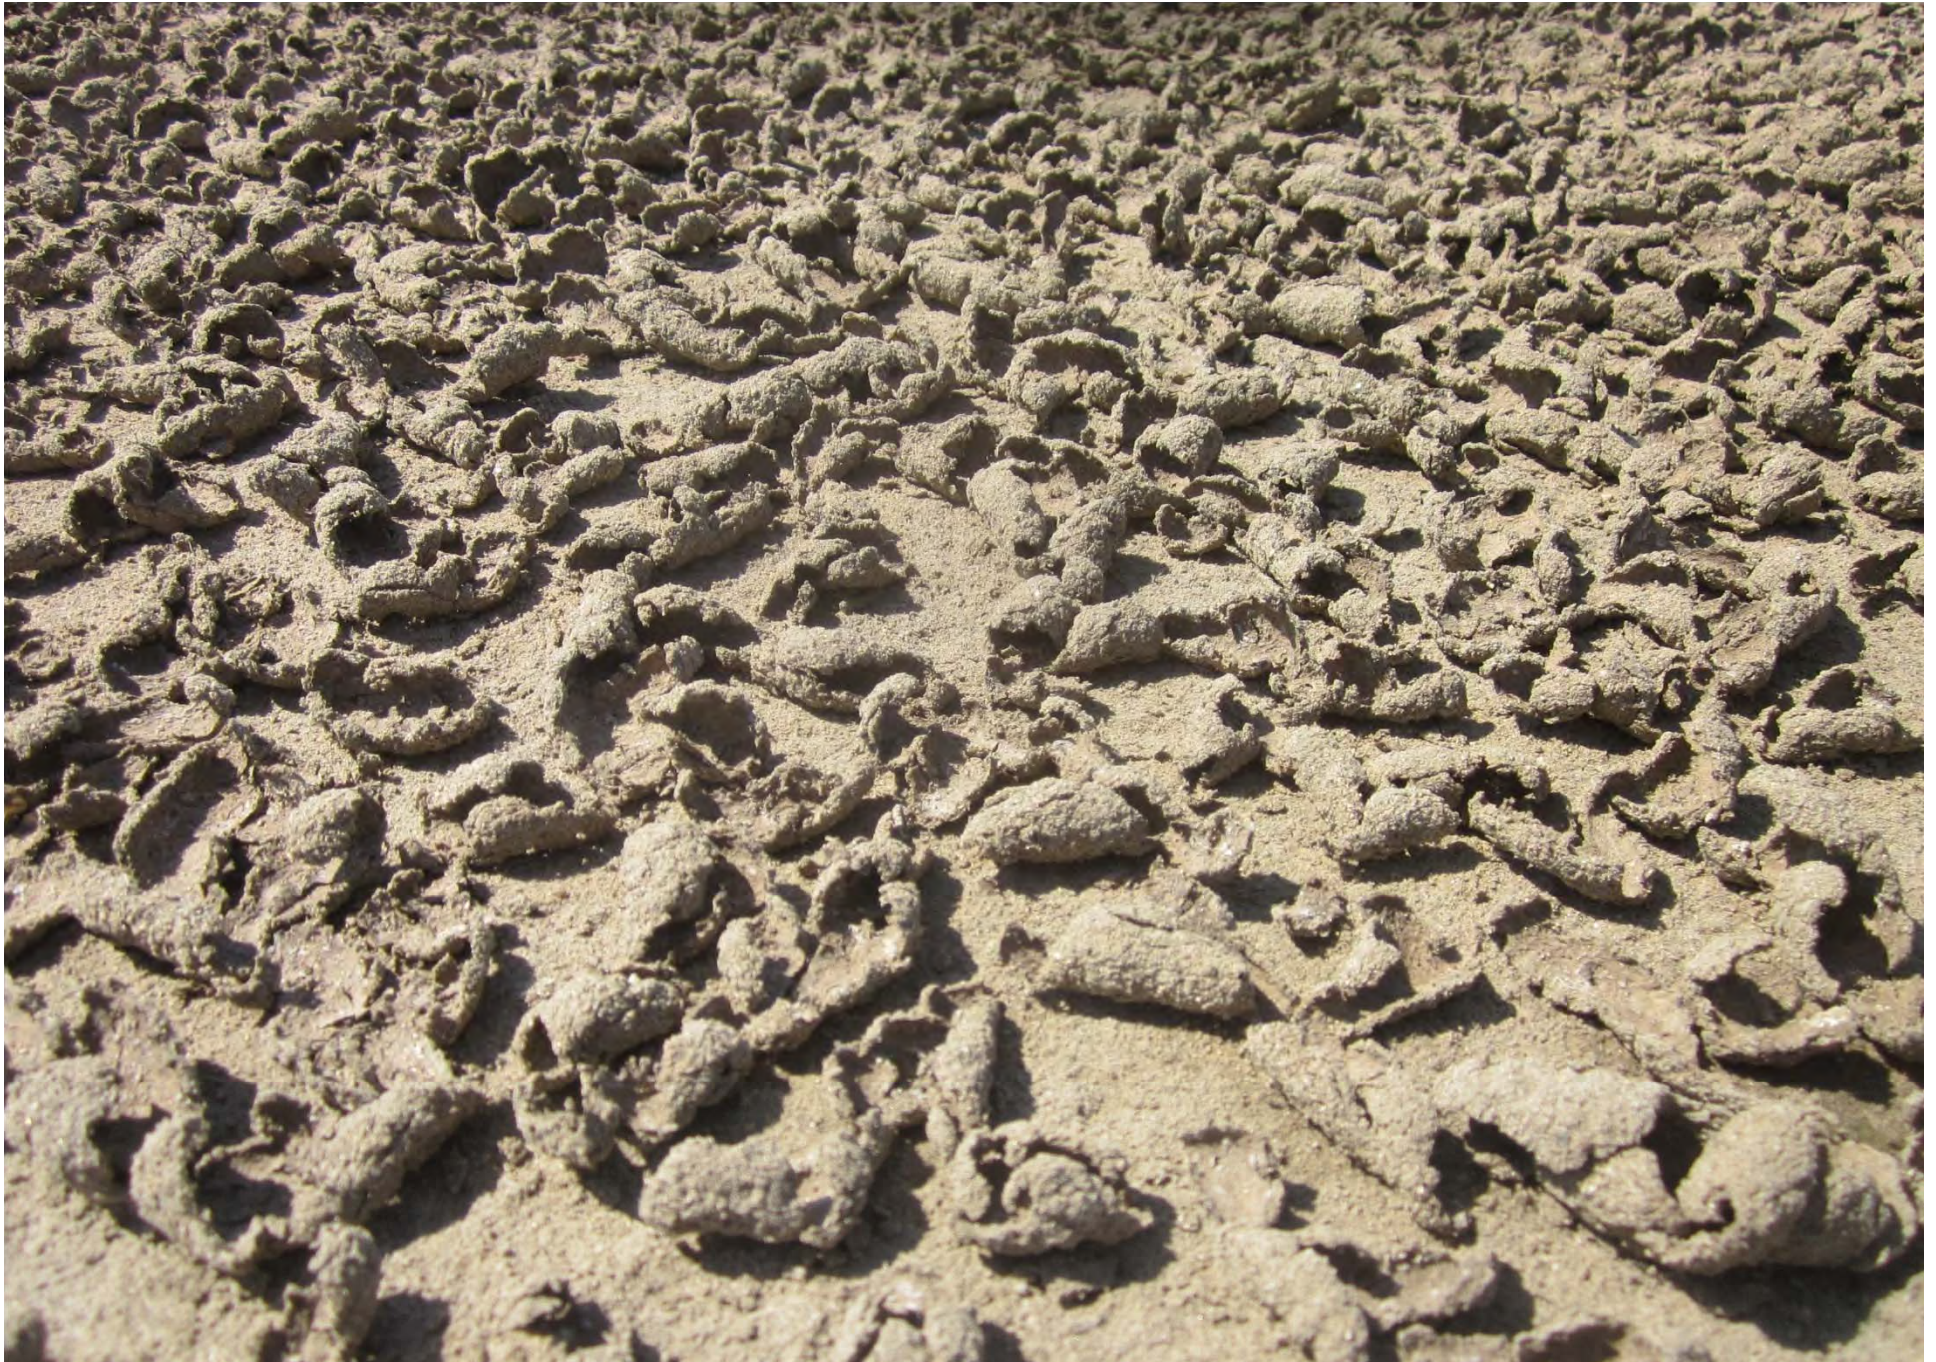
Photo 52 (9B): Basin No. 19 mud/bio-chips overlying sandy-silt sediments (sample)

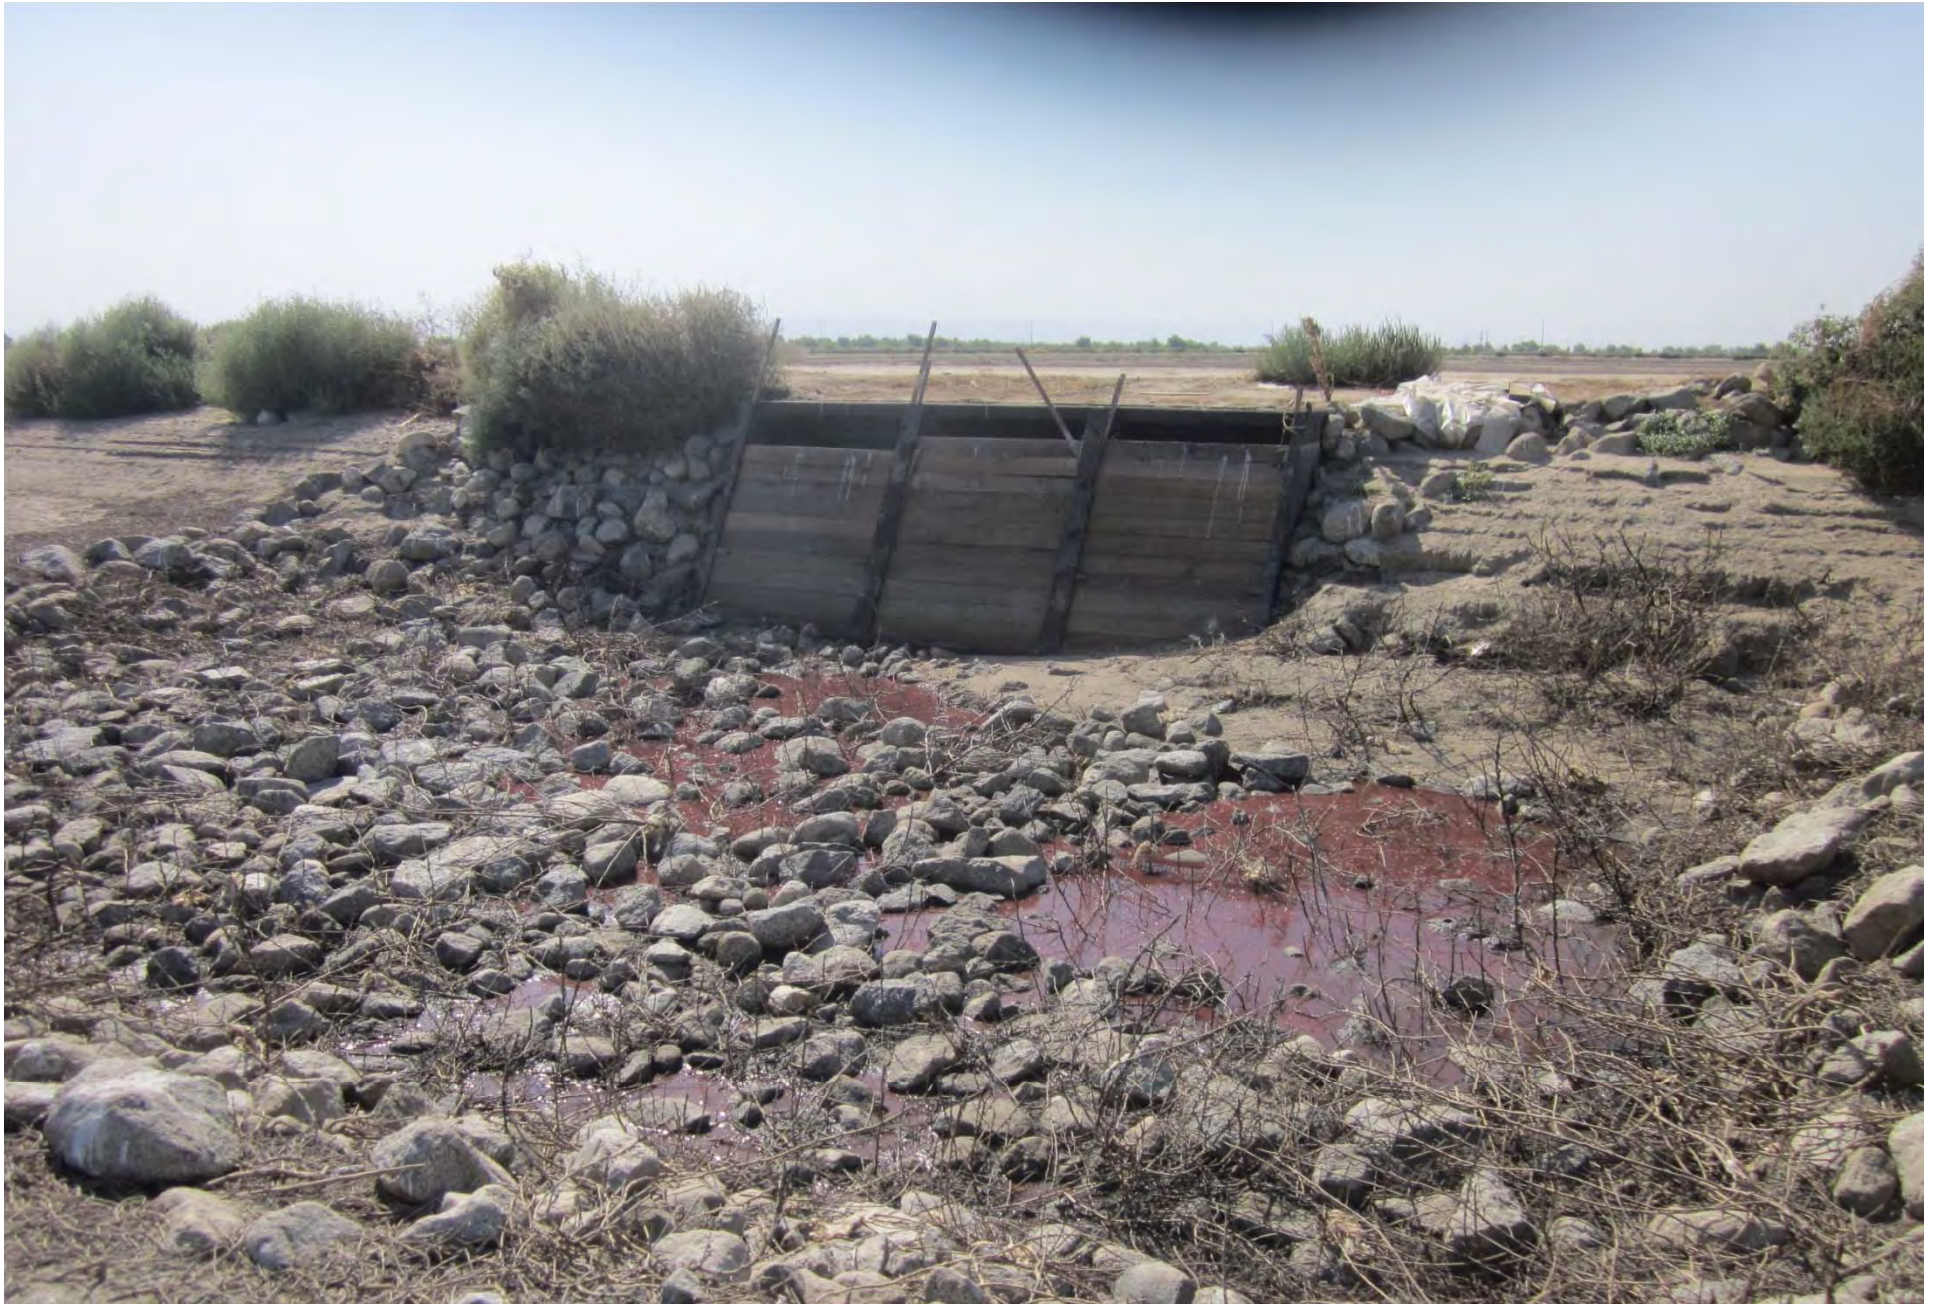
Photo 59 (22P): 3-Bay transfer structure between Basin No. 18 and No. 3; stagnant water in rip-rap with red algae and dead growth

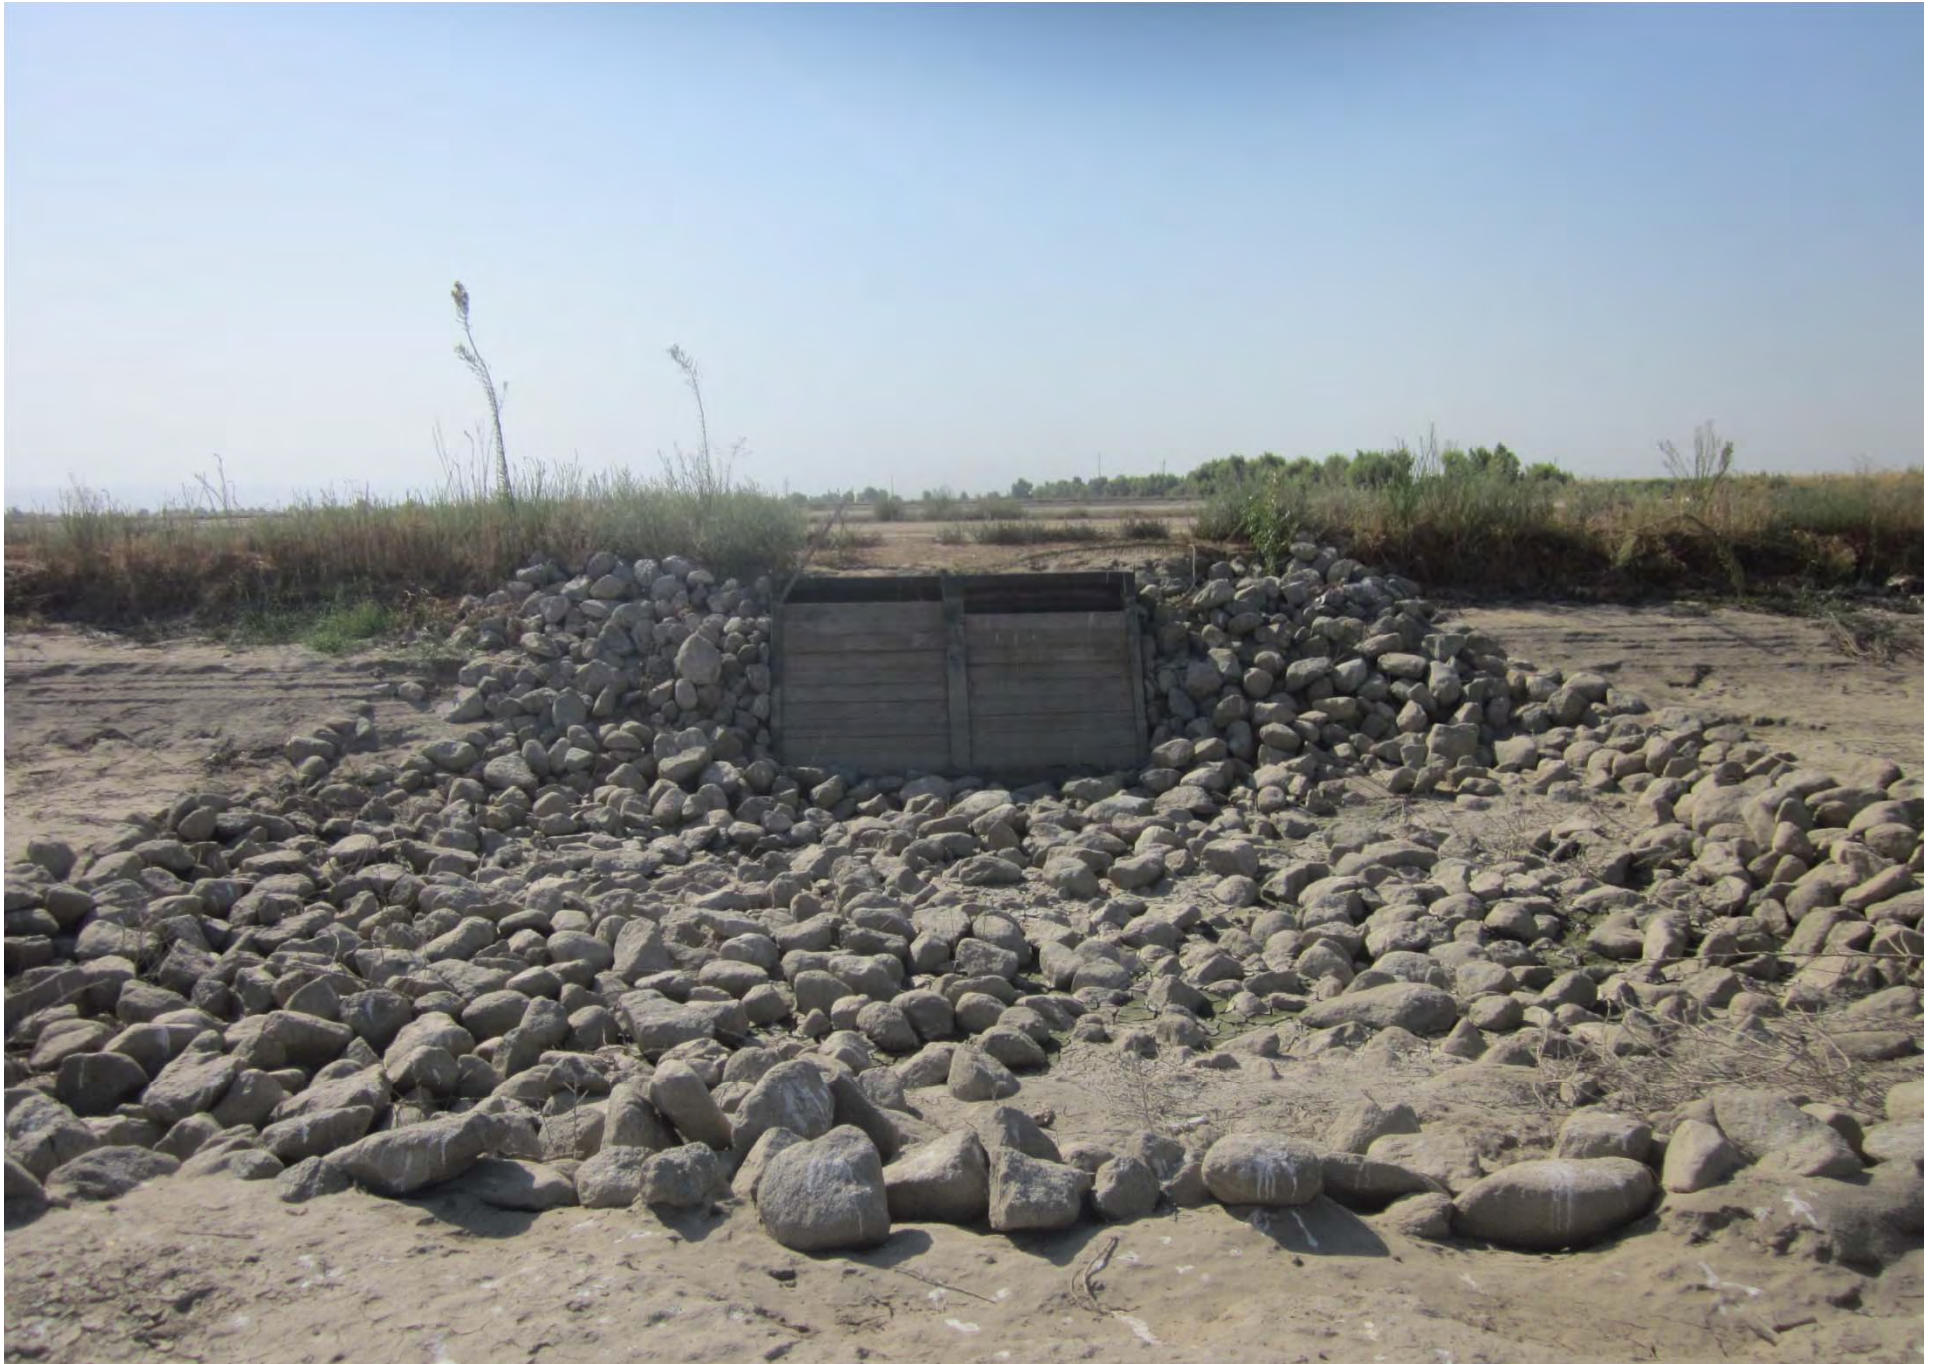
Photo 61 (22C): 2-Bay transfer structure between Basin No. 6 and No. 18

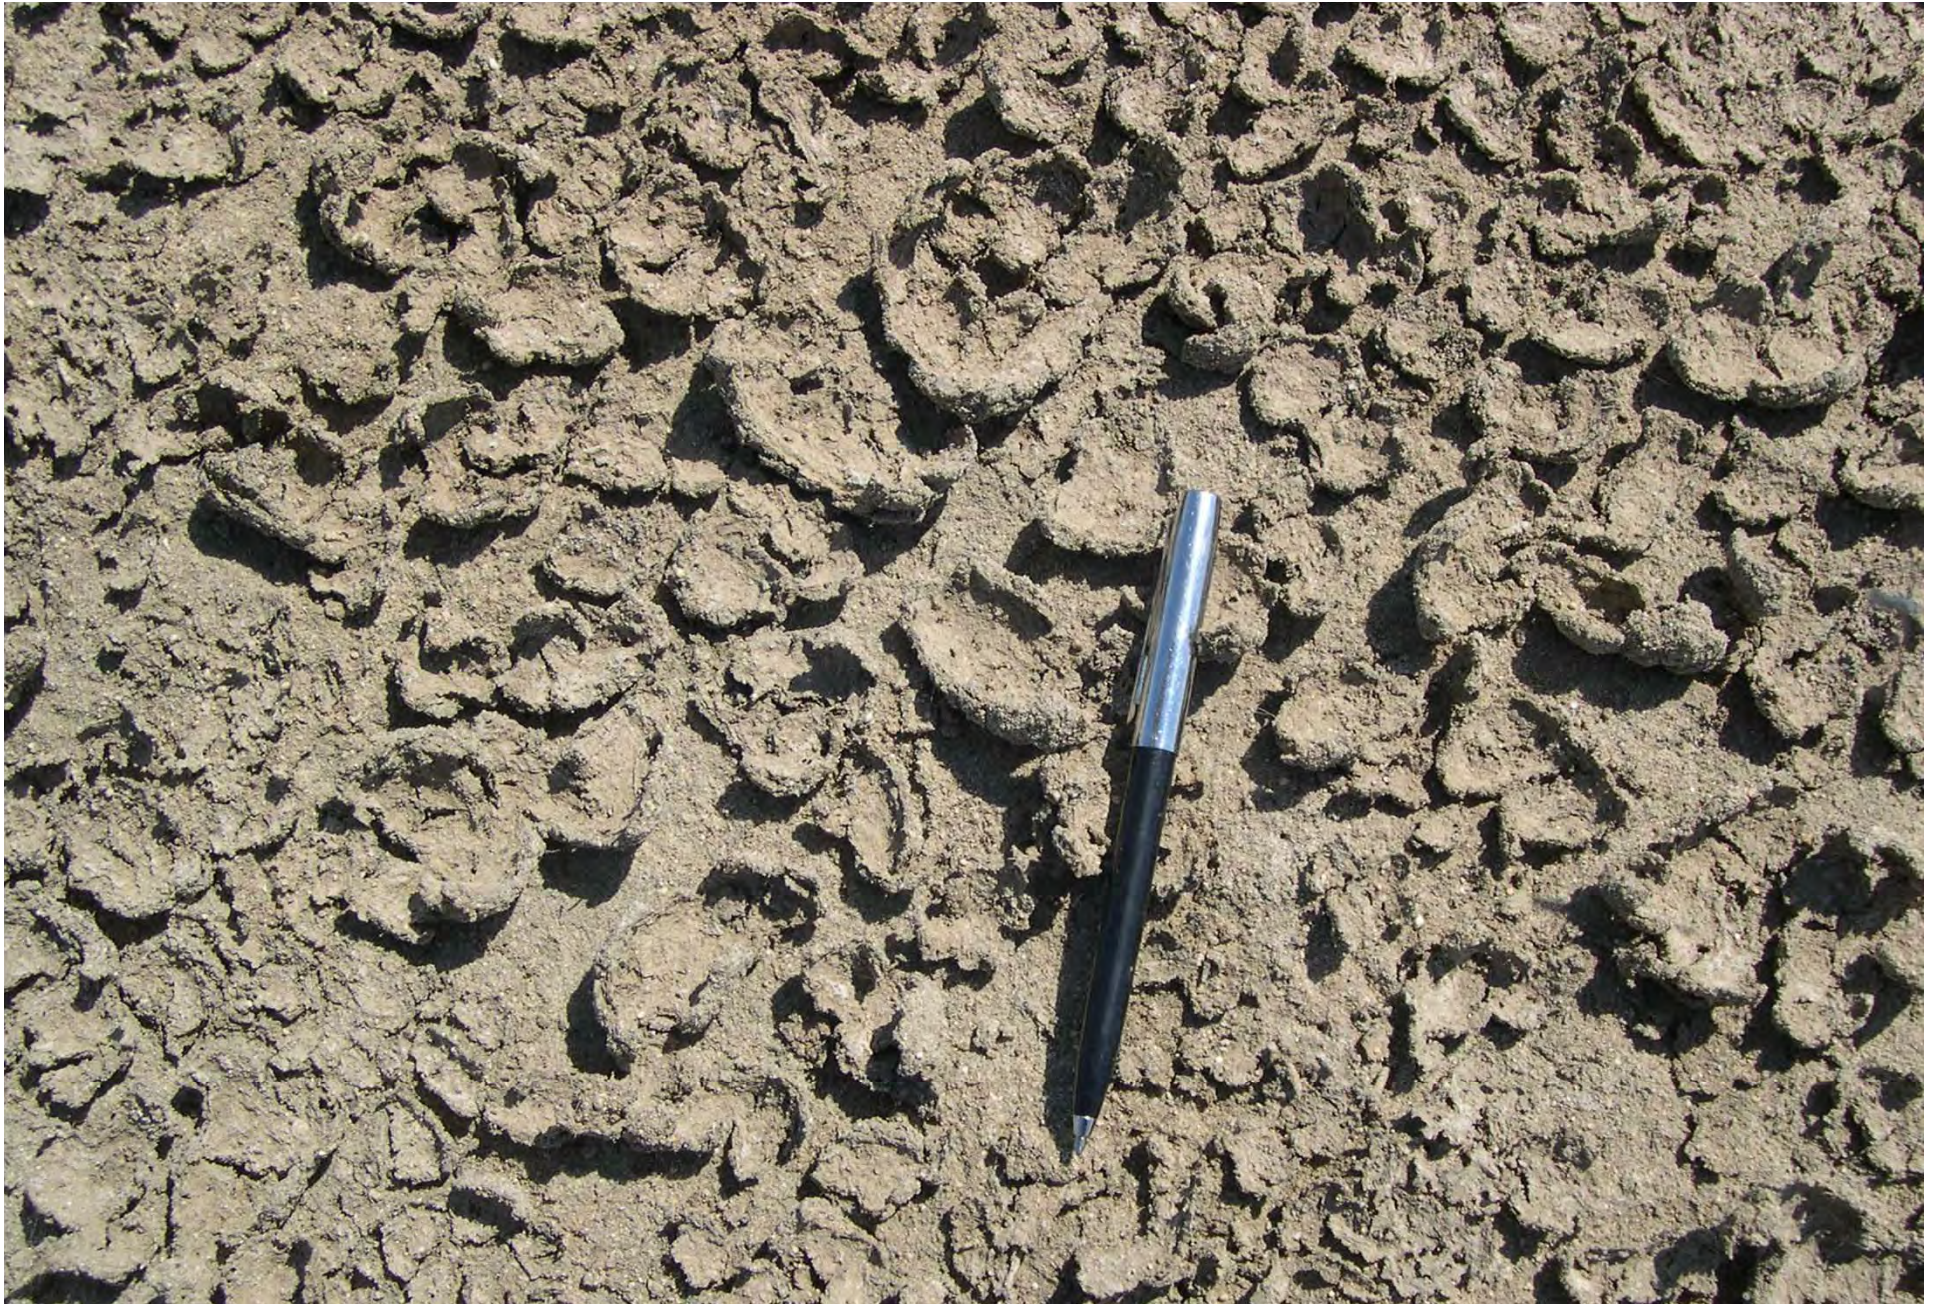
Photo 38b (10A): Basin No. 19 mud/bio-chips ~2-5 cm in length and ~1-4 mm thick overlying sandy silt sediment

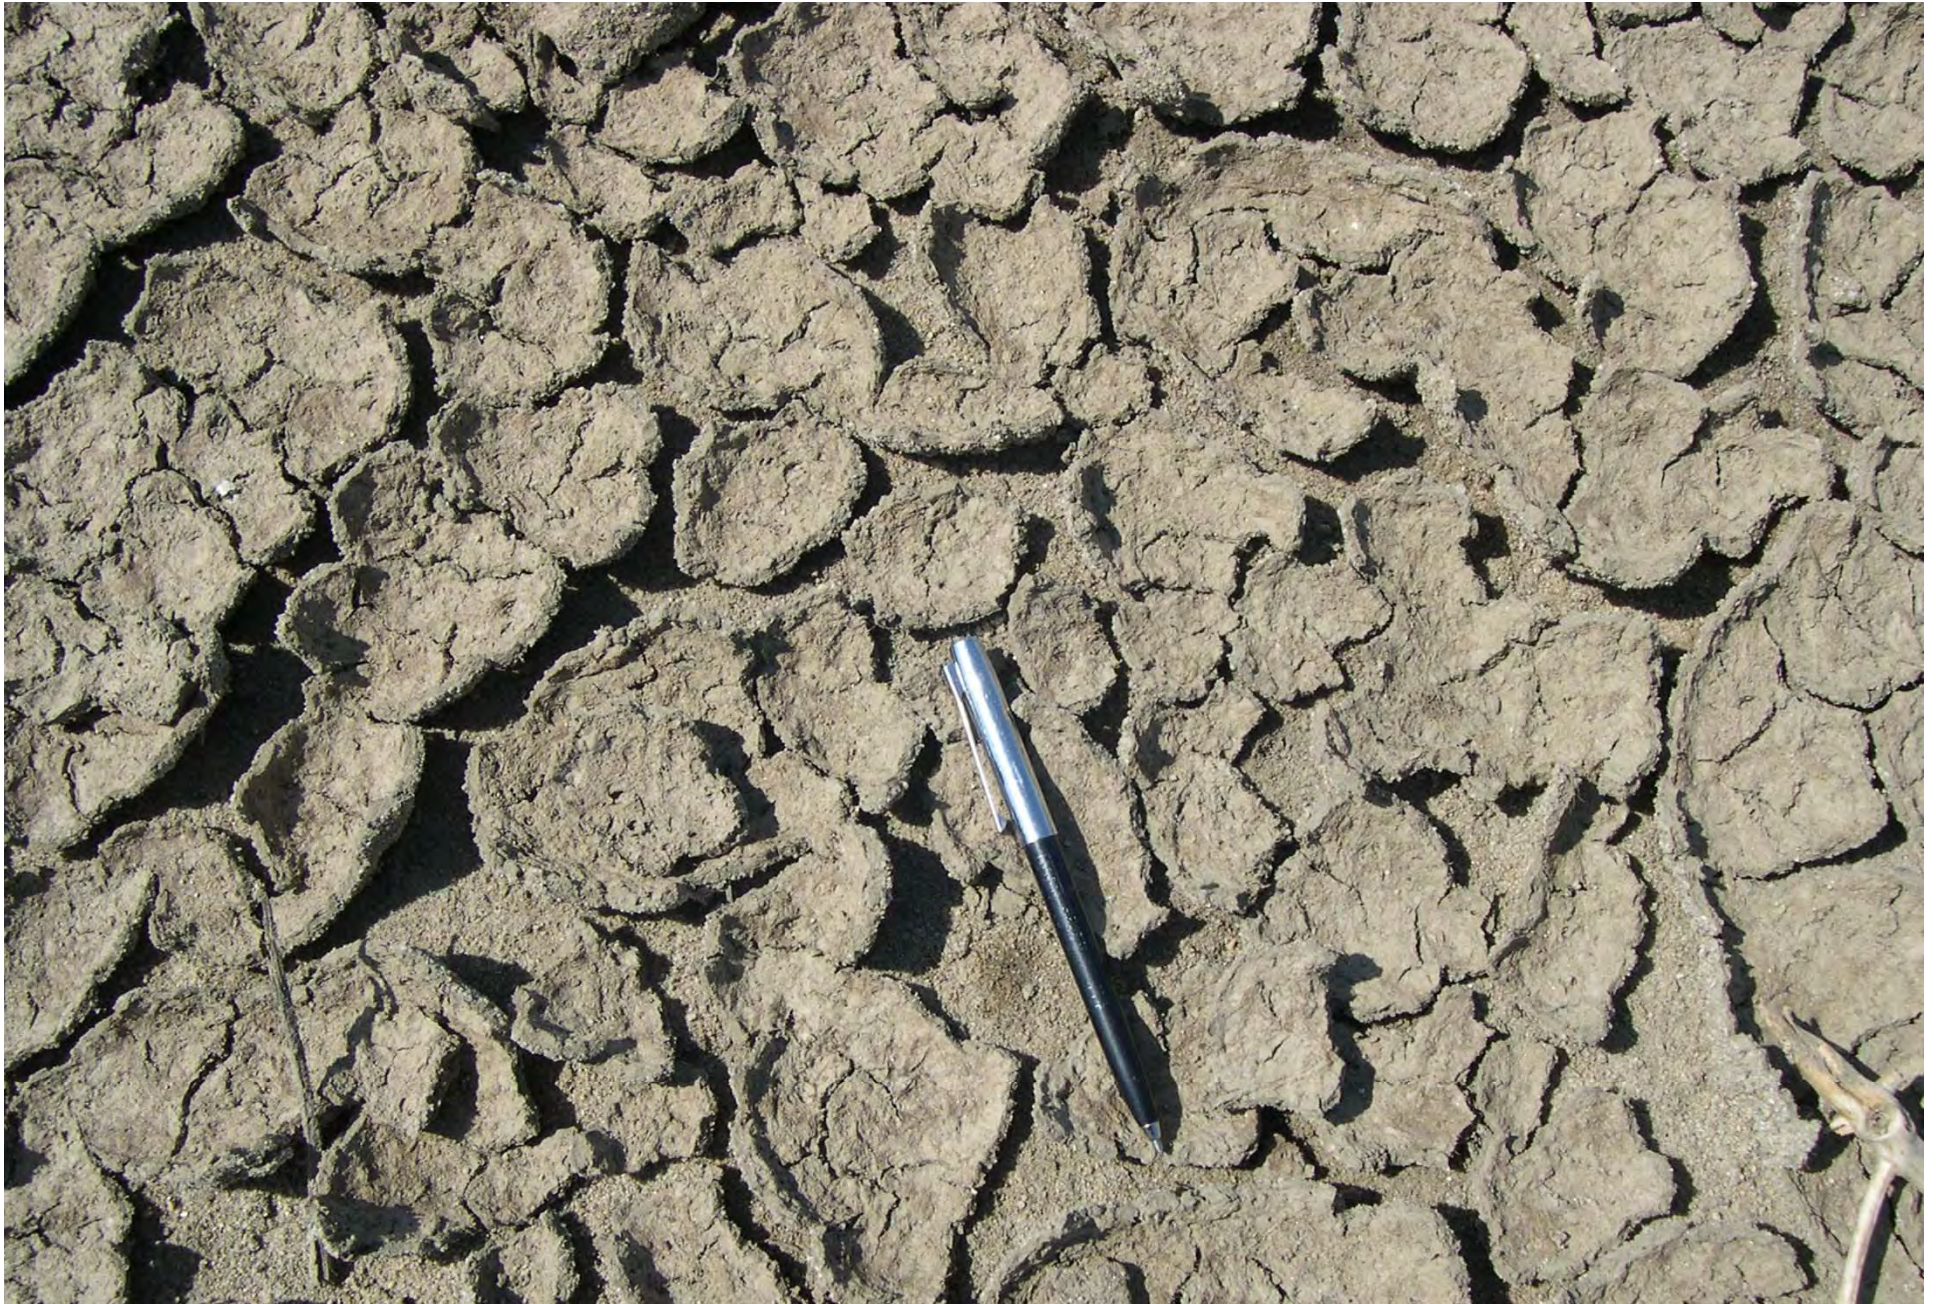
Photo 41b (12E): Basin No. 19 mud/bio-chips ~2-5 cm in length and ~2-3 mm thick overlying sandy silt sediment

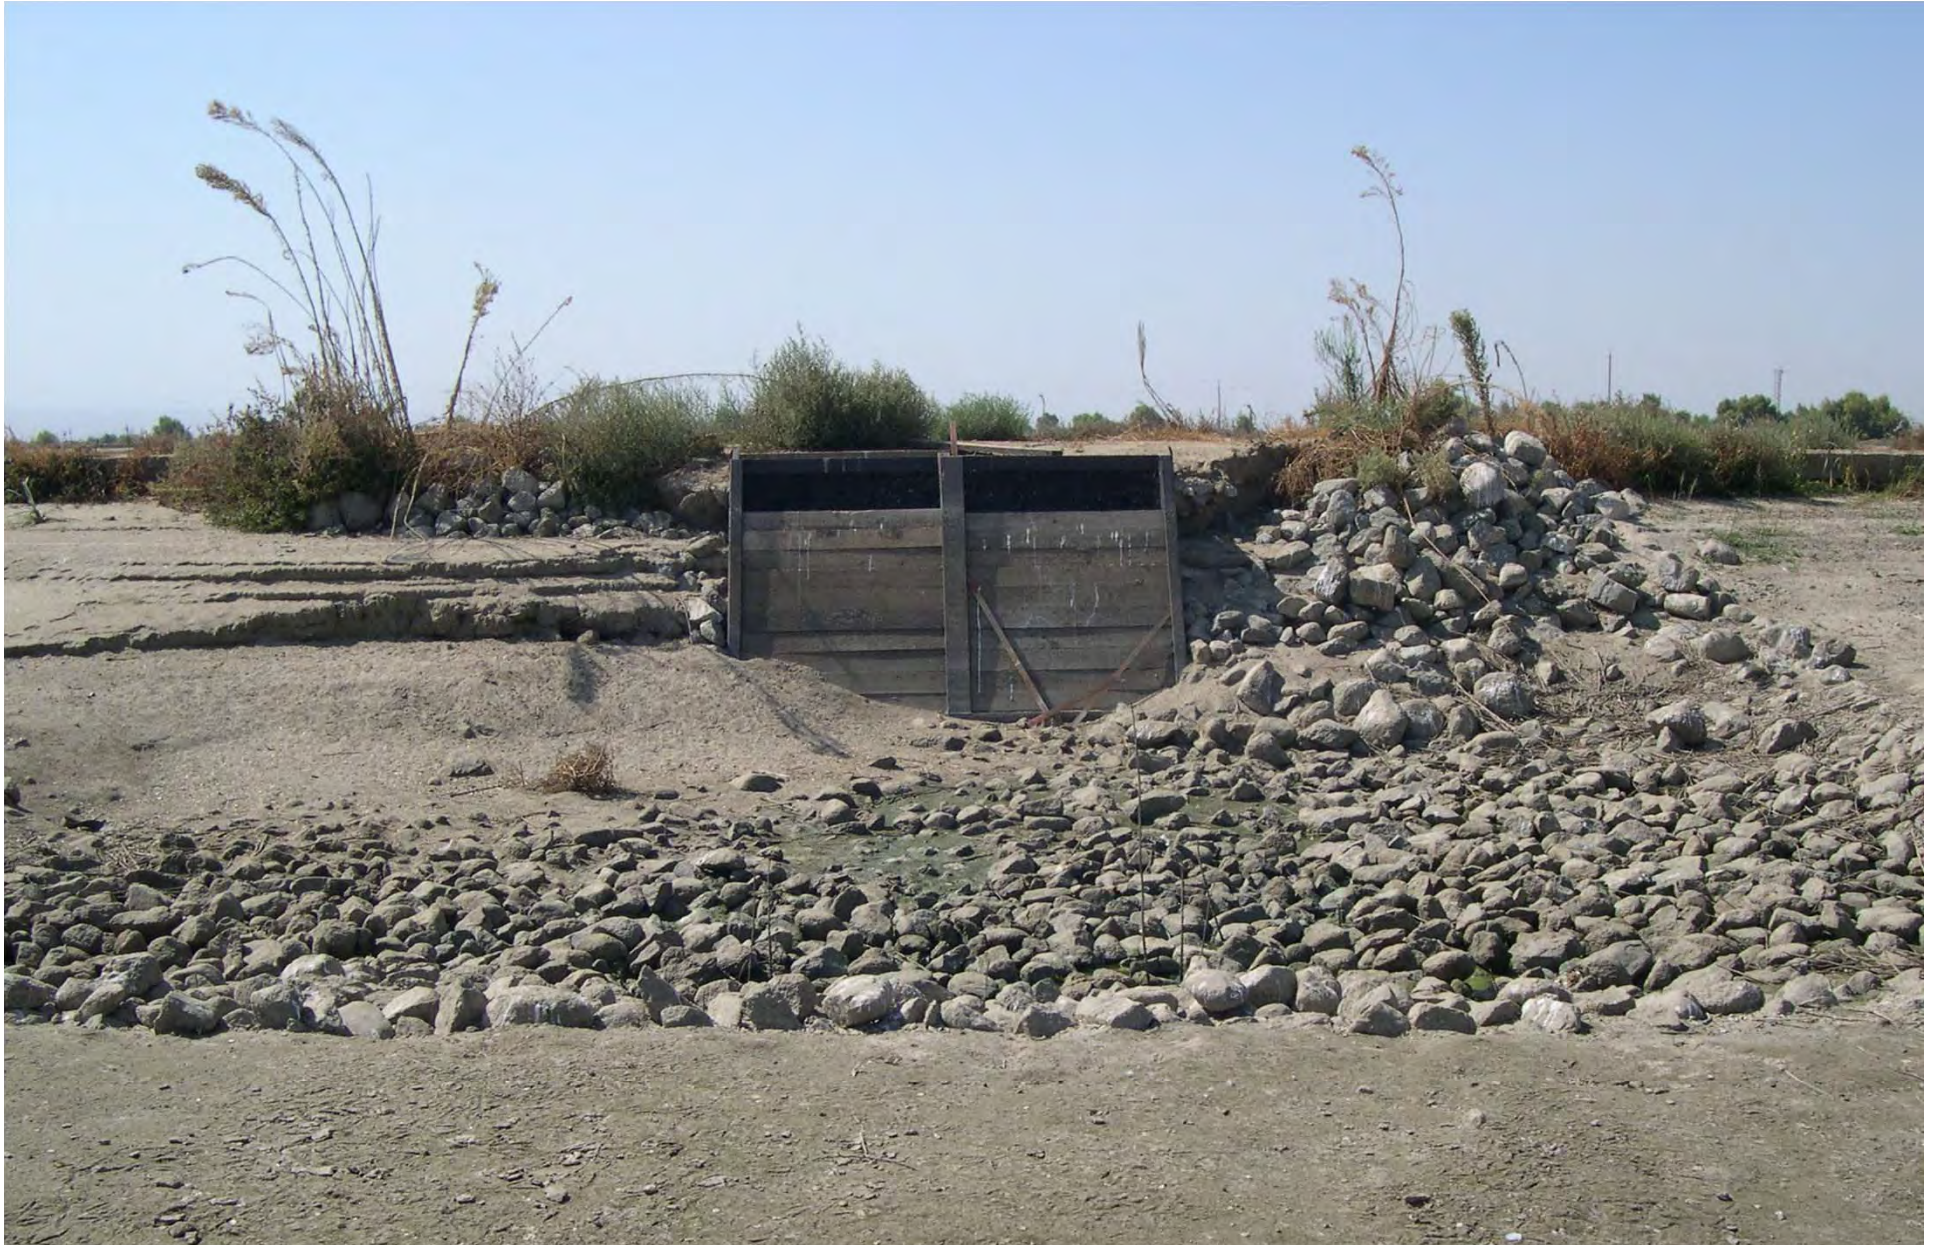
Photo 50b (15F): 2-Bay transfer structure between Basin No. 18 and No. 19; sediment covers part of rip-rap and outlet structure; green algae mat covers sediment adjacent to rip-rap; west berm erosion
