October 11, 2011

Irvine Ranch Water District
Attention: Paul Weghorst
15600 Sand Canyon Avenue
Irvine, CA 92618

Subject: *Strand Ranch South Basin Field Reconnaissance and Remediation Recommendations*

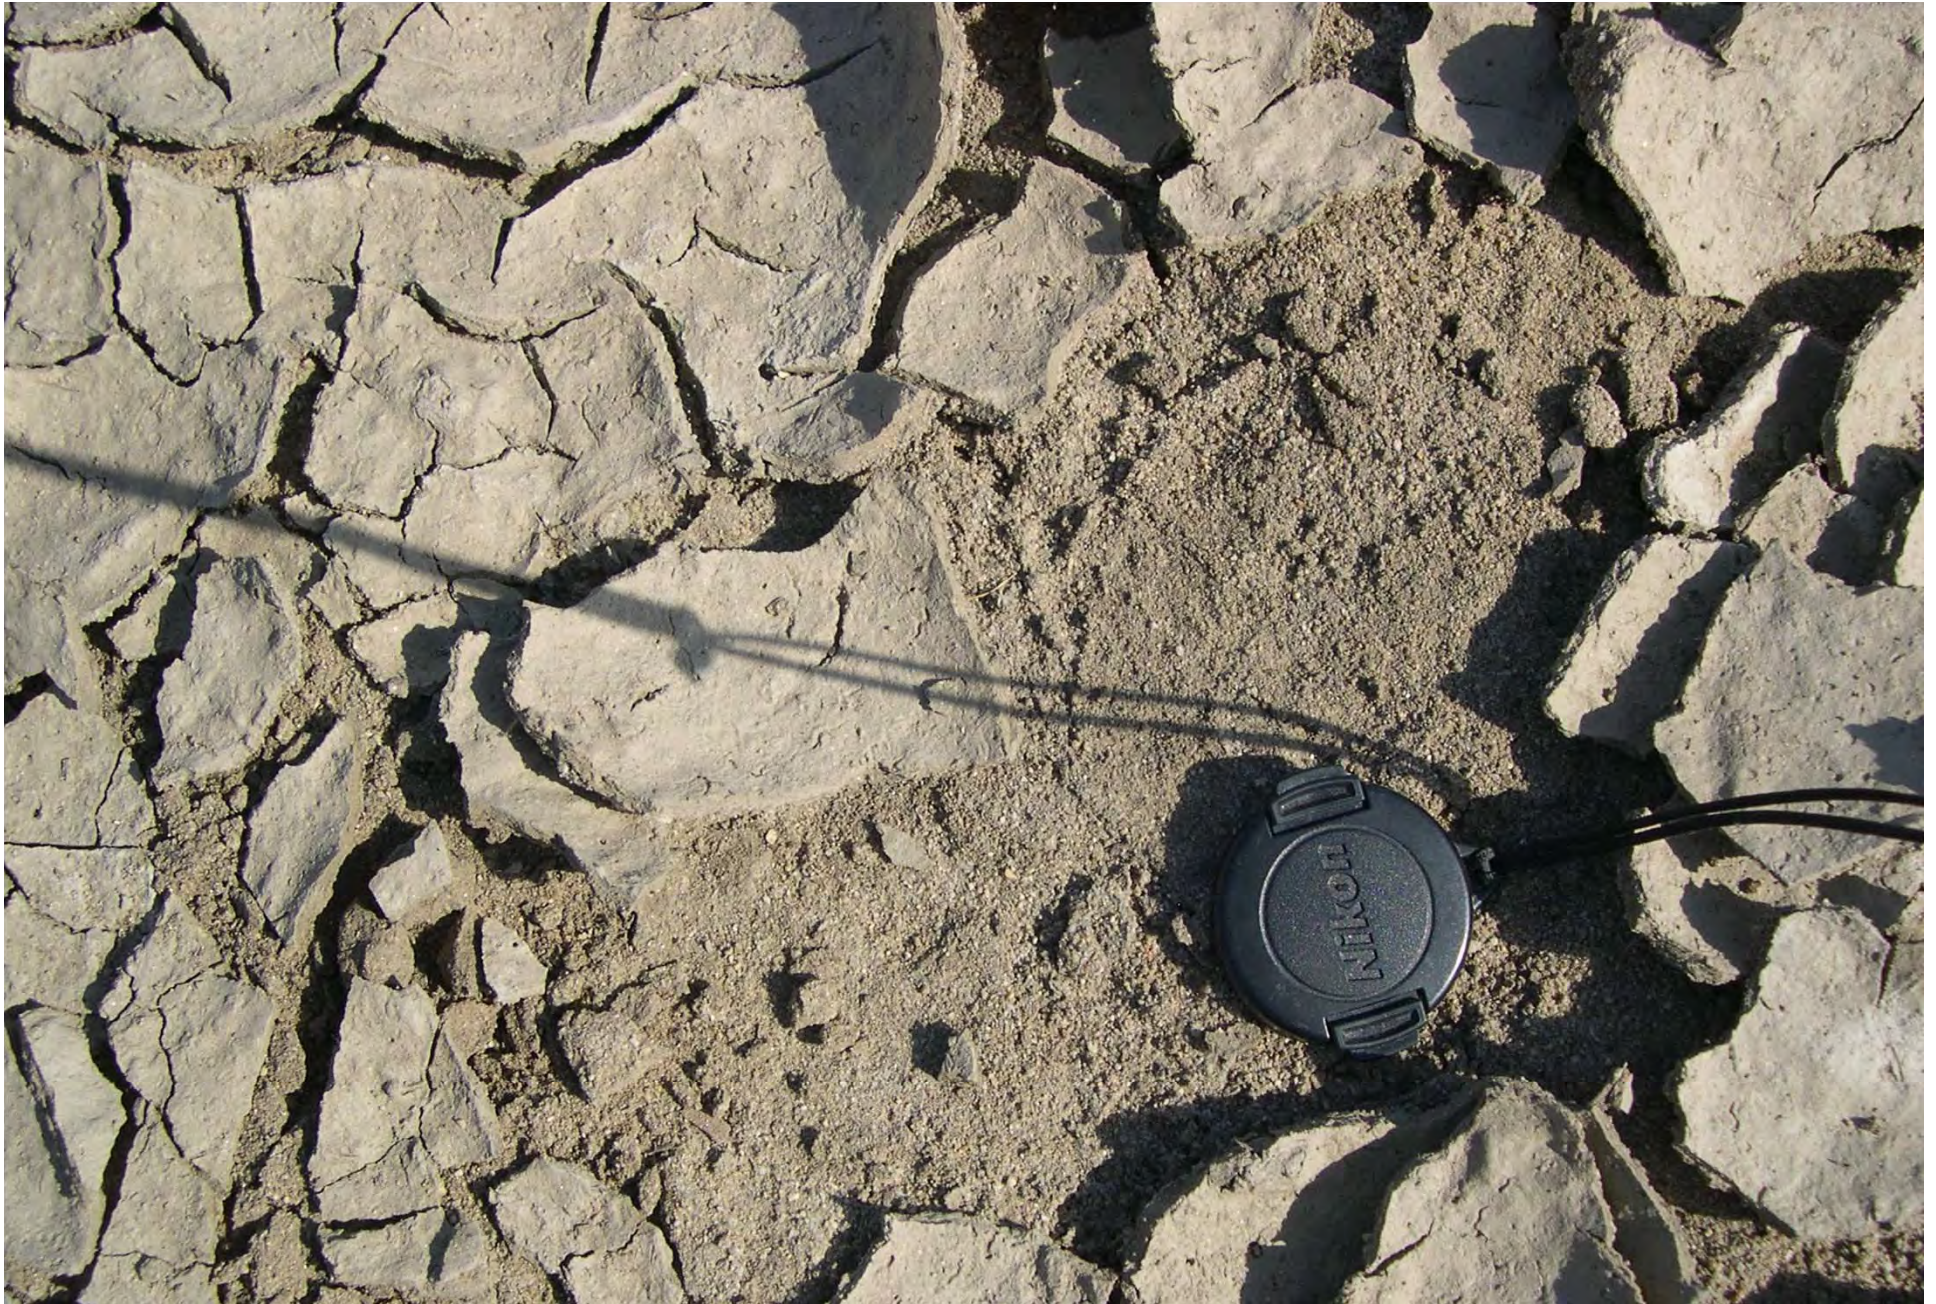
Photo 60b (26C): Basin No. 6 mud-chips ~5-7 cm in length and ~2 mm thick overlying dense sand and silt
