October 11, 2011

Irvine Ranch Water District
Attention: Paul Weghorst
15600 Sand Canyon Avenue
Irvine, CA 92618

Subject: *Strand Ranch South Basin Field Reconnaissance and Remediation Recommendations*

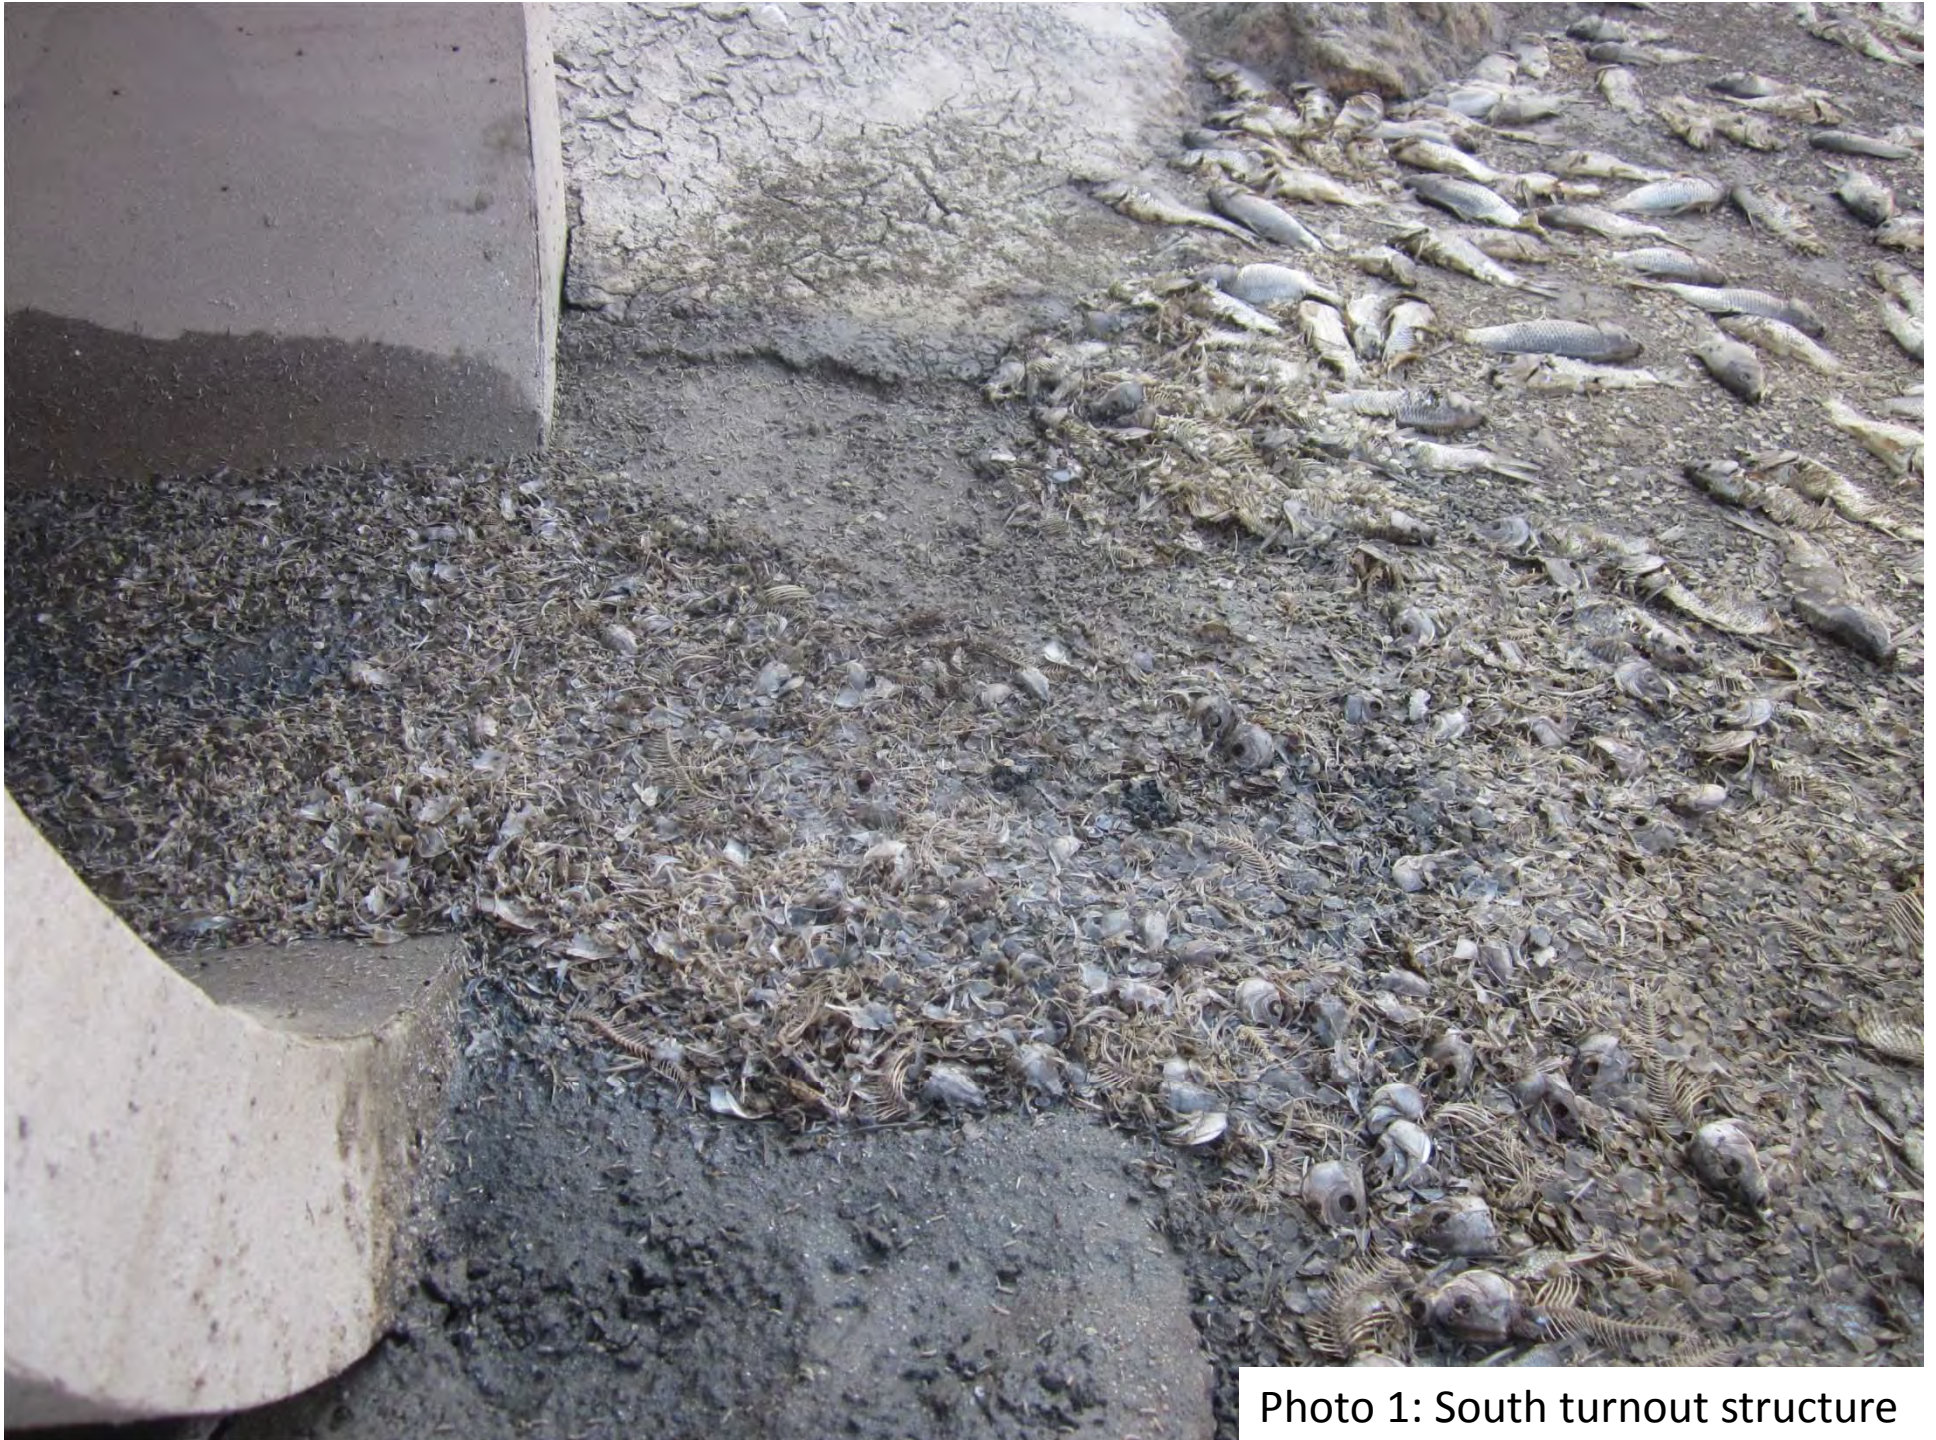
Photo 1: South turnout structure

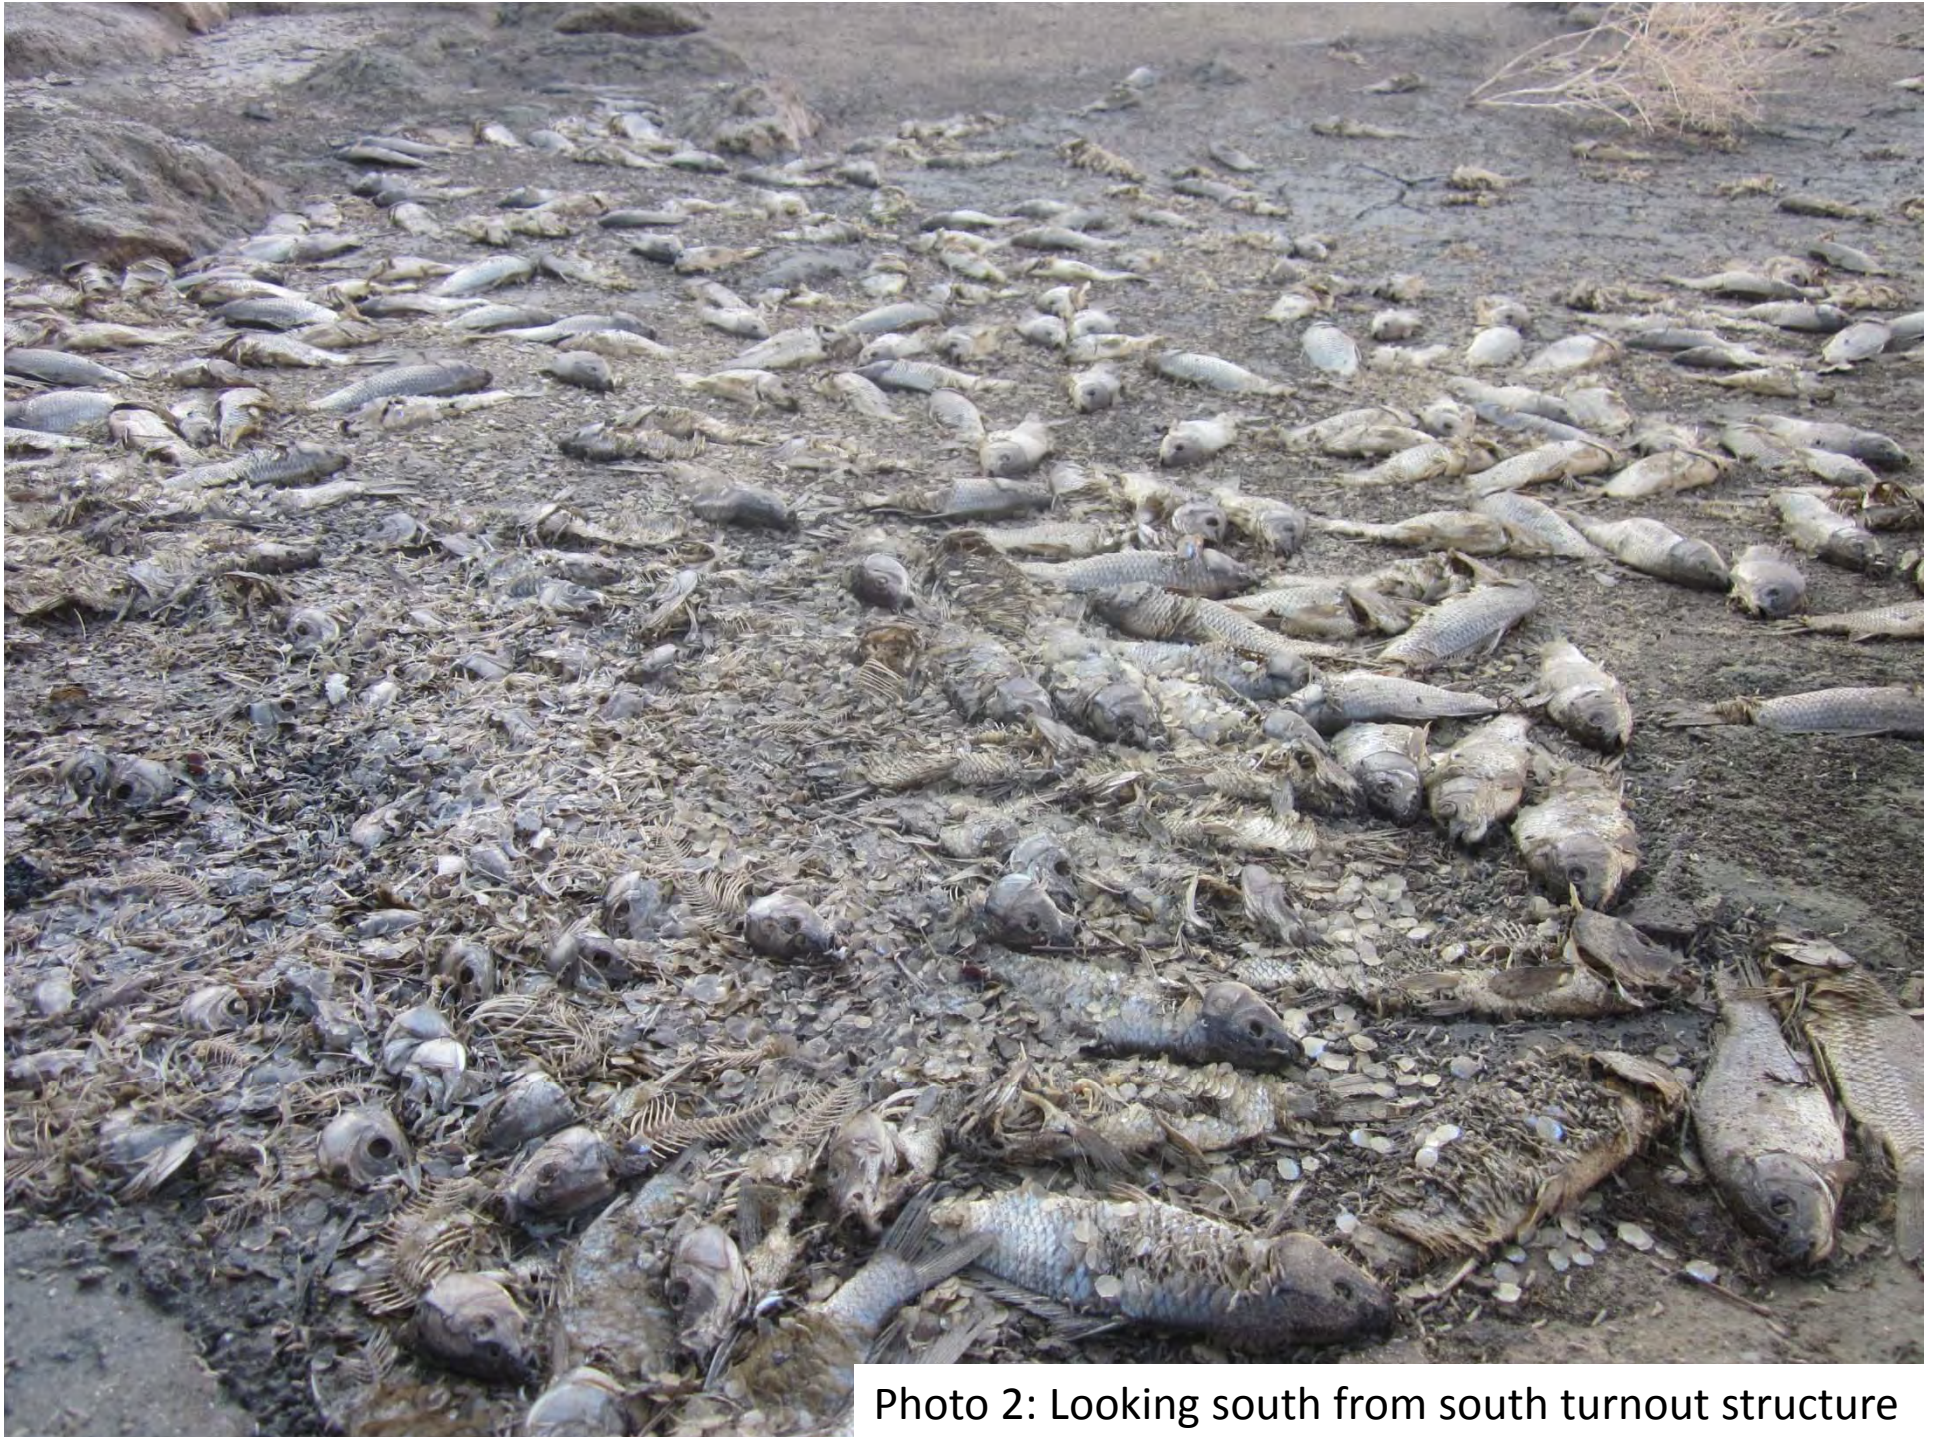
Photo 2: Looking south from south turnout structure

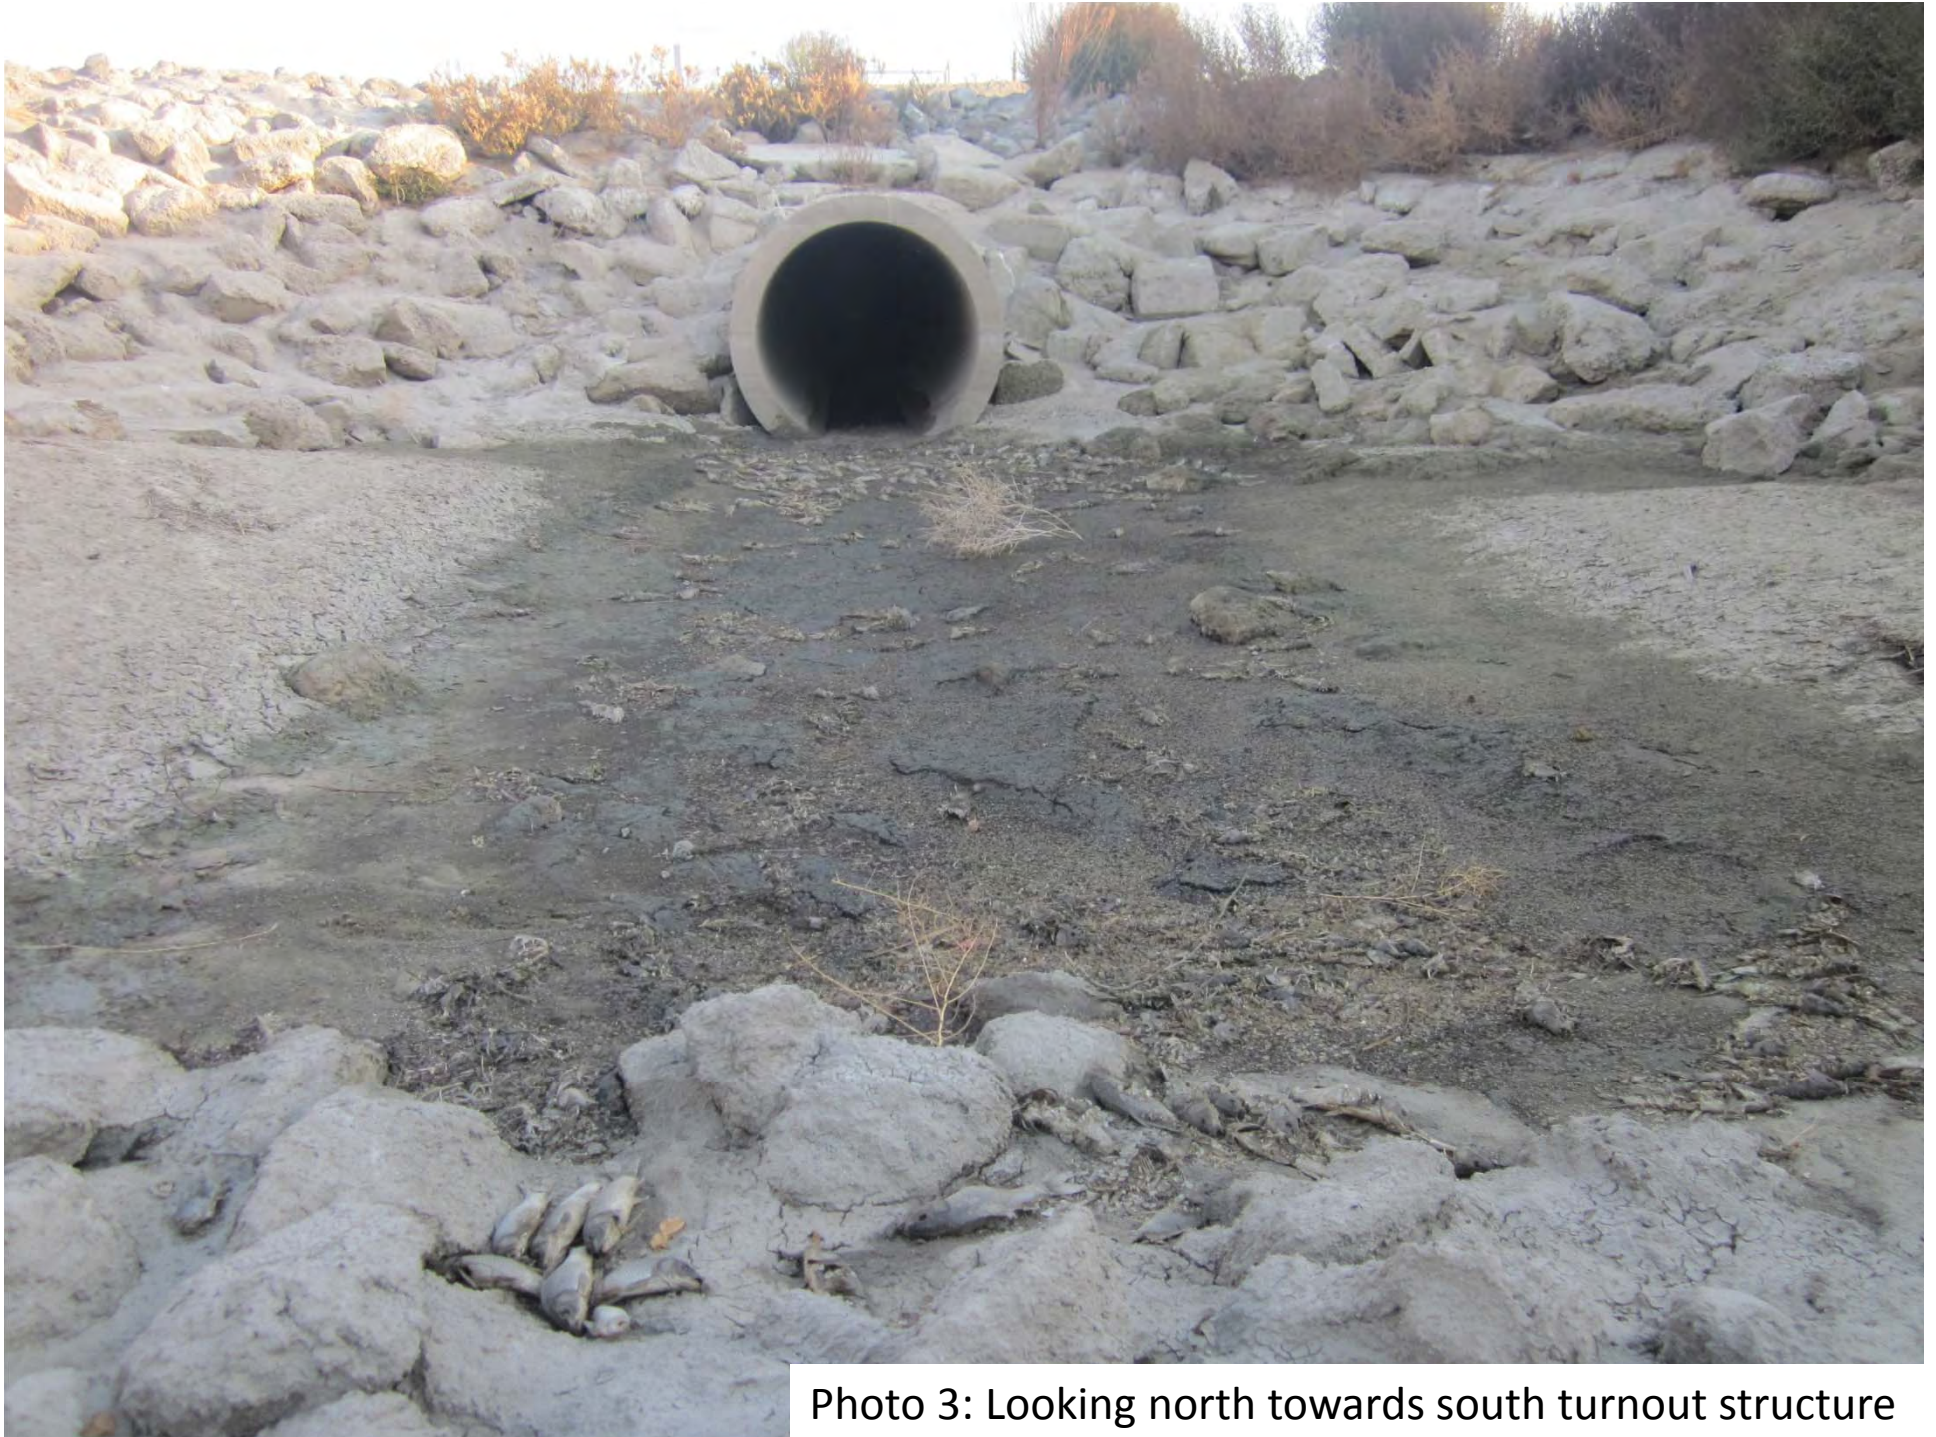
Photo 3: Looking north towards south turnout structure

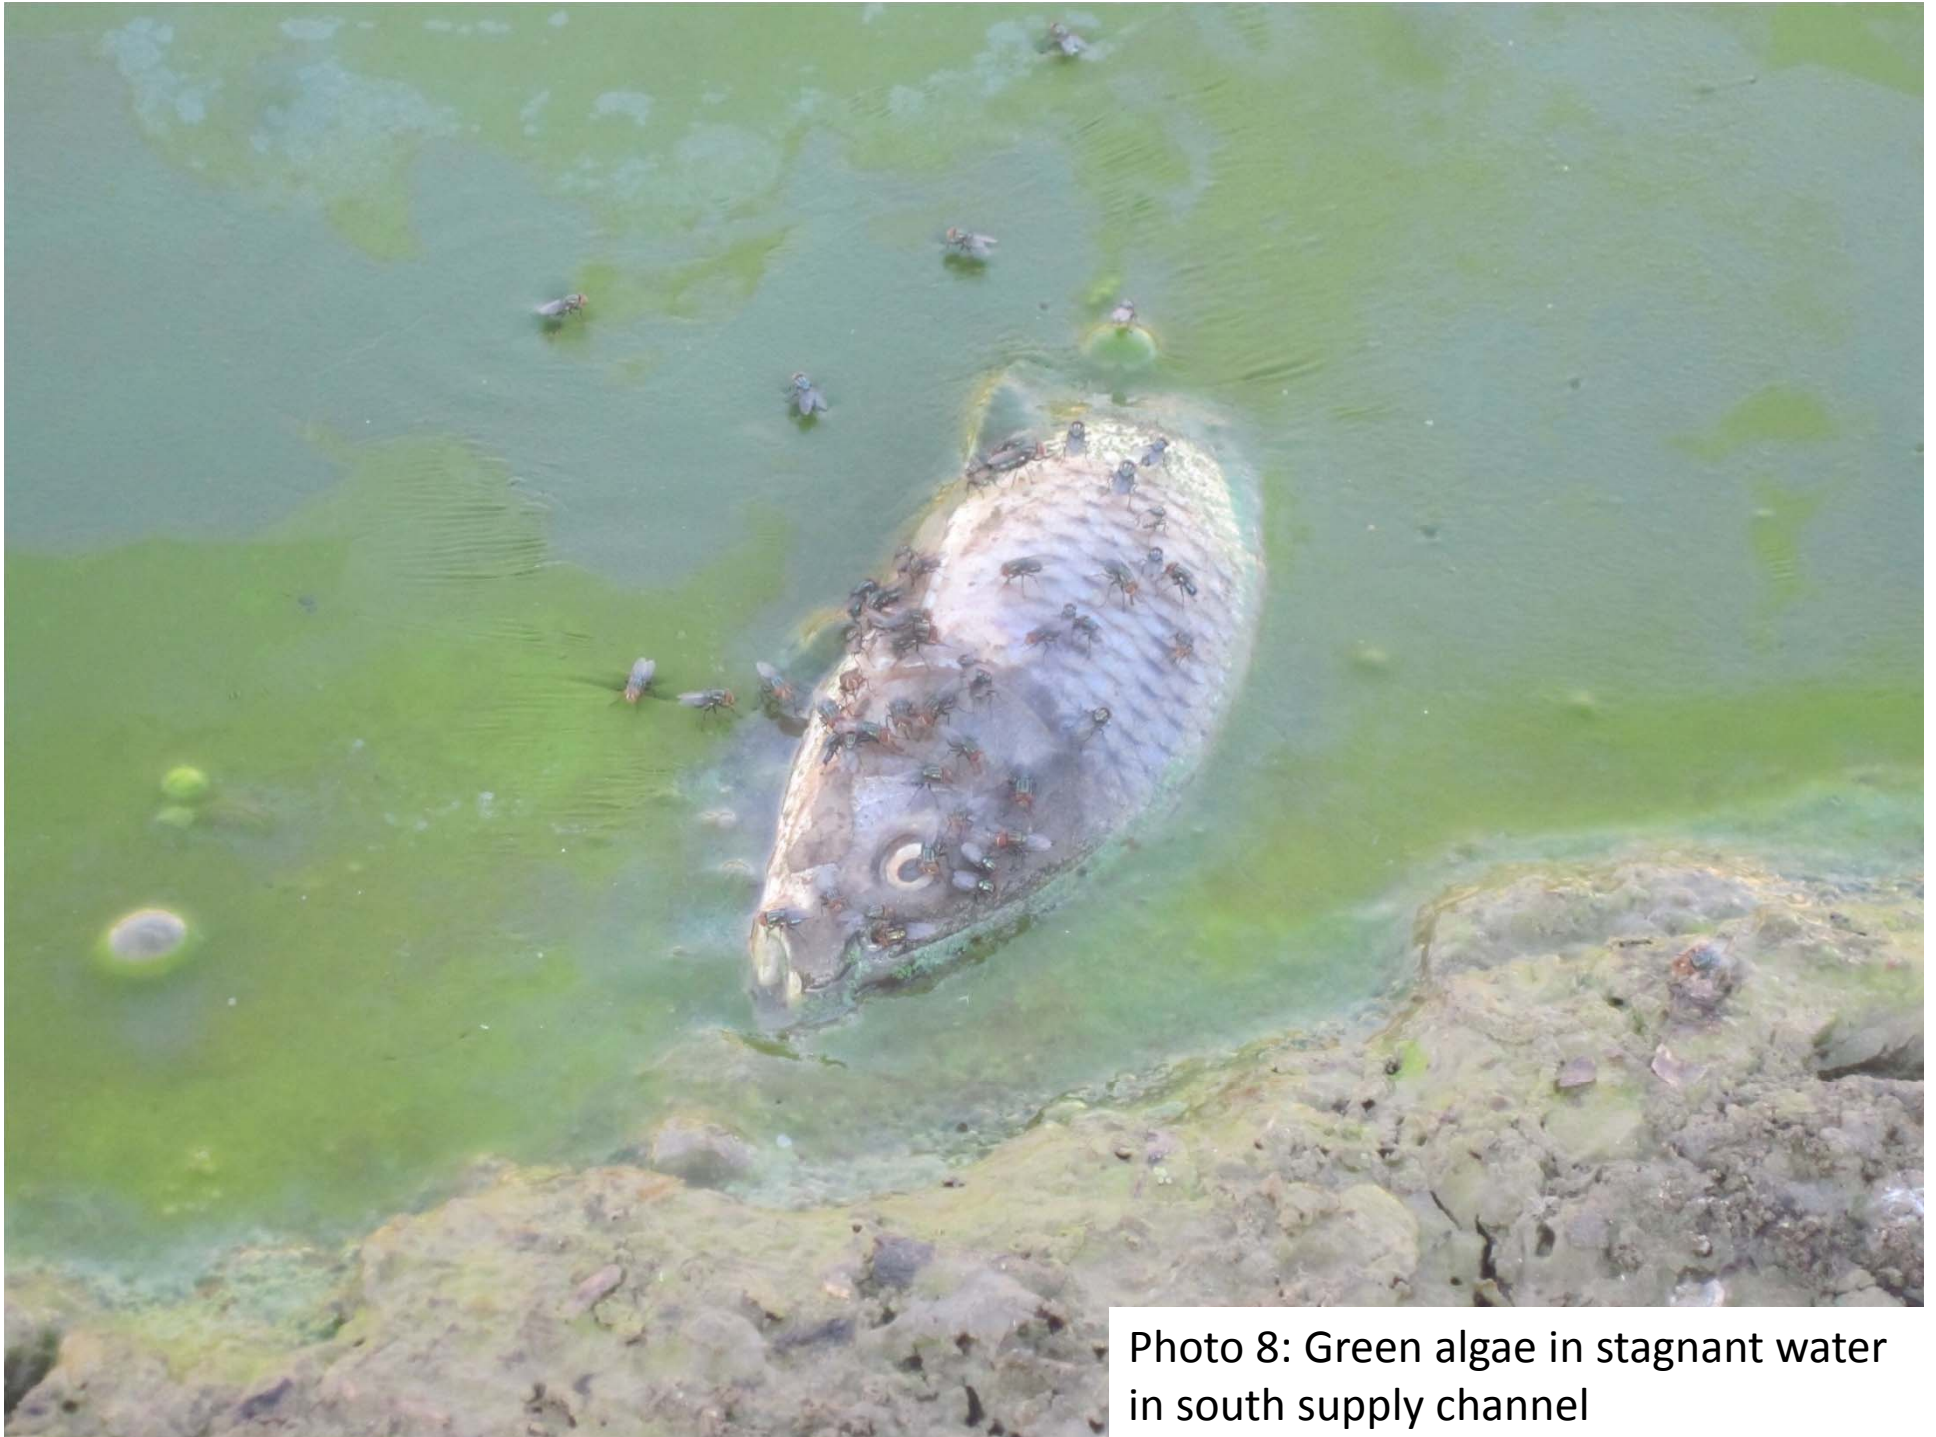
Photo 8: Green algae in stagnant water in south supply channel

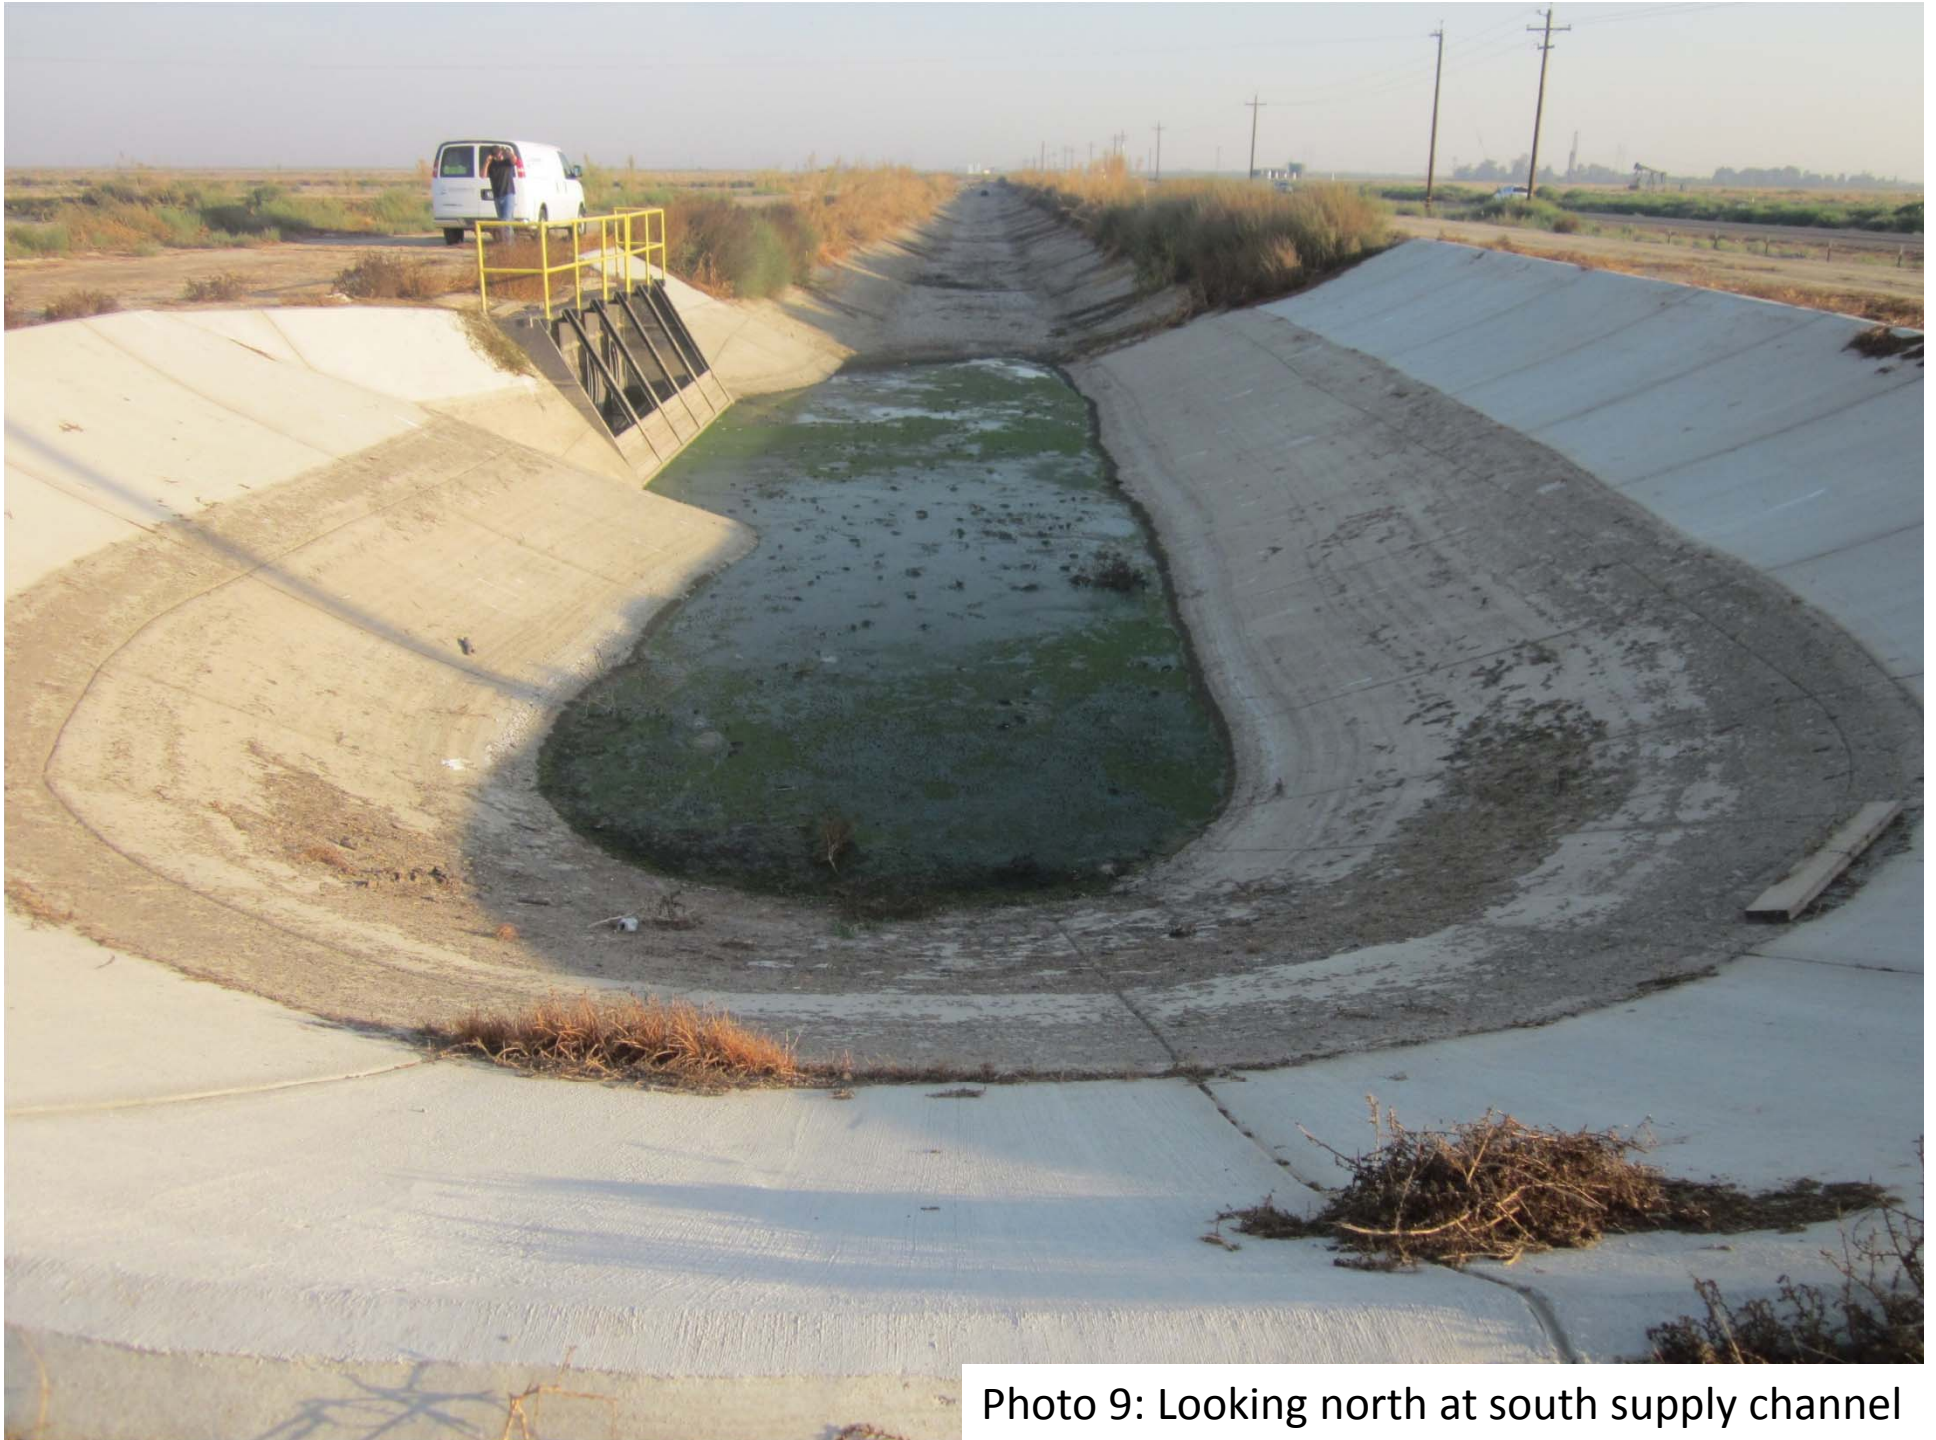
Photo 9: Looking north at south supply channel

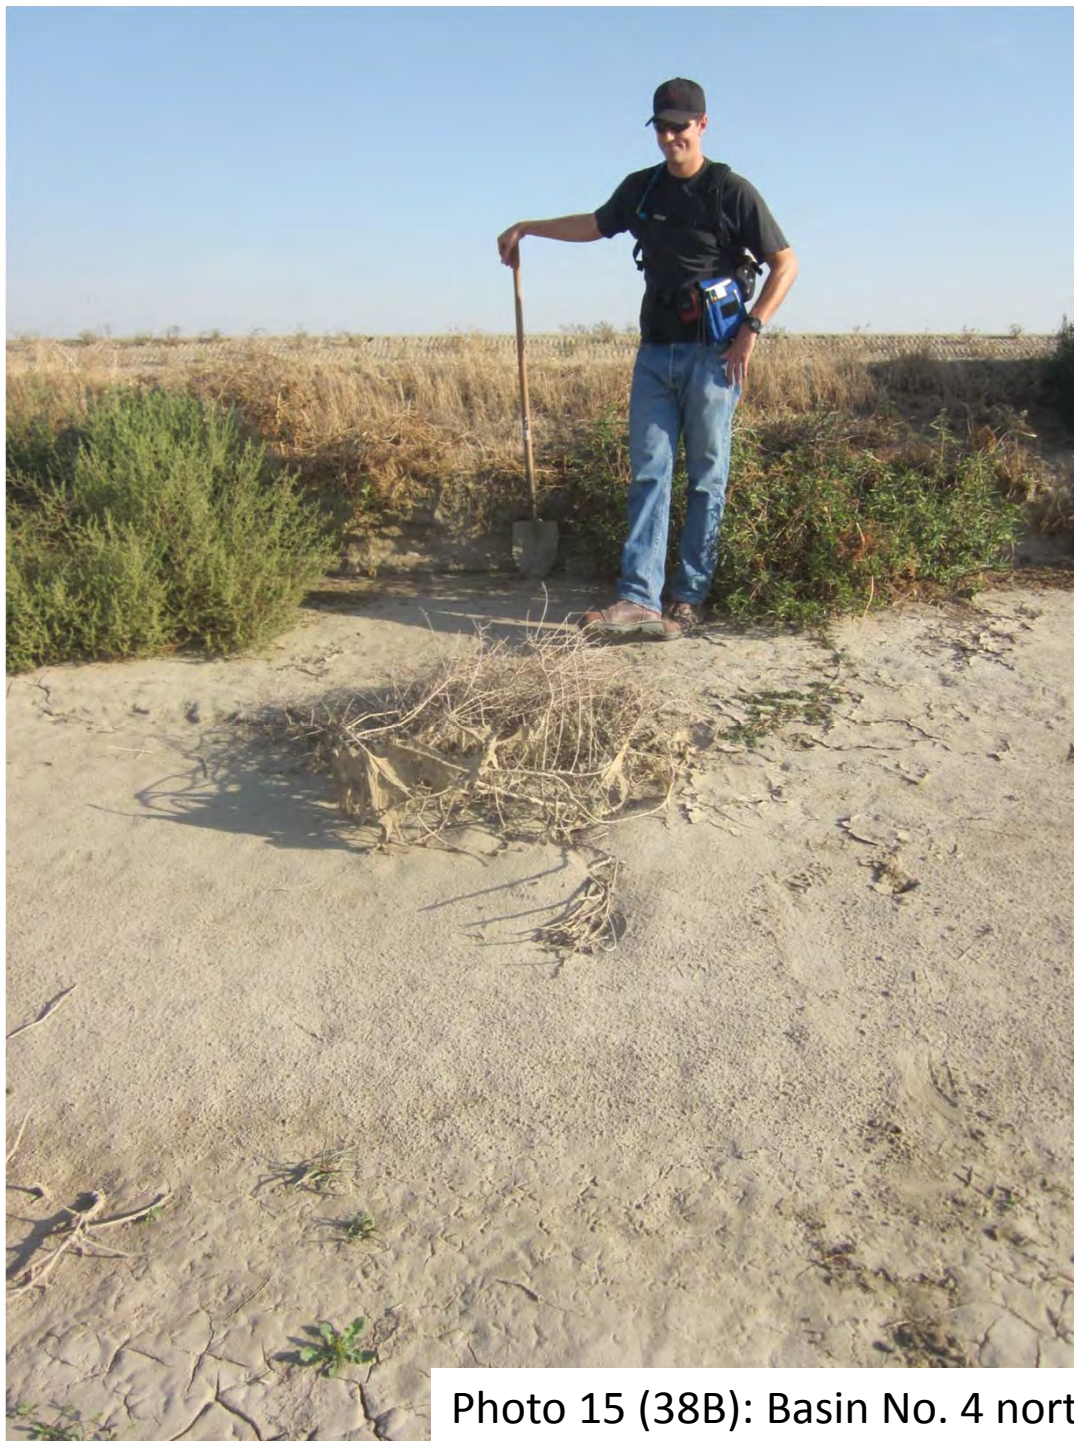
Photo 15 (38B): Basin No. 4 north berm erosion (~2')

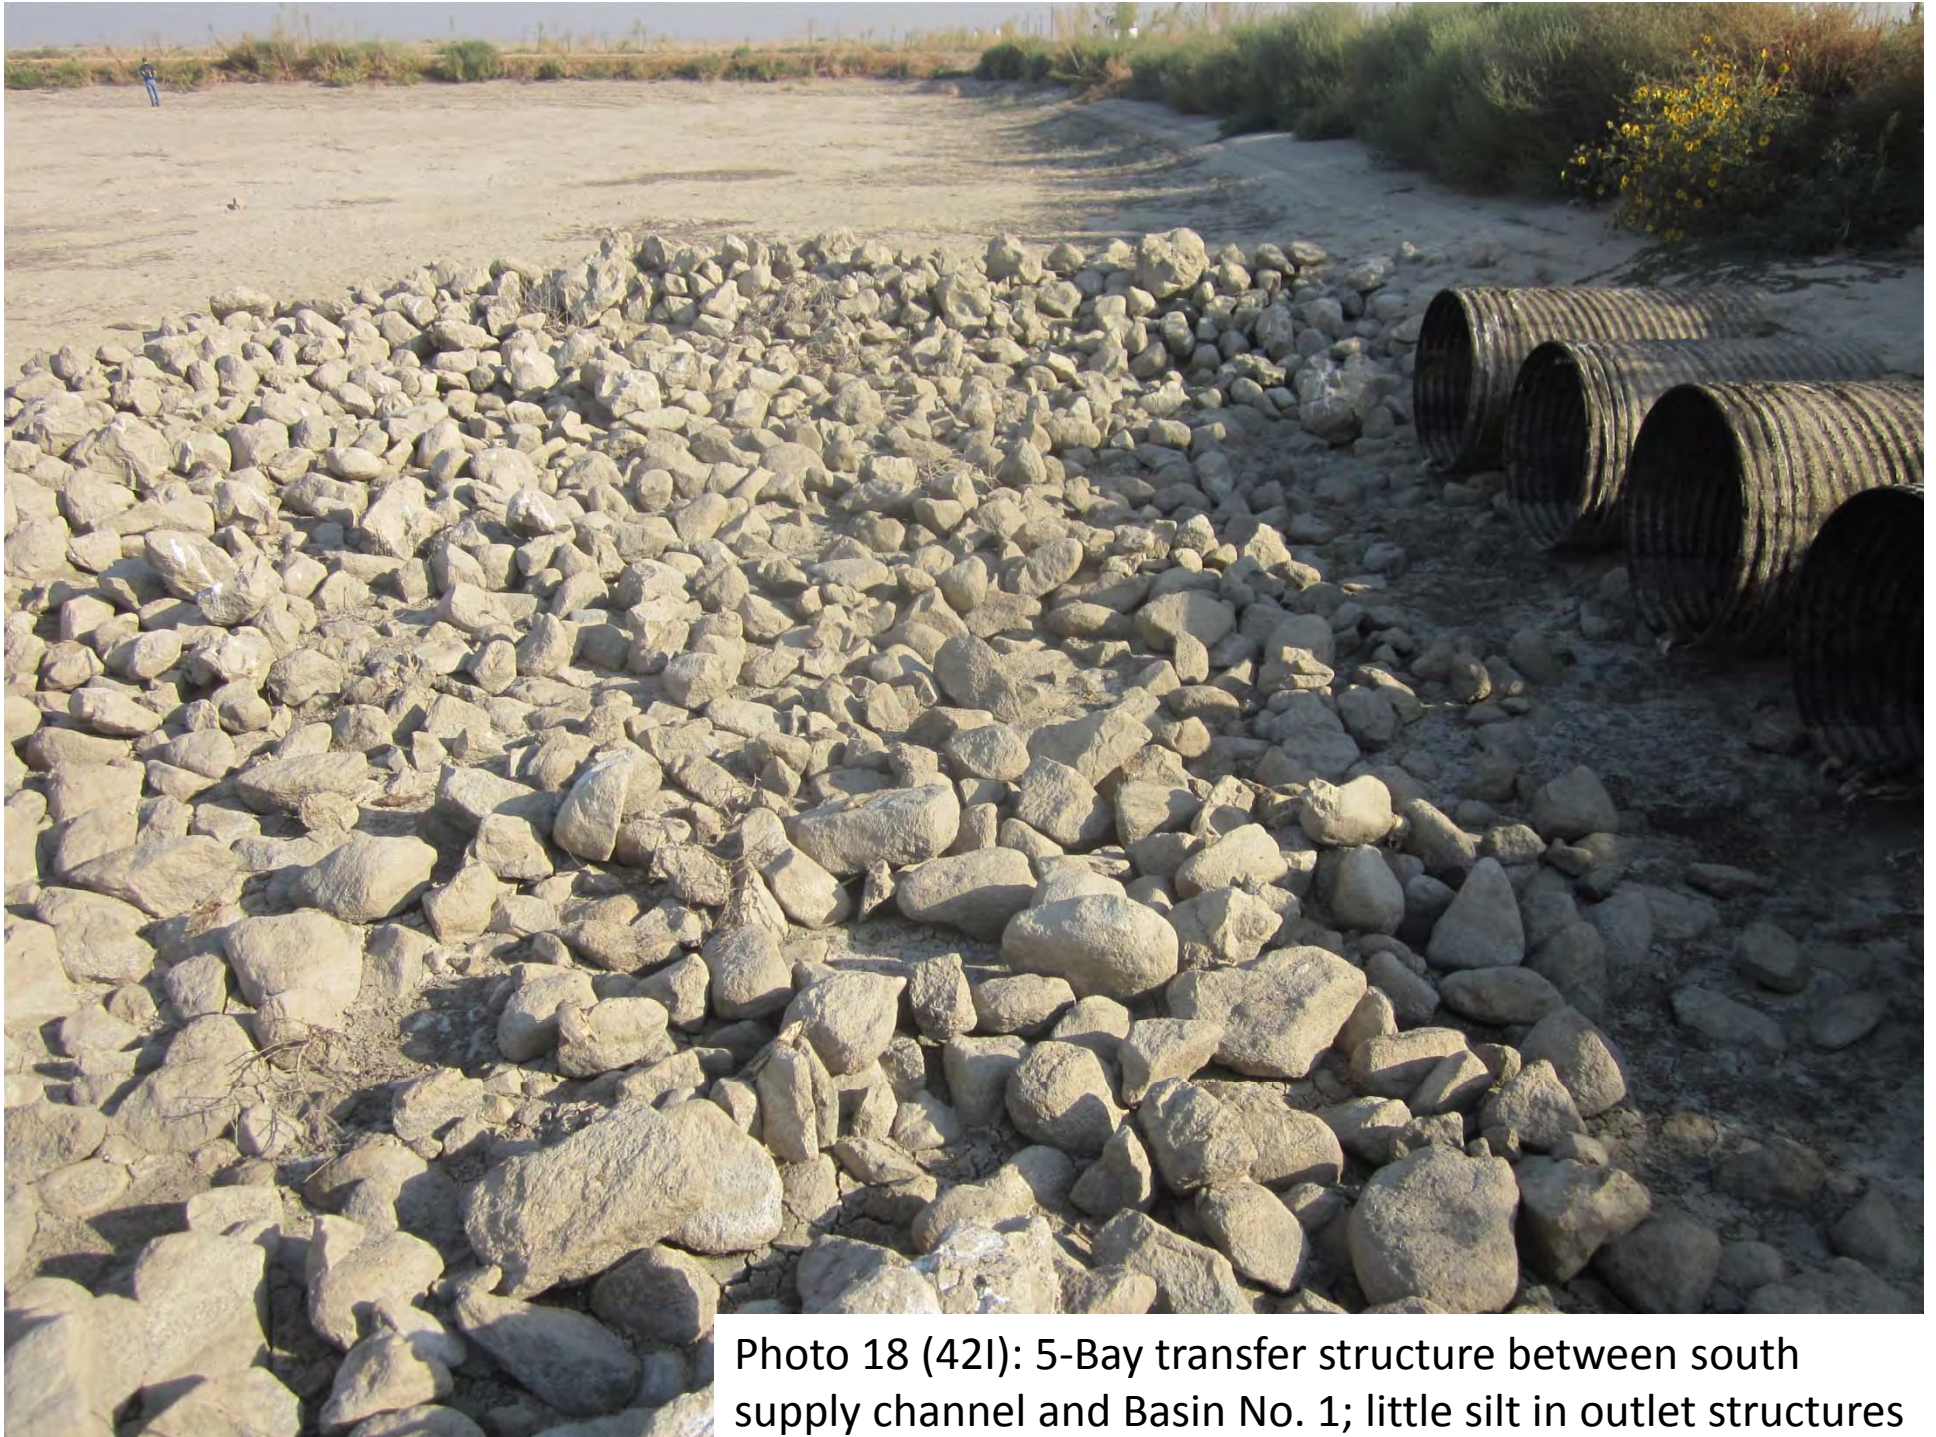
Photo 18 (42I): 5-Bay transfer structure between south supply channel and Basin No. 1; little silt in outlet structures

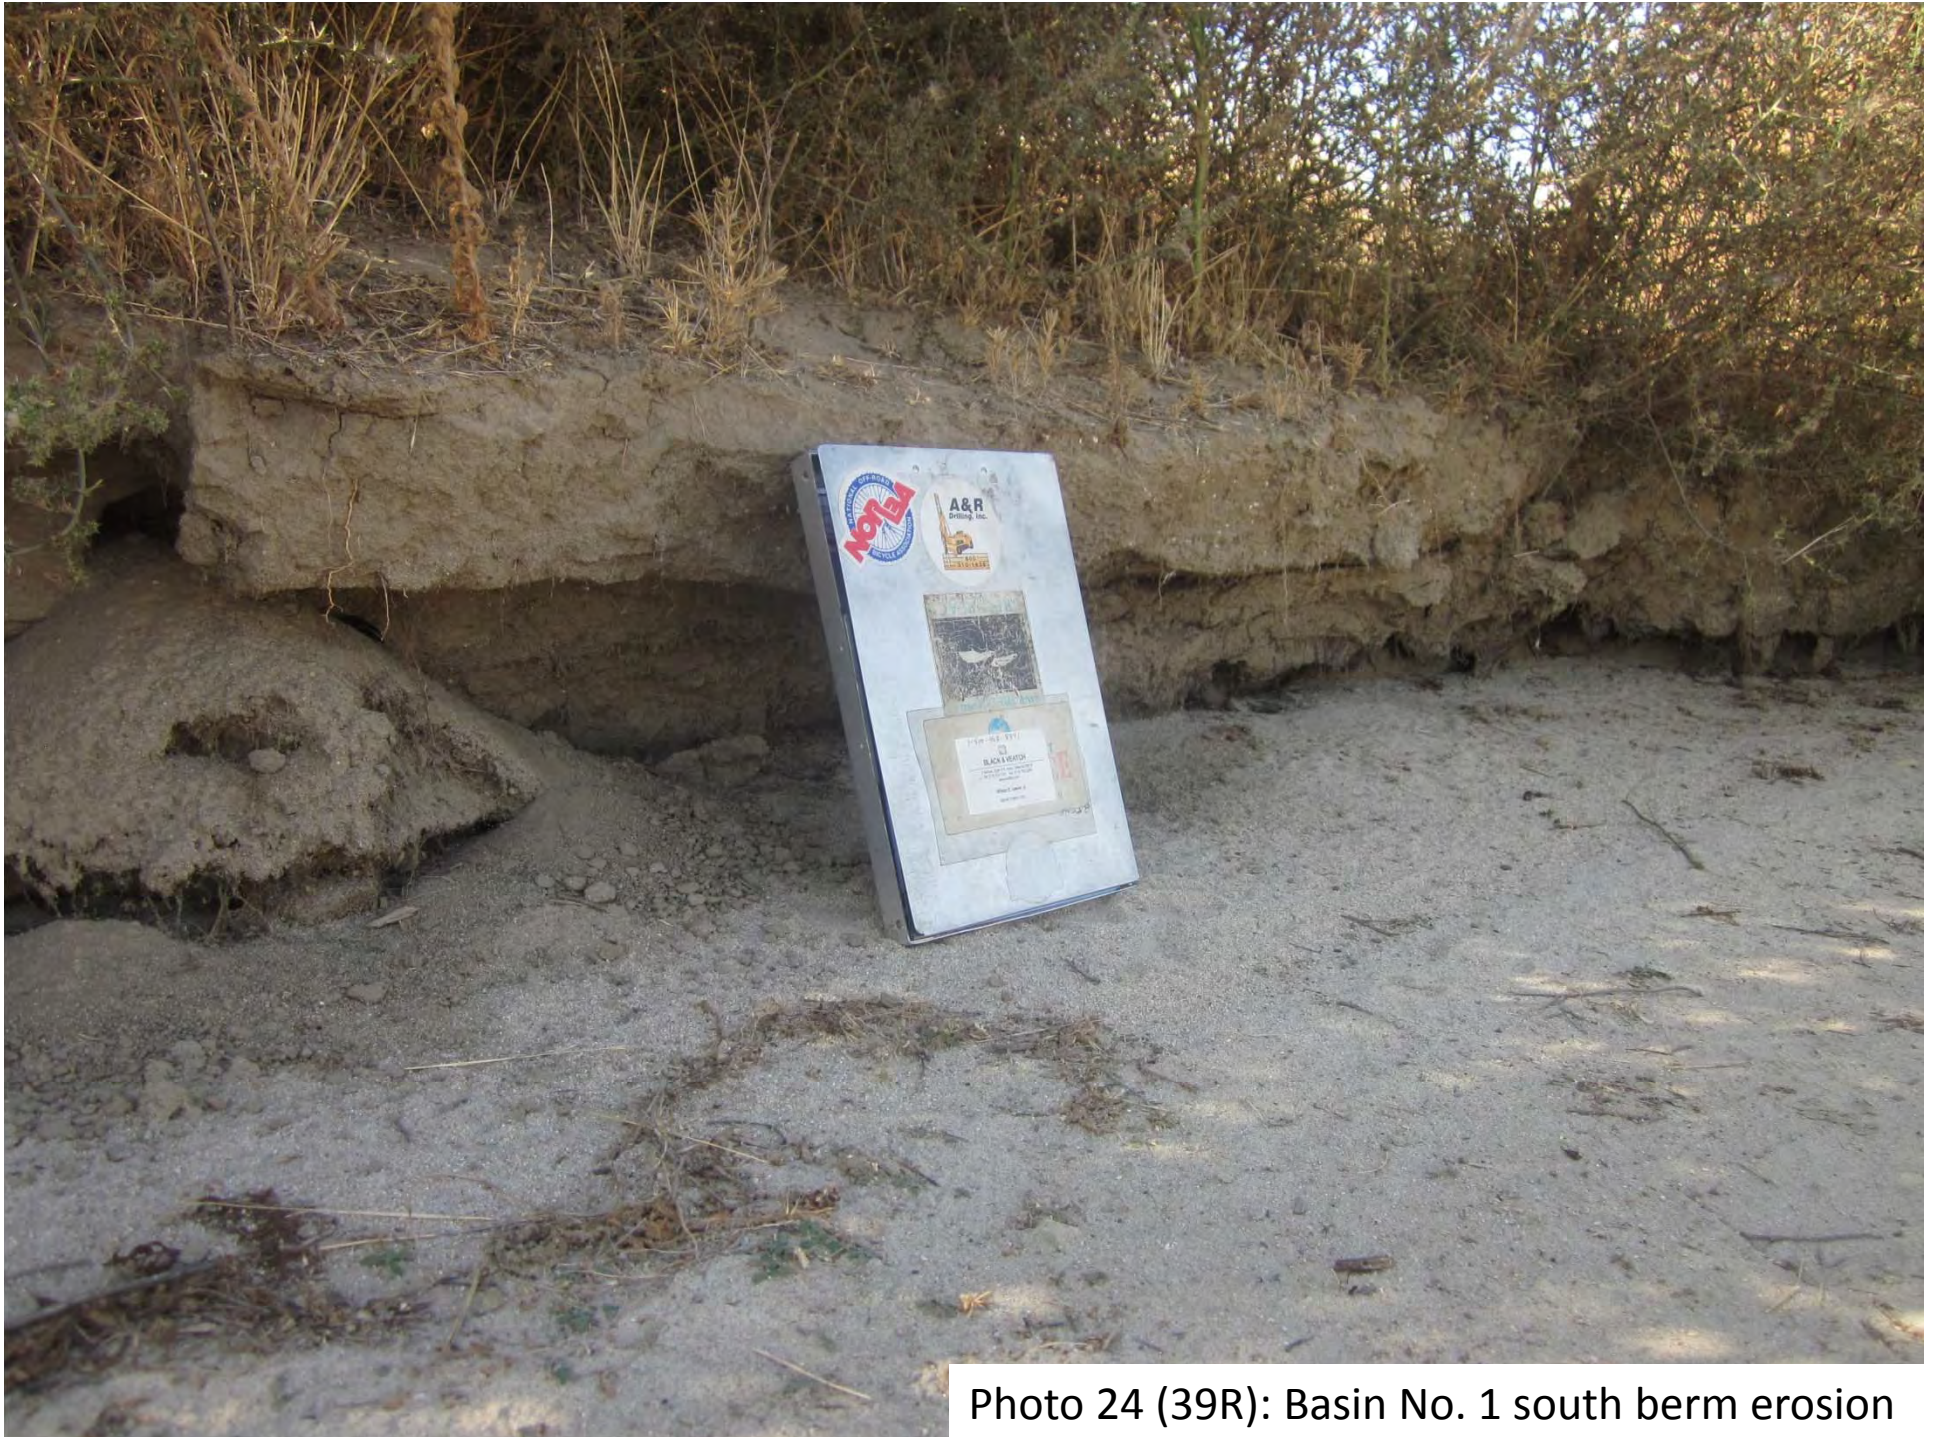
Photo 24 (39R): Basin No. 1 south berm erosion
