October 11, 2011

Irvine Ranch Water District
Attention: Paul Weghorst
15600 Sand Canyon Avenue
Irvine, CA 92618

Subject: *Strand Ranch South Basin Field Reconnaissance and Remediation Recommendations*

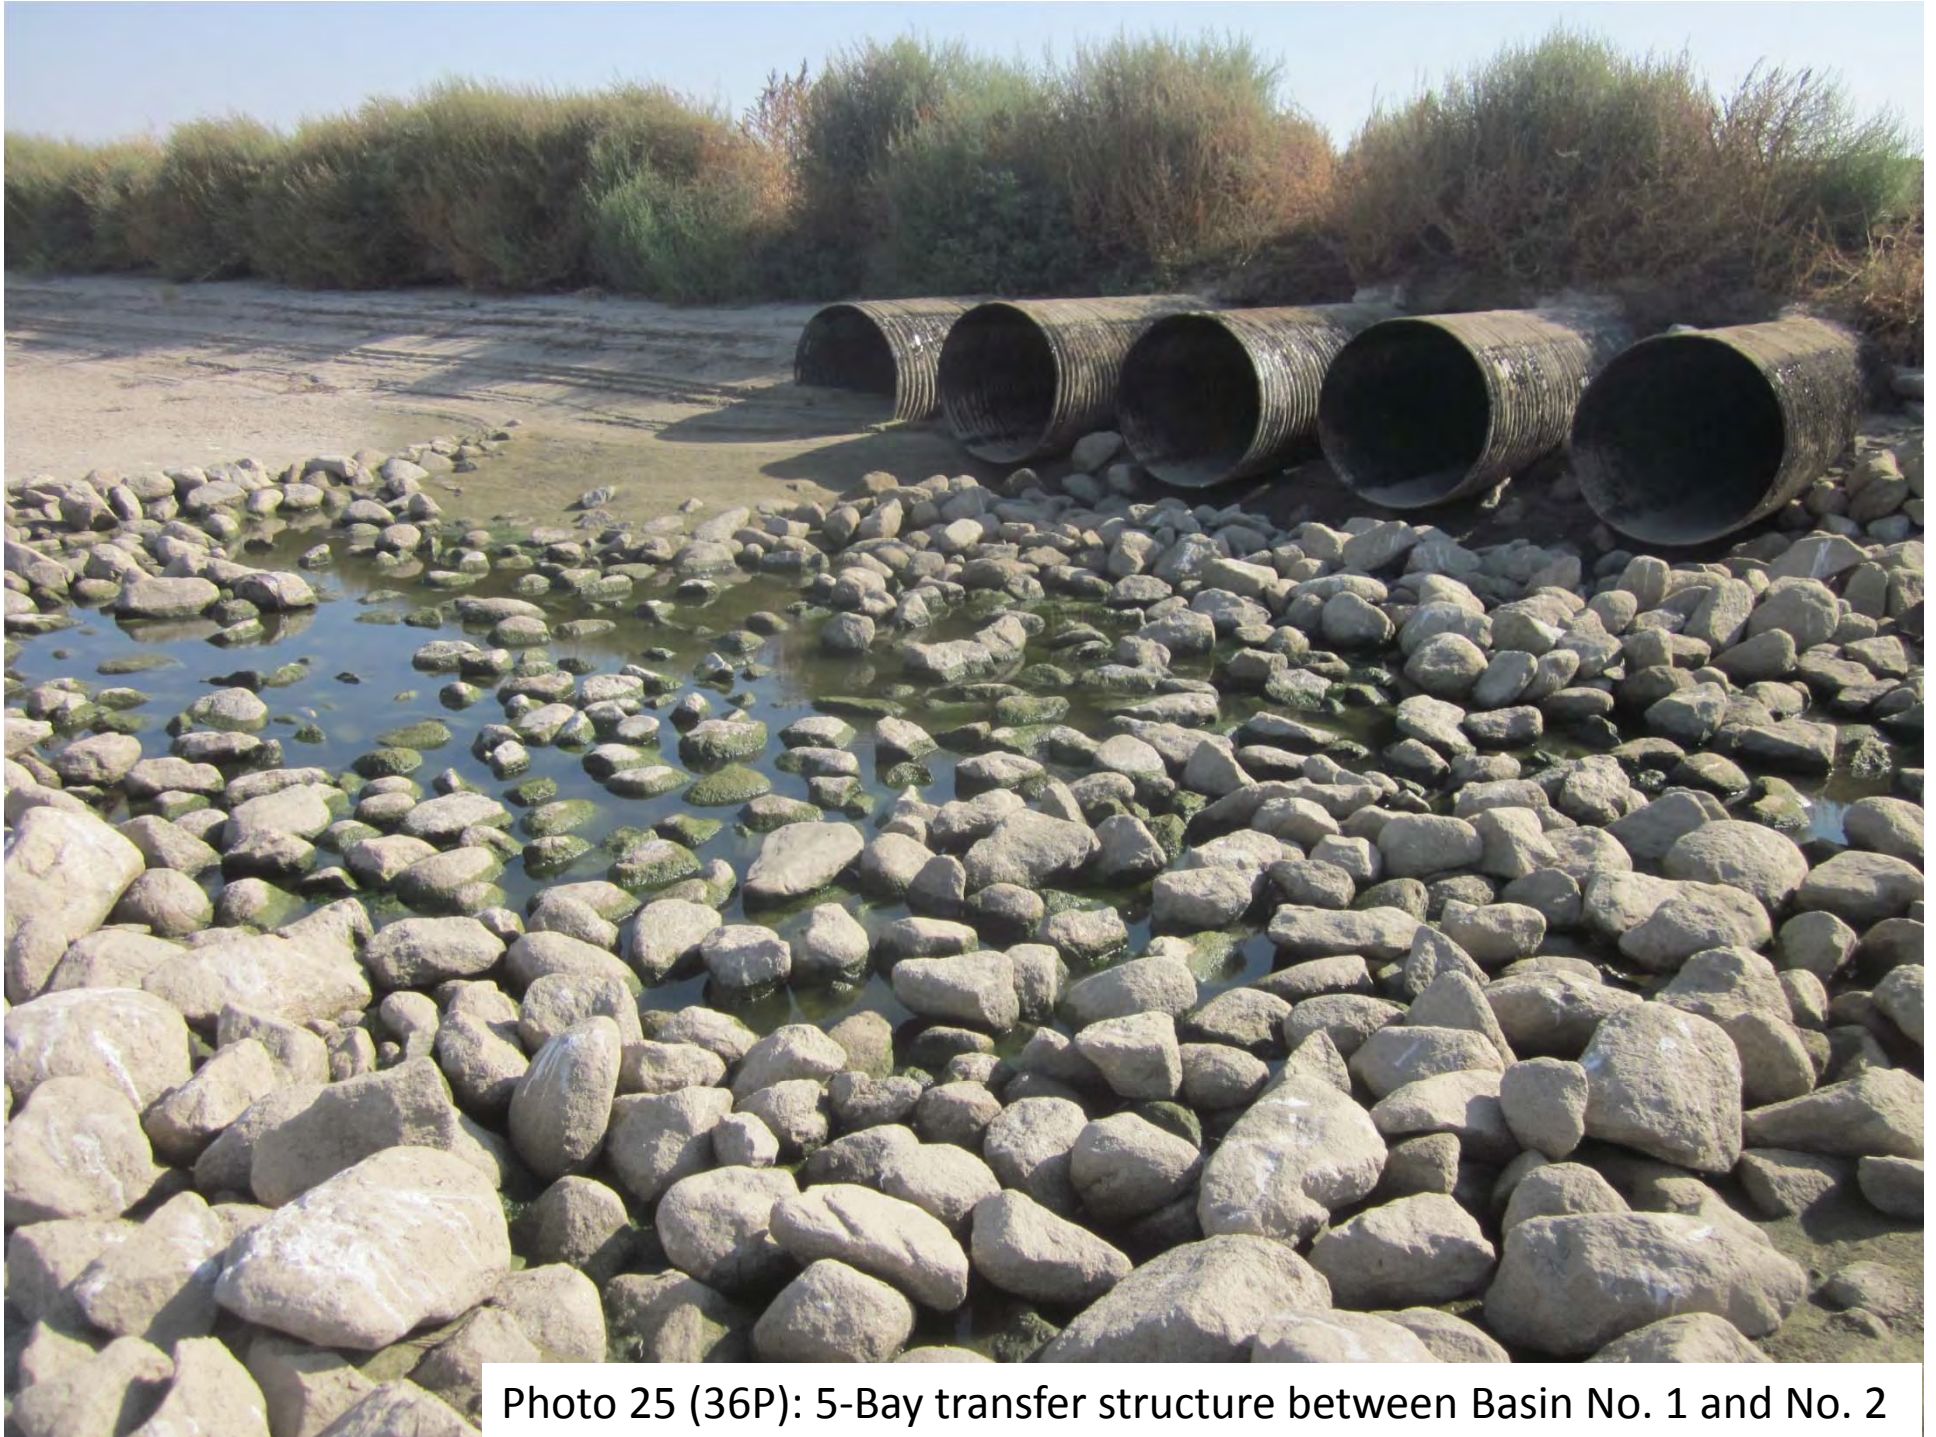
Photo 25 (36P): 5-Bay transfer structure between Basin No. 1 and No. 2

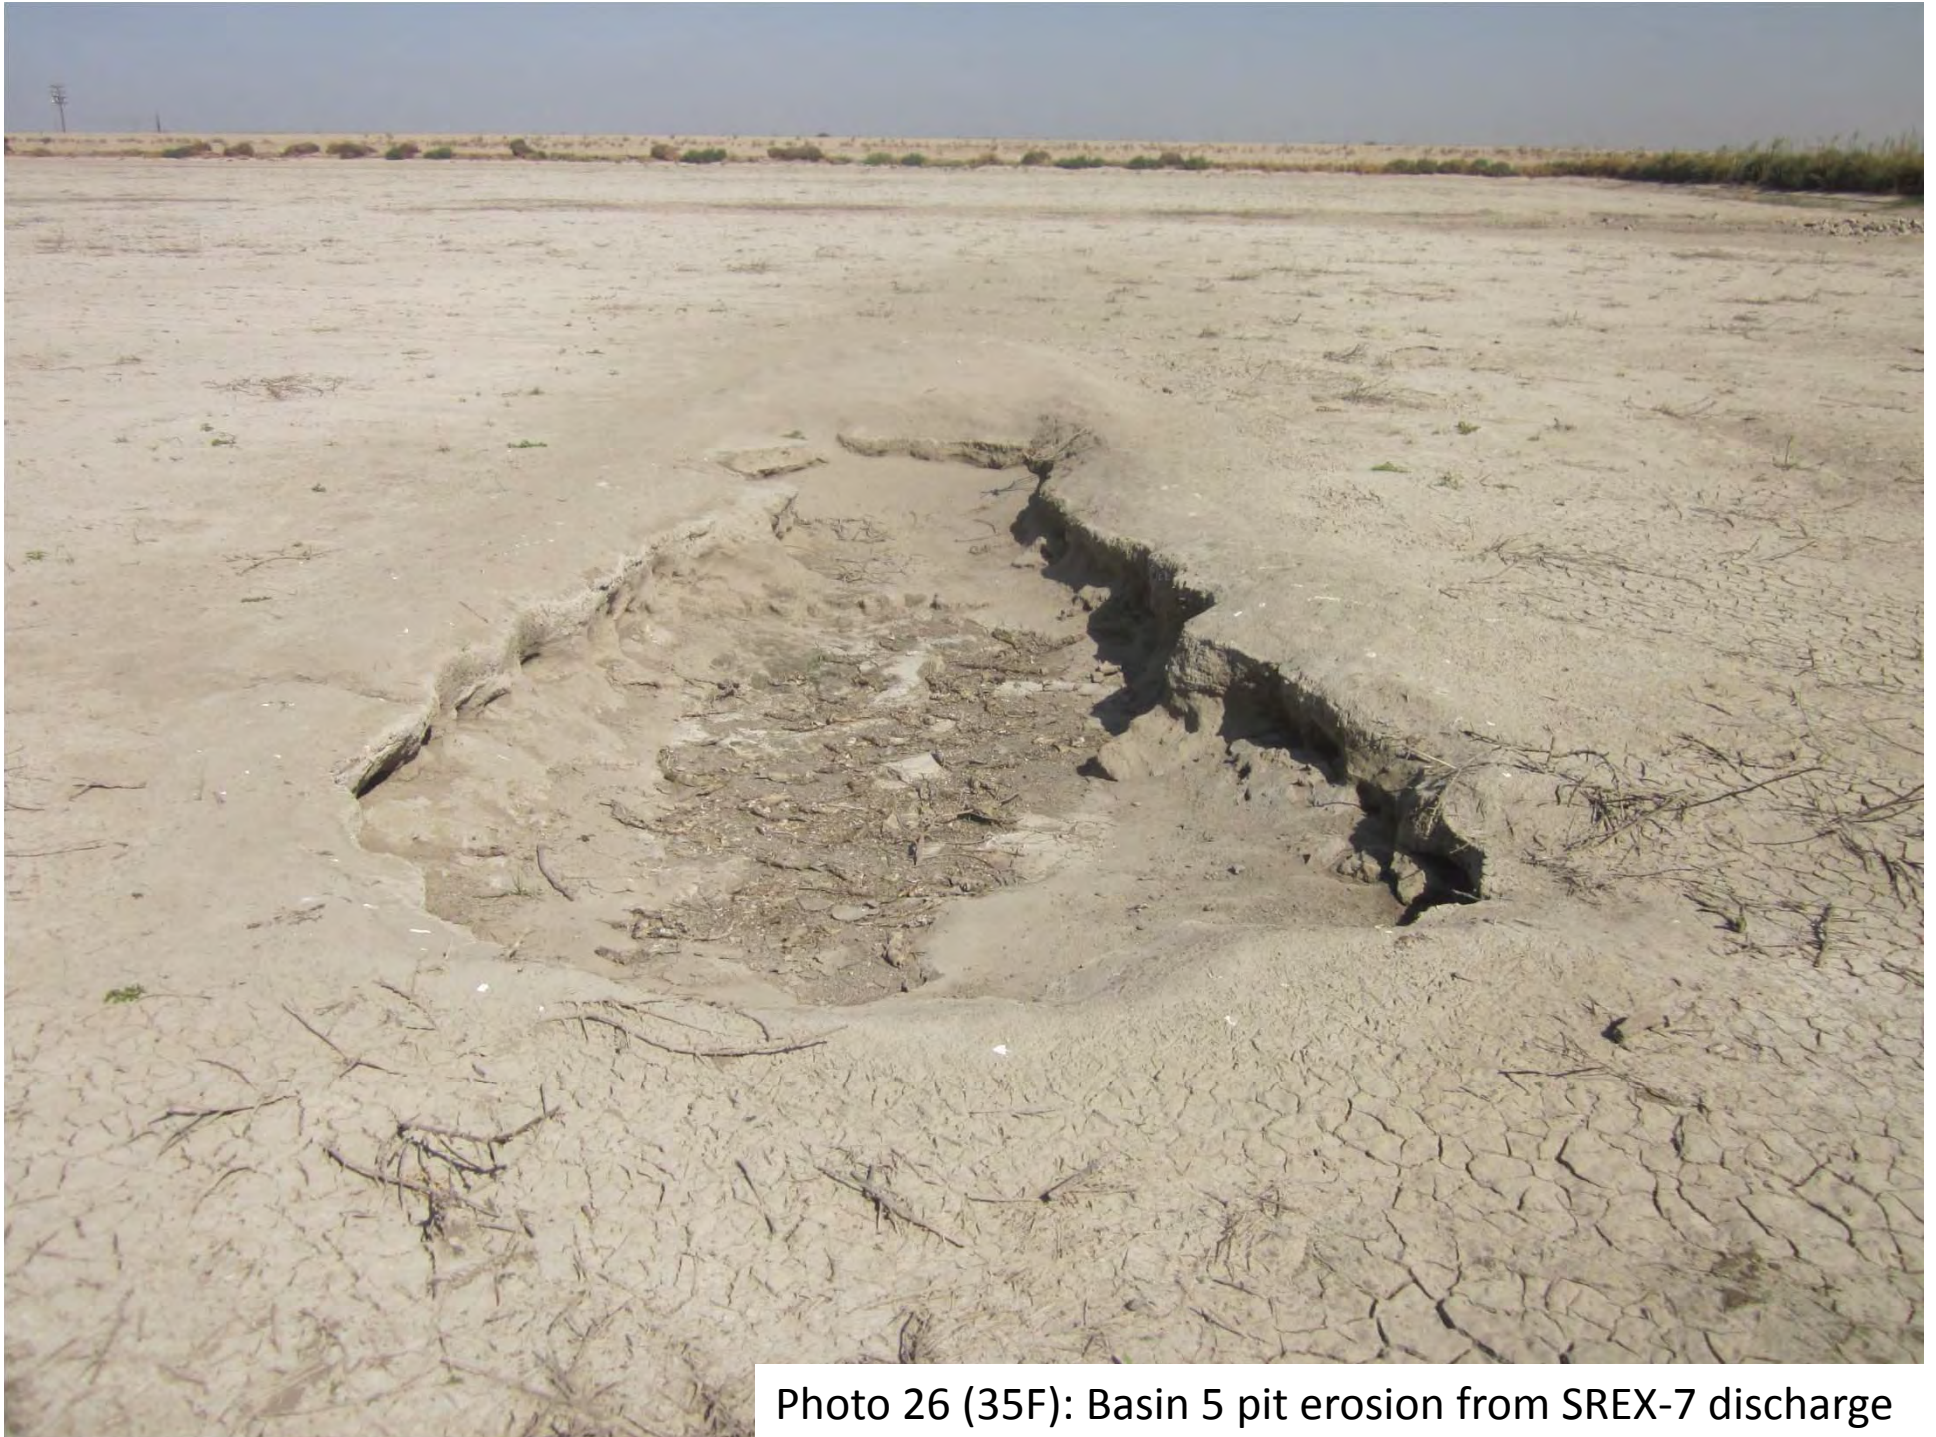
Photo 26 (35F): Basin 5 pit erosion from SREX-7 discharge

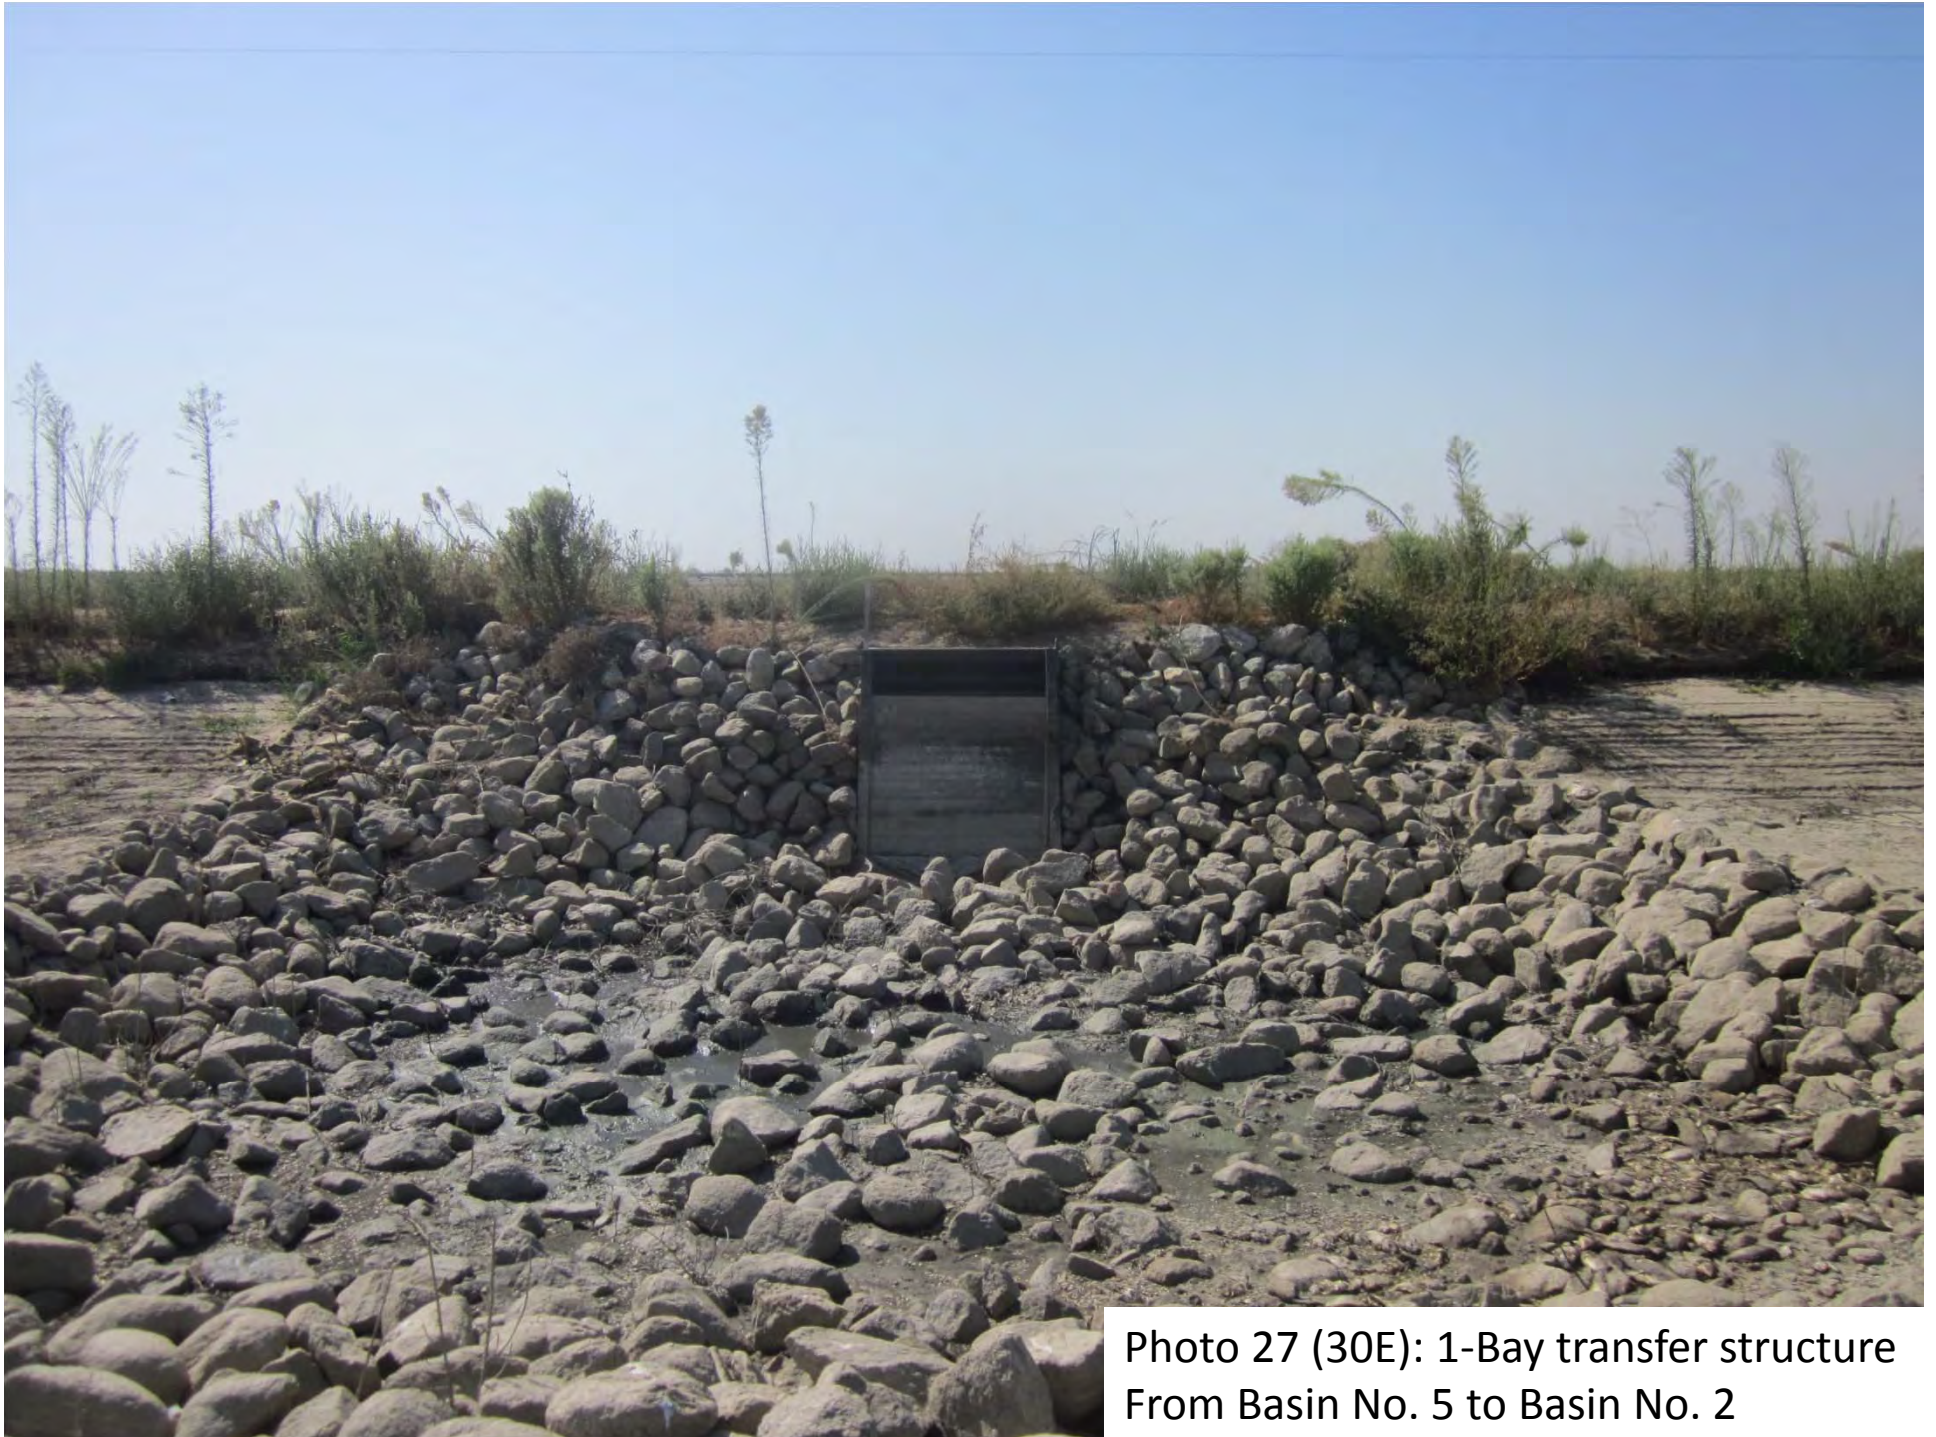
Photo 27 (30E): 1-Bay transfer structure
From Basin No. 5 to Basin No. 2

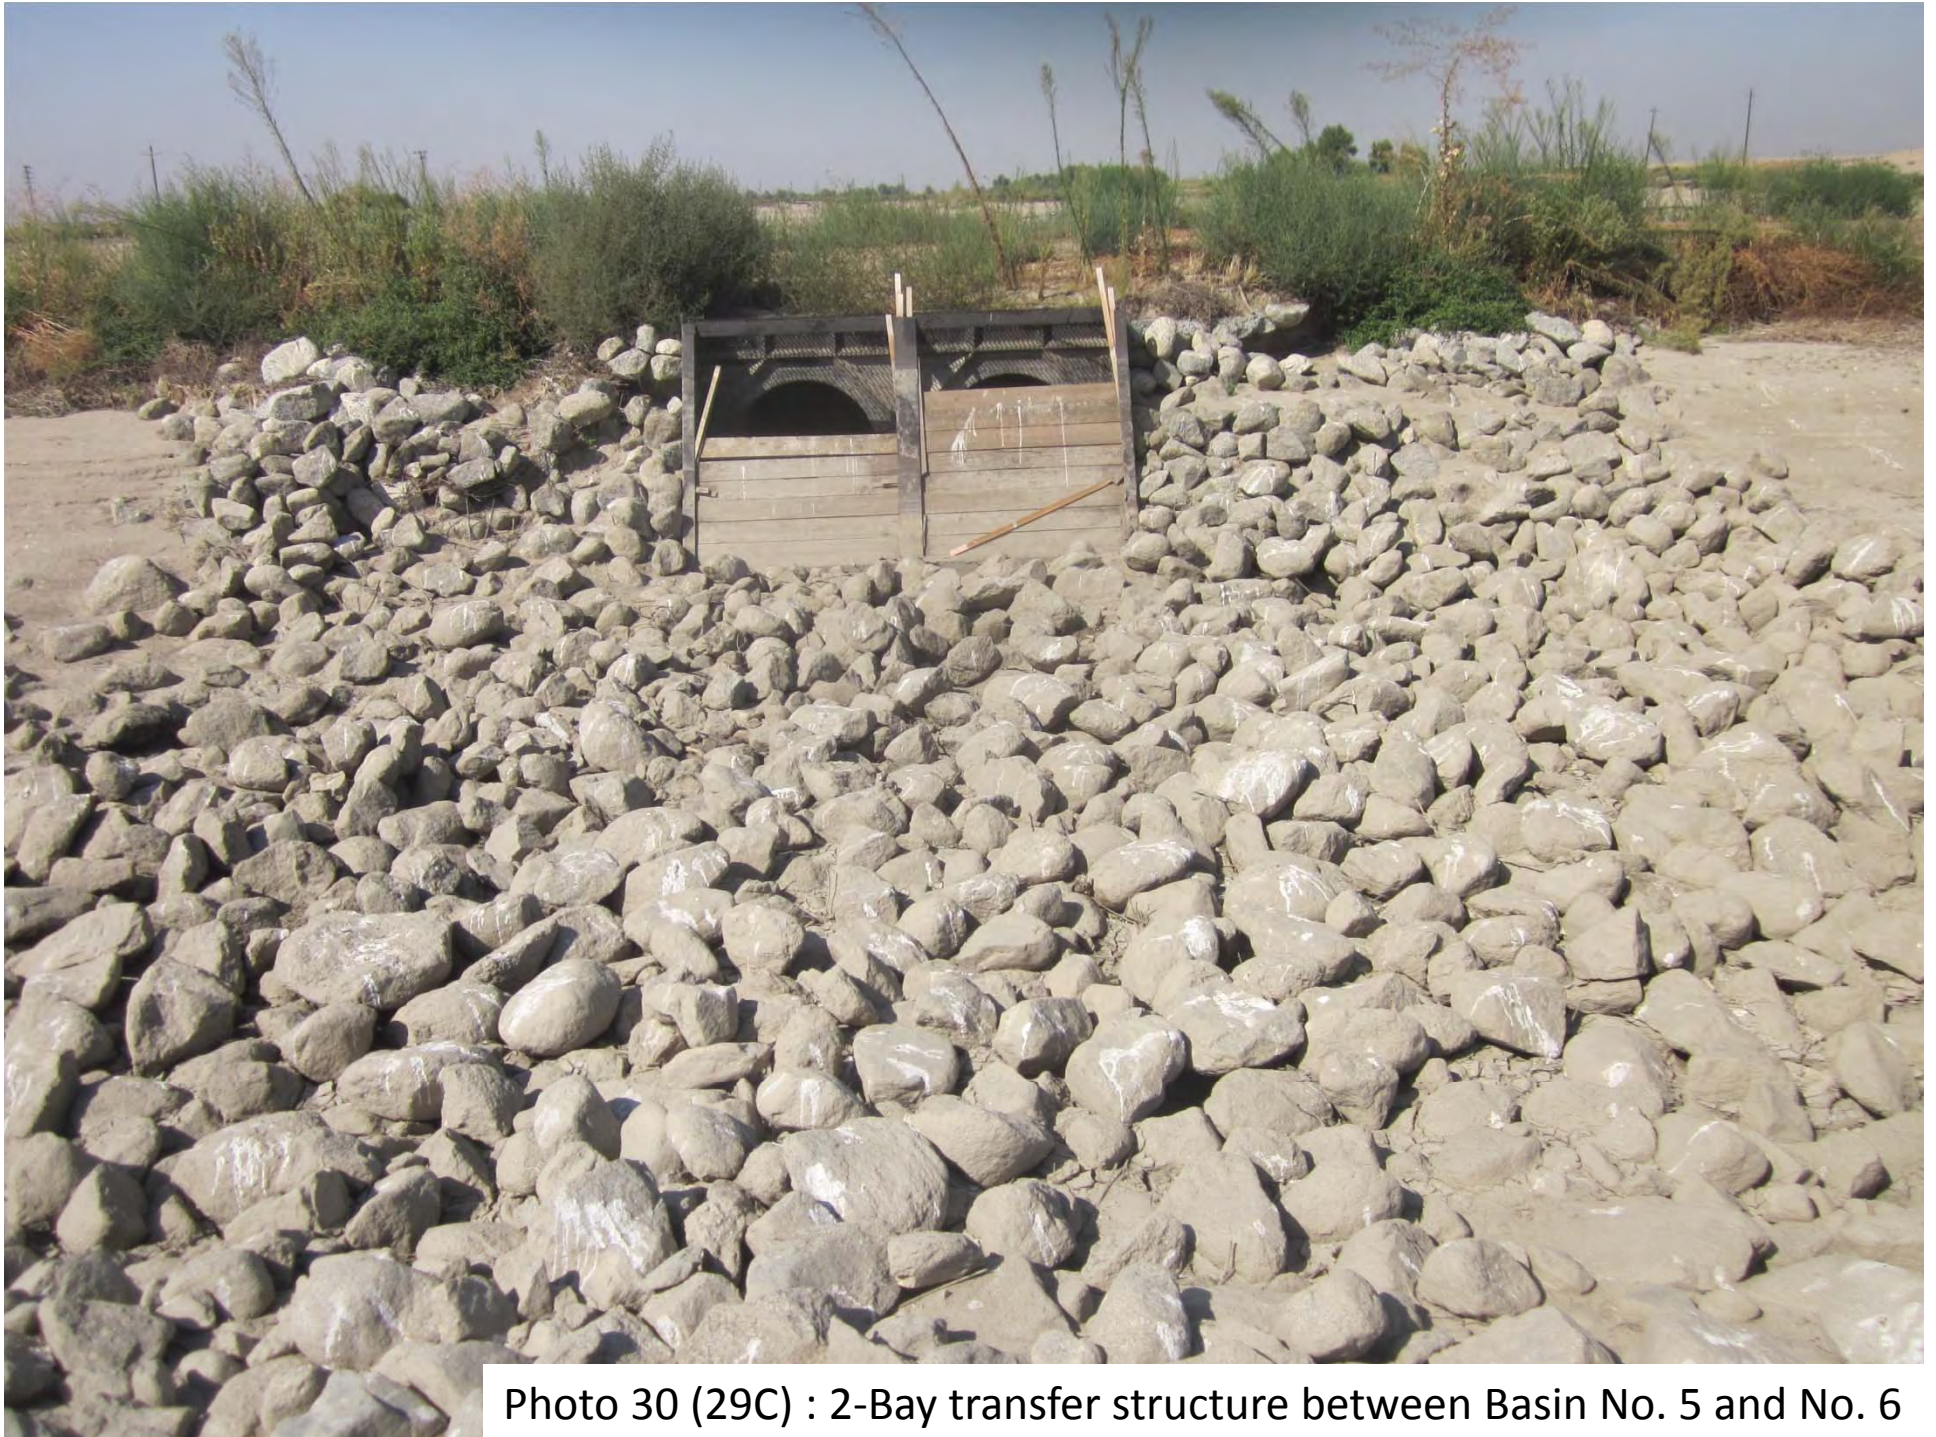
Photo 30 (29C) : 2-Bay transfer structure between Basin No. 5 and No. 6

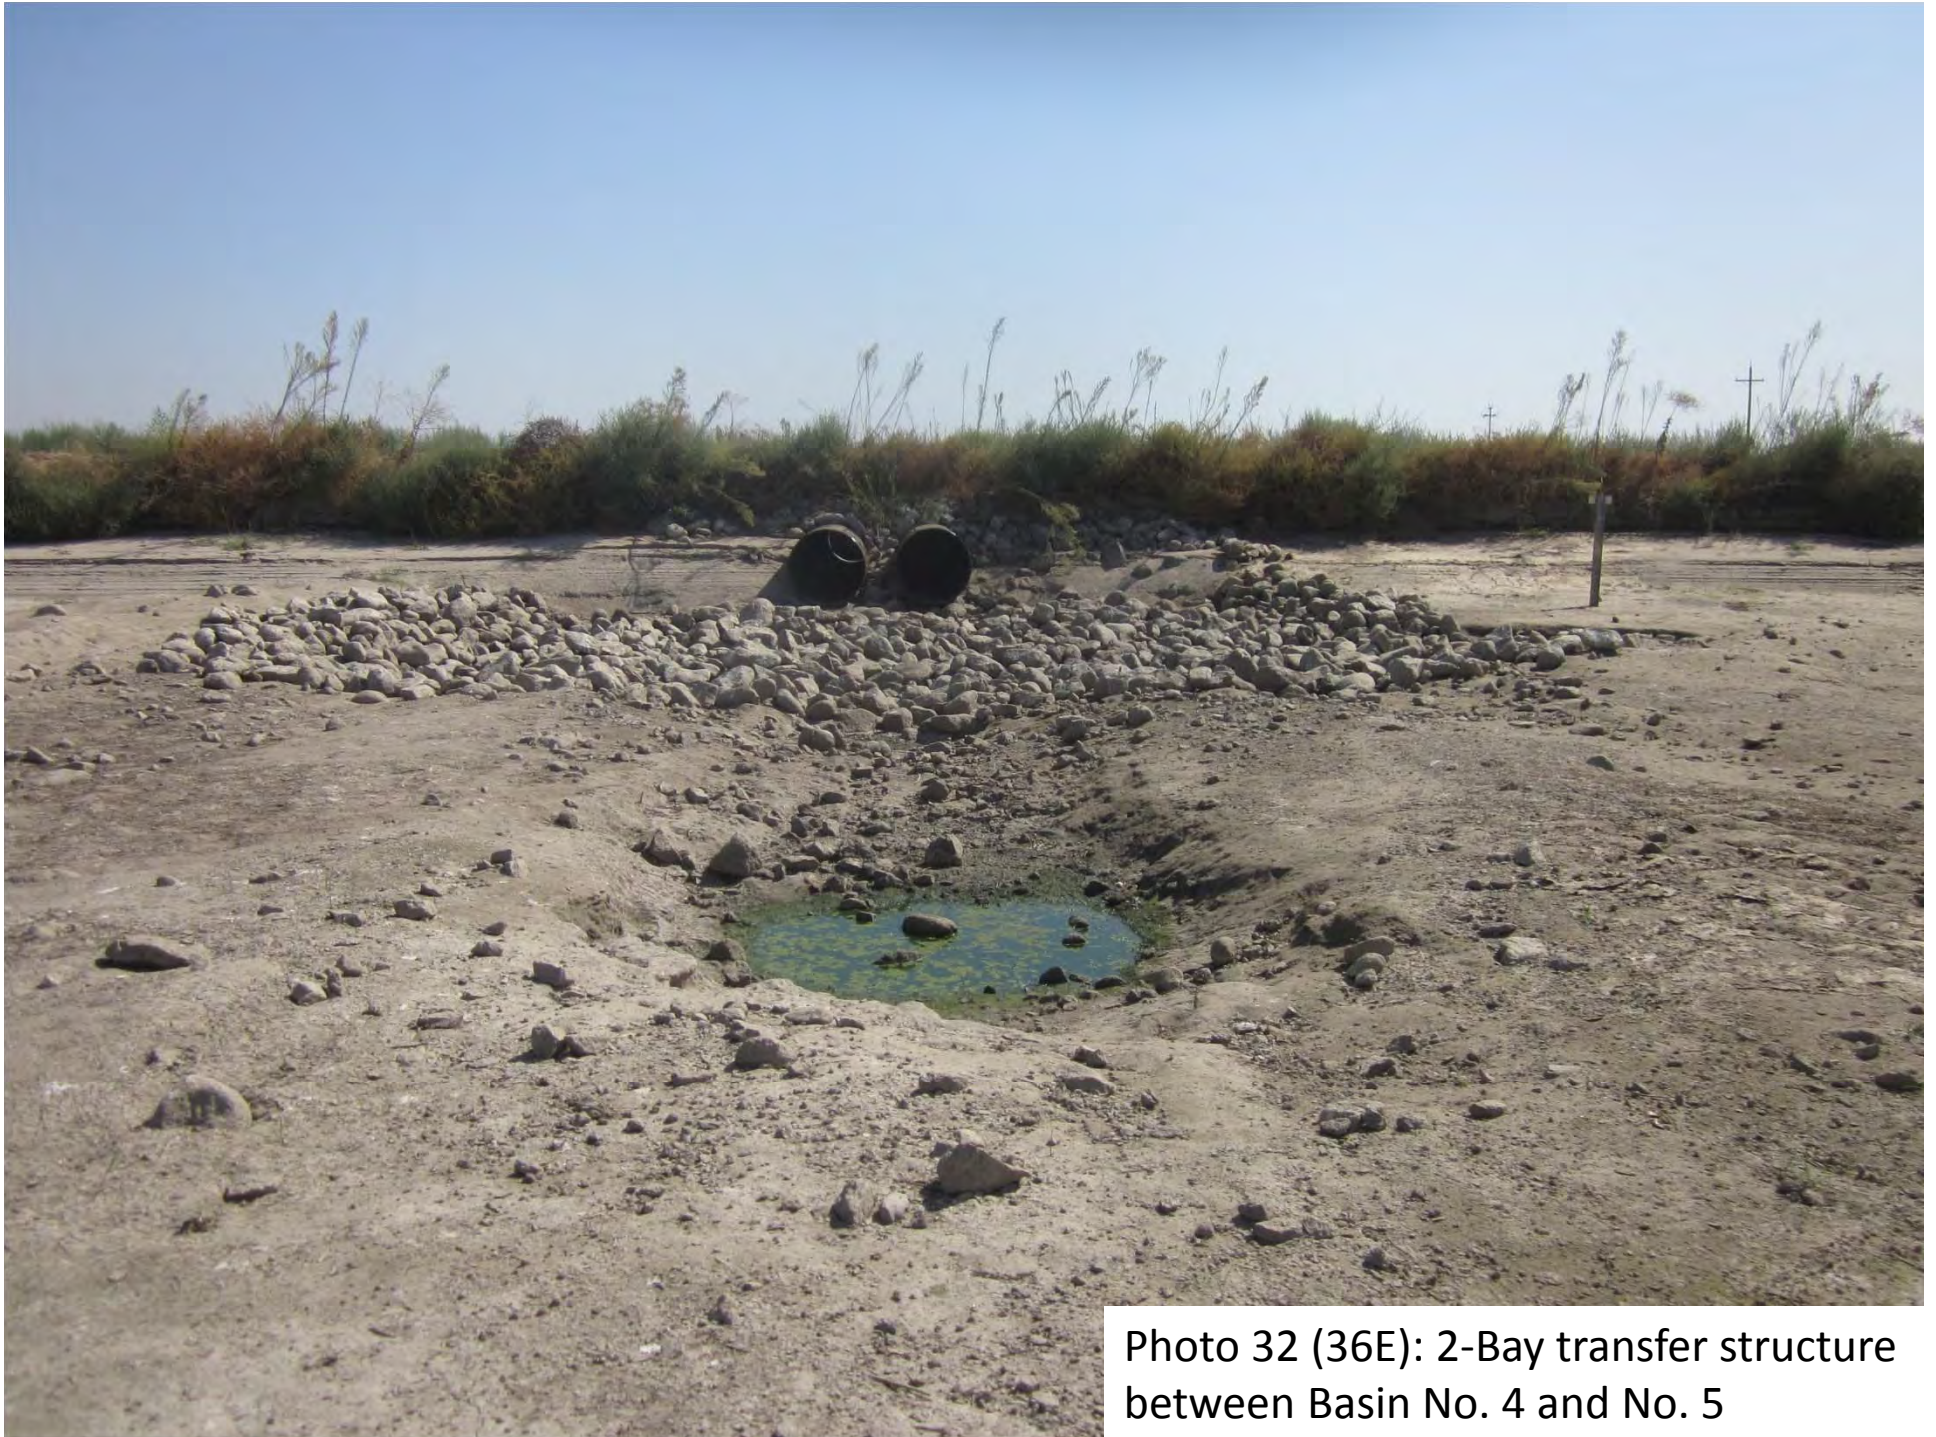
Photo 32 (36E): 2-Bay transfer structure between Basin No. 4 and No. 5

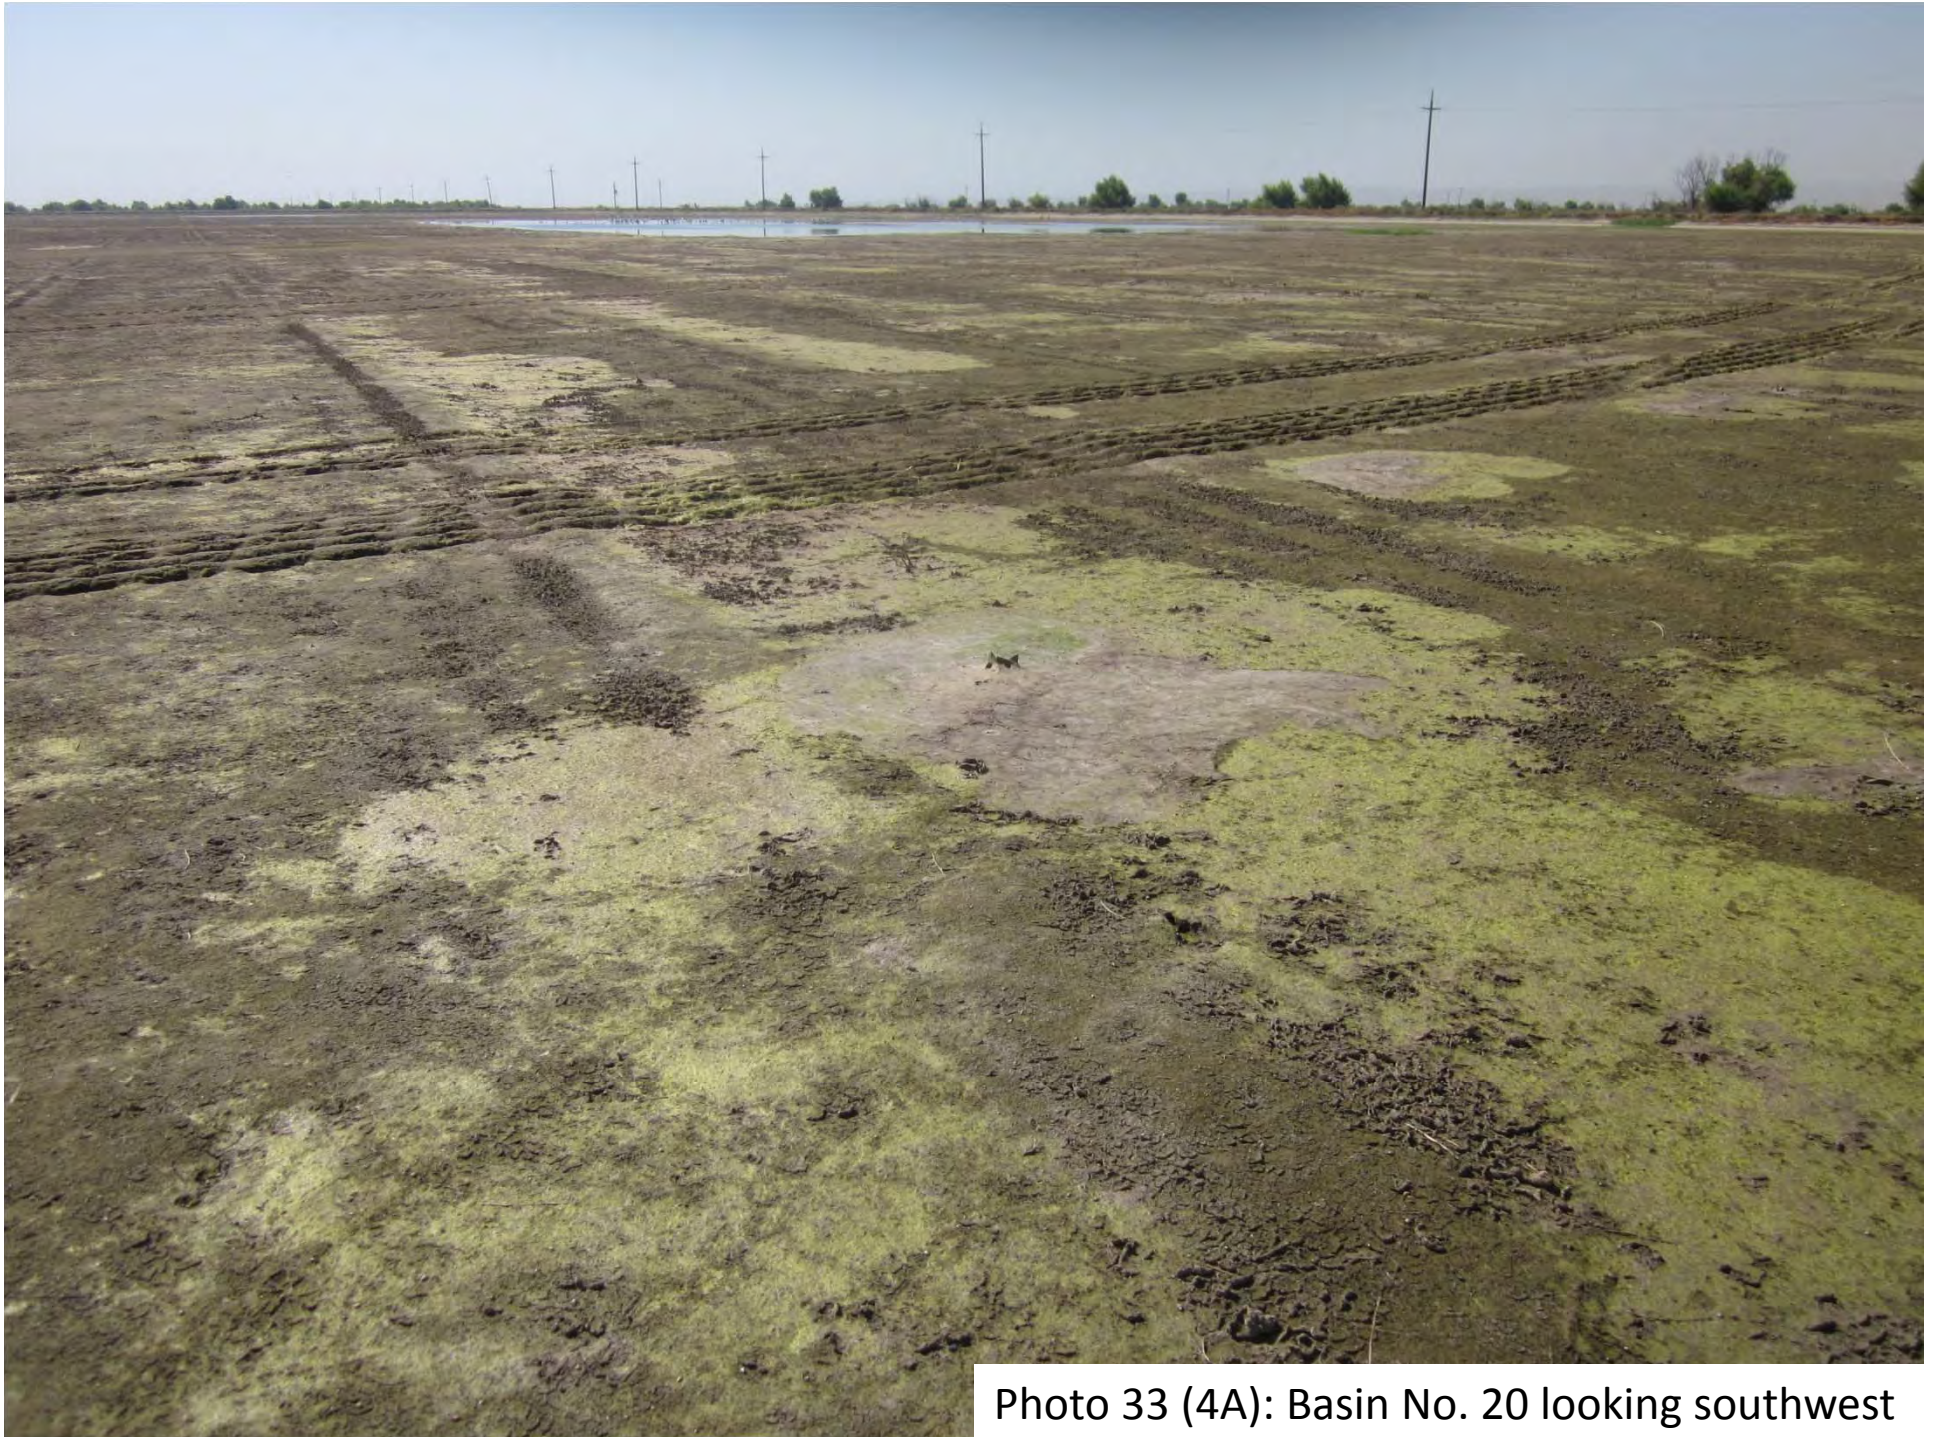
Photo 33 (4A): Basin No. 20 looking southwest

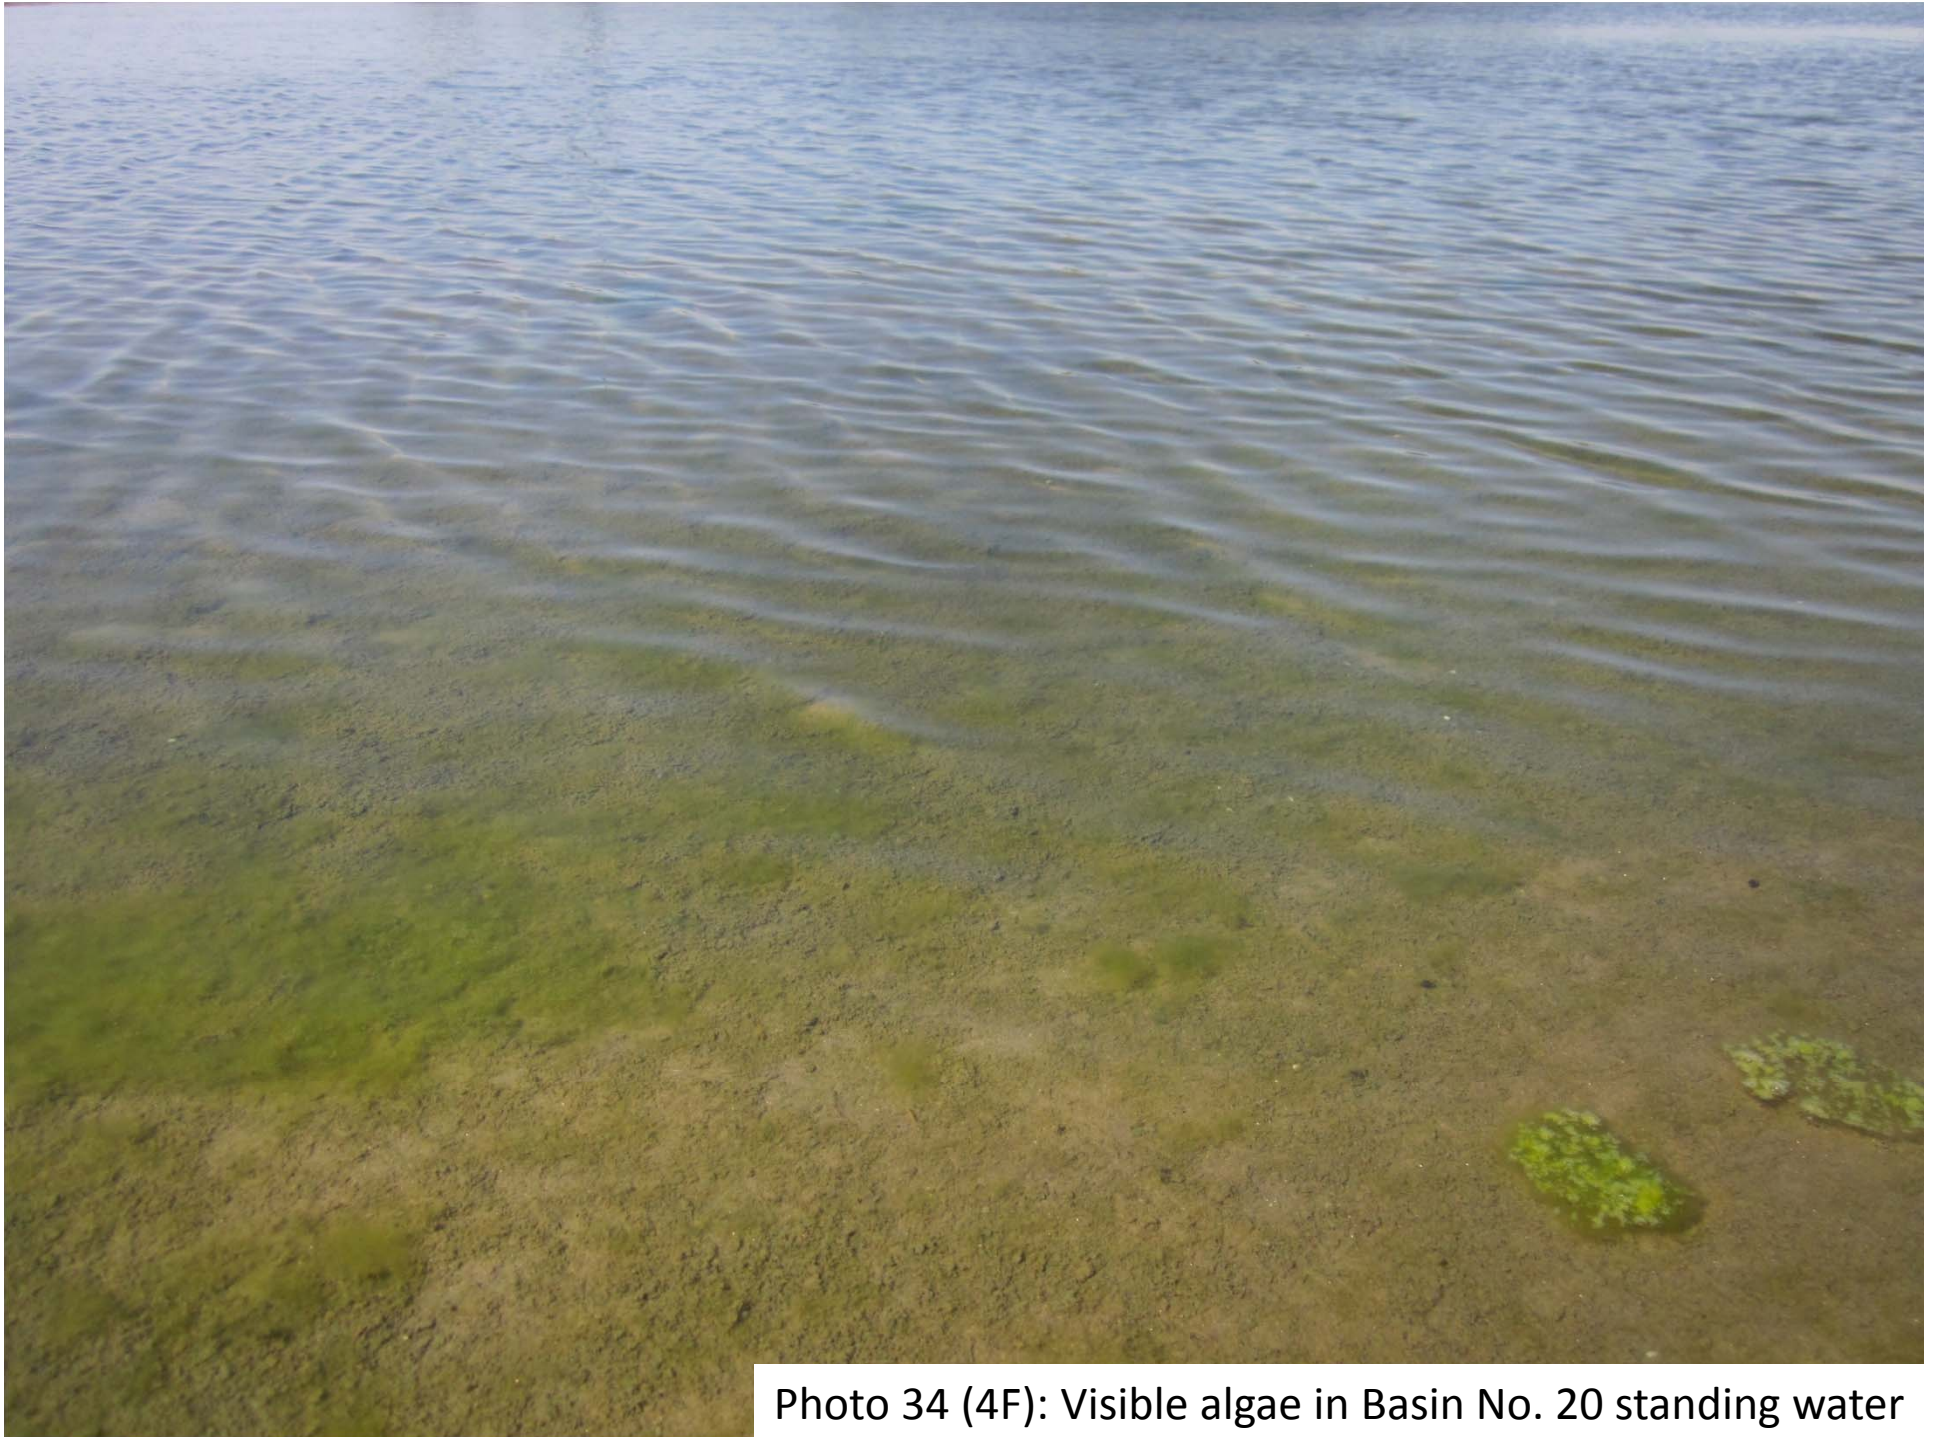
Photo 34 (4F): Visible algae in Basin No. 20 standing water

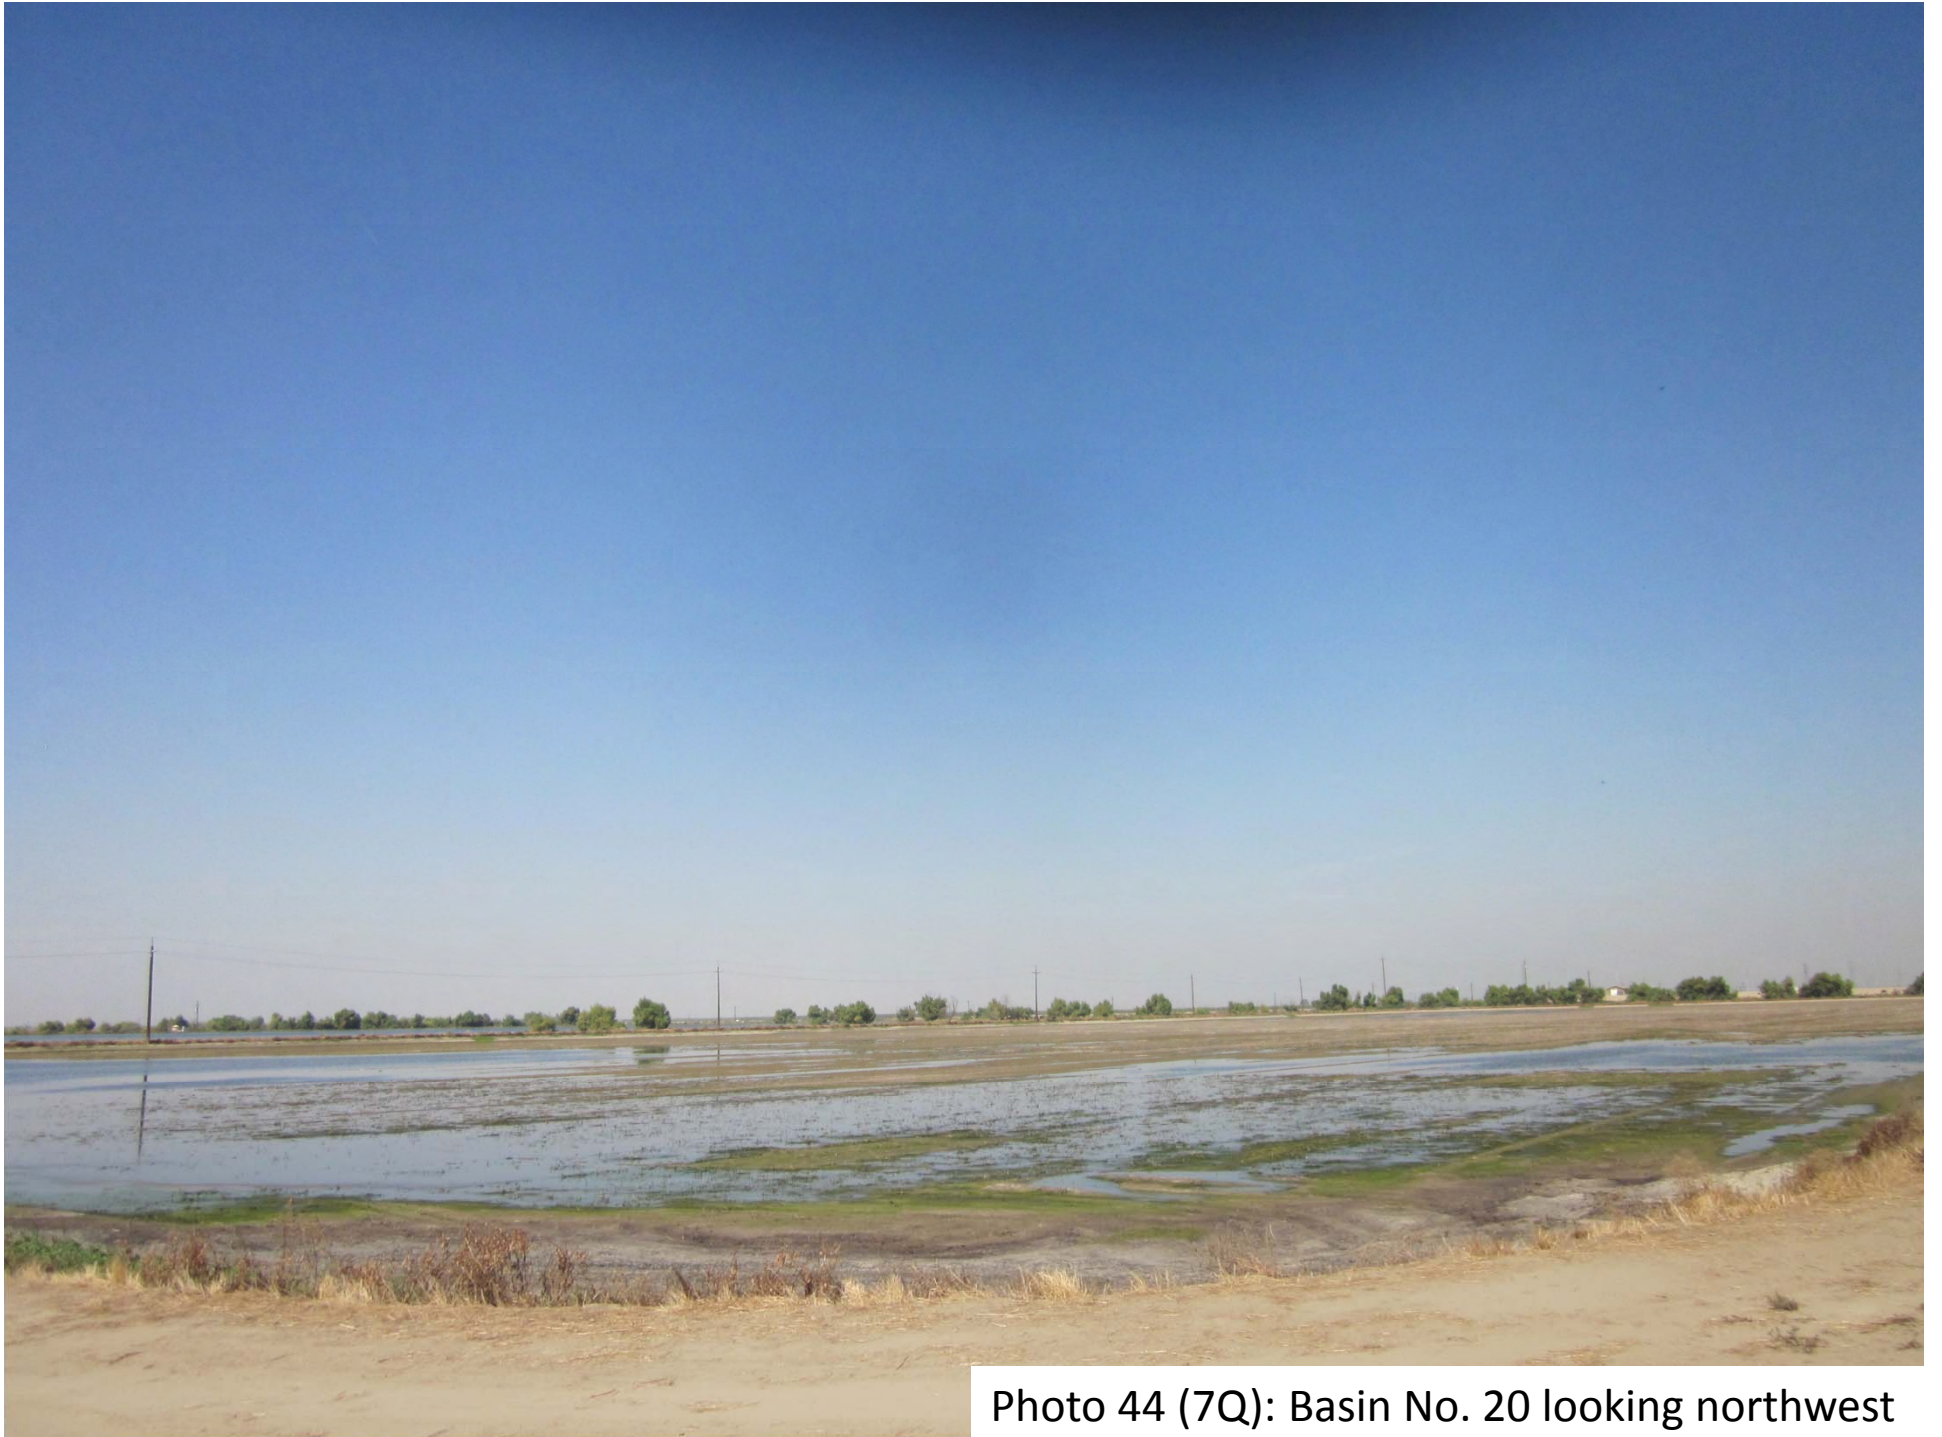
Photo 44 (7Q): Basin No. 20 looking northwest
