October 11, 2011

Irvine Ranch Water District
Attention: Paul Weghorst
15600 Sand Canyon Avenue
Irvine, CA 92618

Subject: *Strand Ranch South Basin Field Reconnaissance and Remediation Recommendations*

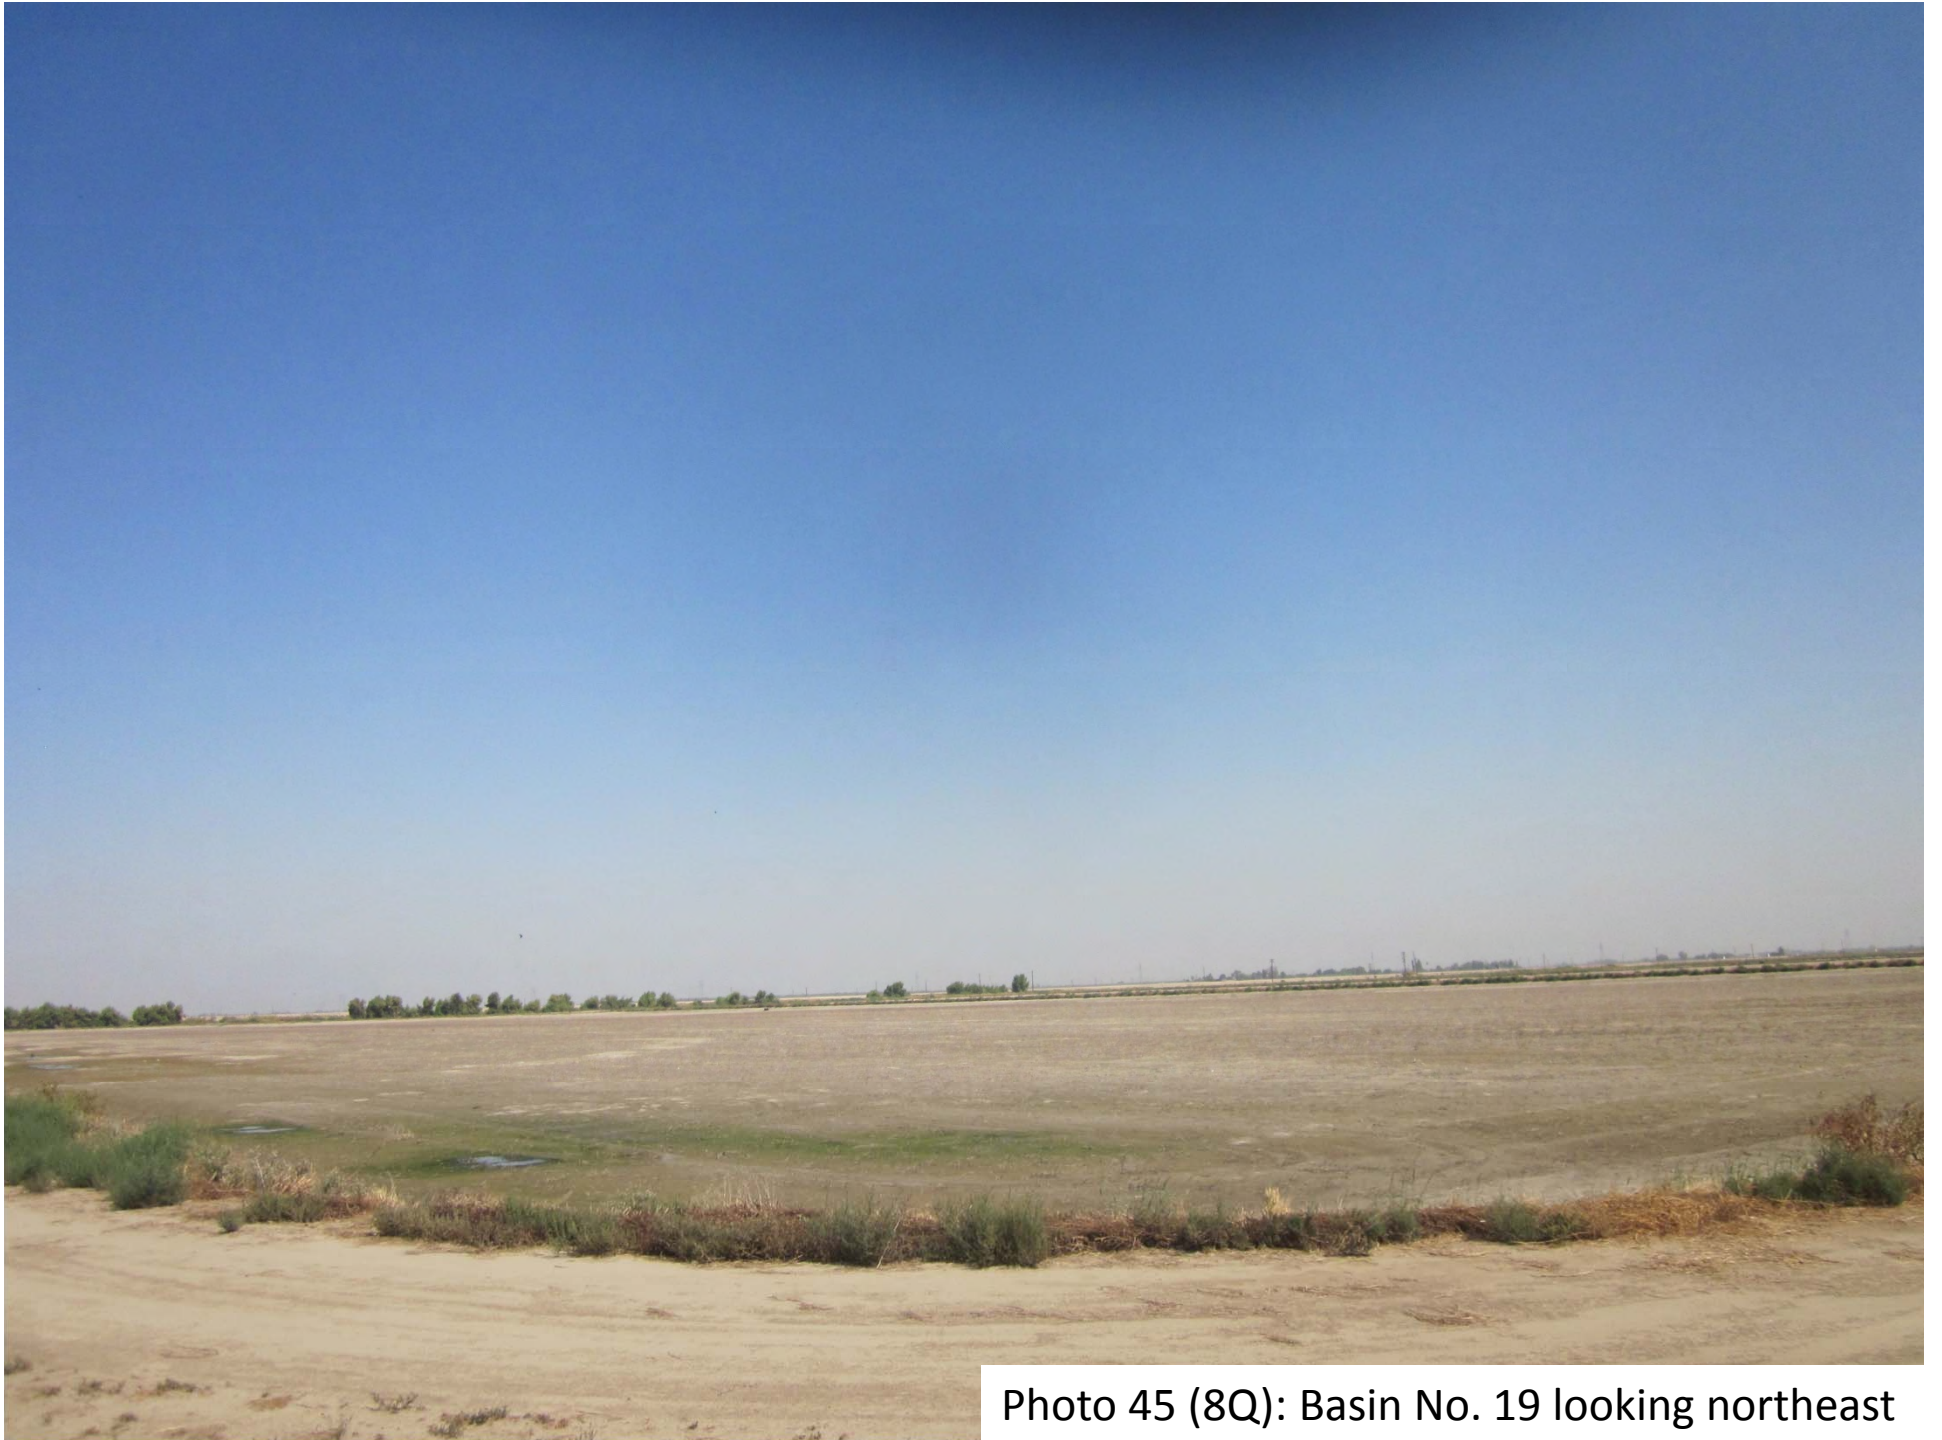
Photo 45 (8Q): Basin No. 19 looking northeast

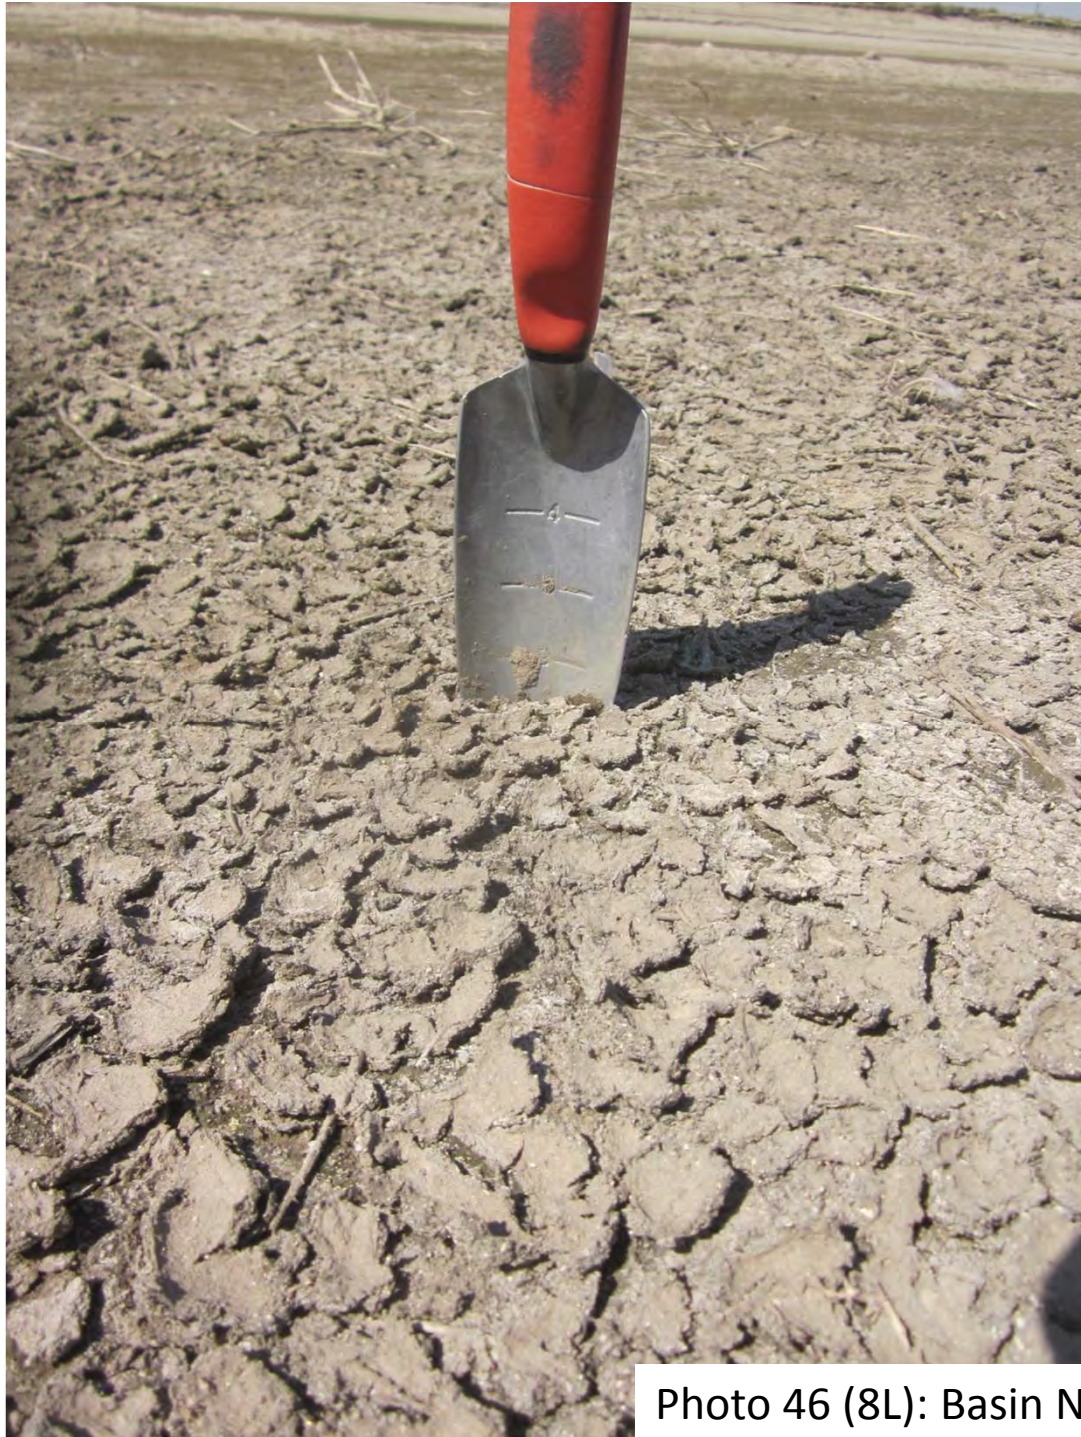
Photo 46 (8L): Basin No. 19 mud/bio-chips

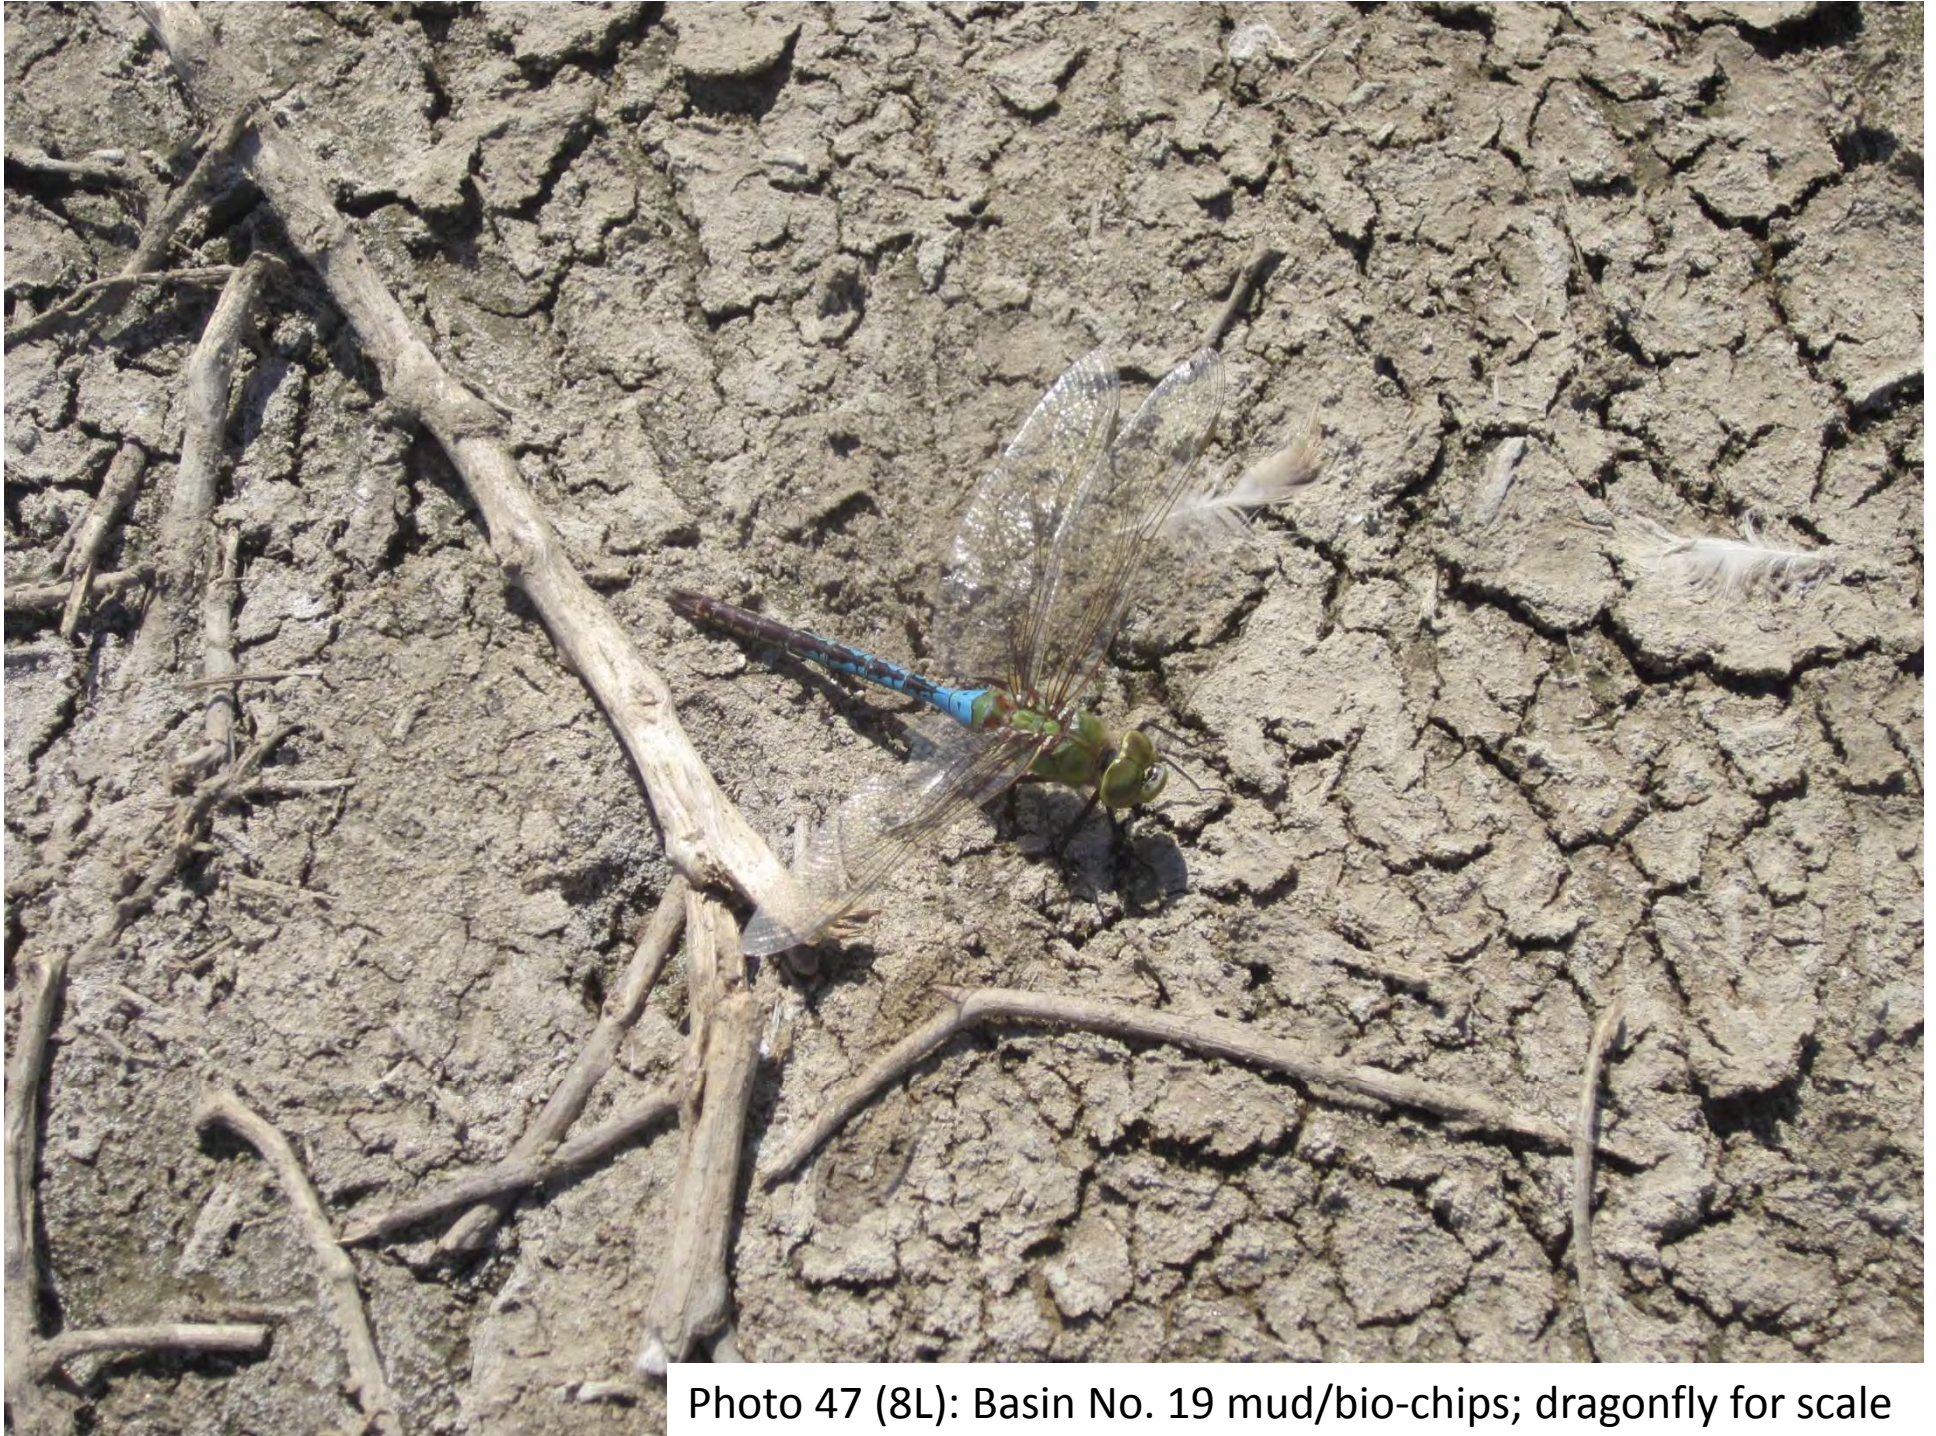
Photo 47 (8L): Basin No. 19 mud/bio-chips; dragonfly for scale

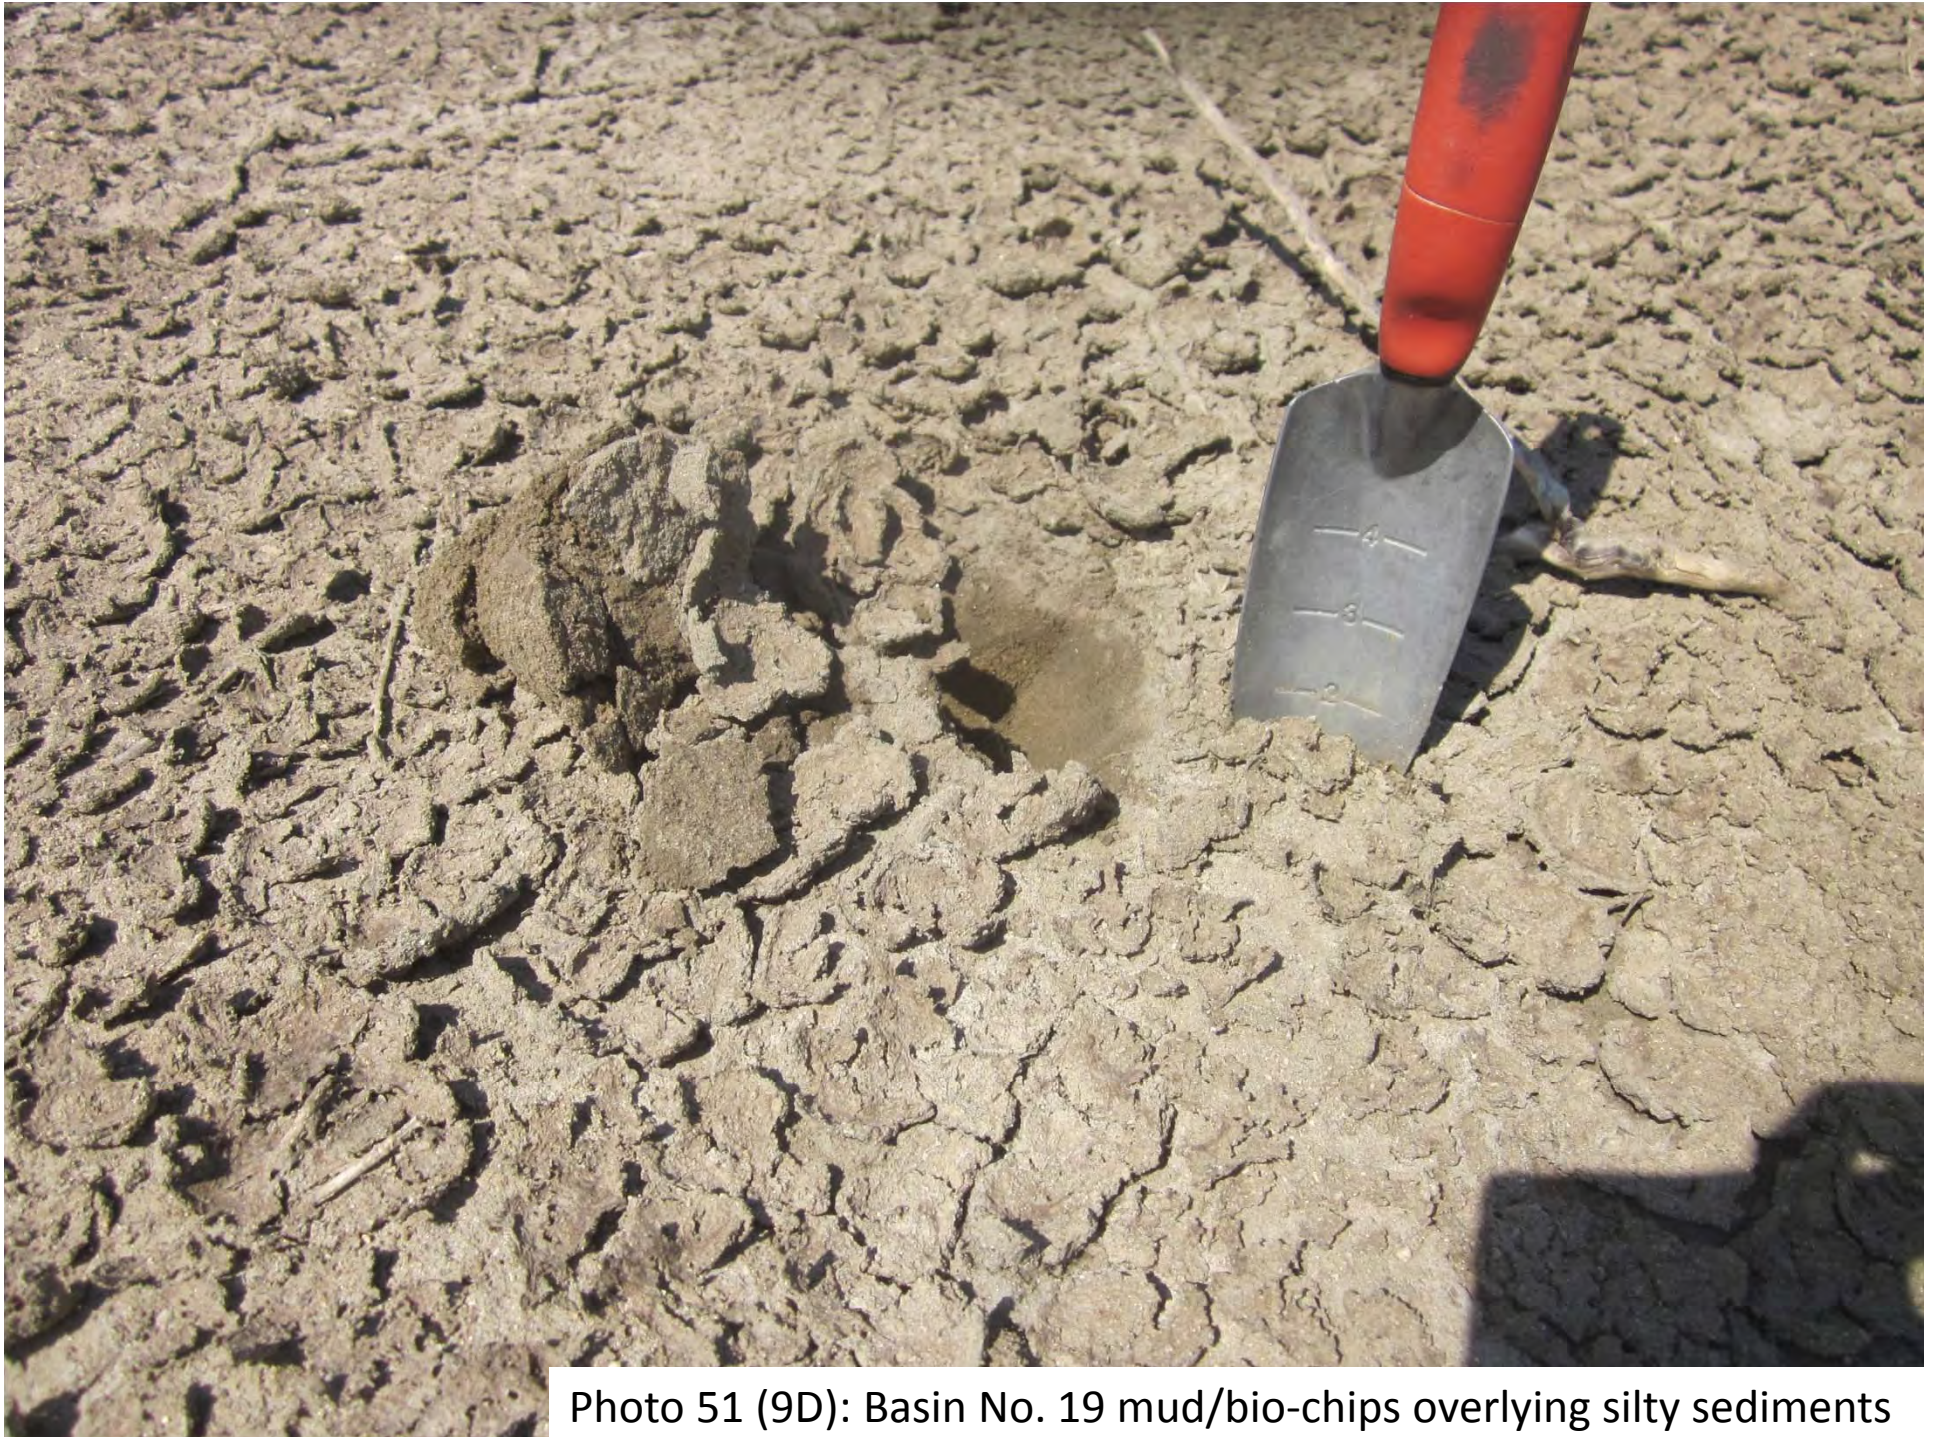
Photo 51 (9D): Basin No. 19 mud/bio-chips overlying silty sediments

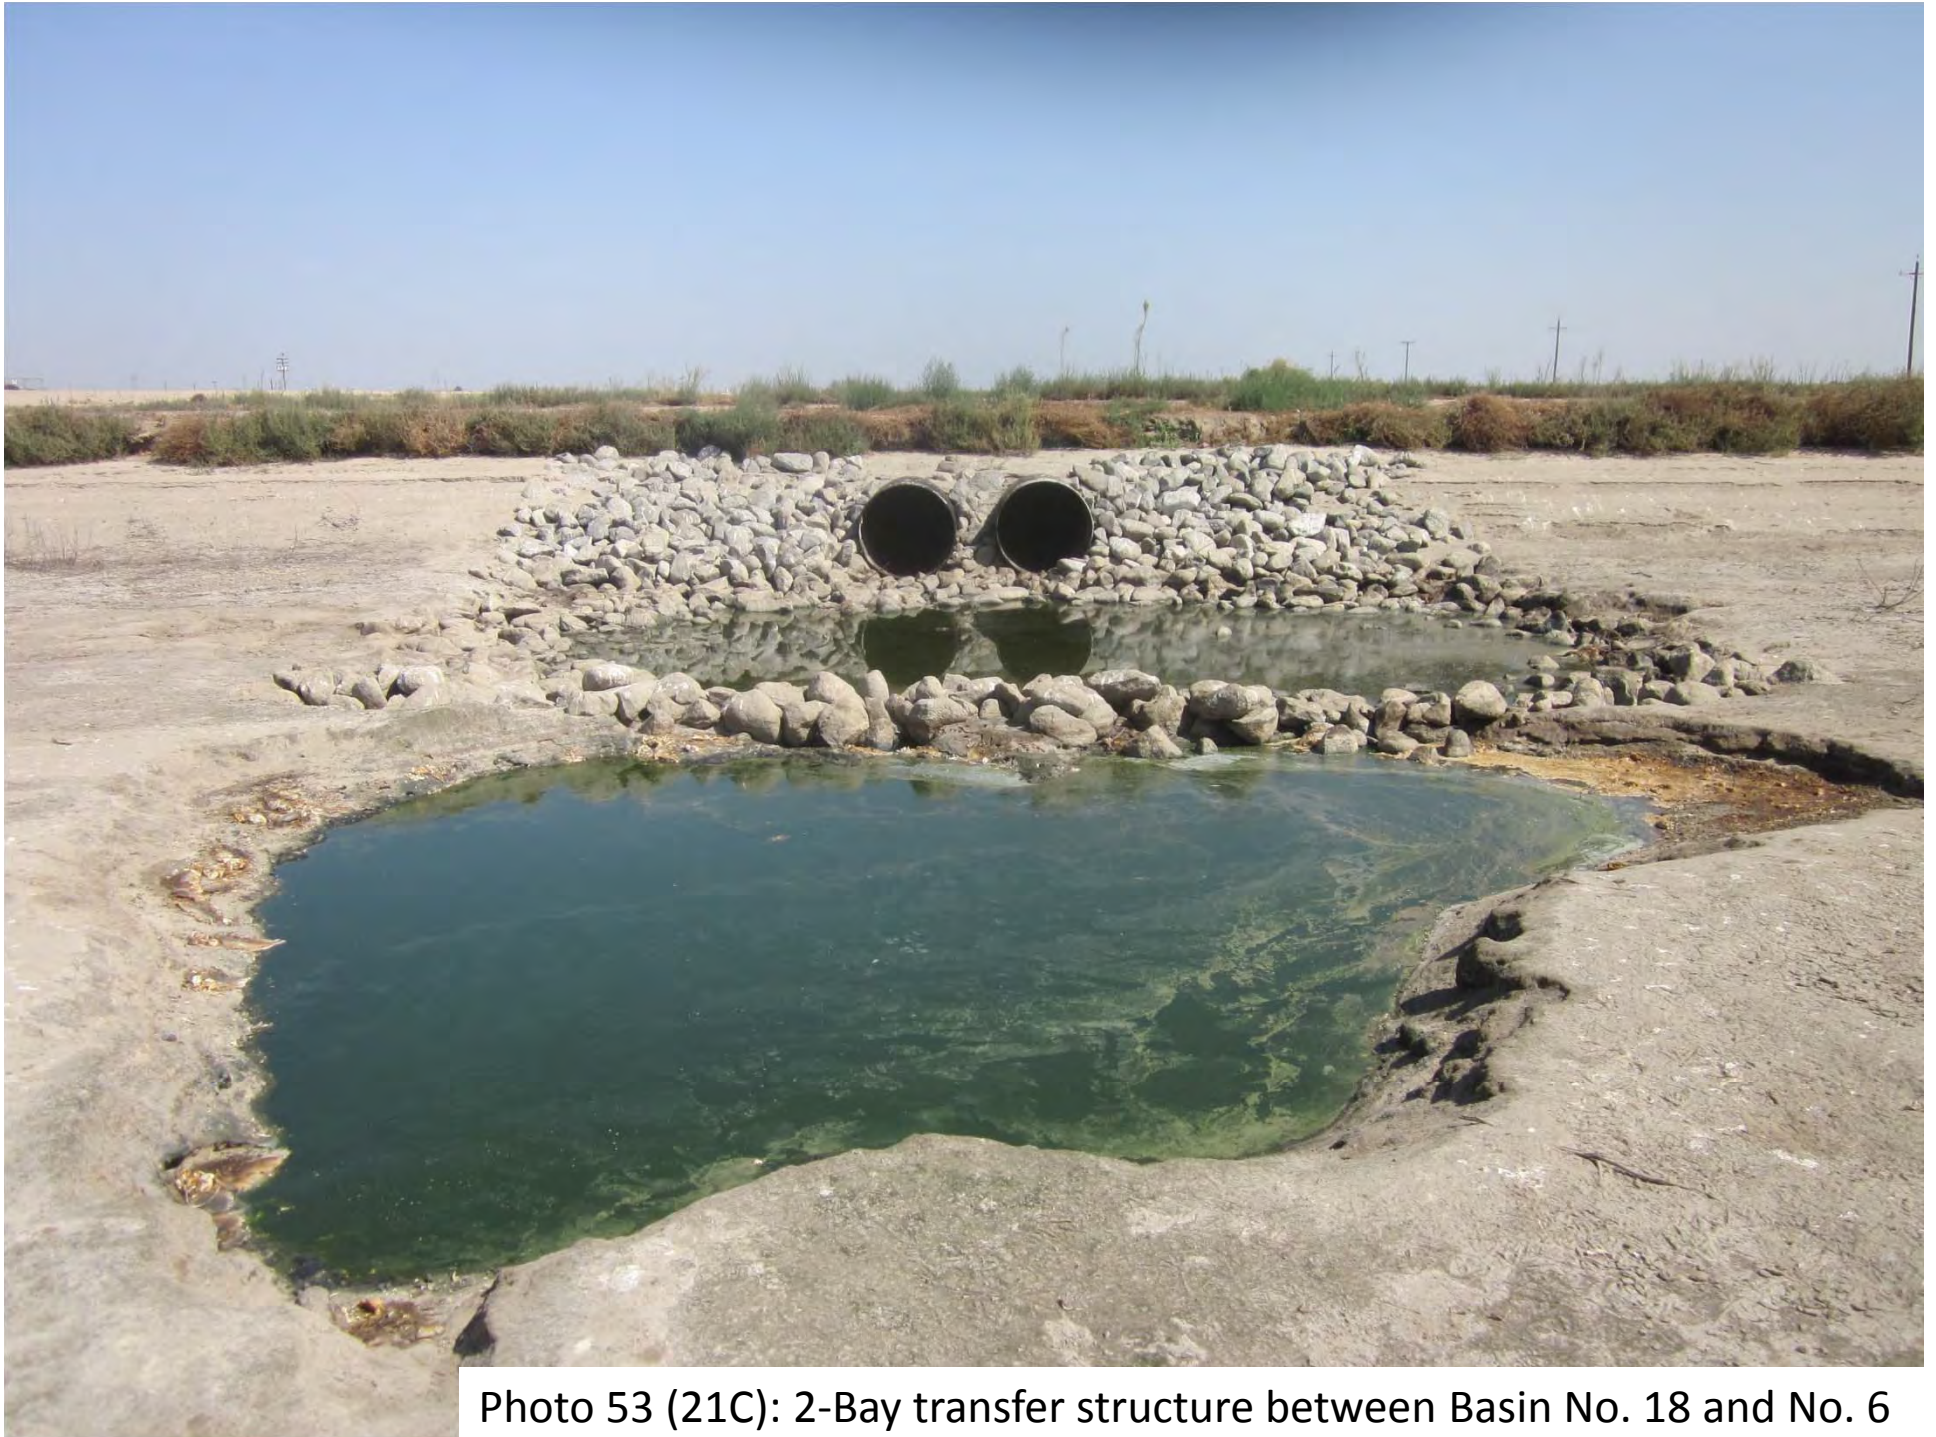
Photo 53 (21C): 2-Bay transfer structure between Basin No. 18 and No. 6

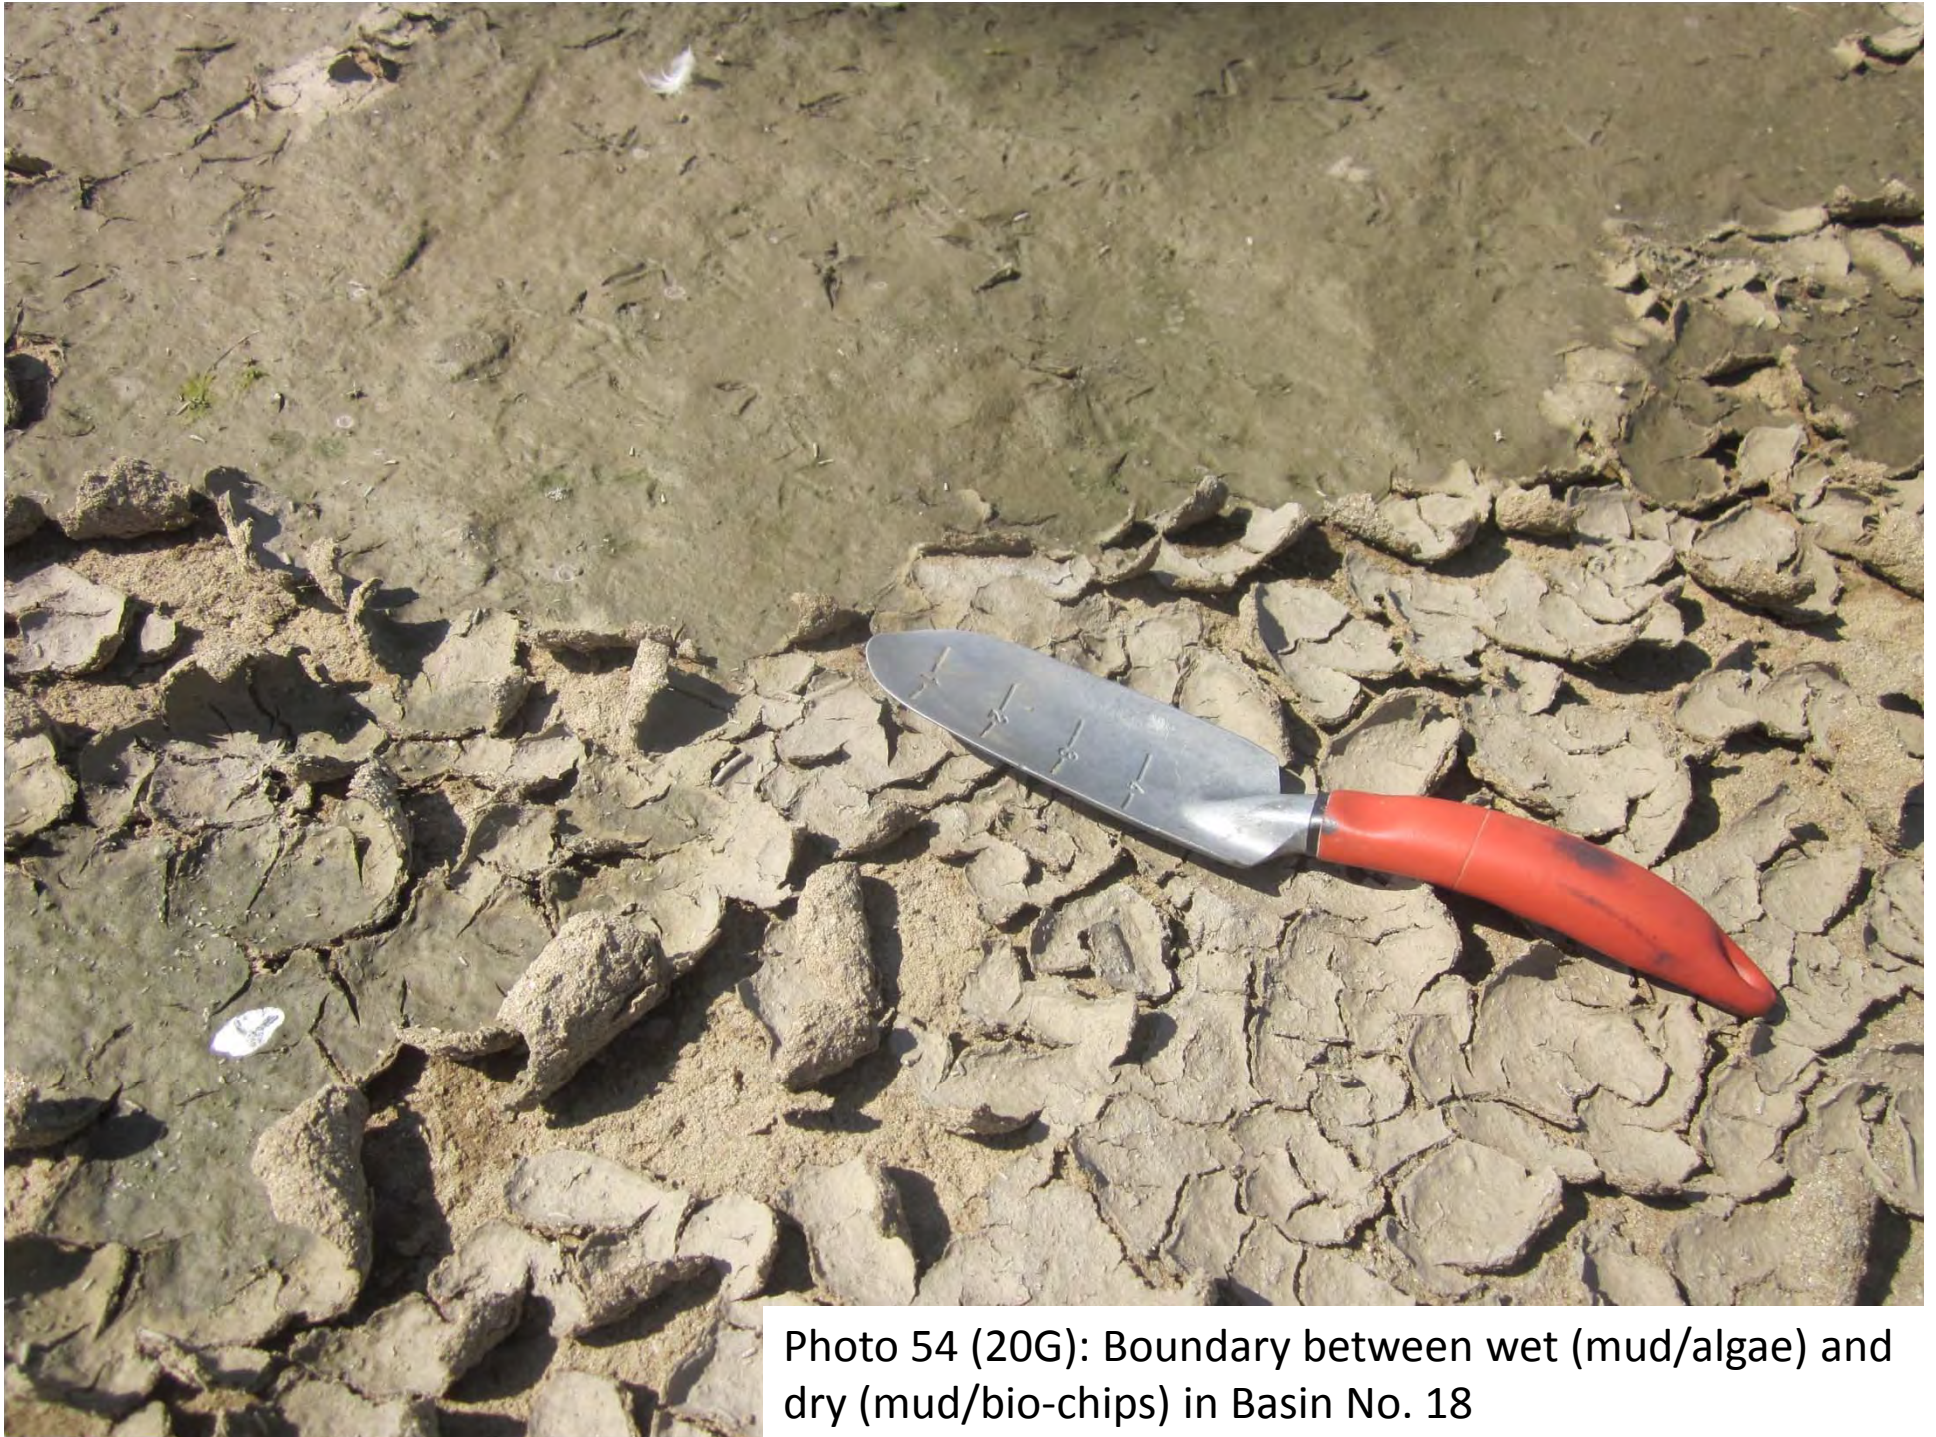
Photo 54 (20G): Boundary between wet (mud/algae) and dry (mud/bio-chips) in Basin No. 18

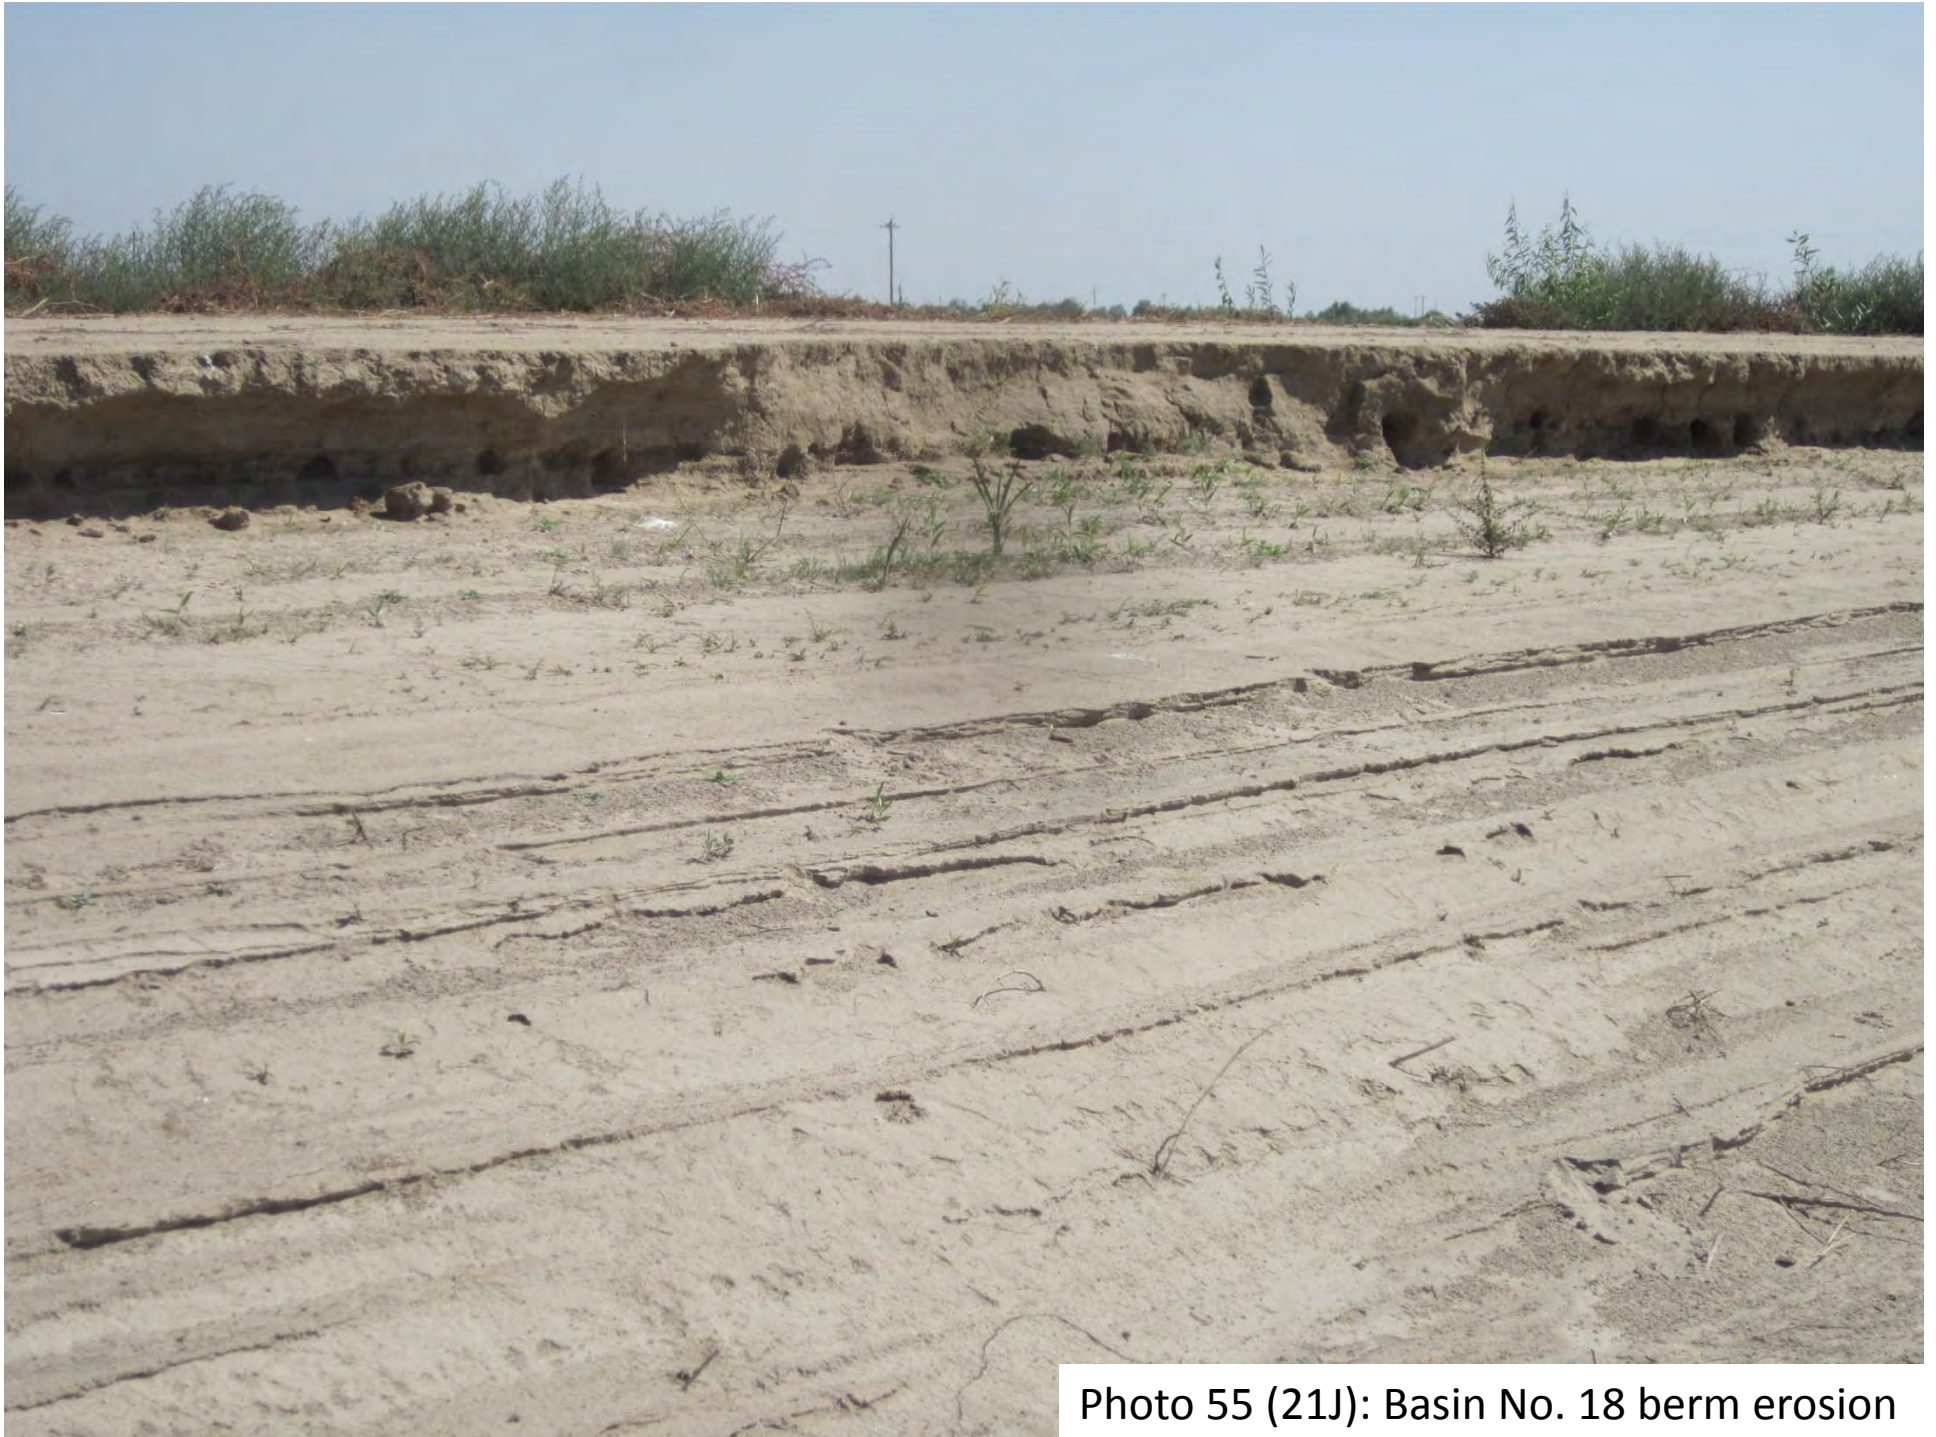
Photo 55 (21J): Basin No. 18 berm erosion

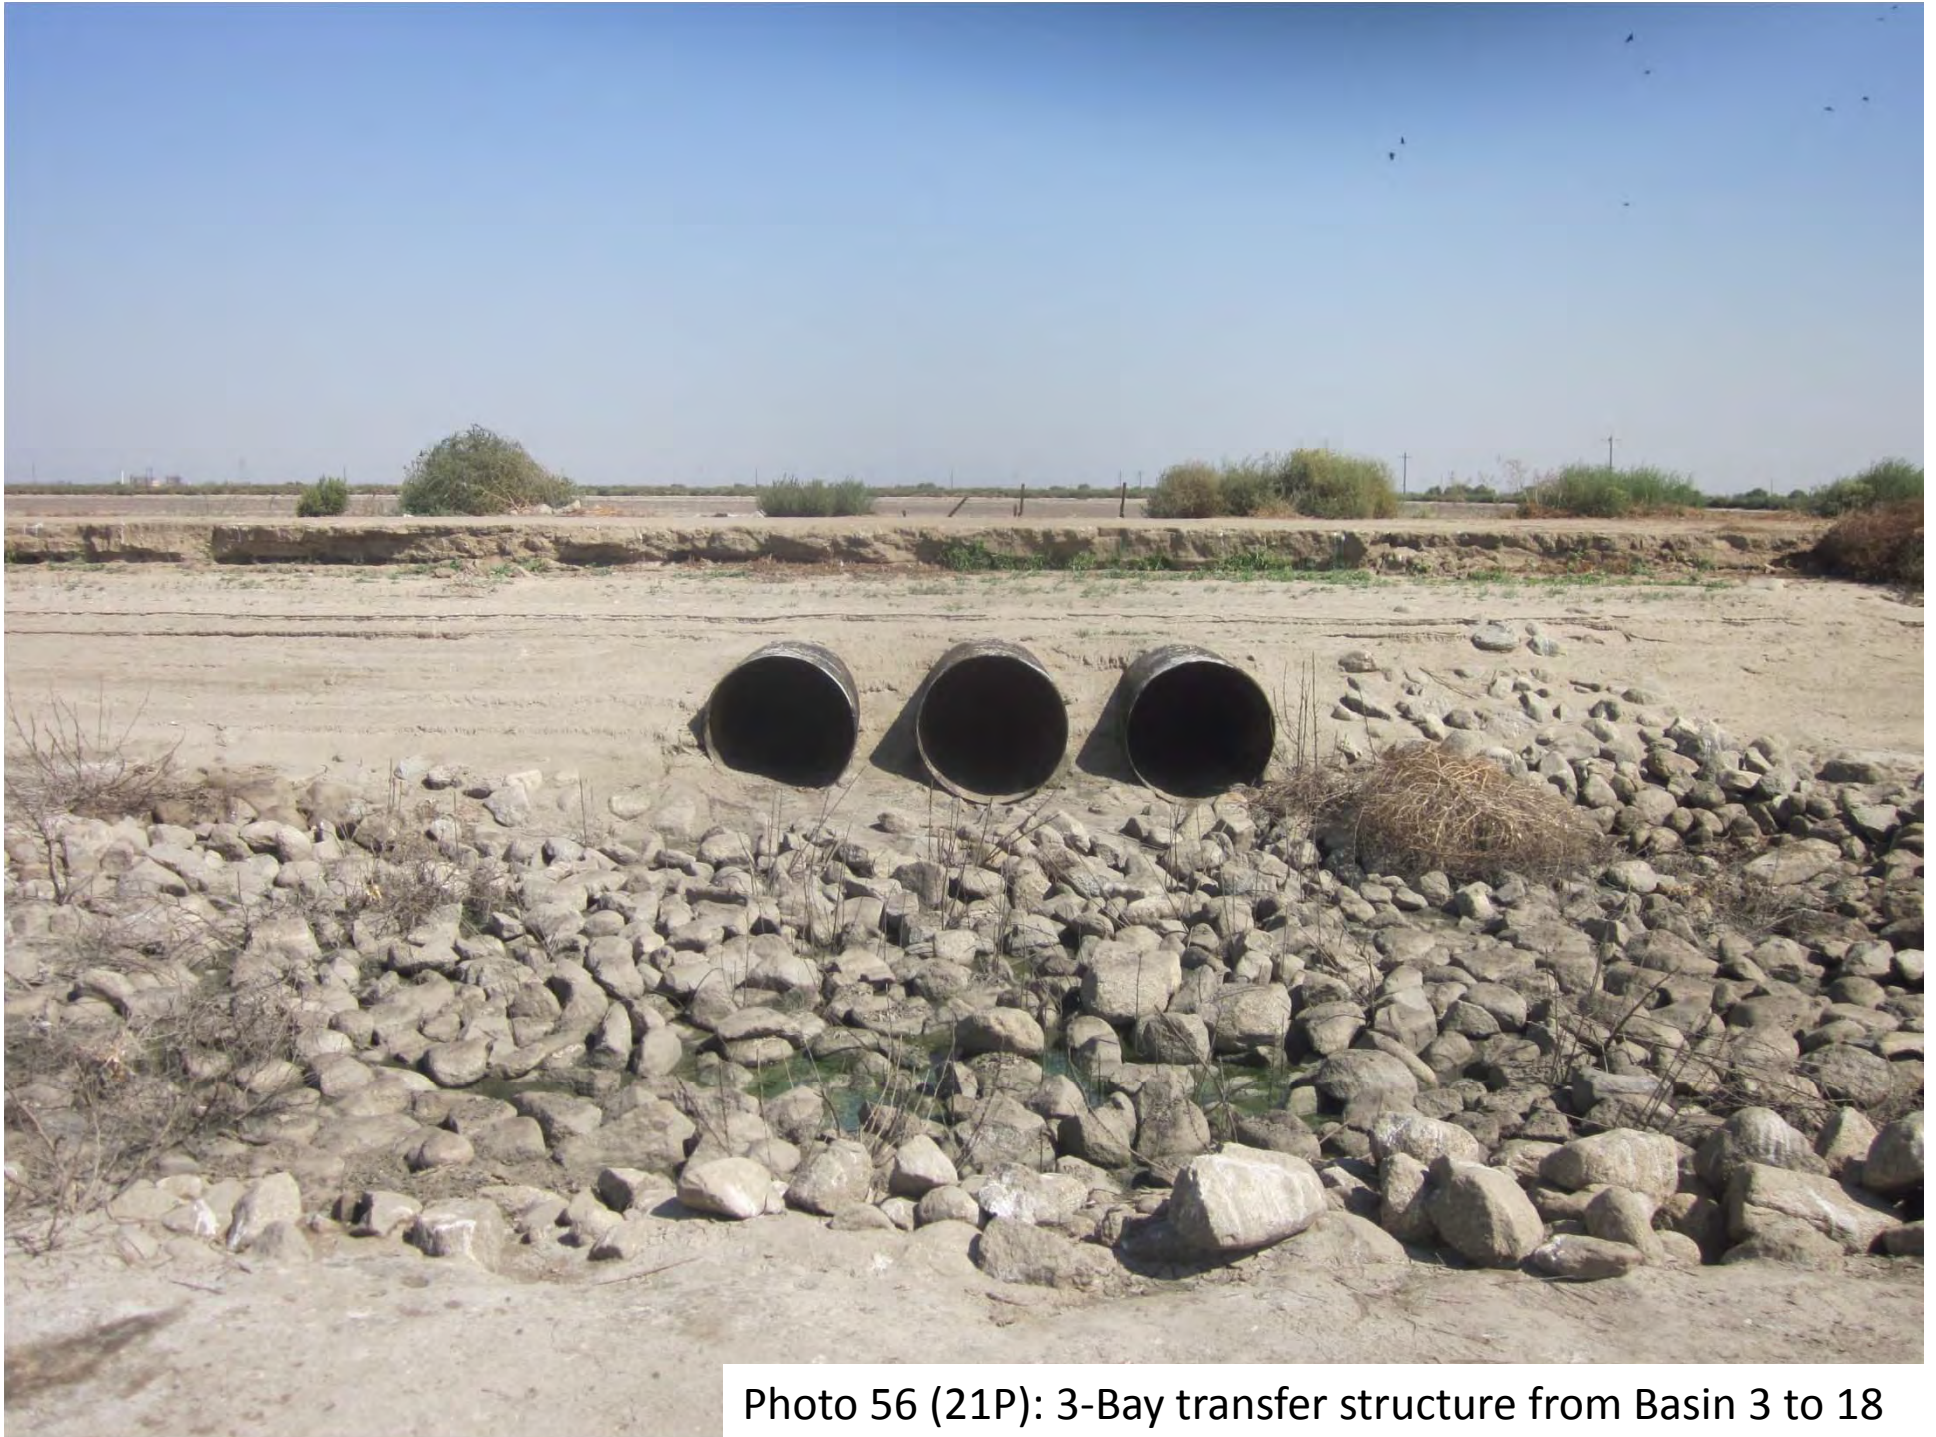
Photo 56 (21P): 3-Bay transfer structure from Basin 3 to 18
