October 11, 2011

Irvine Ranch Water District
Attention: Paul Weghorst
15600 Sand Canyon Avenue
Irvine, CA 92618

Subject: *Strand Ranch South Basin Field Reconnaissance and Remediation Recommendations*

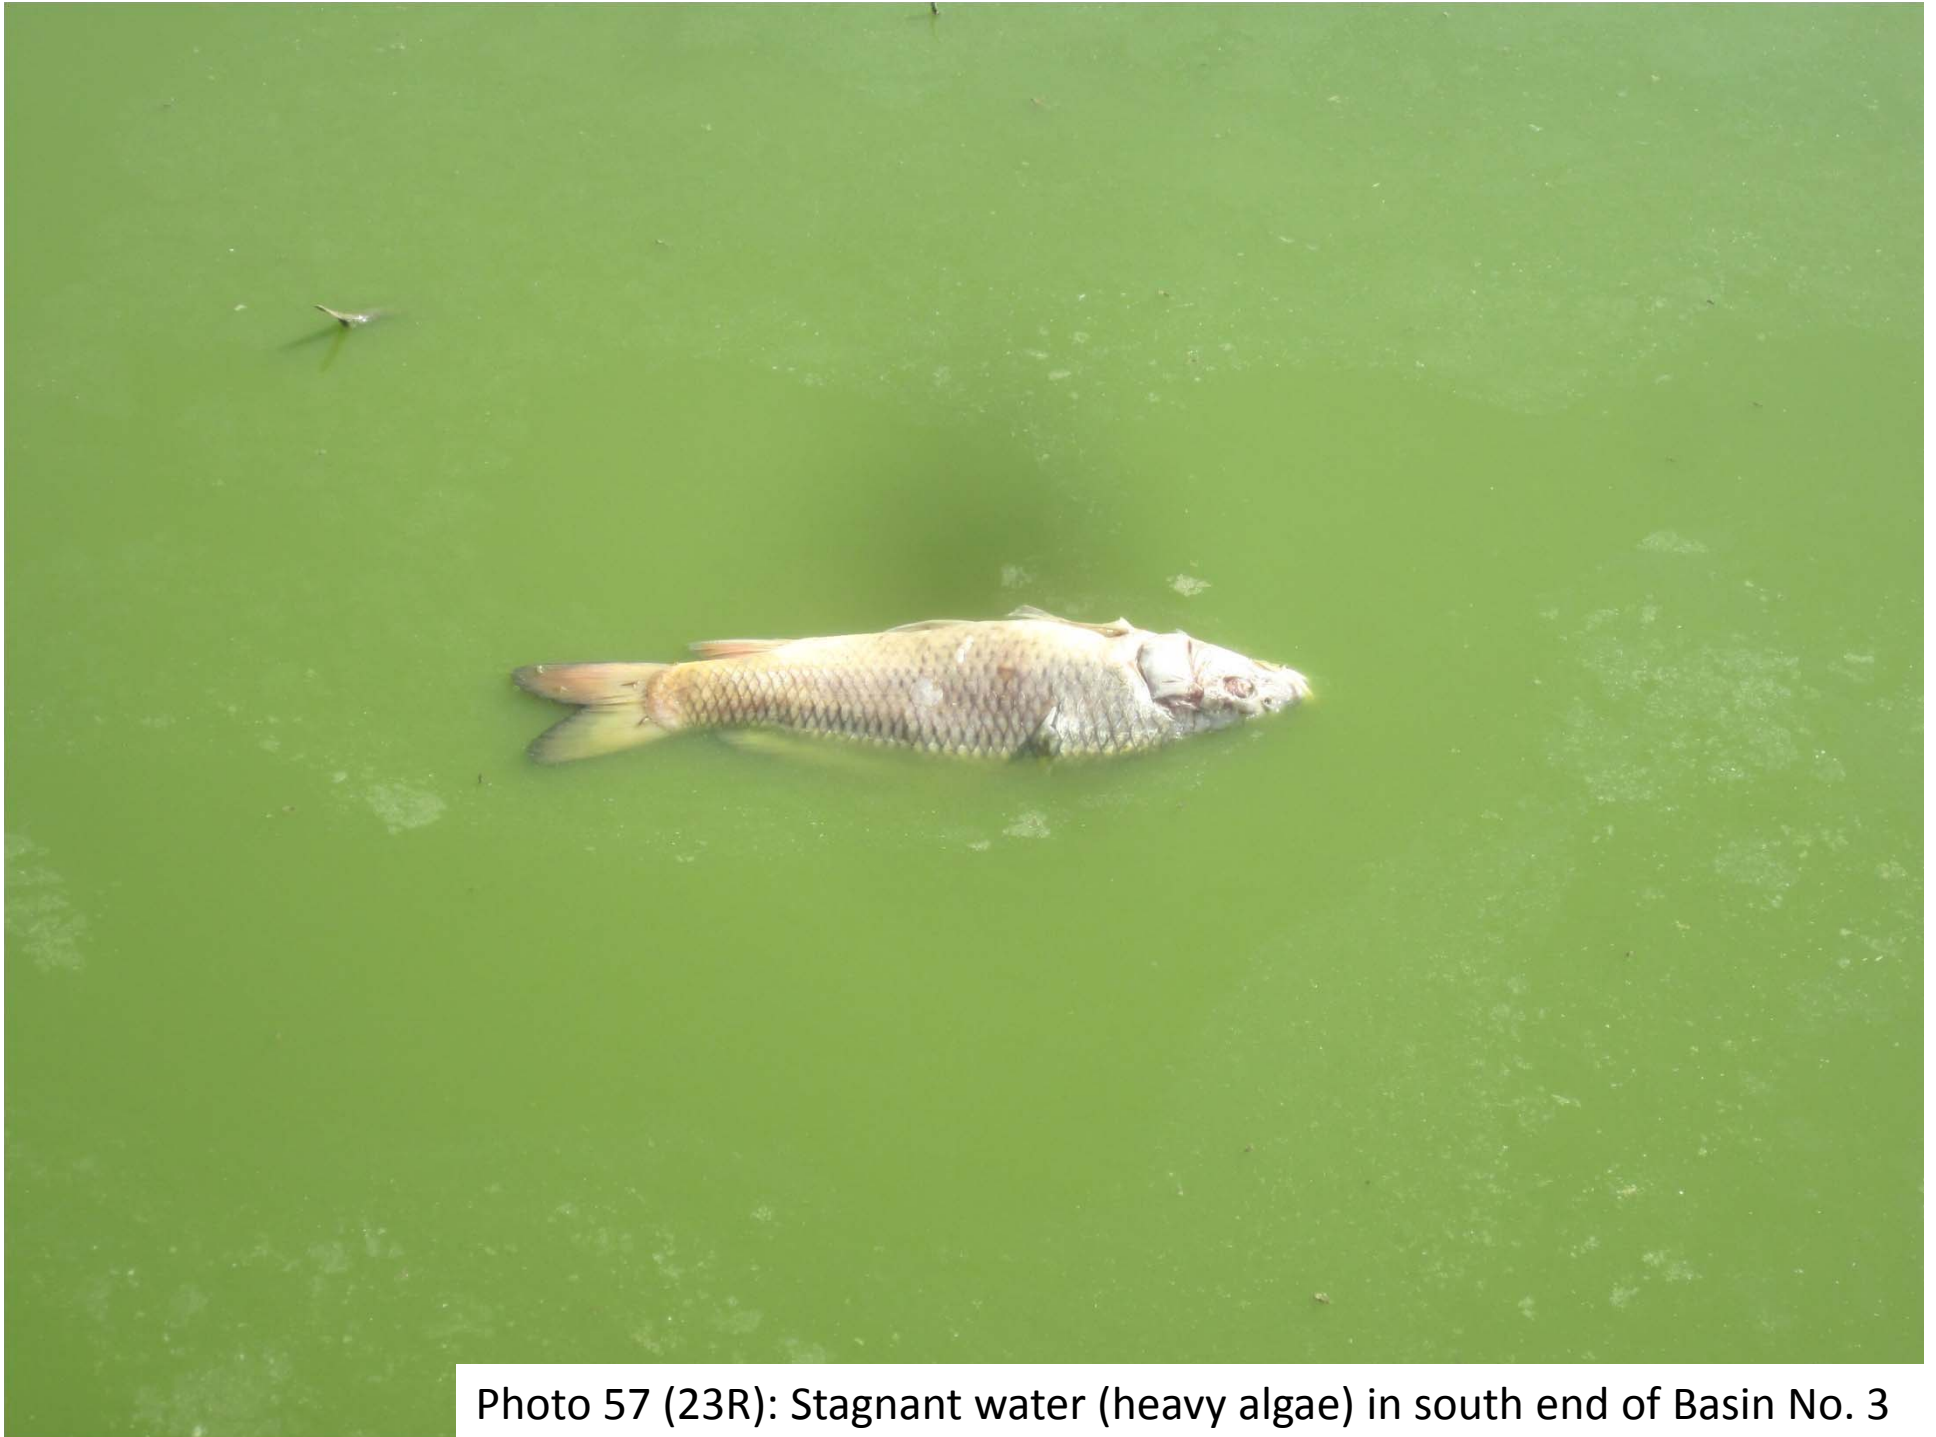
Photo 57 (23R): Stagnant water (heavy algae) in south end of Basin No. 3

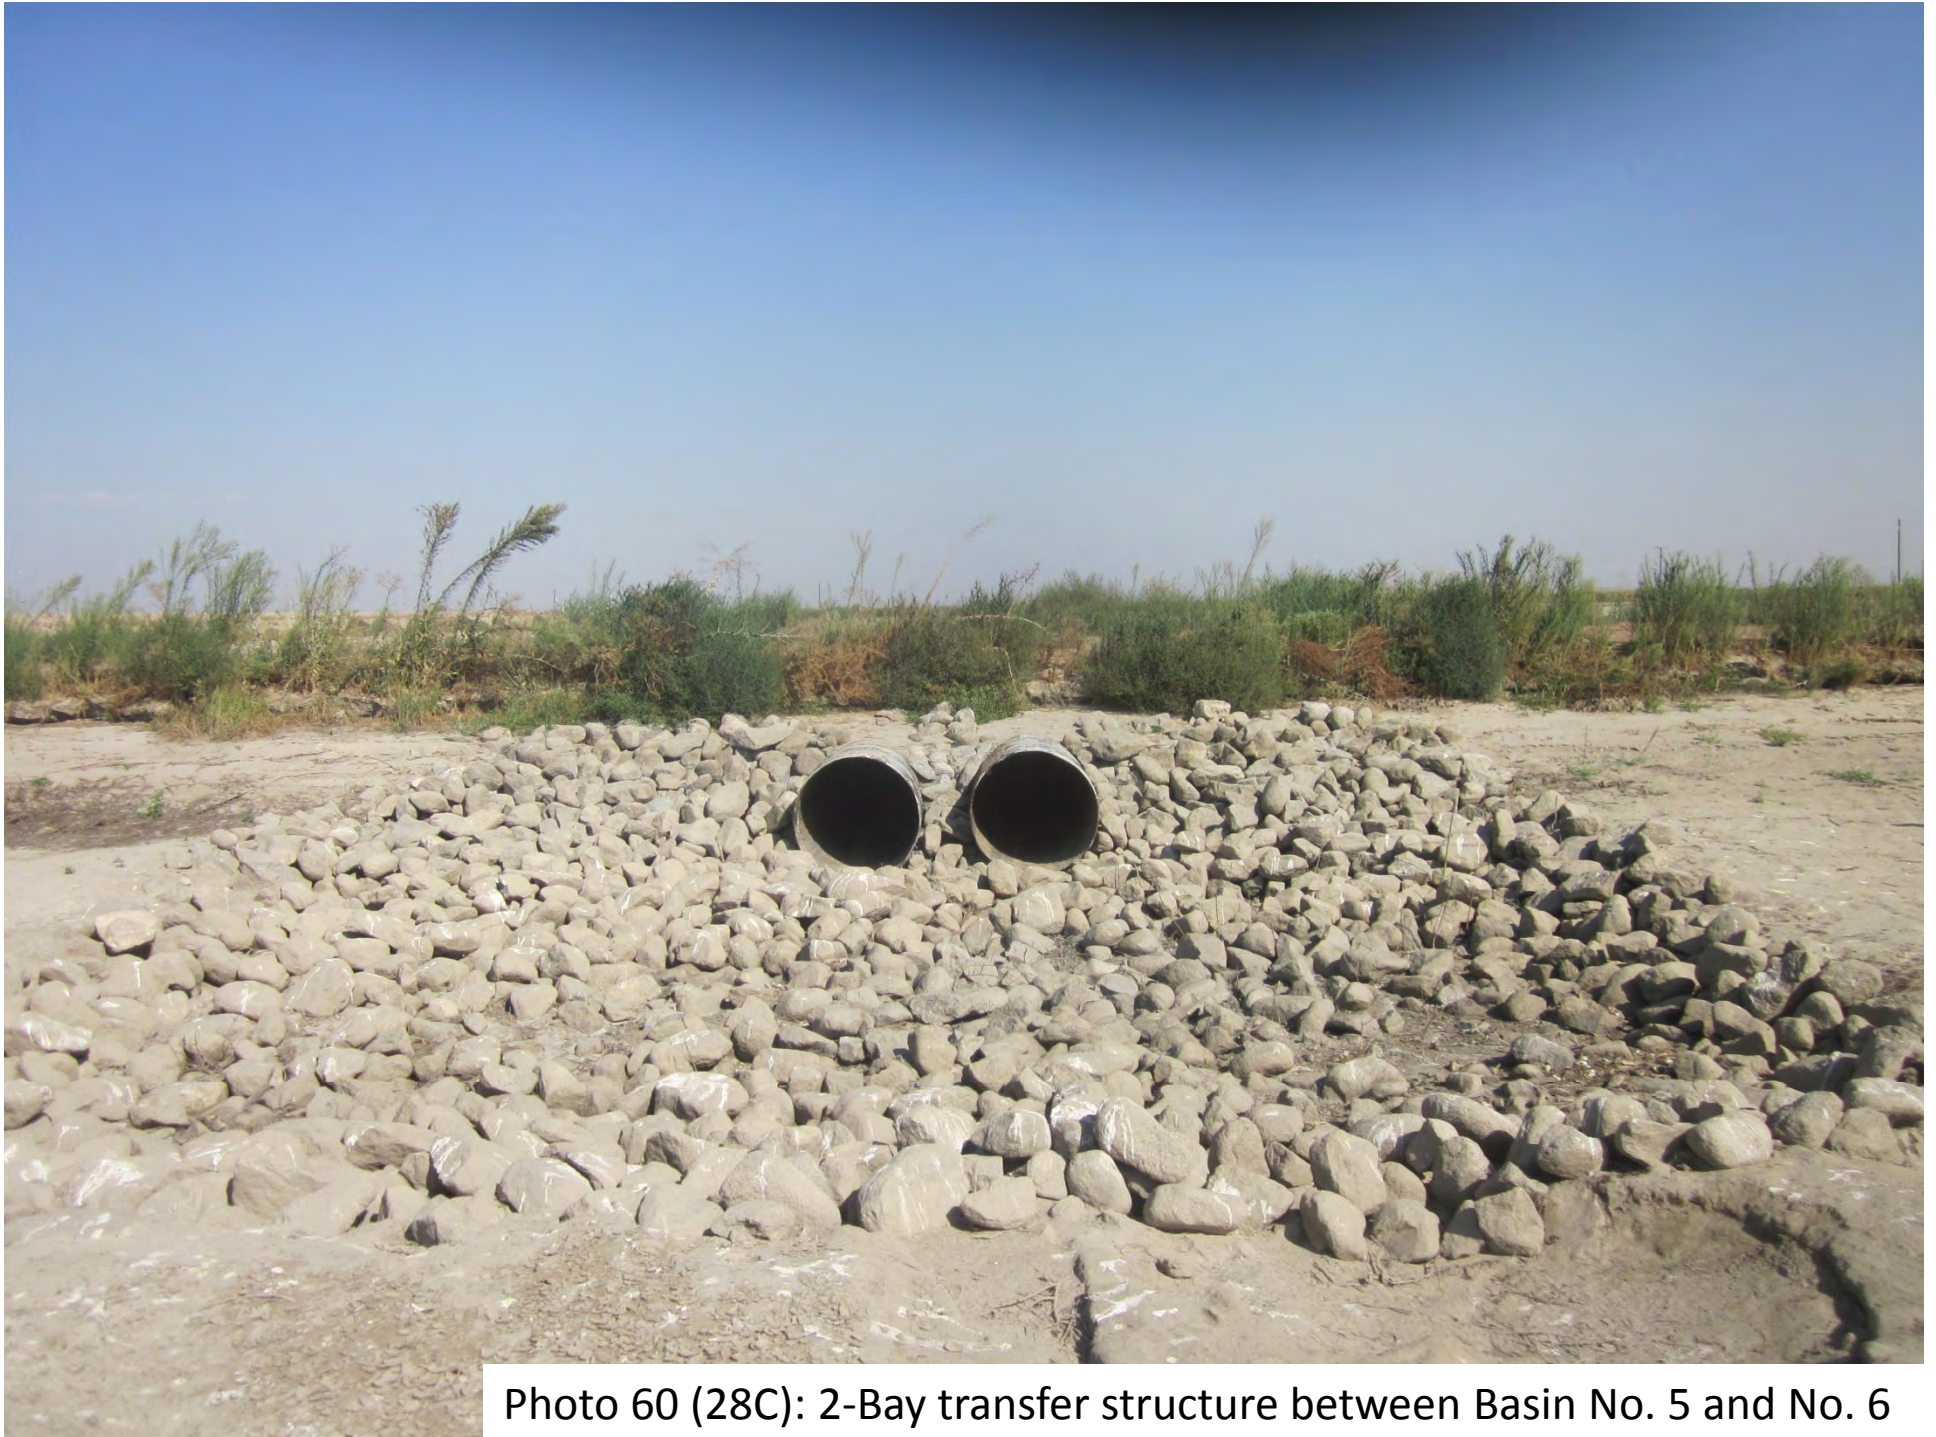
Photo 60 (28C): 2-Bay transfer structure between Basin No. 5 and No. 6

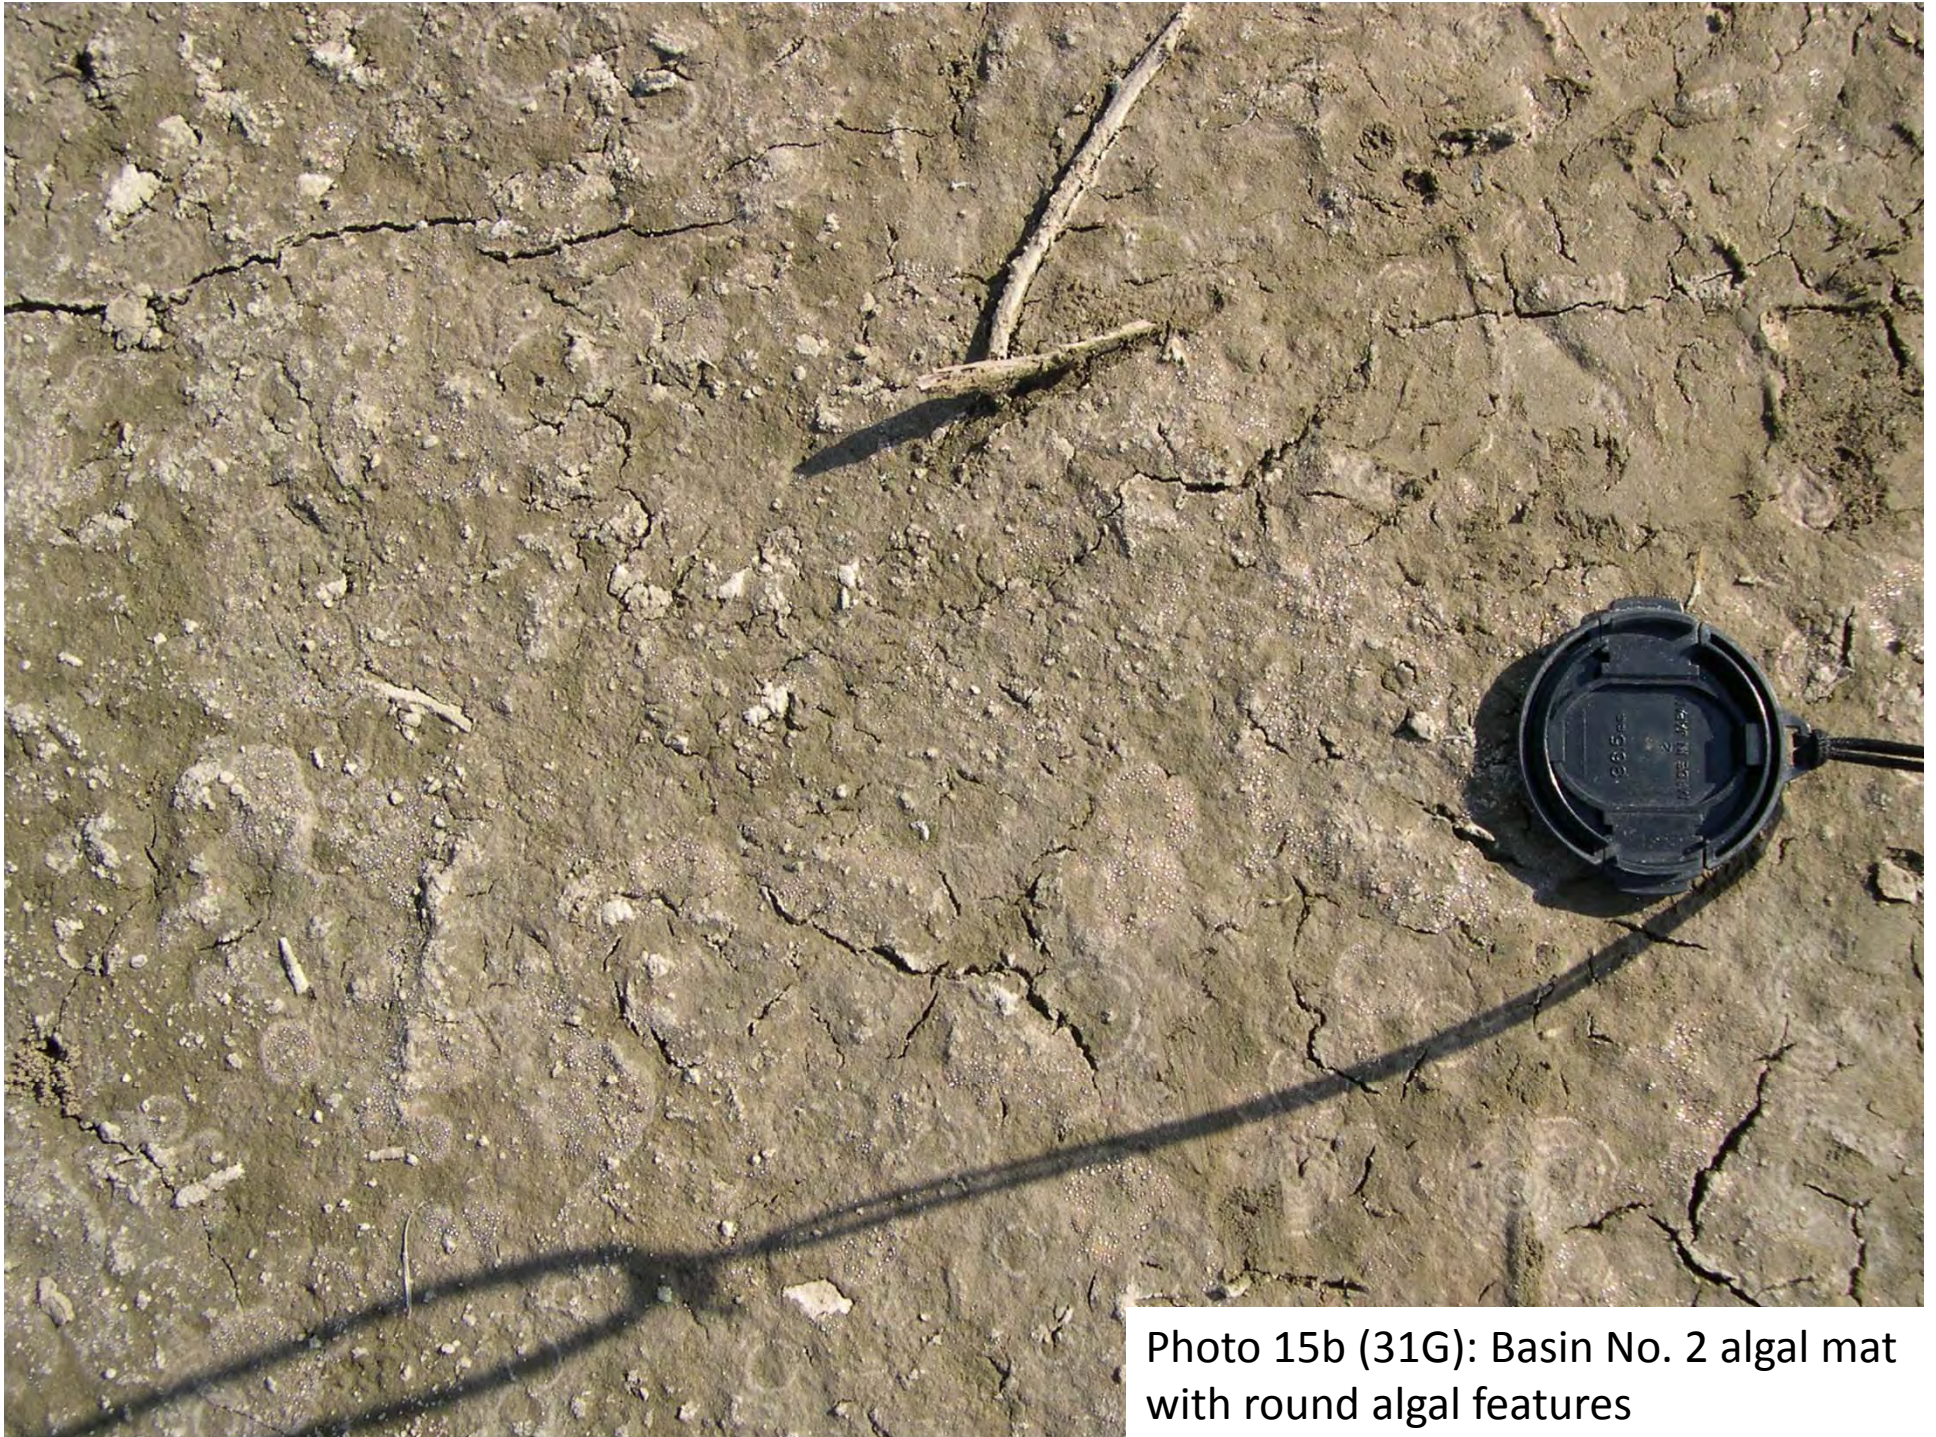
Photo 15b (31G): Basin No. 2 algal mat with round algal features

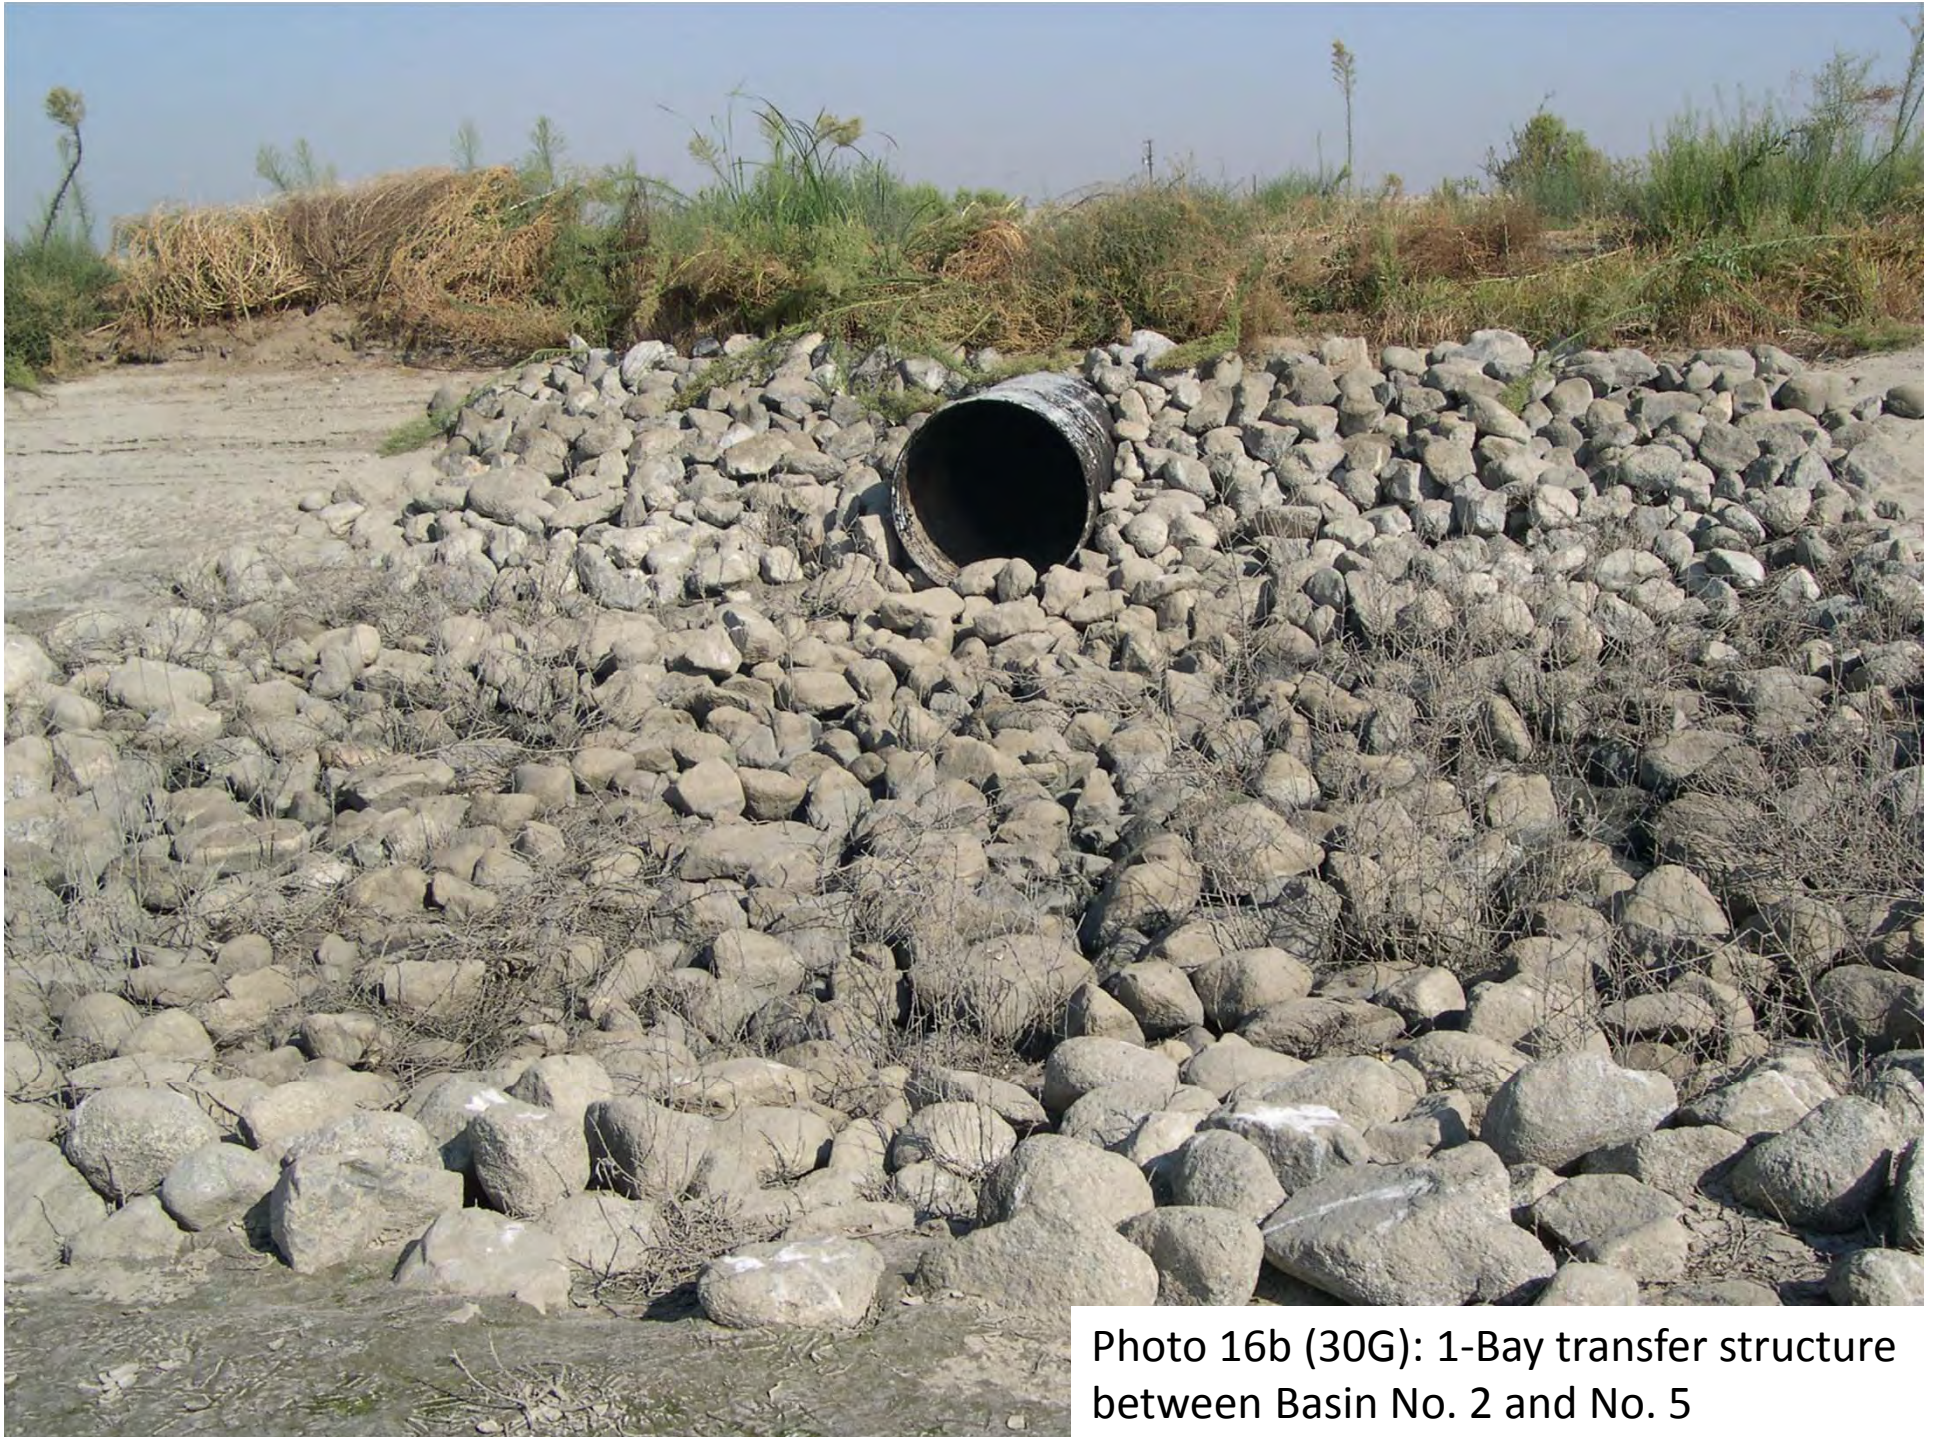
Photo 16b (30G): 1-Bay transfer structure between Basin No. 2 and No. 5

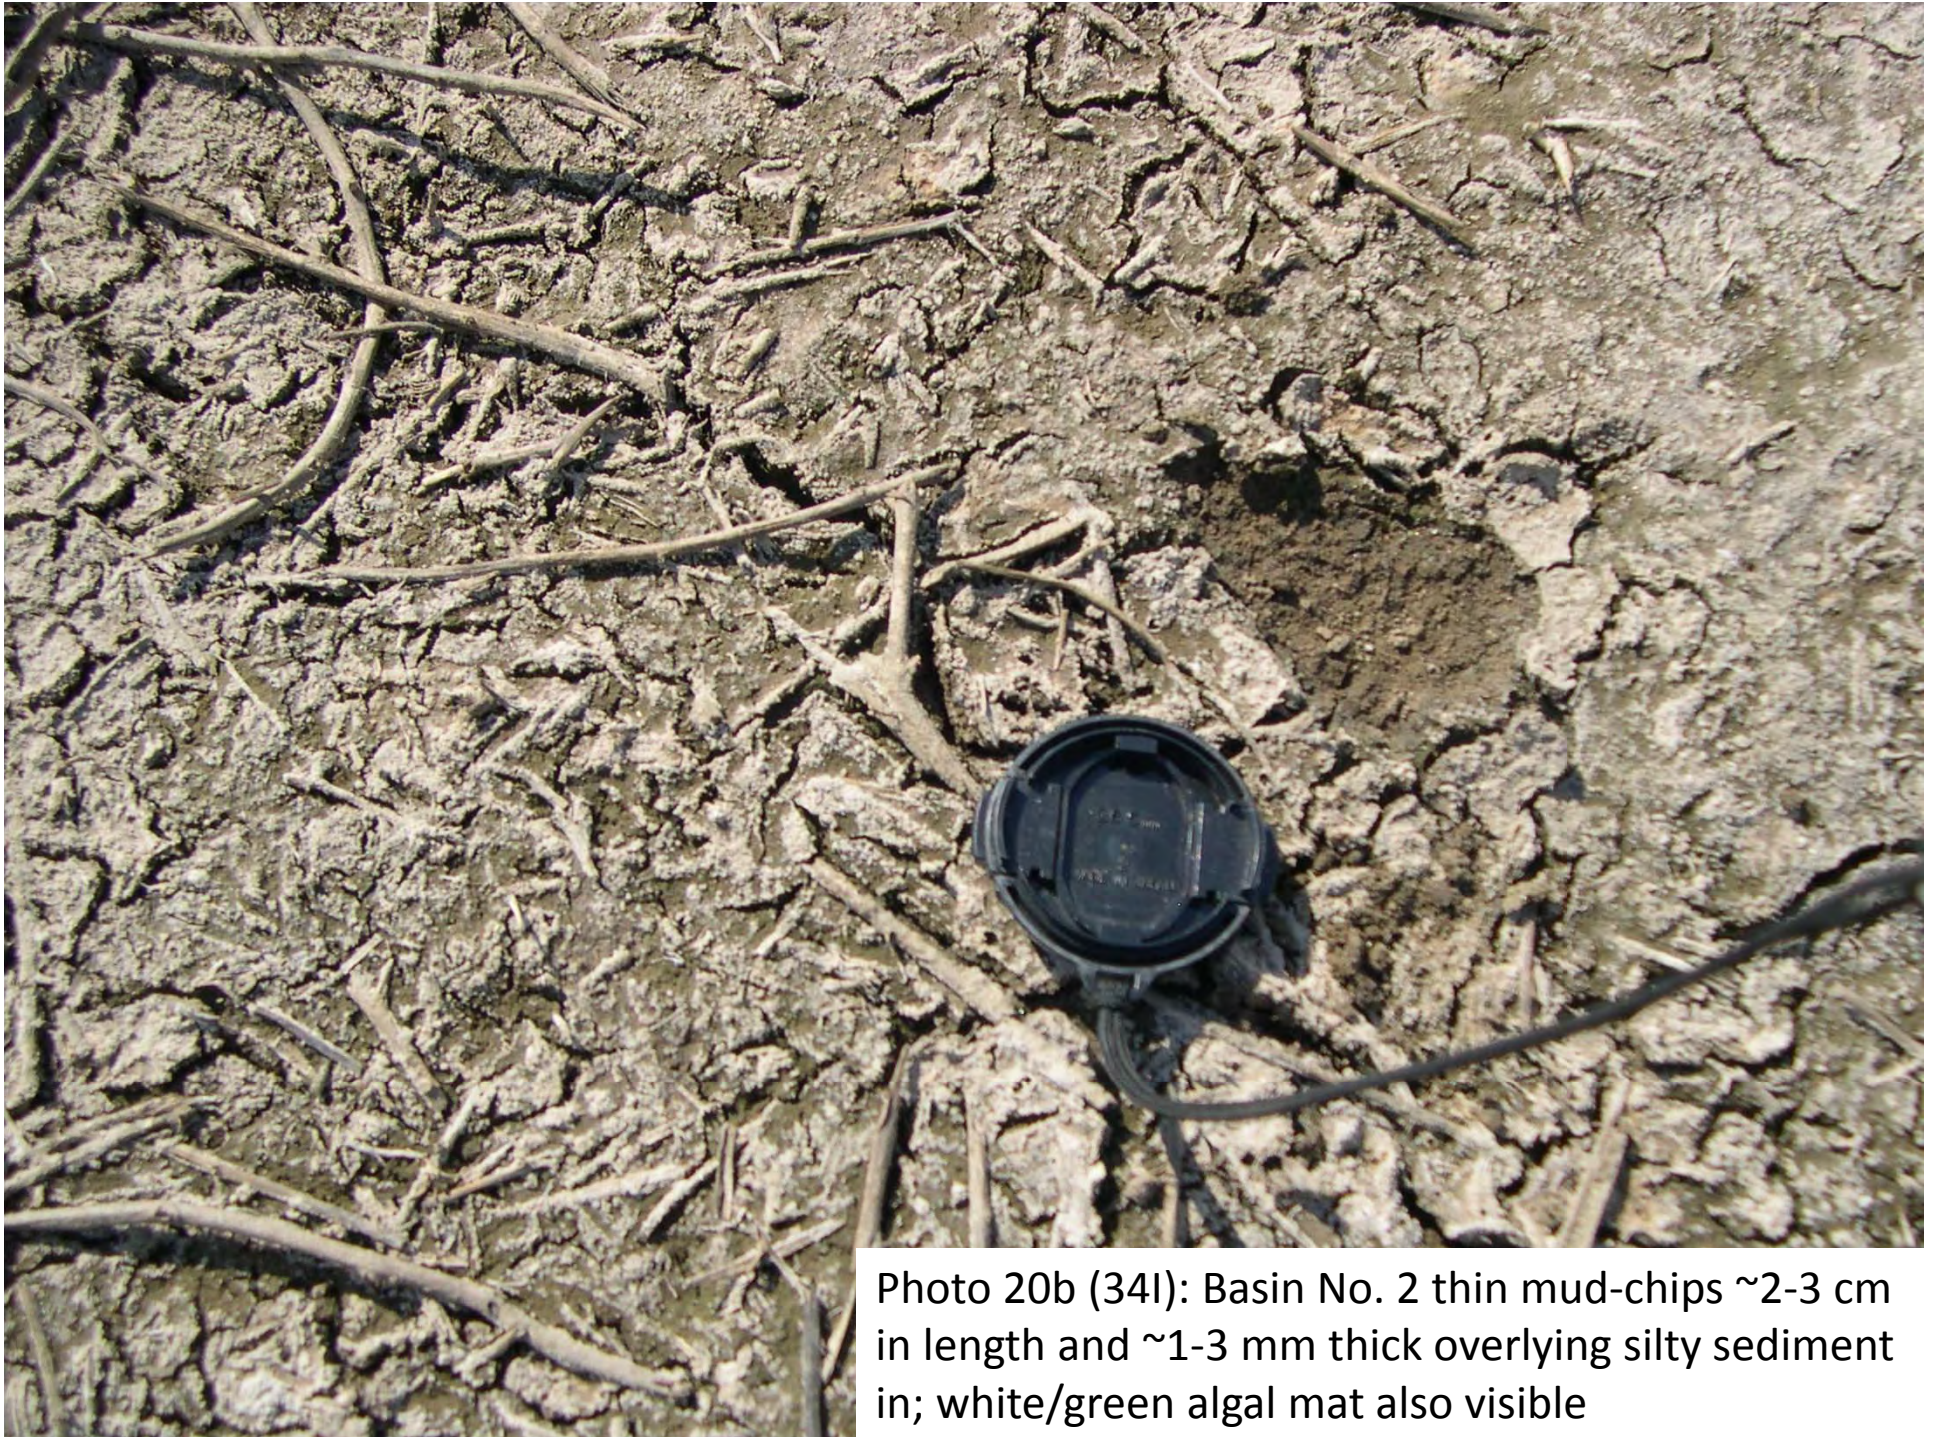
Photo 20b (34I): Basin No. 2 thin mud-chips ~2-3 cm in length and ~1-3 mm thick overlying silty sediment in; white/green algal mat also visible

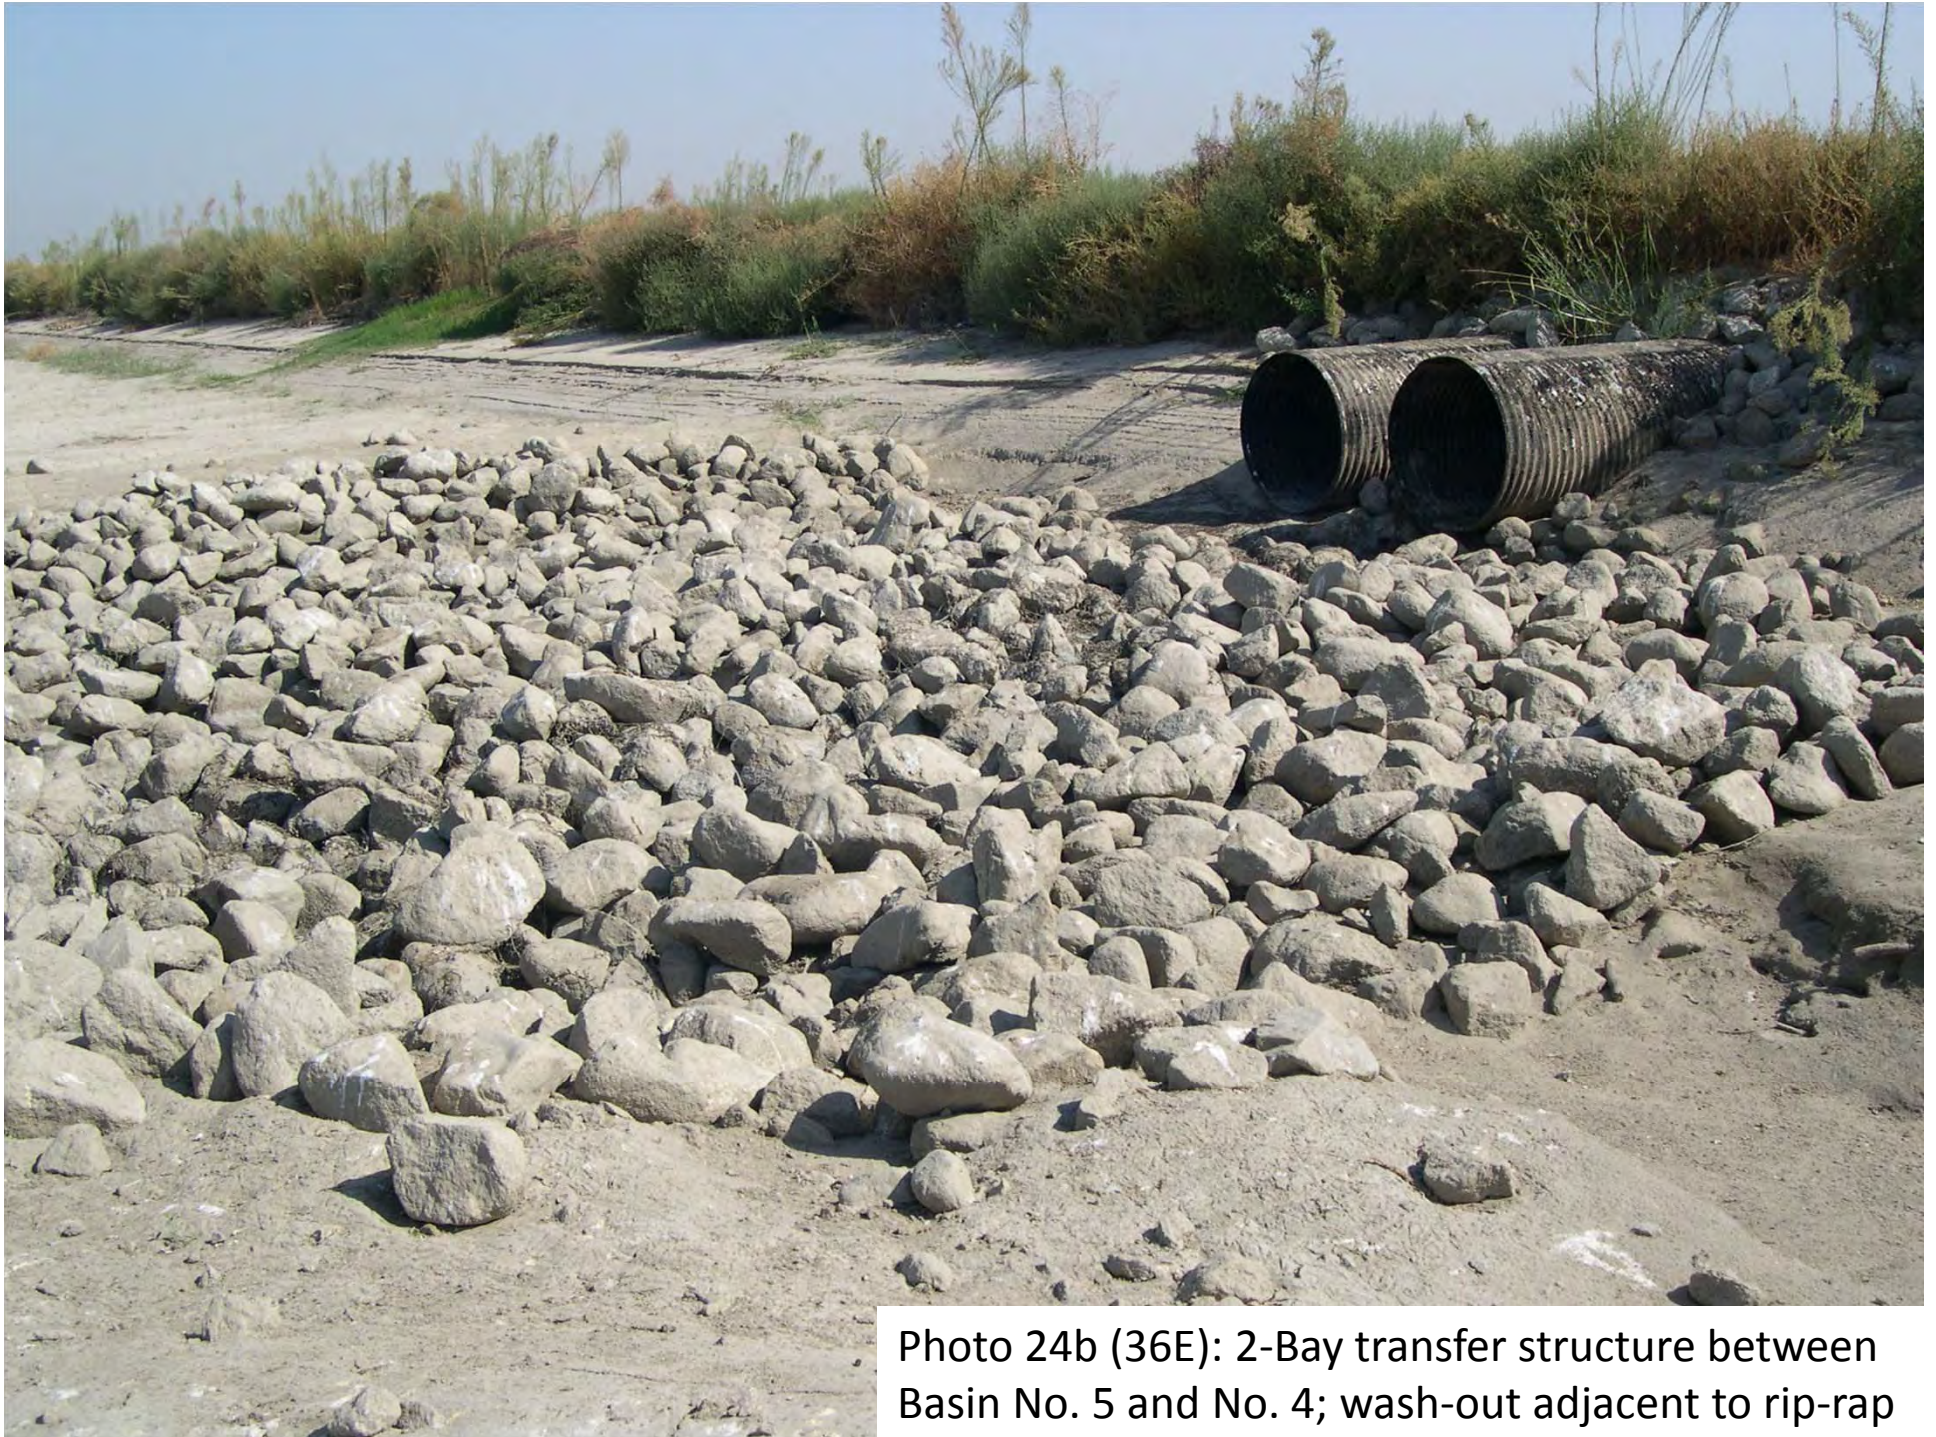
Photo 24b (36E): 2-Bay transfer structure between Basin No. 5 and No. 4; wash-out adjacent to rip-rap

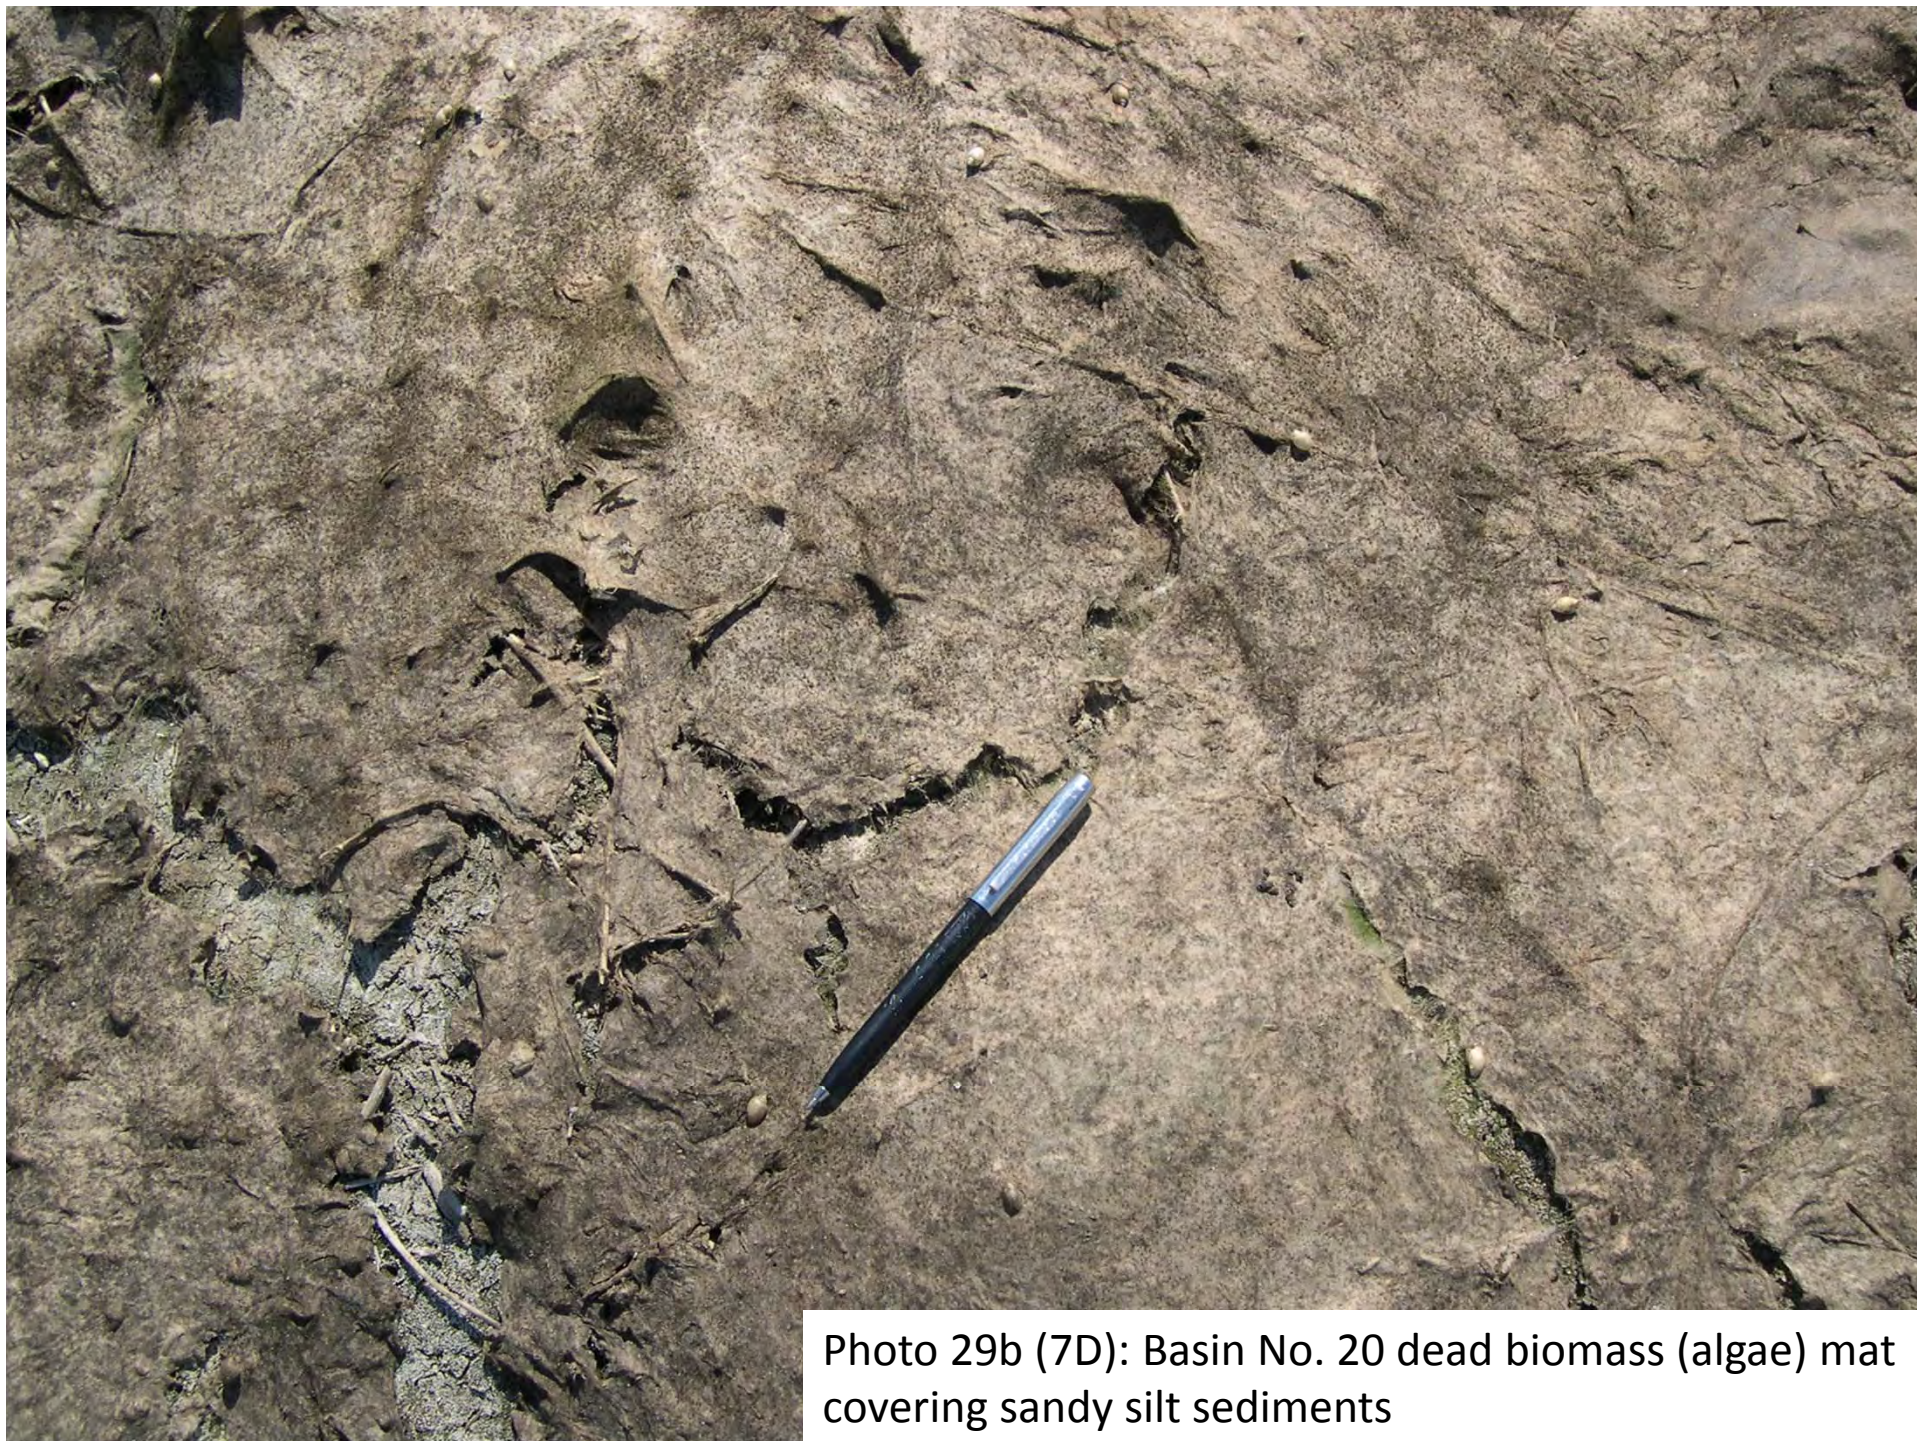
Photo 29b (7D): Basin No. 20 dead biomass (algae) mat covering sandy silt sediments

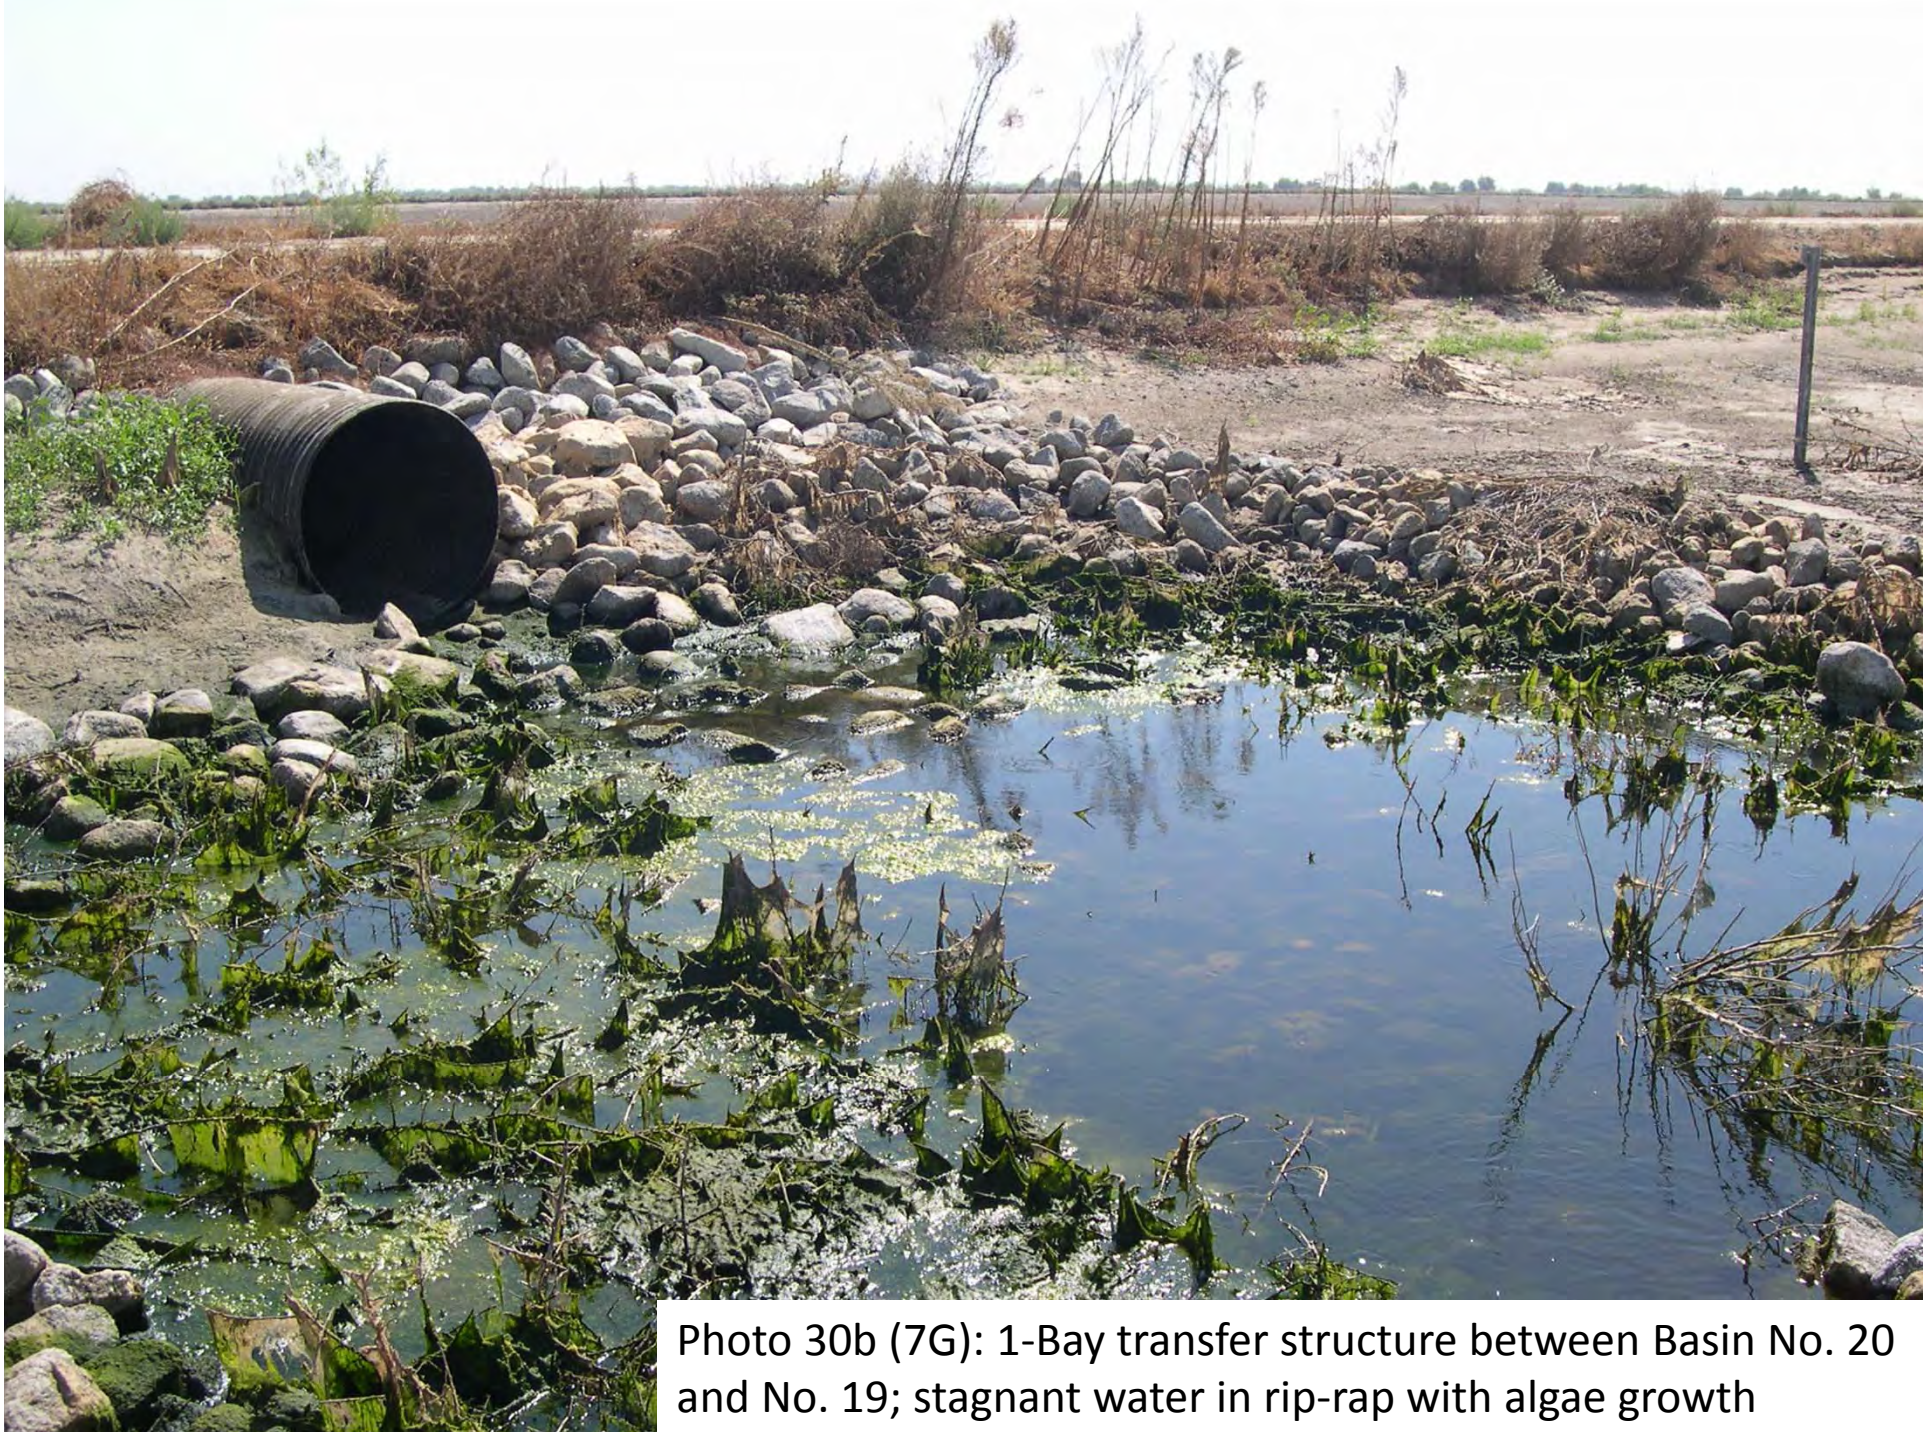
Photo 30b (7G): 1-Bay transfer structure between Basin No. 20 and No. 19; stagnant water in rip-rap with algae growth
