October 11, 2011

Irvine Ranch Water District
Attention: Paul Weghorst
15600 Sand Canyon Avenue
Irvine, CA 92618

Subject: *Strand Ranch South Basin Field Reconnaissance and Remediation Recommendations*

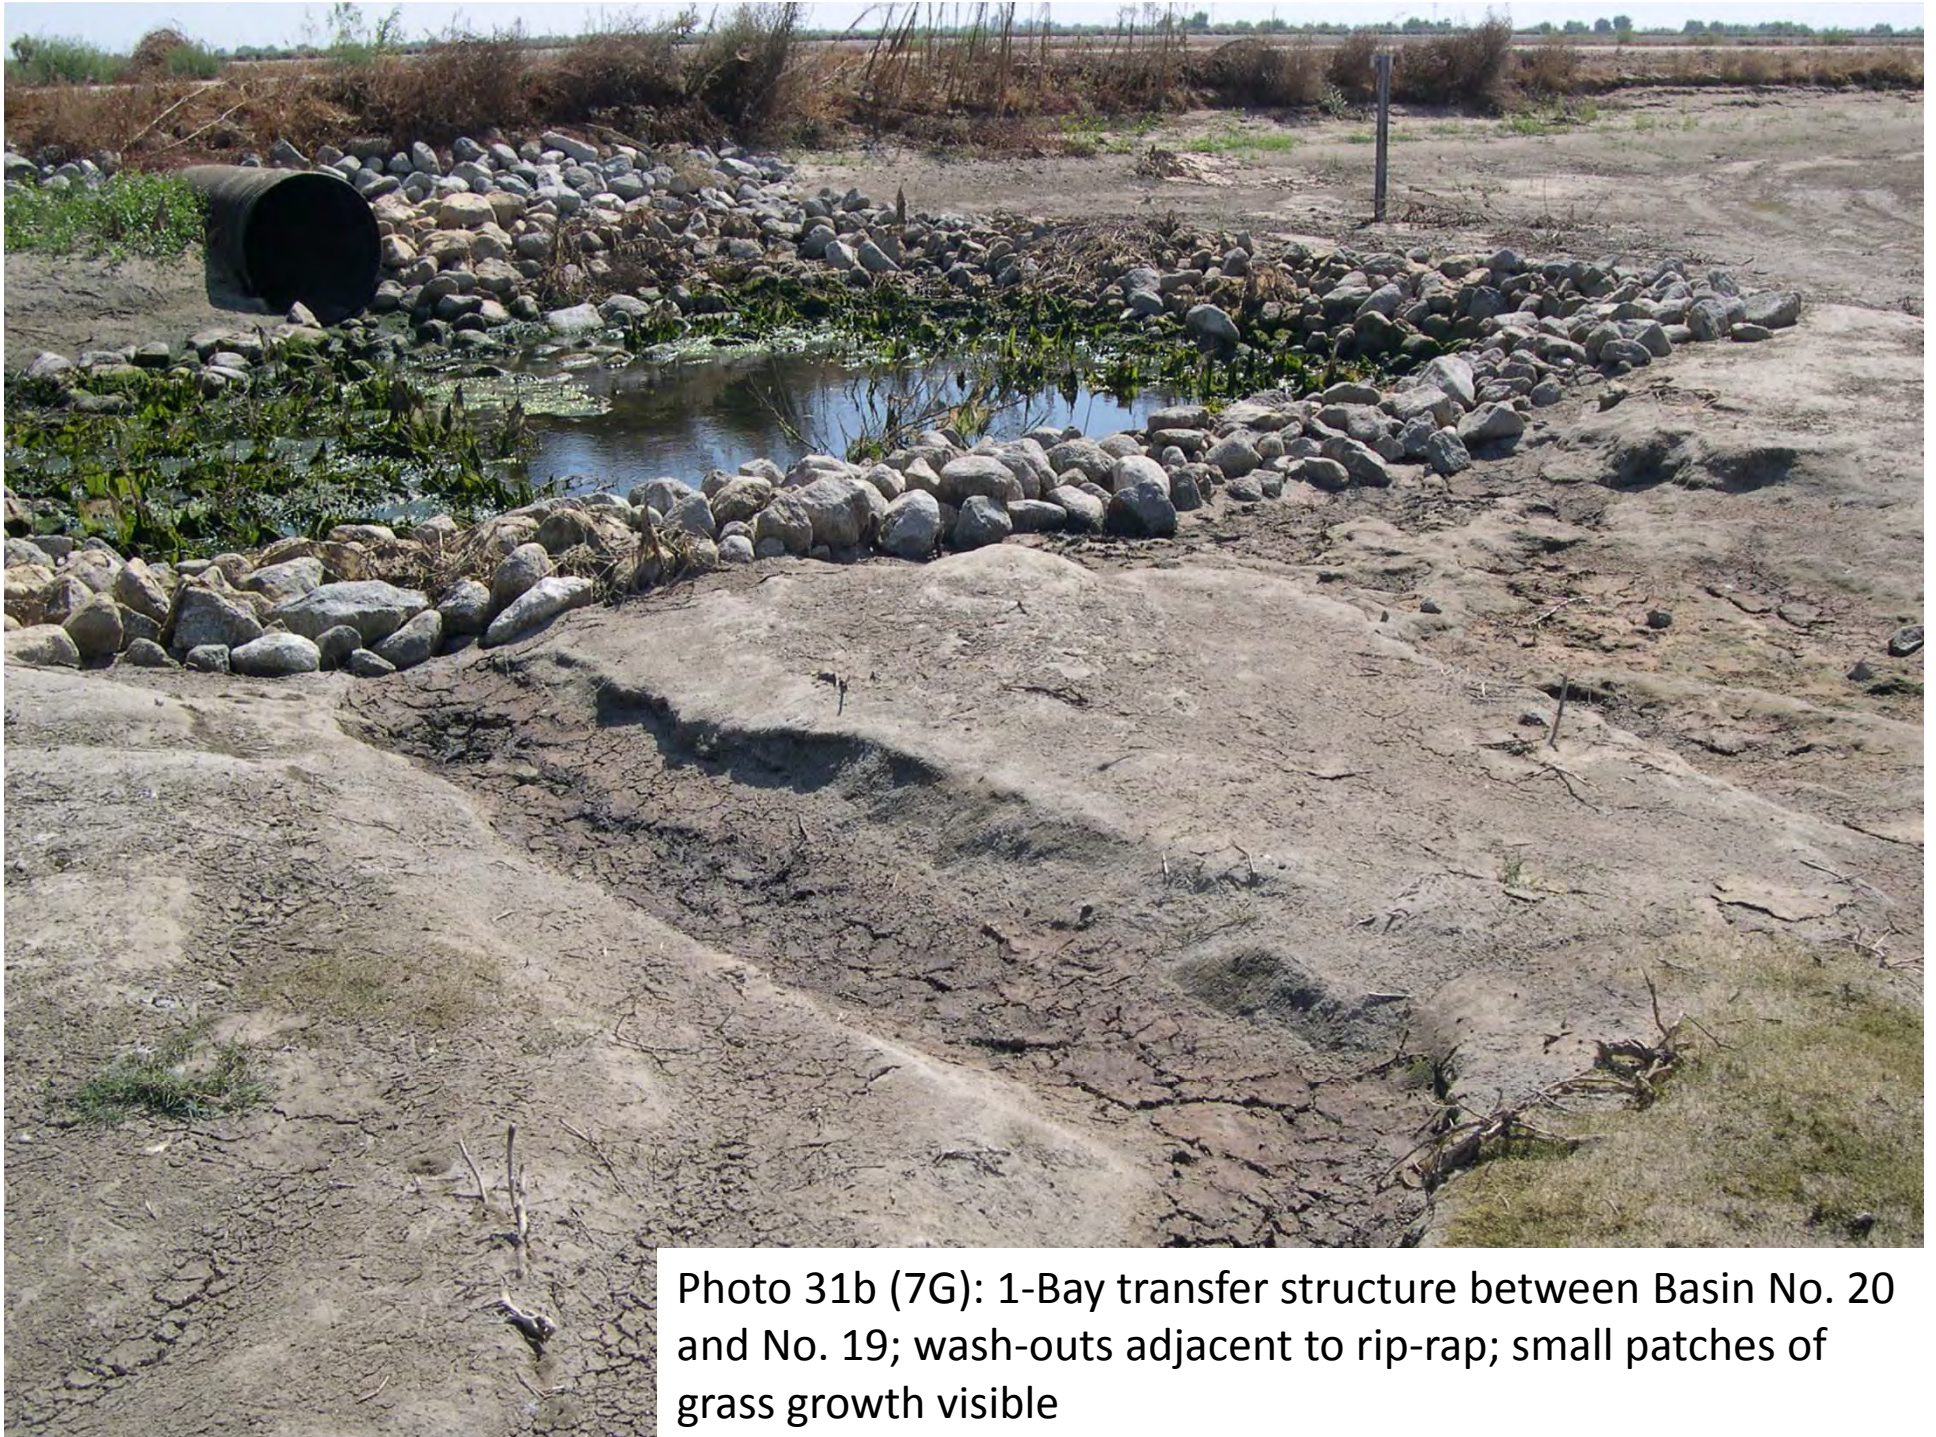
Photo 31b (7G): 1-Bay transfer structure between Basin No. 20 and No. 19; wash-outs adjacent to rip-rap; small patches of grass growth visible

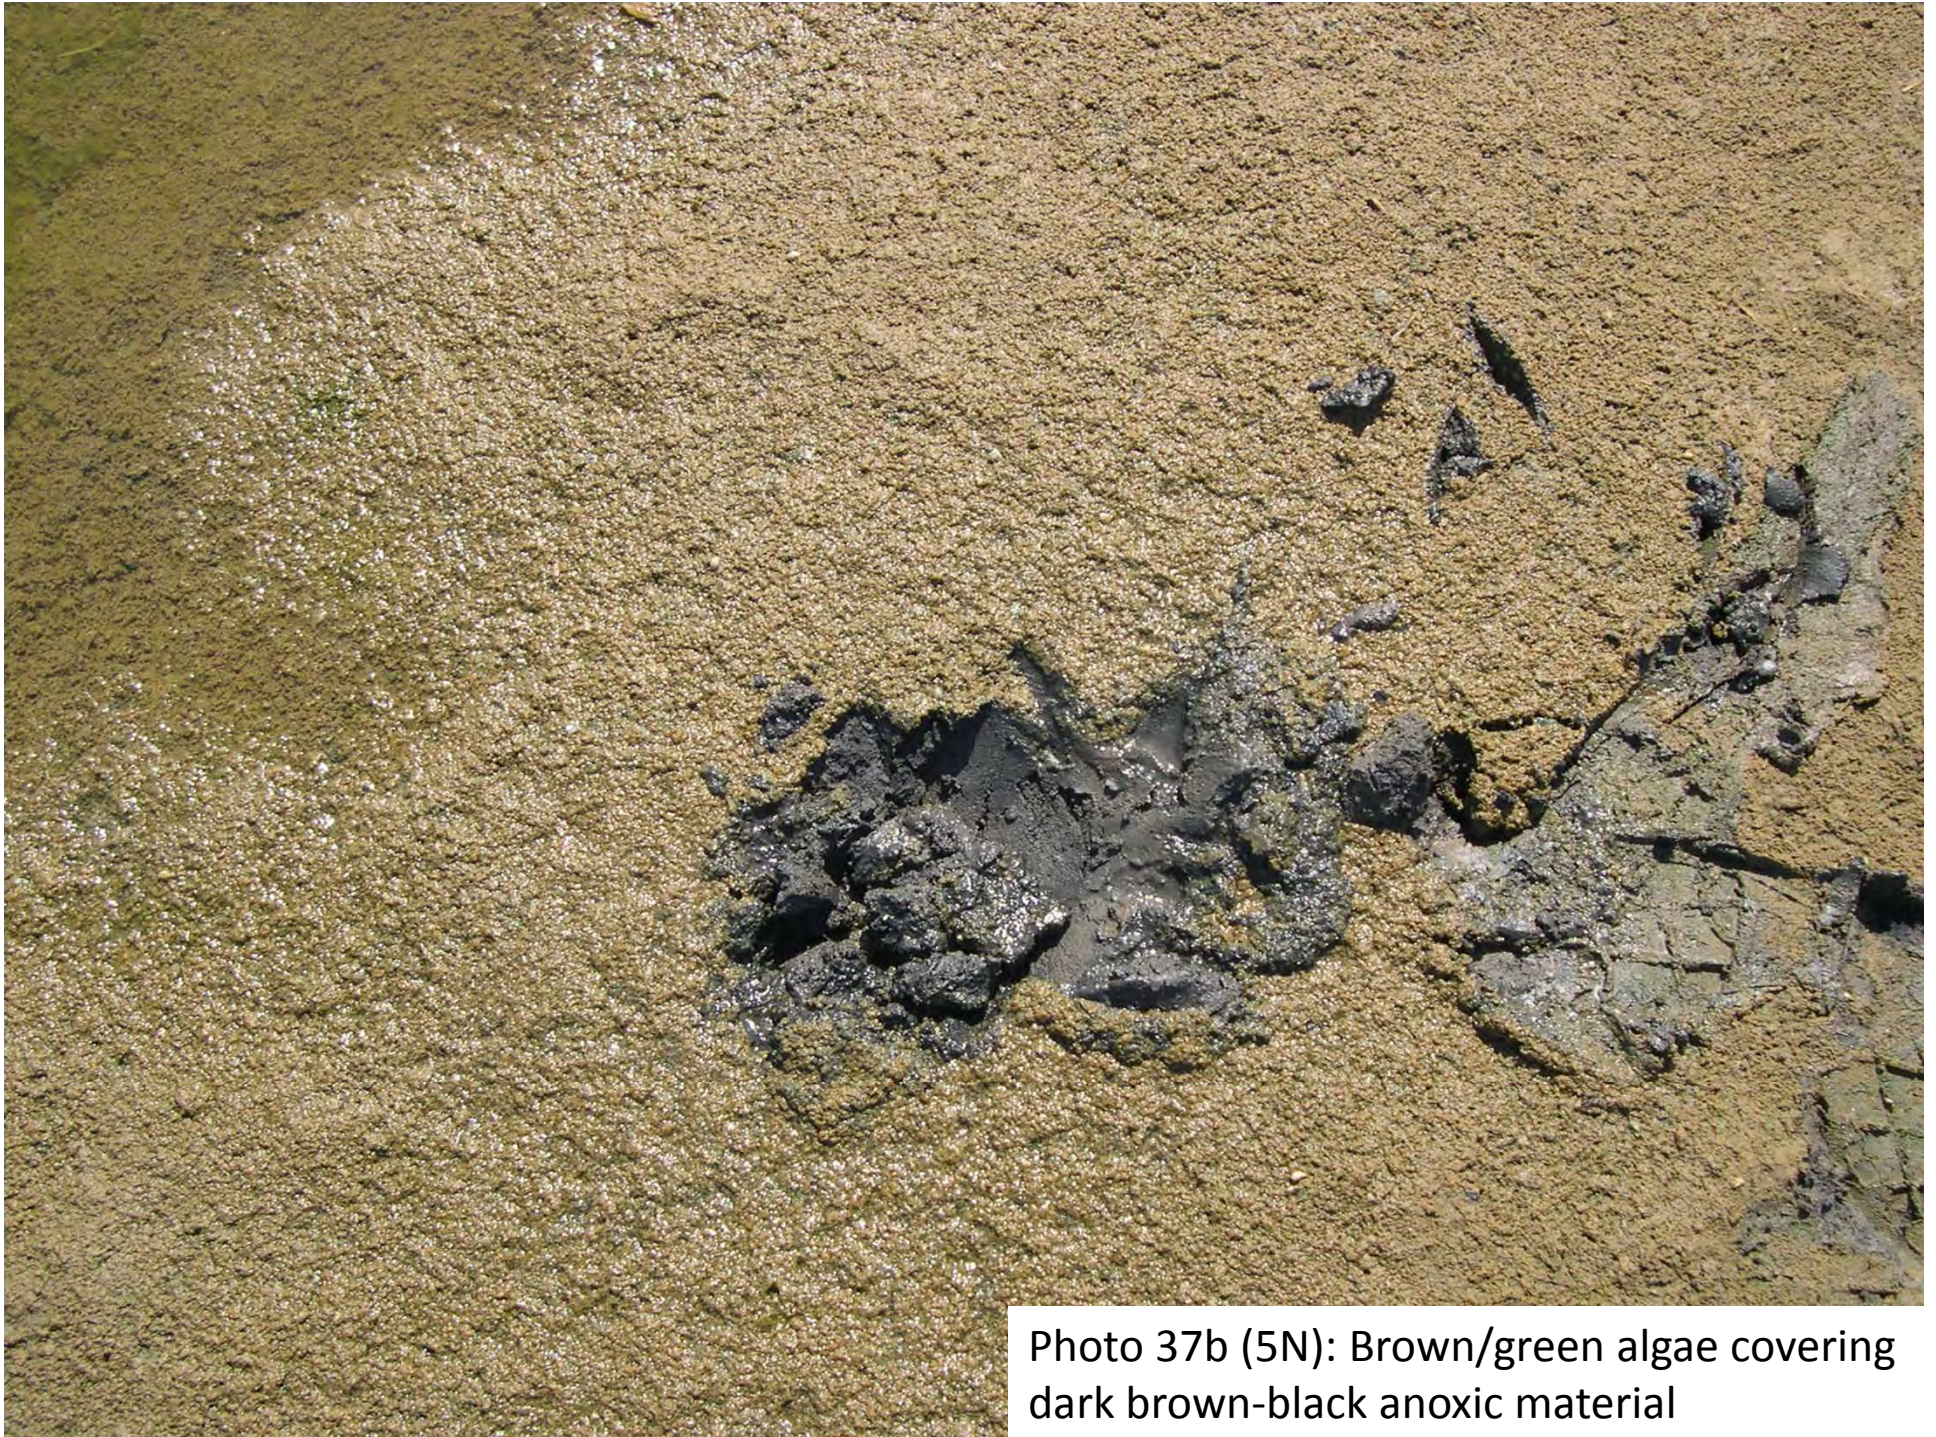
Photo 37b (5N): Brown/green algae covering dark brown-black anoxic material

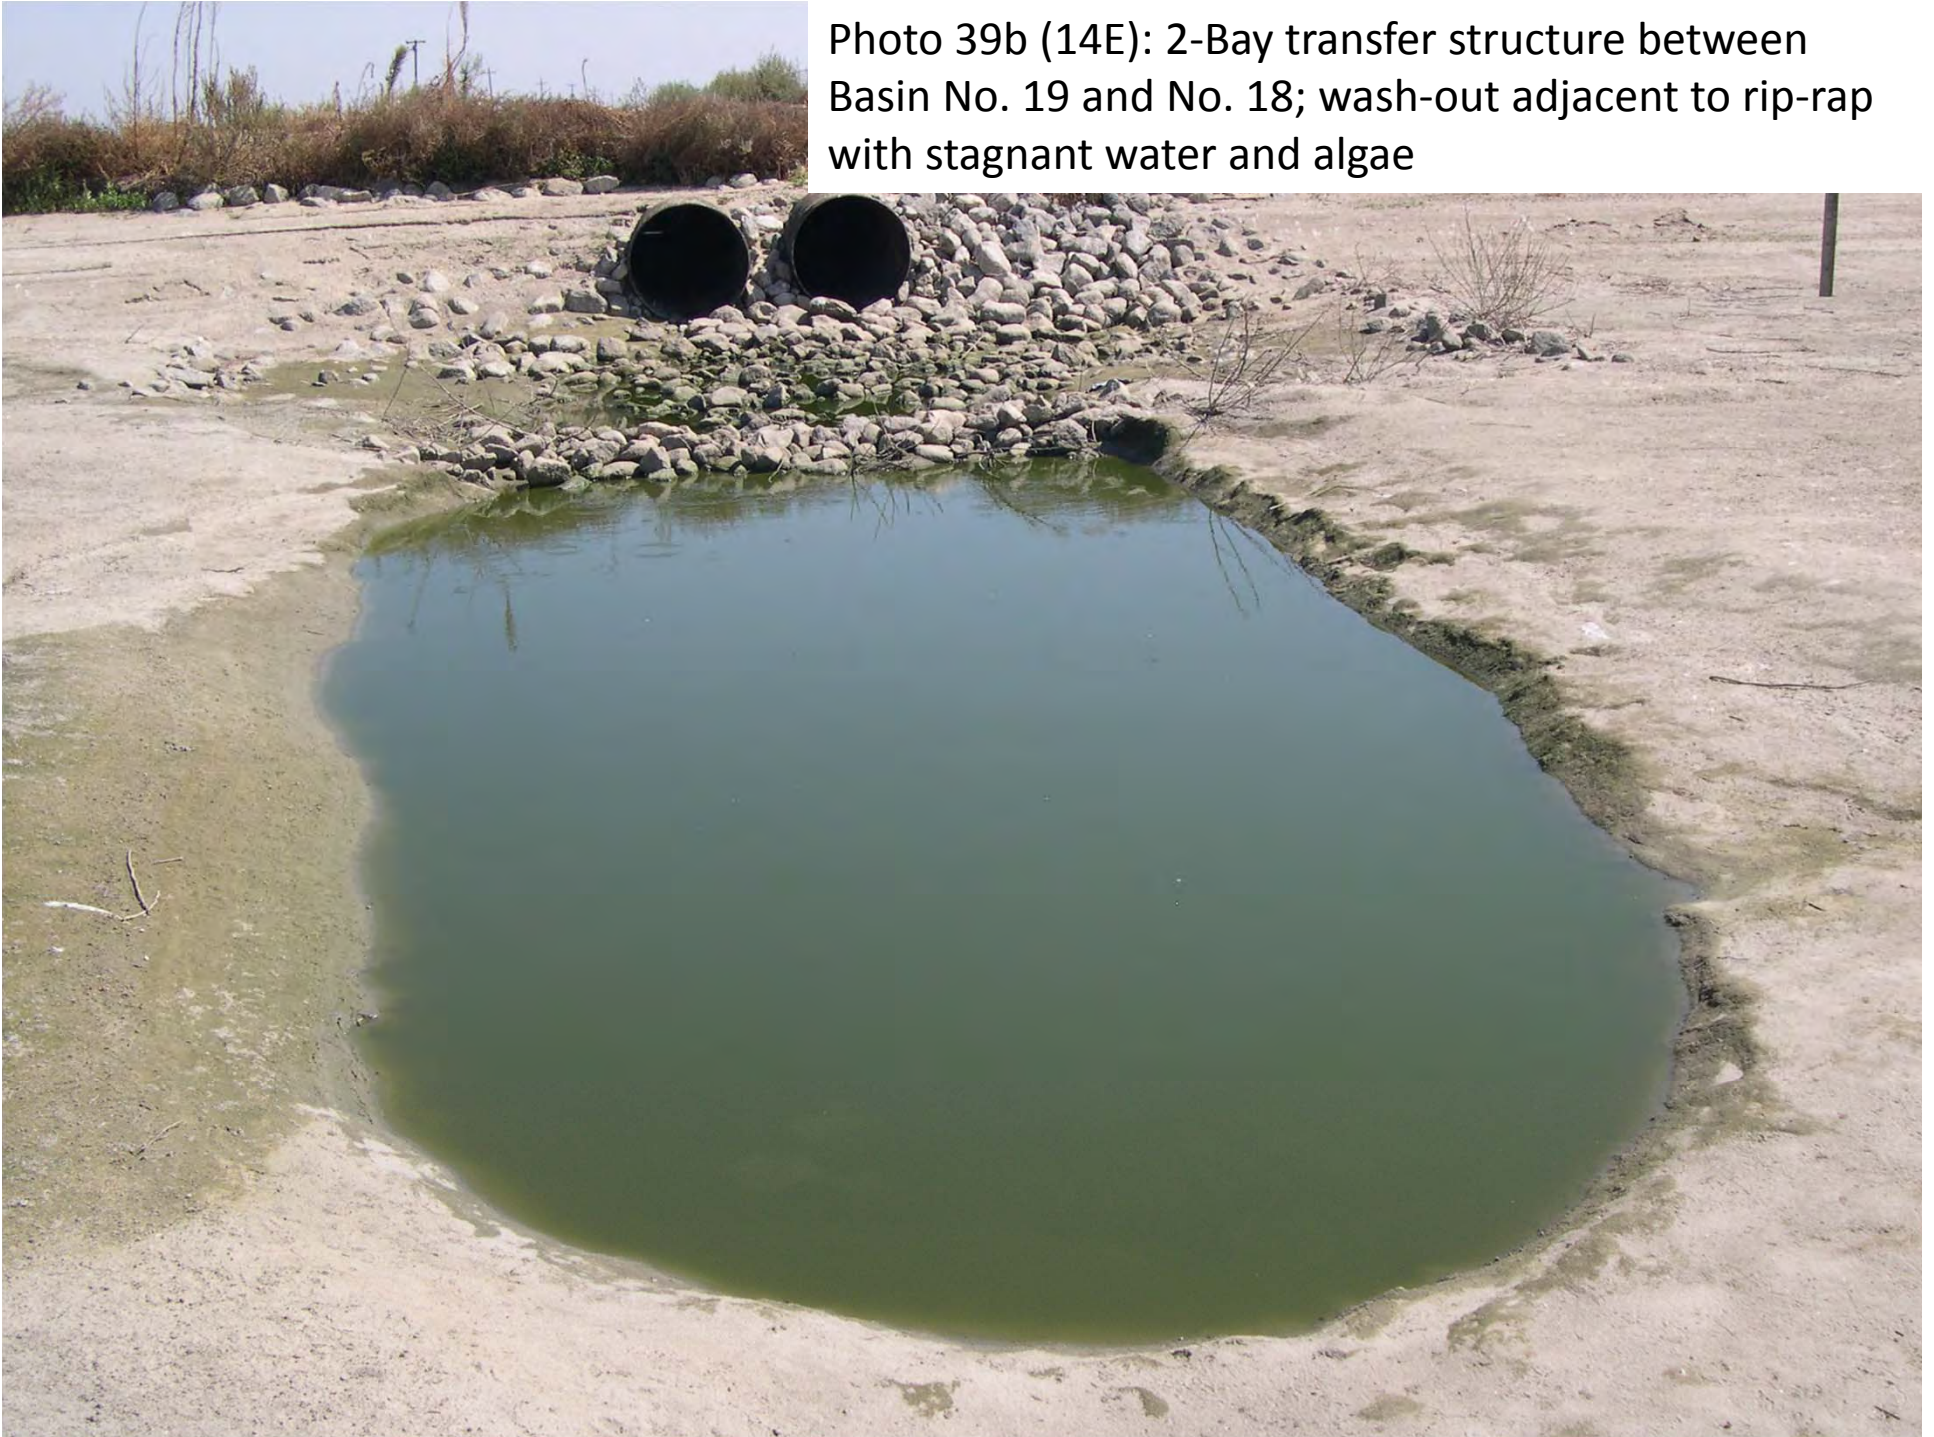
Photo 40b (14E): 2-Bay transfer structure between Basin No. 19 and No. 18; stagnant water and algae in rip-rap

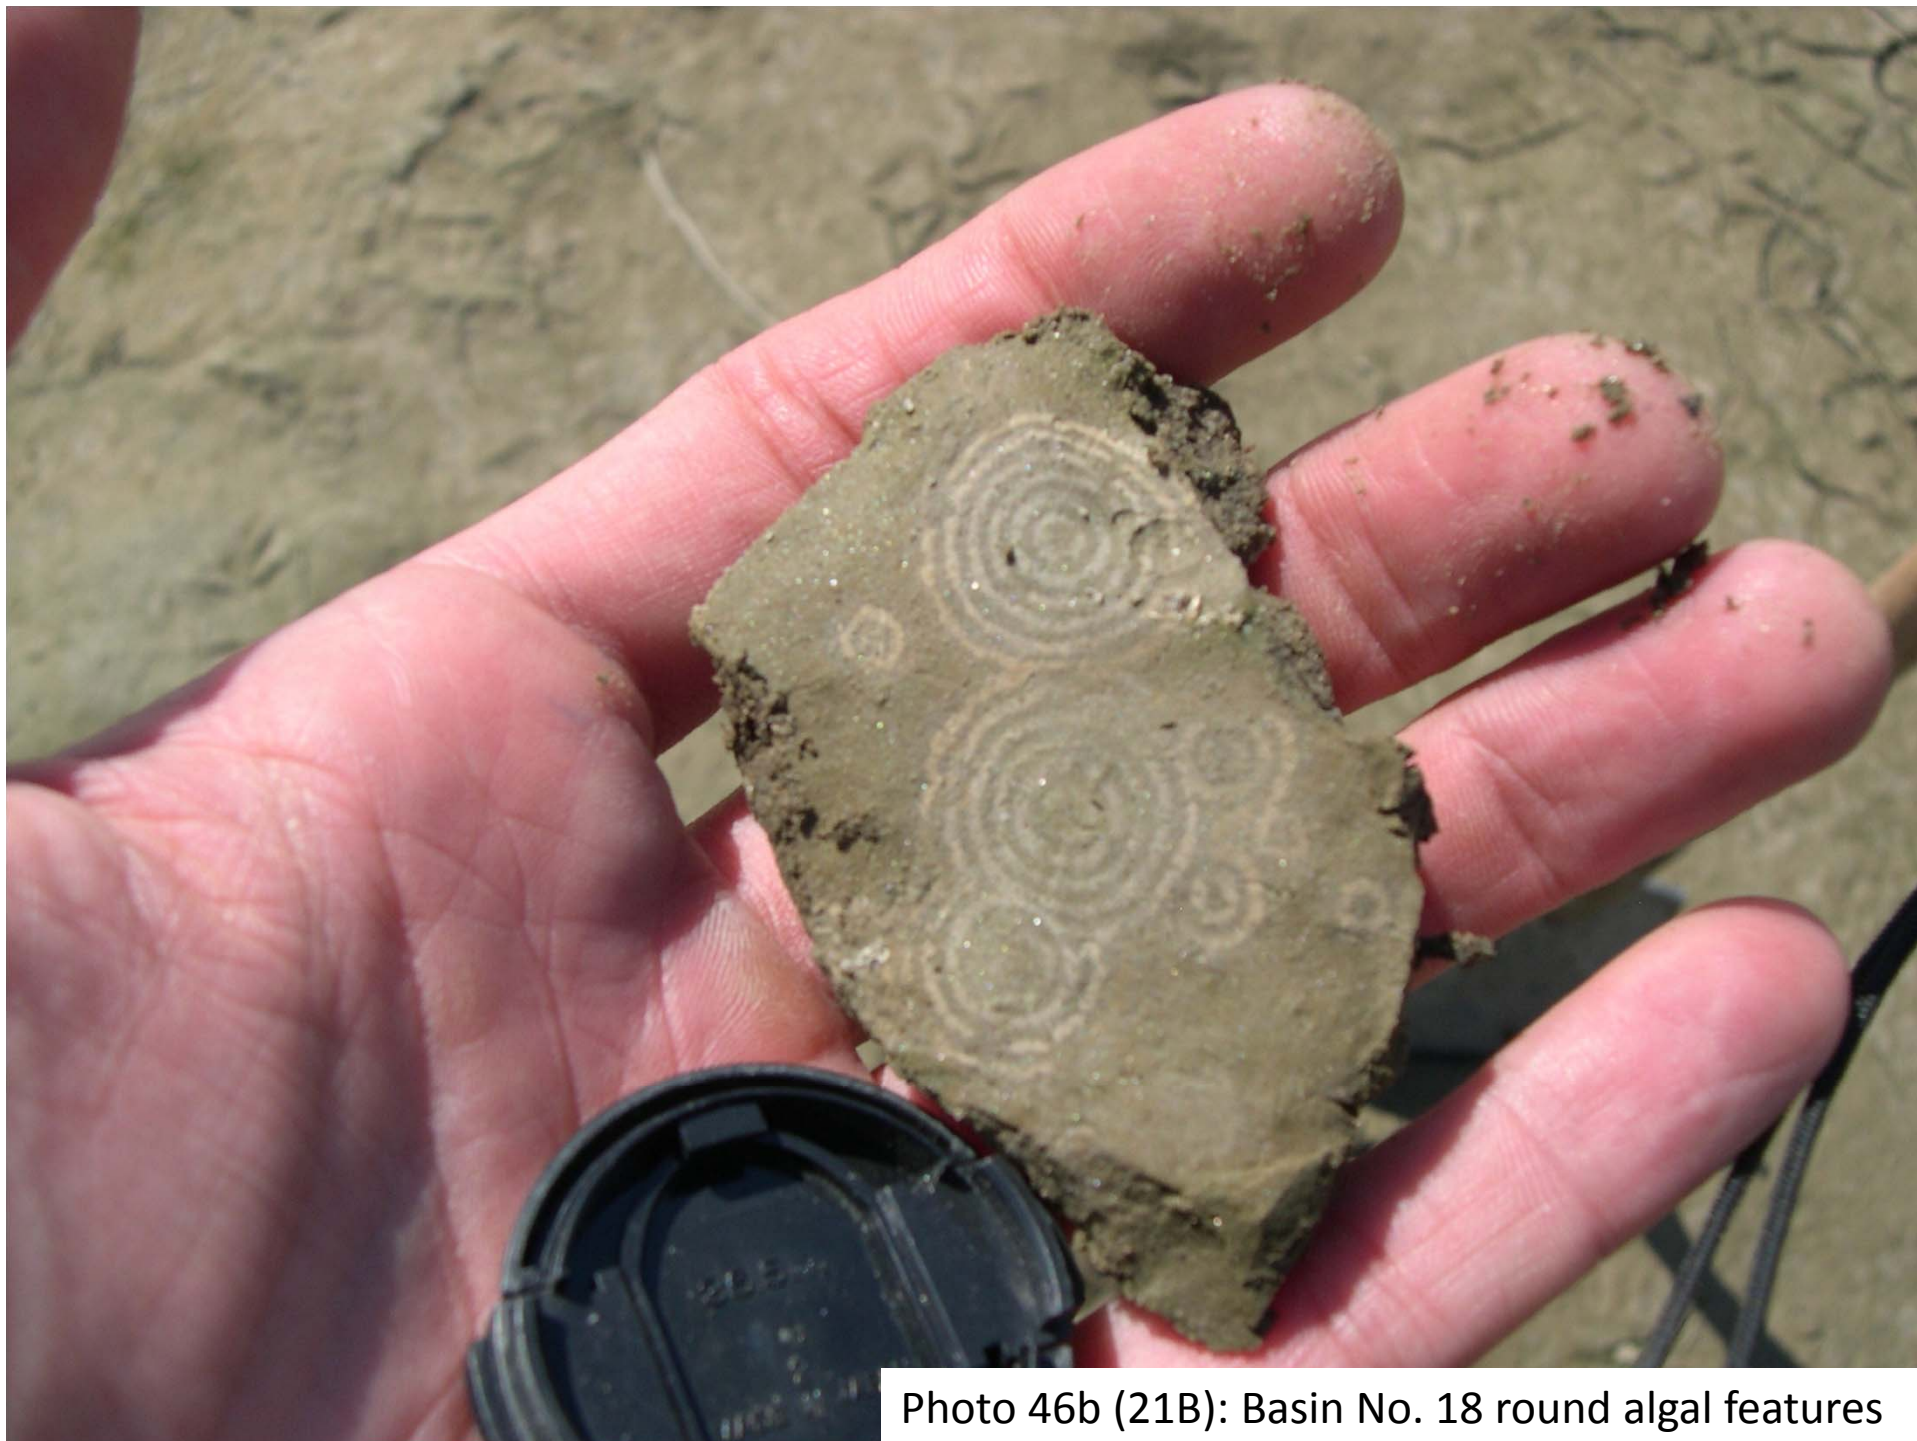
Photo 46b (21B): Basin No. 18 round algal features

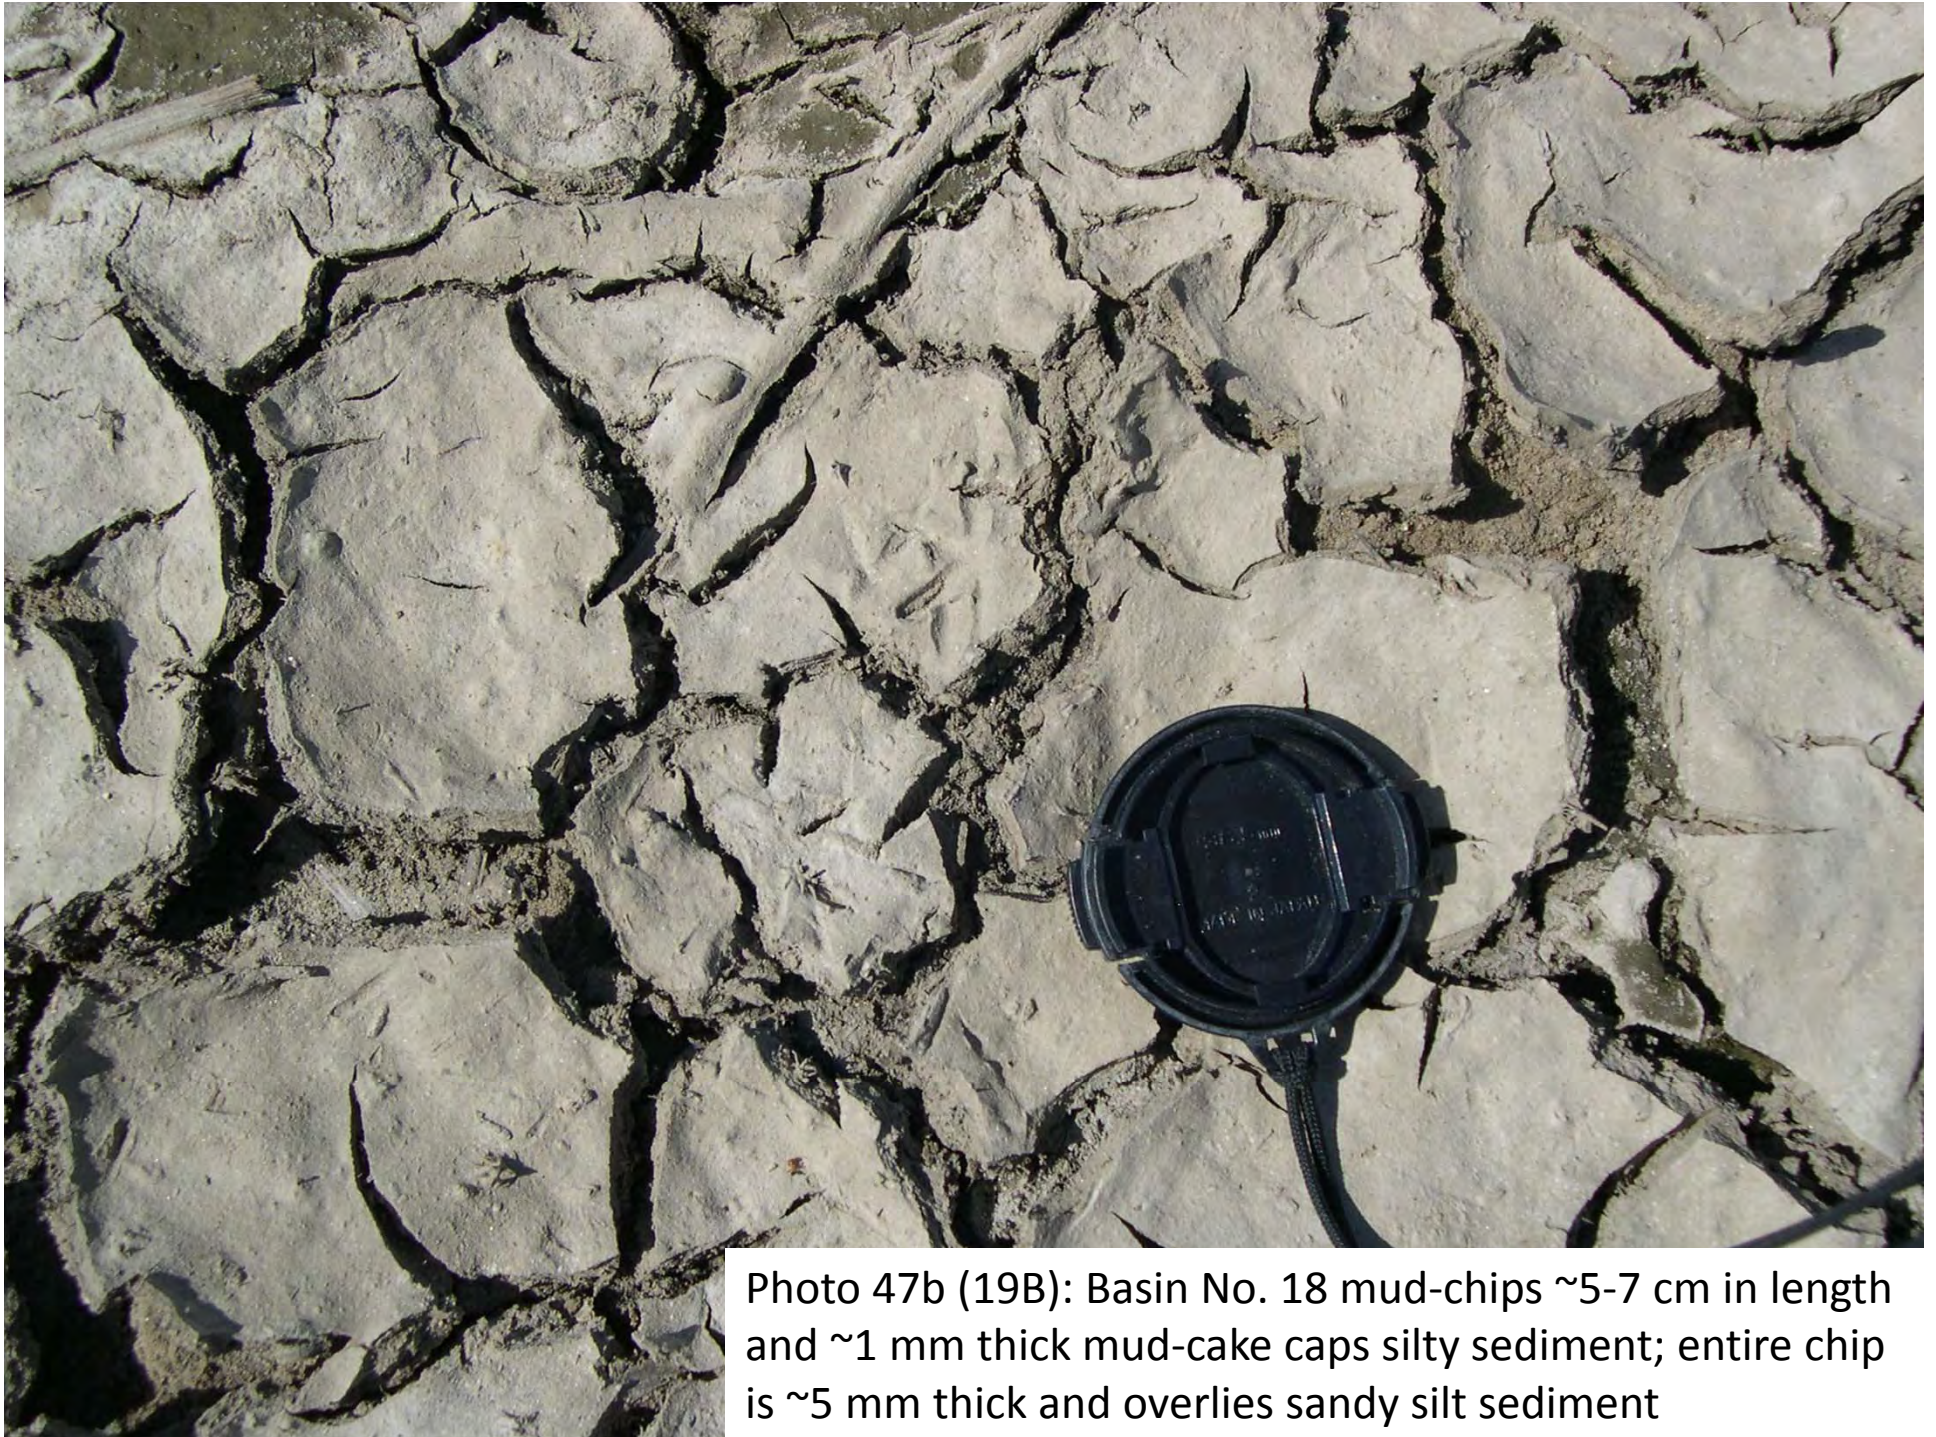
Photo 47b (19B): Basin No. 18 mud-chips ~5-7 cm in length and ~1 mm thick mud-cake caps silty sediment; entire chip is ~5 mm thick and overlies sandy silt sediment

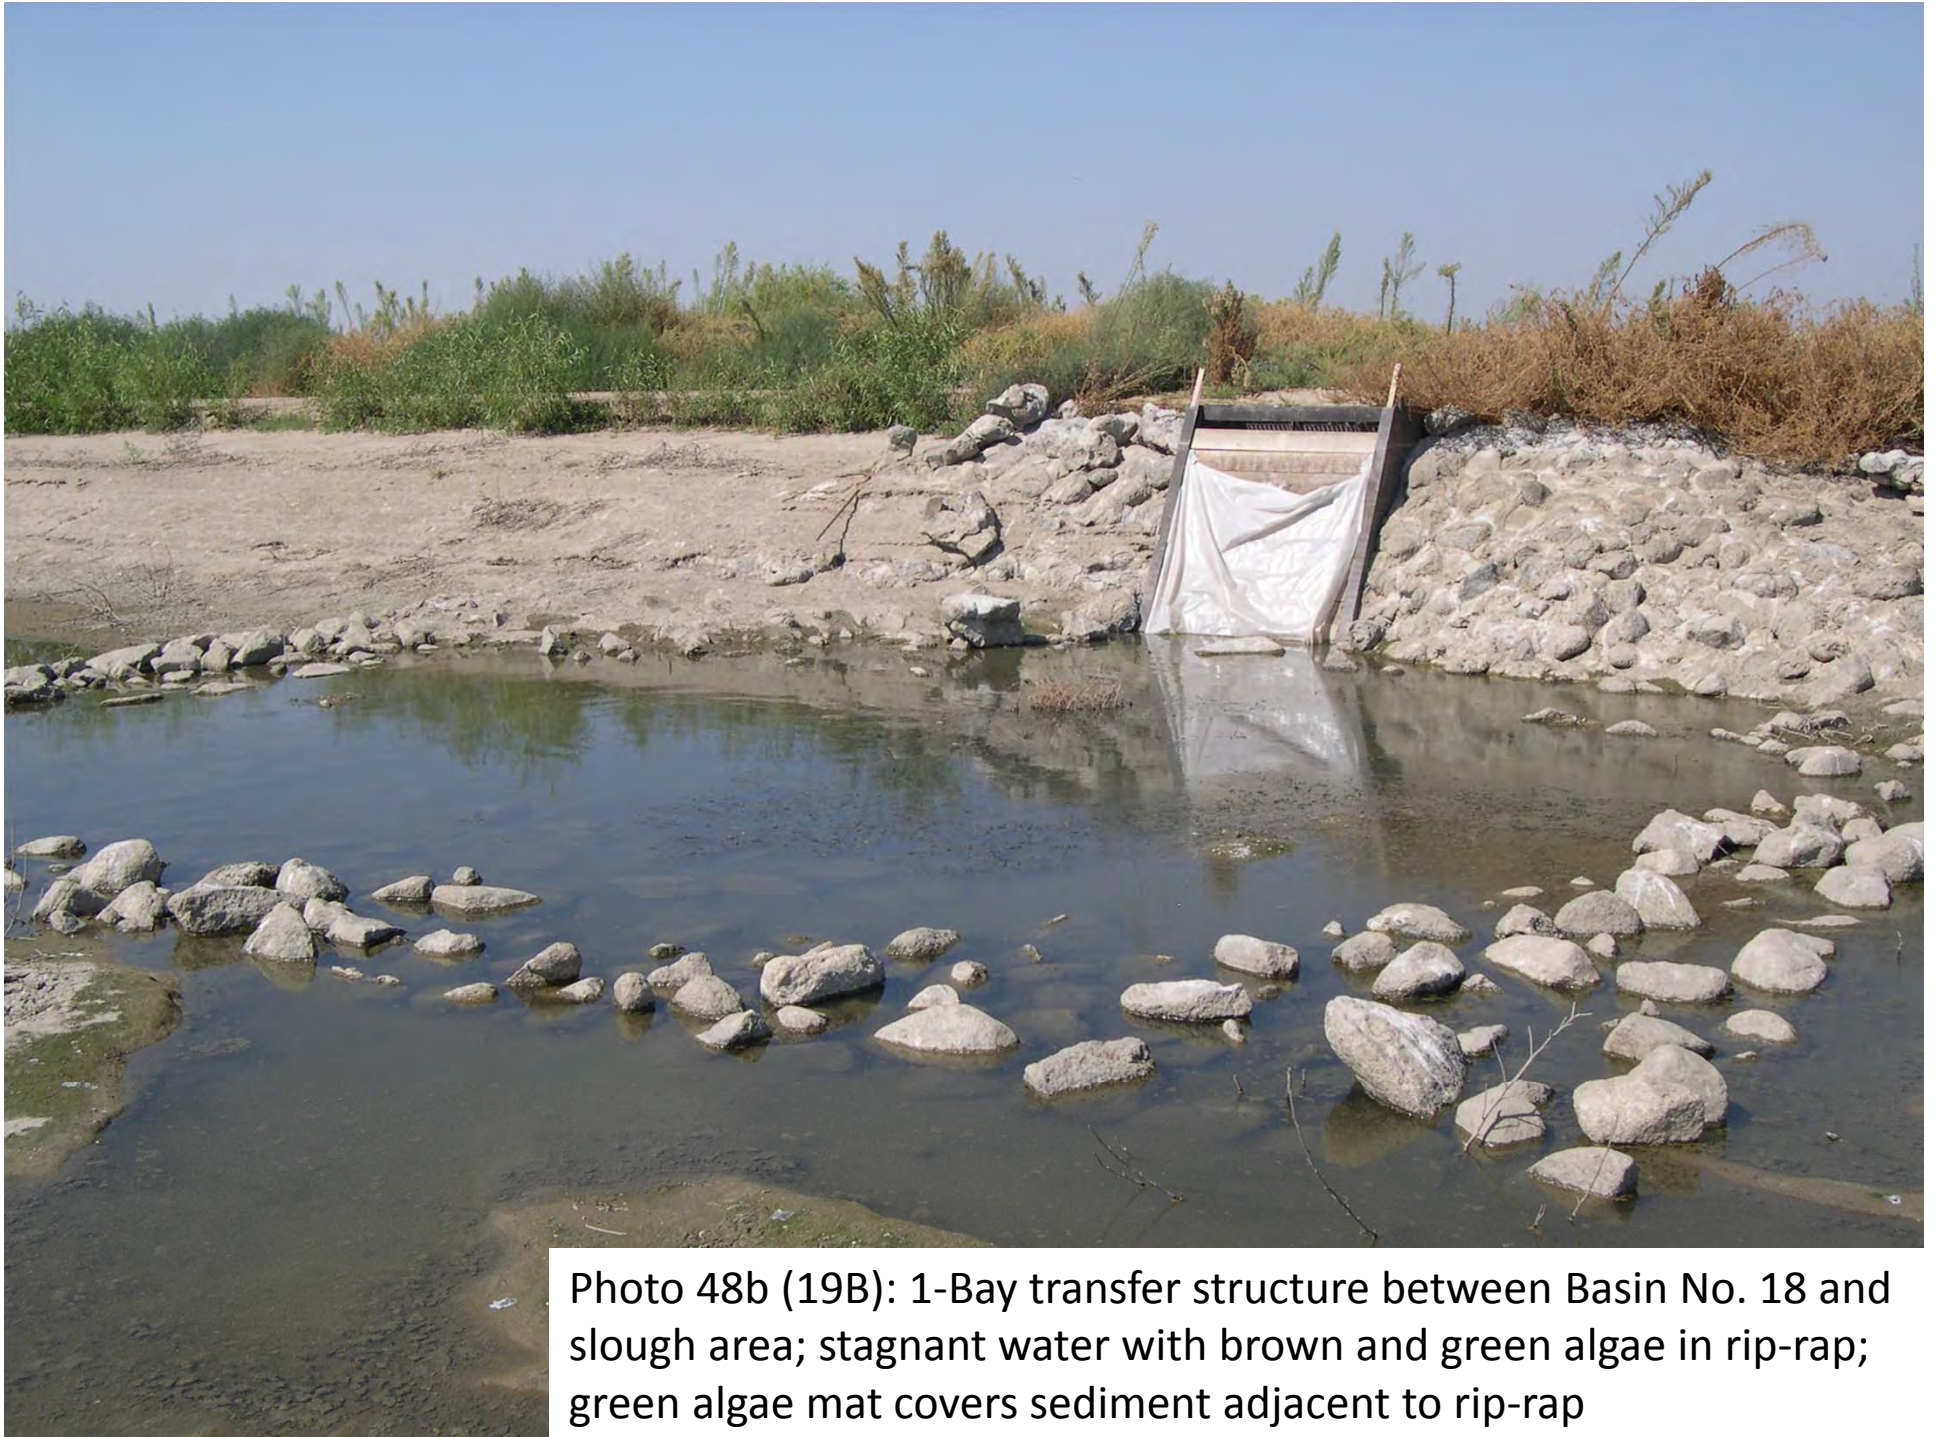
Photo 48b (19B): 1-Bay transfer structure between Basin No. 18 and slough area; stagnant water with brown and green algae in rip-rap; green algae mat covers sediment adjacent to rip-rap

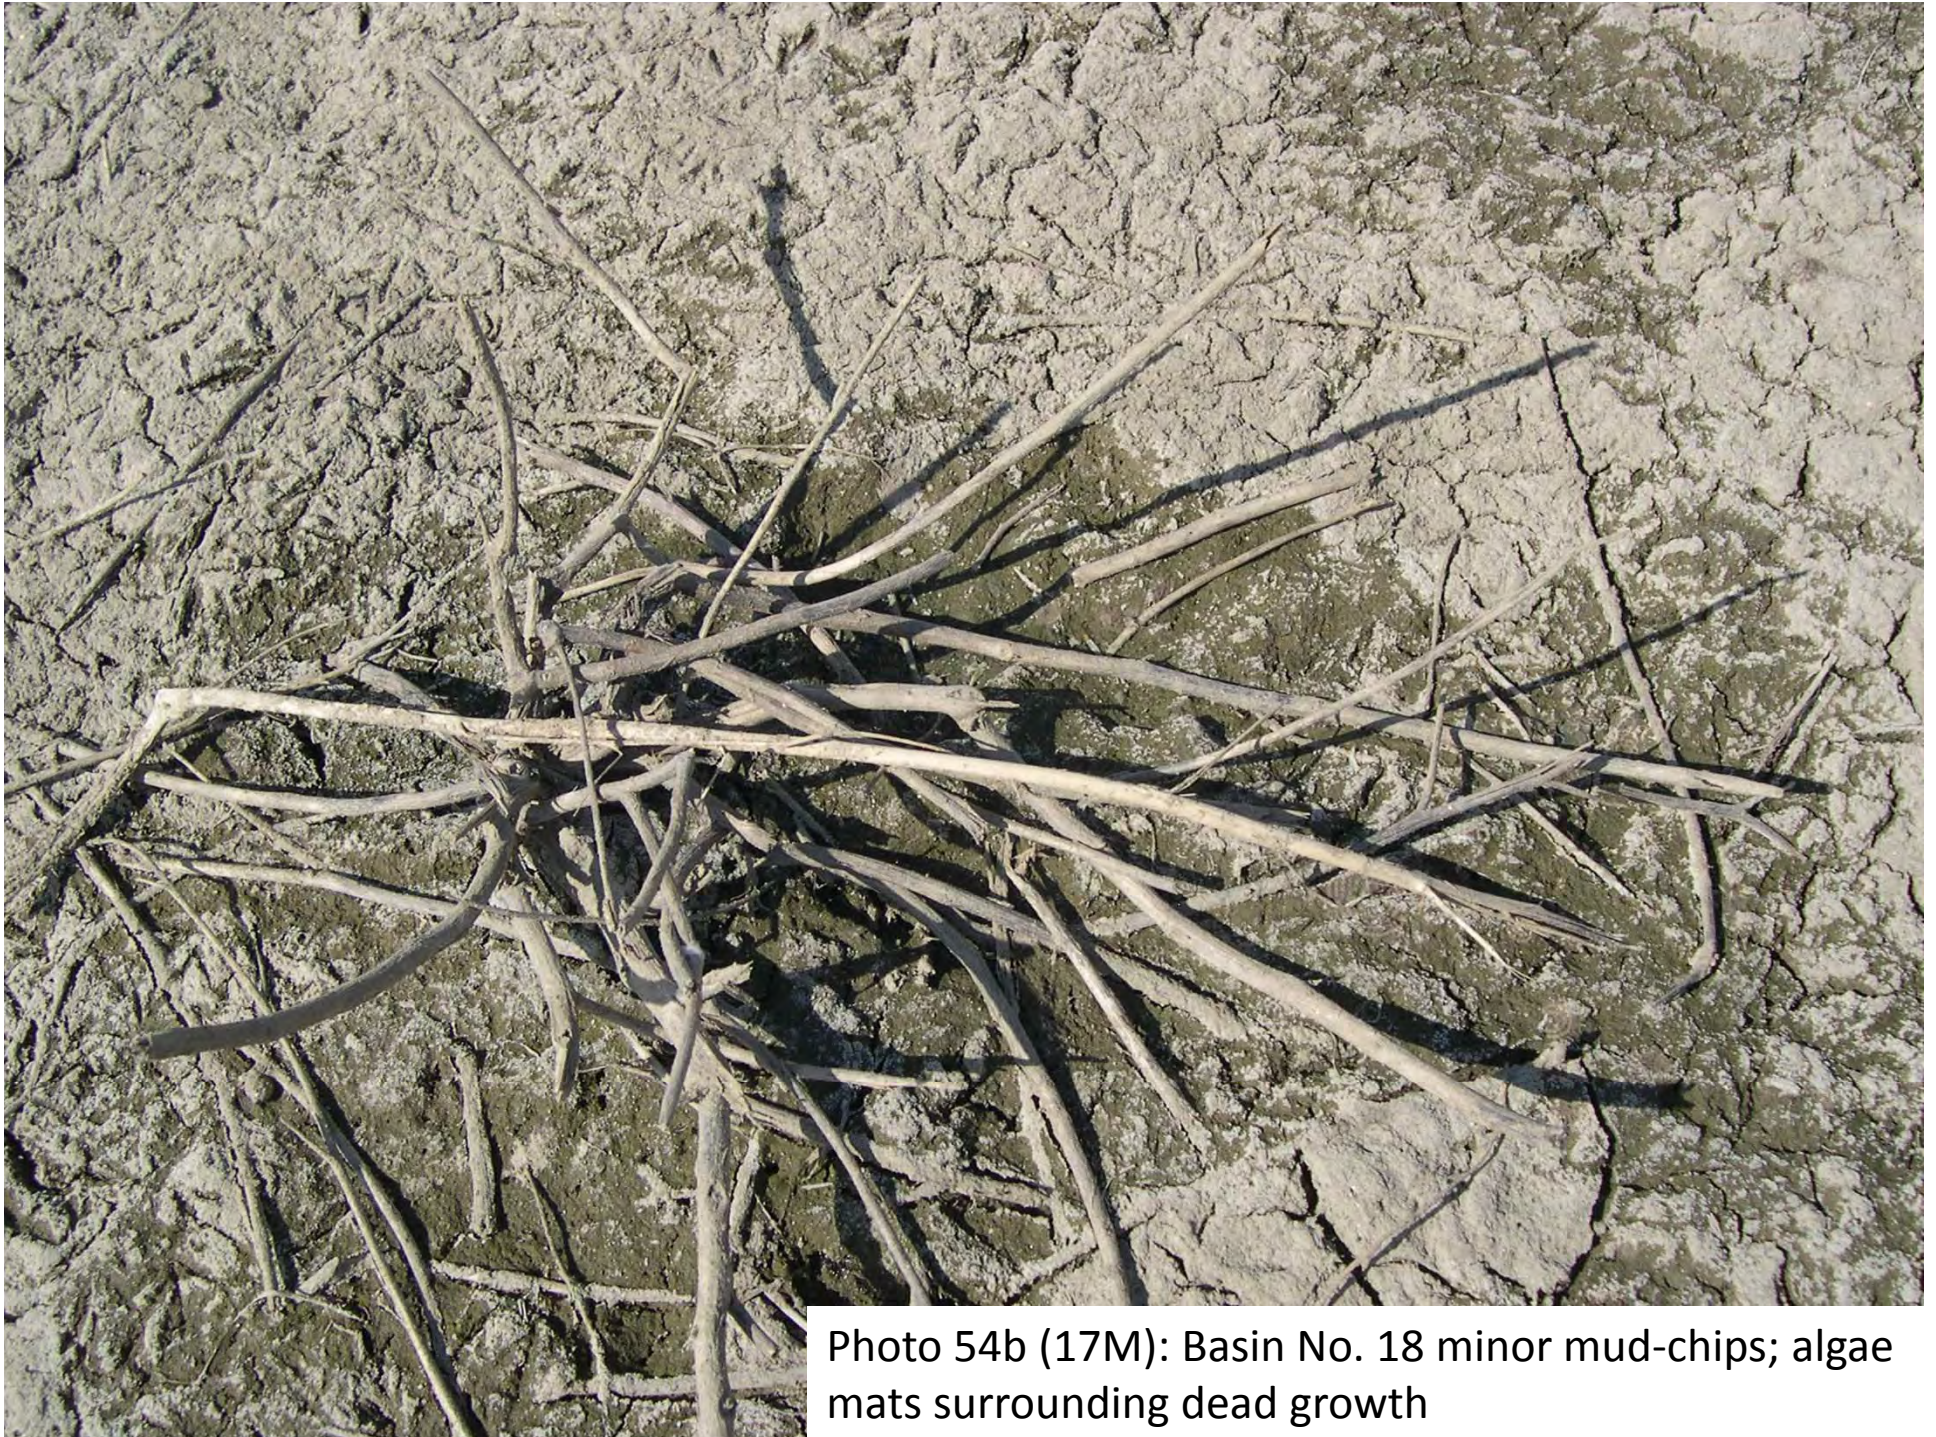
Photo 54b (17M): Basin No. 18 minor mud-chips; algae mats surrounding dead growth

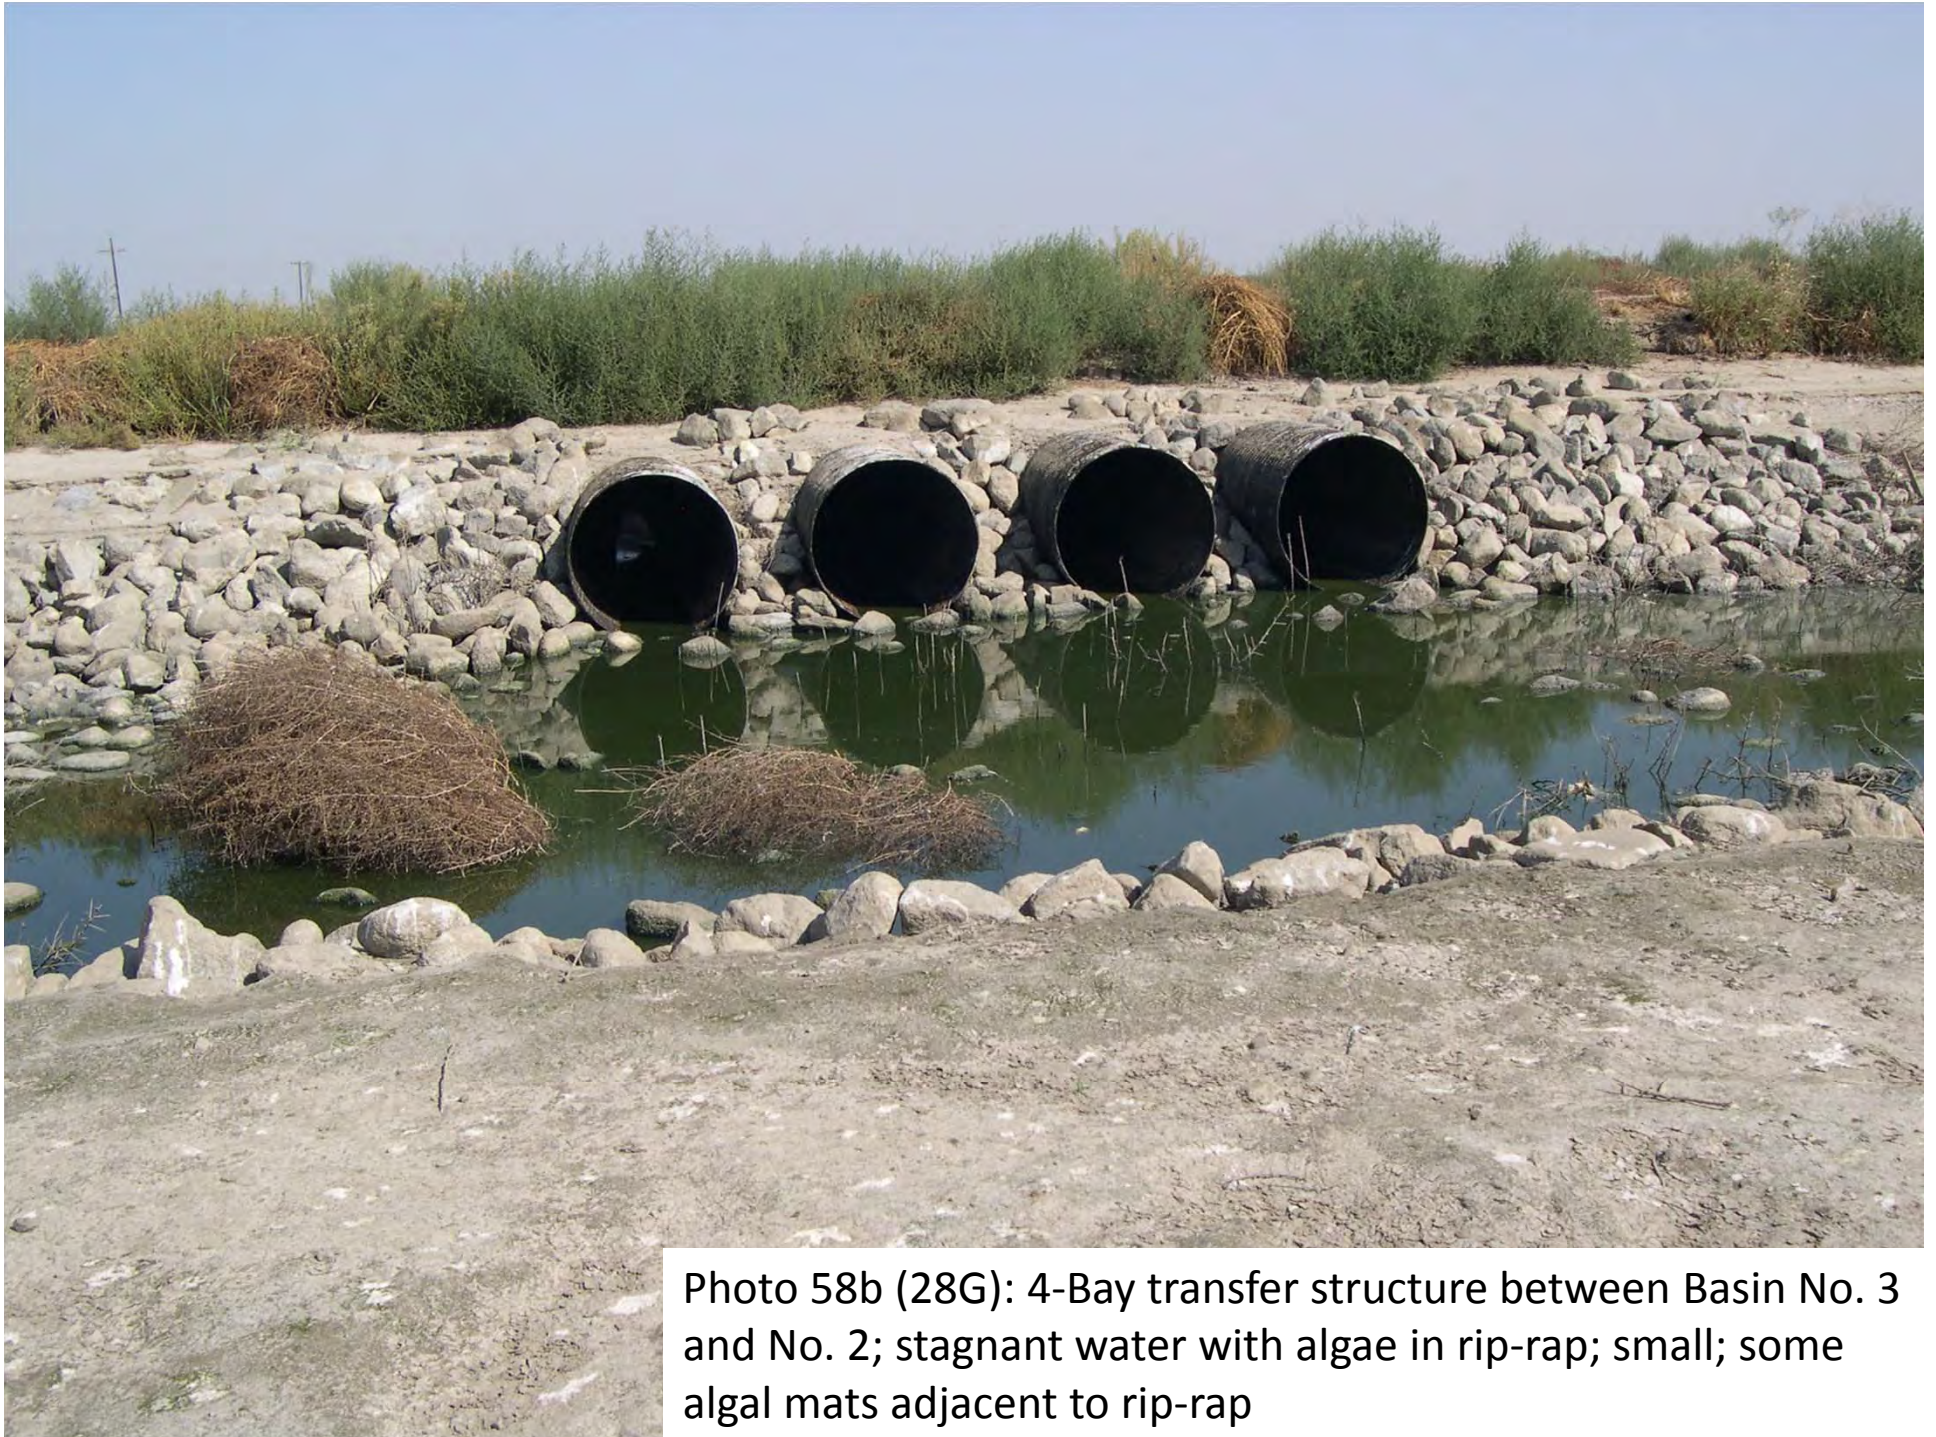
Photo 58b (28G): 4-Bay transfer structure between Basin No. 3 and No. 2; stagnant water with algae in rip-rap; small; some algal mats adjacent to rip-rap
